Preliminary Bat Roost & Emergence Survey Report

Client:	Mr & Mrs O’Gorman
Site:	Eaves House, West Bradford, BB7 3JD
Report Issue Date:	23/01/2025
Report Author:	Carol Edmondson MSc MRSB

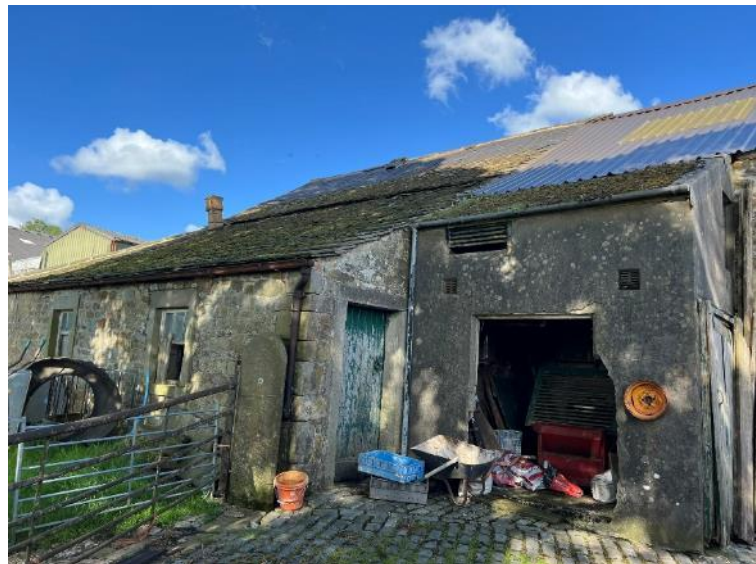
The property is a traditional barn constructed of solid stone walls with a dual pitched slate roof covering, with some parts corrugated sheets, over timber purlin and rafter construction with kingpost trusses.

To the west and north elevations was a single storey wrap around extension with a single pitch roof of slate tiles, forming a cat-slide pitch and block-built walls.

Figure 3: south end of the west elevation, showing part corrugated roof covering and single storey extension.

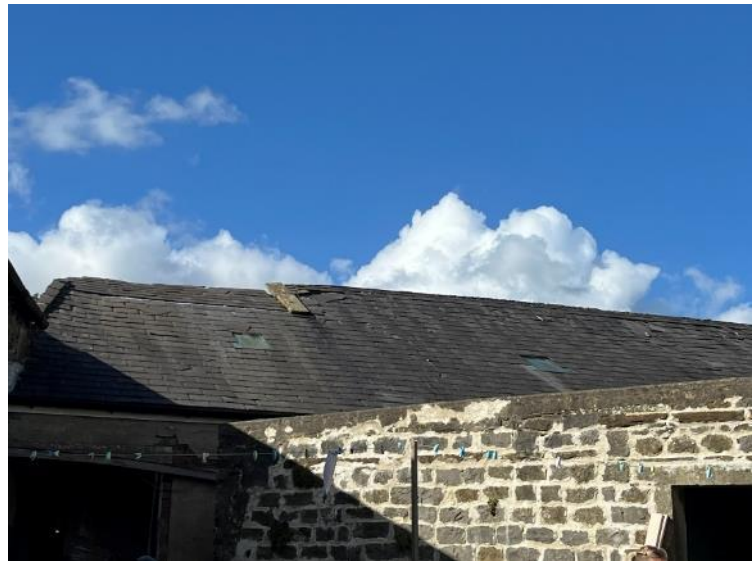
The roofing materials were in a poor state of repair in some areas, leaving gaps under slipped or missing slates, and missing ridge tiles giving access to the ridge, and suitable roosting gaps for crevice dwelling bats.

Figure 4: South facing roof pitch of B3, and front fascia of B2. Gaps can be seen in the roof materials at the ridge of B3.

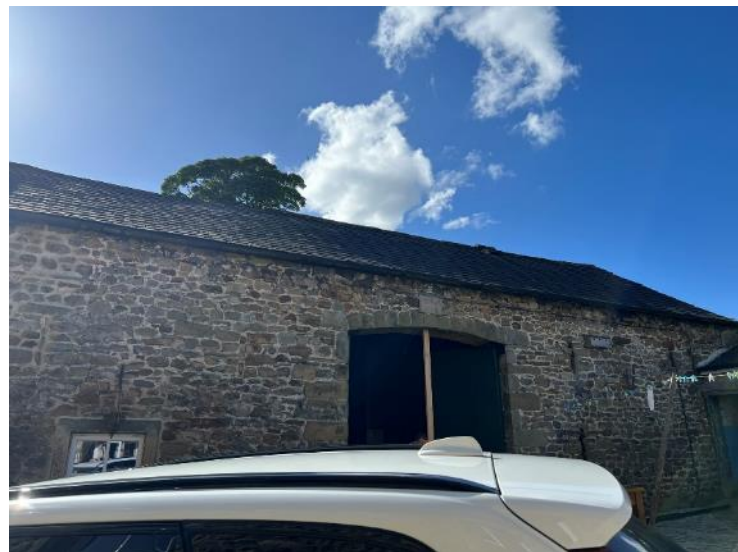
Figure 5: B1 east elevation, main entrance.

To the rear (north elevation) of B3 there were gaps at the wall tops which could afford entry to the buildings by birds or bats.

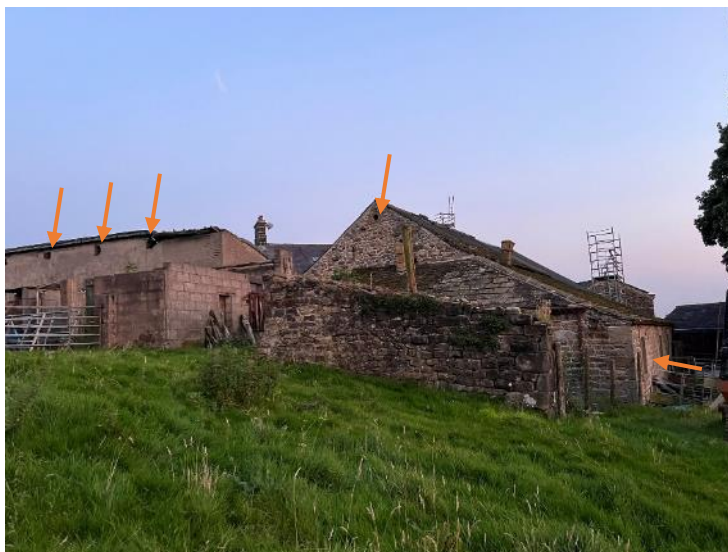
Similarly at the apex of B1 on the north gable end.

Figure 6: B1 & B3: North elevations with openings marked by arrows.

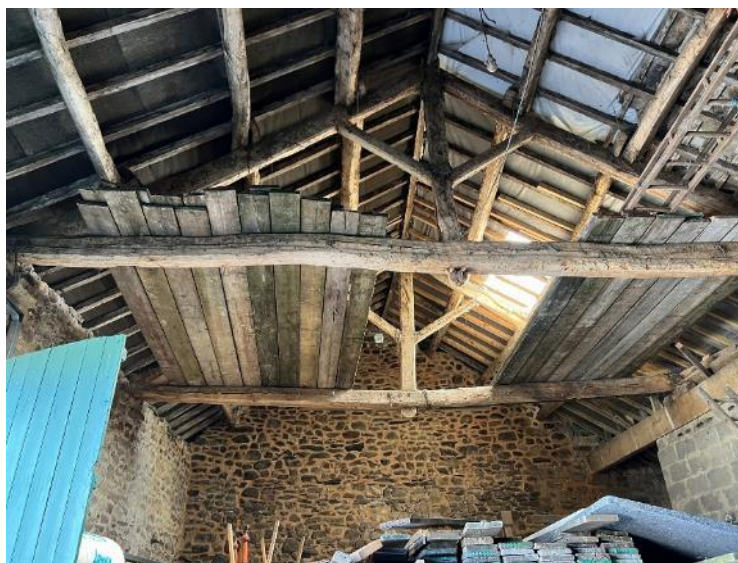
The roof structure of B1 formed suitable roosting gaps for crevice dwelling bats in the joints, and behind purlins.

The beams & joists also formed suitable perching and feeding sites for both bats and barn owls.

Figure 7: Example of exposed timbers and roof lining of B1.

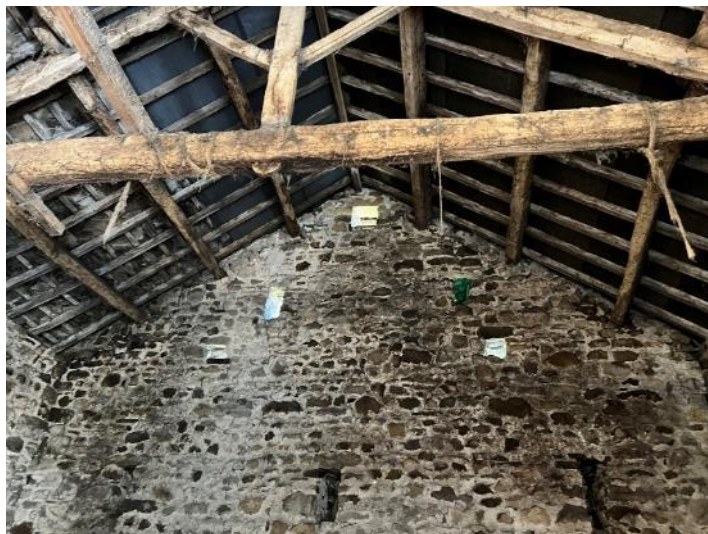
Figure 8: Showing the roof open to the underside of the tiles in places in B1.

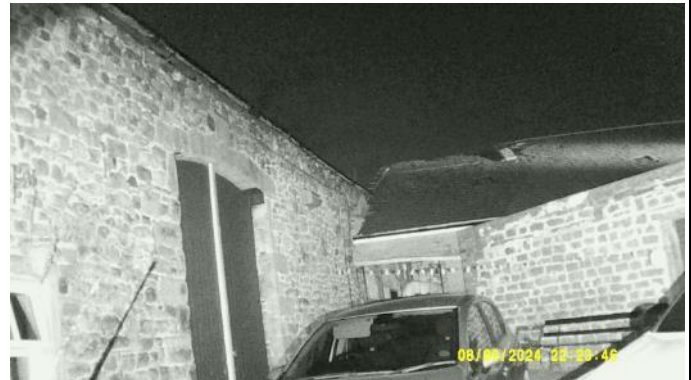
**Camera Position 1 & Surveyor P1
 Nightfox Whisker survey 1 & 2, Flir thermal Survey 3.**

Observing the courtyard formed by B2, B1, the entrance to B3 & the farmhouse.

Moderate level of foraging by several common pipistrelle bats in the courtyard and flying over the buildings, including entering and exiting the open barn door to B3 (E on image).

On survey #1 a single bat landed above the large barn door to B1 (D on image below), rested for 1 minute then flew off again (G).

Survey#3: FLIR thermal camera footage showed bats flying and foraging in the doorway of B3, either from the courtyard, or within, consistent with the Nightfox Whisker footage on survey #1 and surveyor notes.

No bat emergences recorded on any of the surveys that didn't correspond with bats seen entering to forage (from P2).

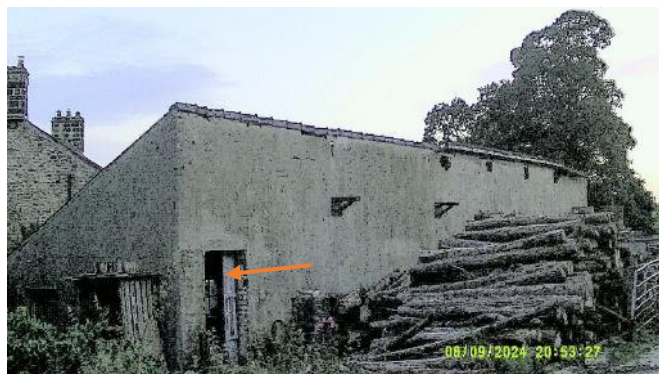
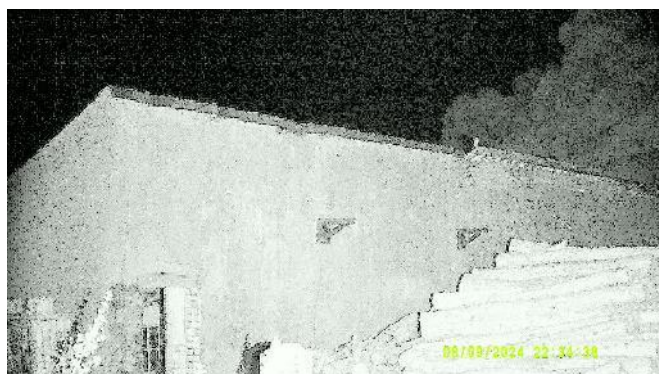
Camera Position 2 & surveyor P2

Observing the east and north elevations of B3

High levels of foraging by common & occasional soprano pipistrelle bats (passing surveyor from the shippen to the north on all 3 surveys), foraging in the yard, passing over B3 and circling the site.

Survey 1 & 2: Single C. pipistrelle bat seen entering the open doorway early in the survey (arrow on image upper right), corresponding with timing of bats seen foraging in the doorway at P1.

No bat emergences recorded on any of the surveys that didn't correspond with bats seen entering to forage.

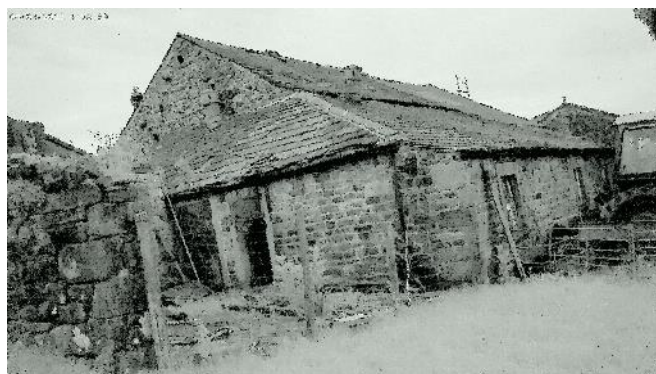
Camera Position 3 & surveyor P3

Observing the west gable of B3 & north/west elevations of B1.

A high number of common and occasional soprano pipistrelle bats were observed foraging around the building, passing from the east behind the surveyor's position. There were also occasional passes over the buildings (example shown in thermal image still, below right). Myotis species were seen foraging around mature trees to the west. Social calls were frequently recorded throughout all surveys.

No bats were seen entering or emerging from this area of the buildings.

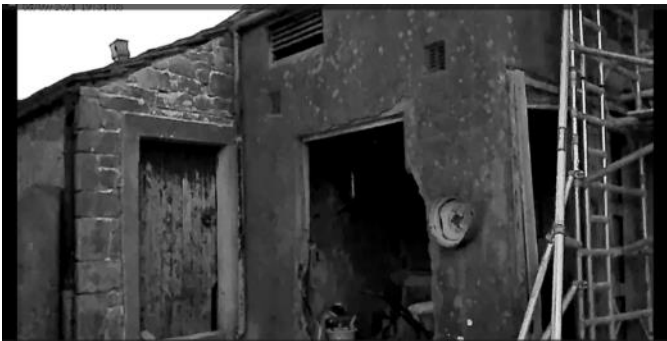
<p>Static detector recordings: (Peersonic RPA4 + external microphone)</p>	<p>B1: No bat calls recorded B3: Occasional common pipistrelle foraging from 30 -40 mins after emergence time. 1-3 individuals.</p>
