# **Preliminary Bat Roost Assessment & breeding birds survey**

## **Site: 144, Ribchester Rd, Salesbury**

30<sup>th</sup> November 2024

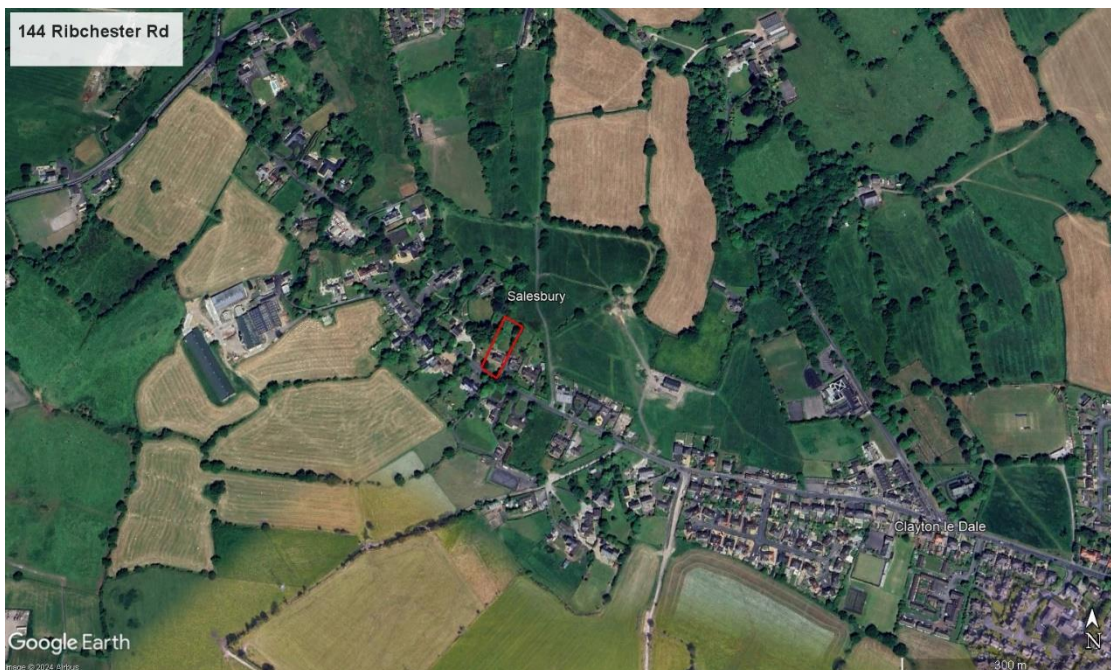
Figure 1: Aerial photo of site, showing surrounding landscape structure.

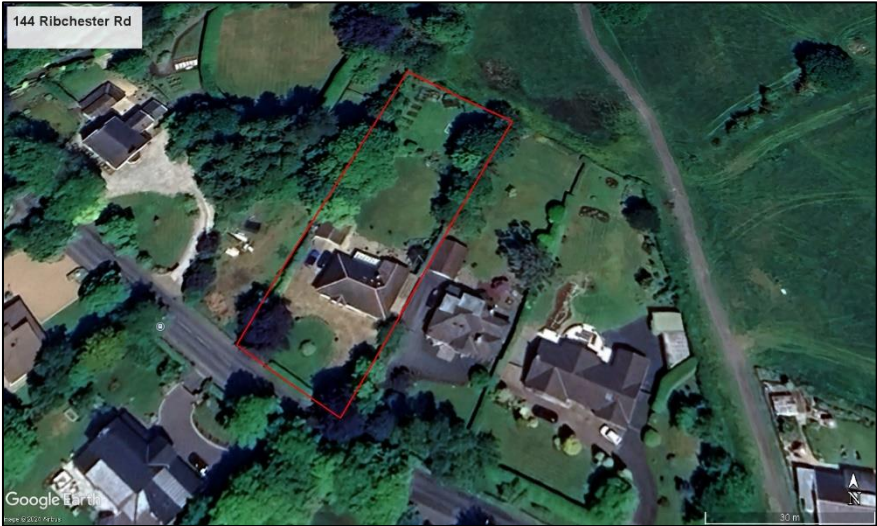
<p>Photo 1: Overview of the site with the structure to be demolished outlined.</p>
<p><b>Potential roosting features:</b></p> <p>All roofline materials, windows and doors were uPVC and in an excellent state of repair, with no gaps to the wall or cracks that could be used by bats for roosting.</p>

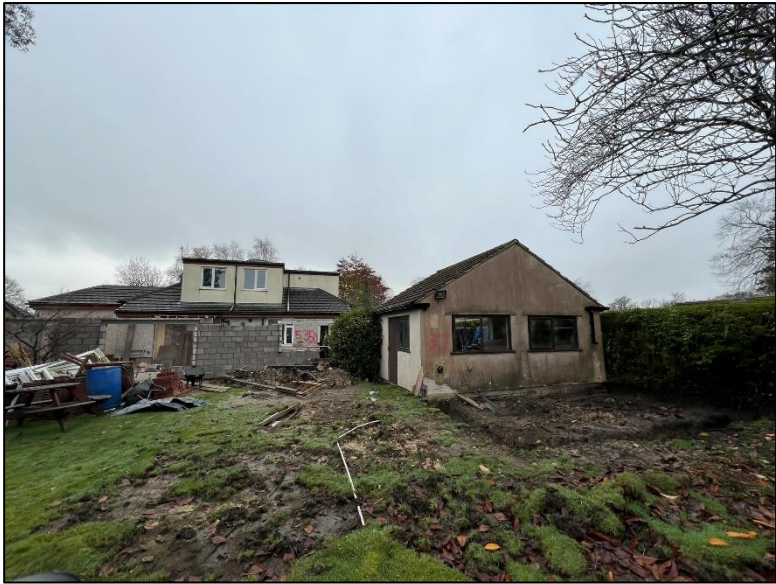
<p>Photo 2: North elevations of the house, showing the area where the single storey extension is to be added.</p>

Roofing materials were all in an excellent state of repair, with no lifted or cracked tiles forming potential gaps for crevice dwelling bats.

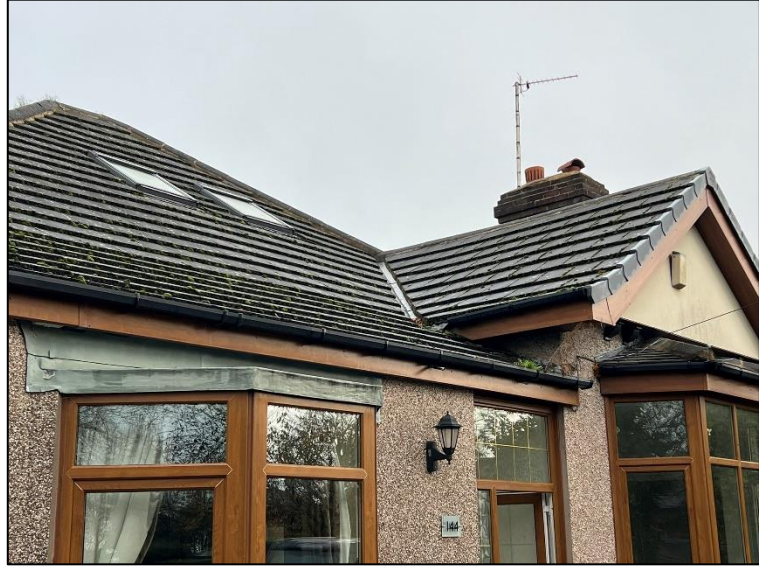
Photo 3: South elevation of the building, showing roof tiles and ridge and roofline materials in good order.

Overall, there were no gaps or crevices that could be used by bats for roosting in the building.

No potential bat roosting features (PRF's).

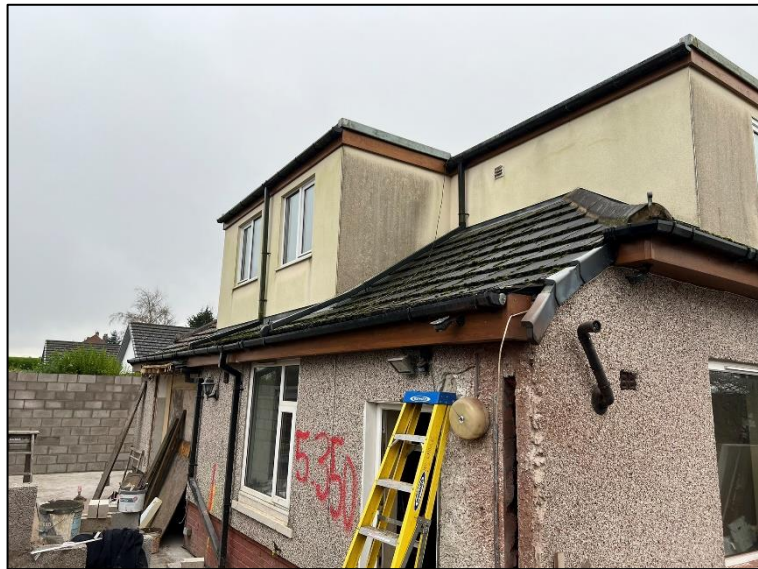
Photo 4: North elevation showing close-up of area where the extension will be constructed. The corner section of the gutter box is shown removed for inspection.

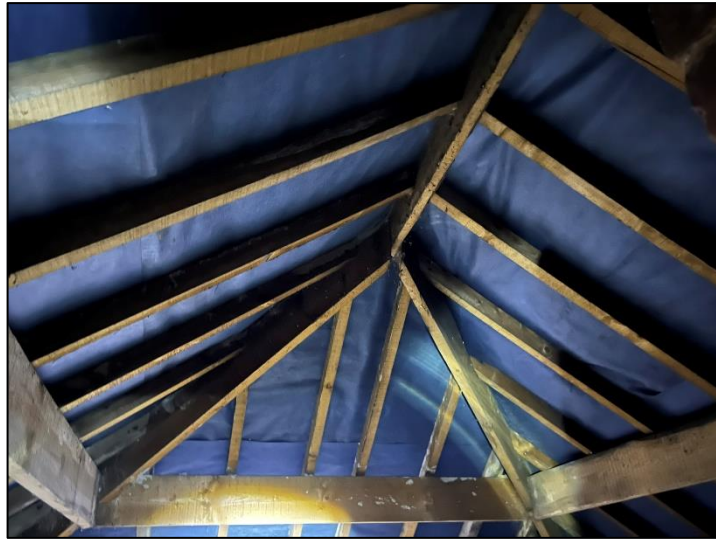
There were areas of the roof space along the eaves on all elevations, accessible for survey.

There were no signs of these spaces having been used by bats. The roofing felt appears to be recent (breathable roof membrane), with no daylight gaps visible.

Photo 5: Example of the new roof materials.

<b>Survey assessment conclusions</b>	There is suitable bat foraging habitat in the proximity of this site, and records of EPSML's in the 2km study area. However, taking into account the nature and condition of this small extension, and the lack of potential roosting features as described above, the surveyor considers that the building has a <b>negligible</b> likelihood of supporting roosting bats. The removal of this extension is not considered likely to cause disturbance to any bat roosts potentially present in the surrounding area.
<b>Foreseen impacts</b>	There is a negligible risk that bats could be injured or killed during the building process.
<b>Recommendations</b>	No further surveys. However, if bats are found during any stage of the development, work should stop immediately, and a suitably qualified ecologist should be contacted to seek further advice.
<b>Enhancements</b> <i>The Local Planning Authority has a duty to ask for enhancements under the NPPF and circular 06/2005: Biodiversity and Geological Conservation. Para.99</i>	<p>The installation of a bat box on the building when finished will provide additional roosting habitat for bats in the area e.g. Local supplier:</p> <ul style="list-style-type: none"> <li>• Greenwoods Ecohabitats</li> <li>• <a href="https://www.greenwoodsecohabitats.co.uk/bats">https://www.greenwoodsecohabitats.co.uk/bats</a></li> <li>• Kent Bat Box (timber).</li> </ul> <p>Bat boxes should be positioned 3-5m above ground level facing in a south/south-westerly direction with a clear flight path to and from the entrance.</p> <ul style="list-style-type: none"> <li>• Cavity bat boxes are also a good option in new construction for example available from:  <a href="https://www.nhbs.com/ib-vl-05-vivara-pro-build-in-woodstone-batbox?bkfno=252213">https://www.nhbs.com/ib-vl-05-vivara-pro-build-in-woodstone-batbox?bkfno=252213</a></li> </ul> <p>The use of "Bat tiles are not recommended in this instance due to the presence of the breathable roof membrane, which can entrap bats in the fibres.</p>

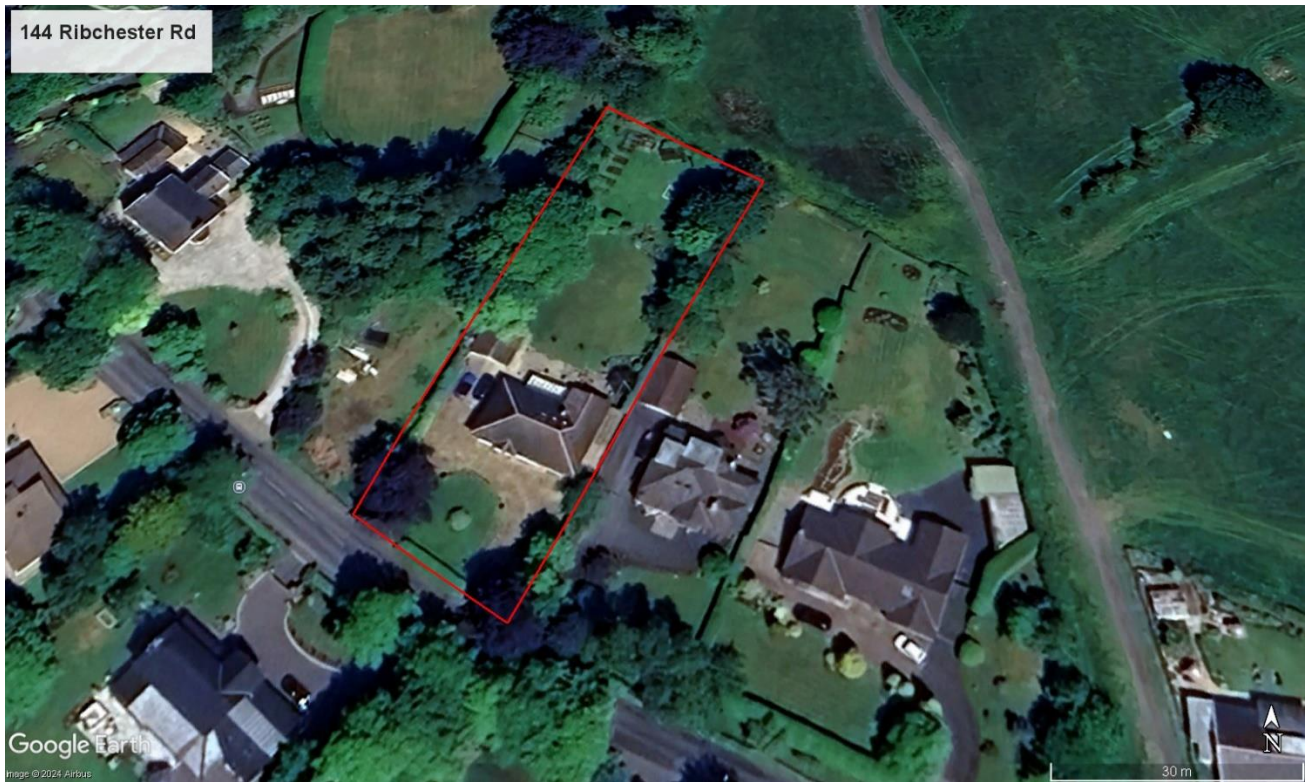
### Appendix 1: Survey Plan

There is one survey building on the site which is illustrated in the map in Appendix 1. The environmental variables recorded at the time of the survey are shown in Table 2.
