**BAT SURVEY, AT -  
THE GREEN  
BOLTON BY BOWLAND**

REFERENCE NO 7184

The proposal is to remove 3no single storey lean to extensions to an existing cottage.

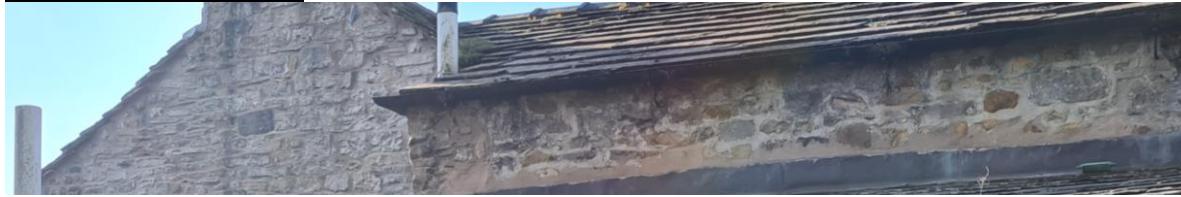
The existing cottage has pointed random solid stone walls

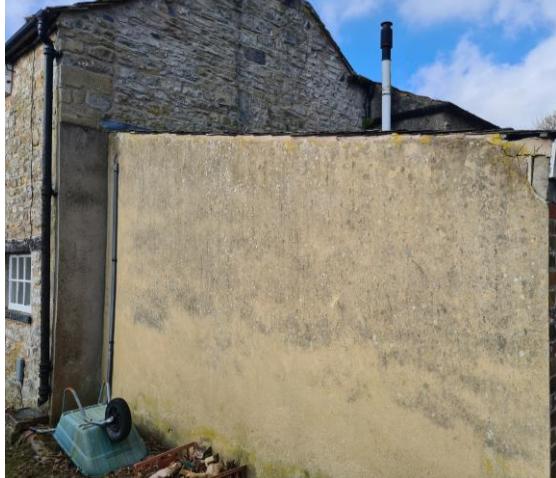
The garage has block/ brick walls with a smooth render finish.

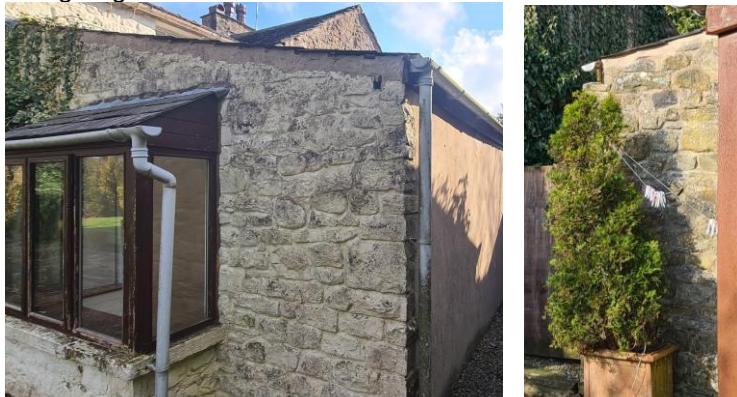
The southwest lean to extension has stone faced side walls and a smooth rendered finish to the southwest elevation.

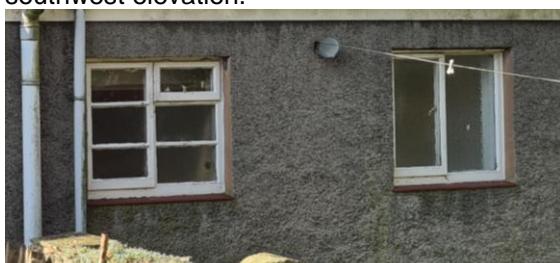
The Northeast lean to has a rough cast render finish.

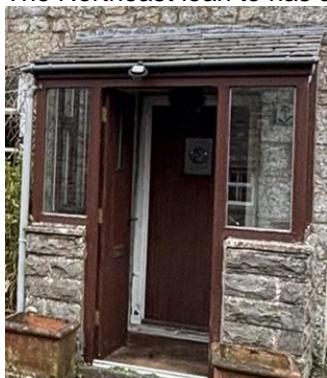
Solid stone base walls with glass above.

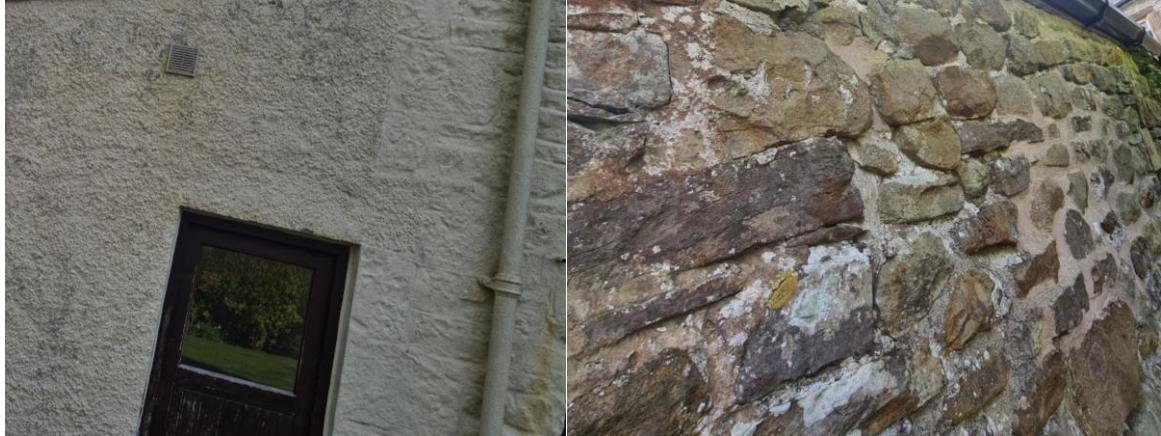
All the stone and rendered walls are in reasonable condition. There are no significant cracks in the render walls. All the pointing is present to the stone sections of wall. No access points were found to be present in the walls to be removed.

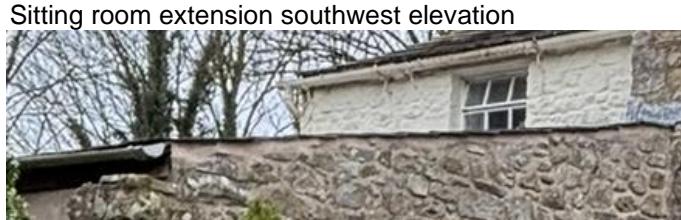
The Garage roof.

House extension Northeast elevation

Sitting room extension southwest elevation

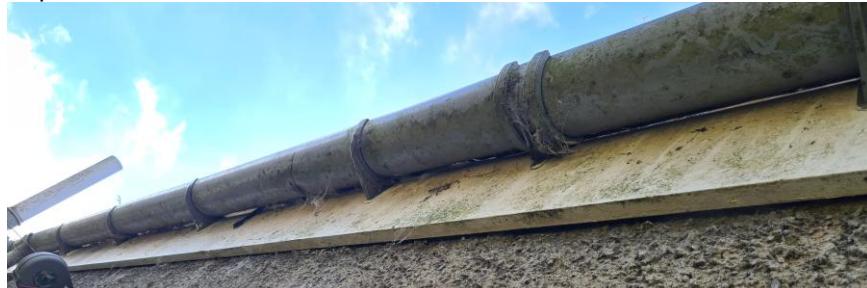
The roofs are in reasonable condition, there are no slipped slates, and all are tight fitting as are the flashings at the wall abutments.

The timber fascia's on all the structures were largely flush fitting, any marginal gaps could be closely inspected.

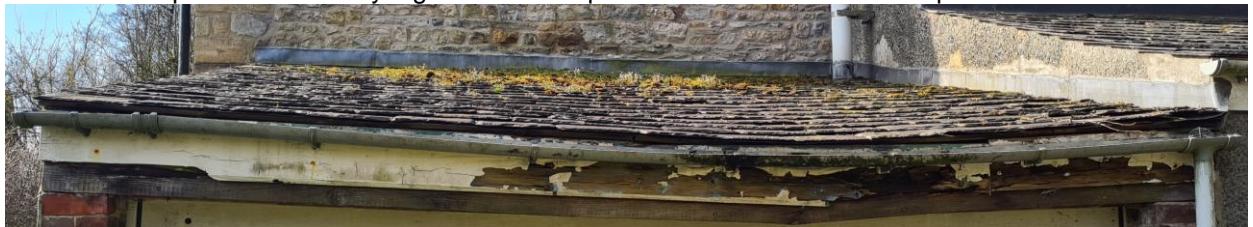
The garage door opening timber beam has split leading to deflection in the roof and preventing entry into the building. The eaves and any crevices were closely inspected. There were no signs of current or historic bat presence and any high value roost potential was not found to be present.

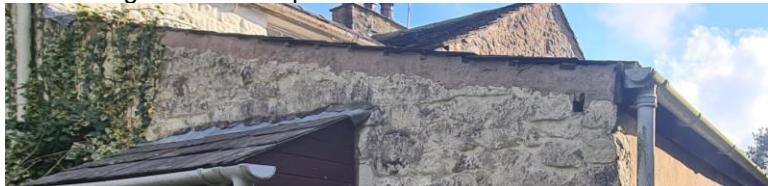
All the verges were well pointed northwest elevation of southwest extension

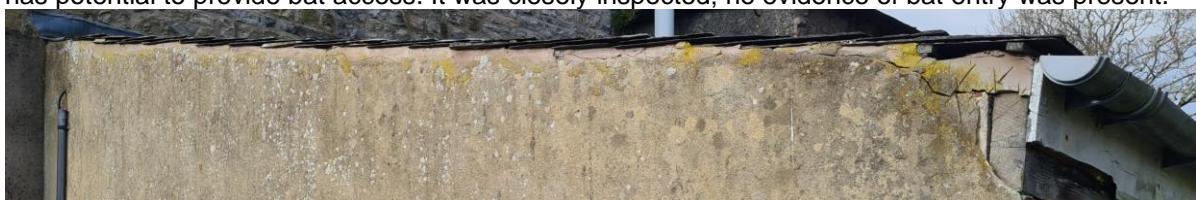
Garage southeast elevation, some slight degradation of the pointing at the eaves forming a gap which has potential to provide bat access. It was closely inspected; no evidence of bat entry was present.

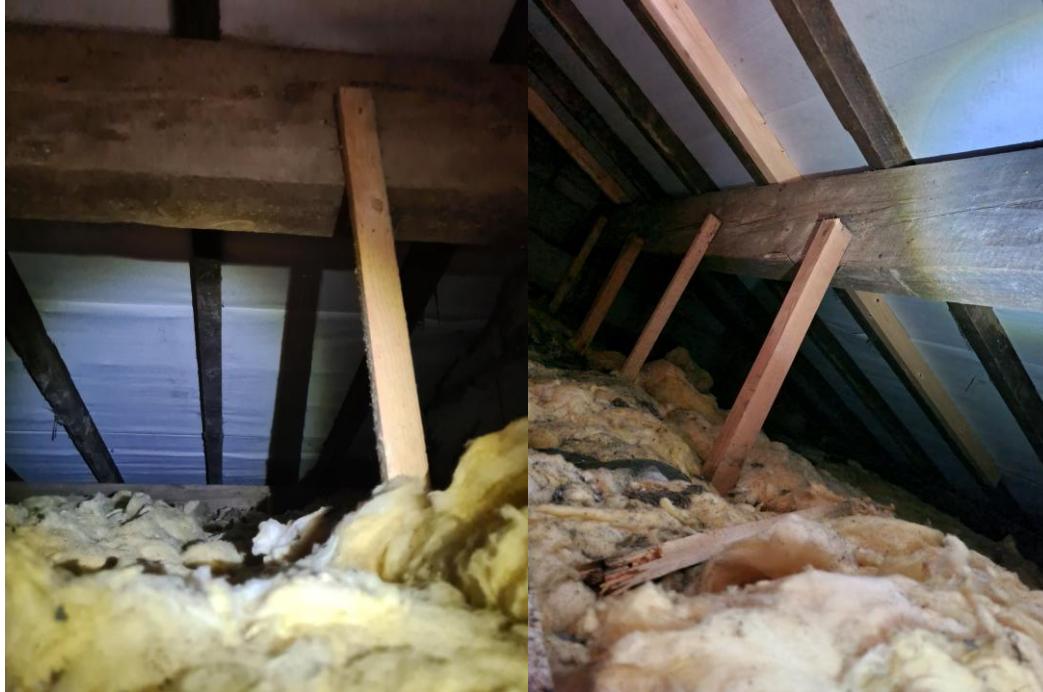
The roof void over the sitting room extension was viewed from the ceiling hatch. The timbers were in good condition as was the modern roof underlay. Insulation quilt was present at ceiling level.

The space was clean with no insect or dropping remains. The structure did not have any cracks or crevices with the potential to provide roost habitat for bats. No current or historic evidence of bat presence was found.

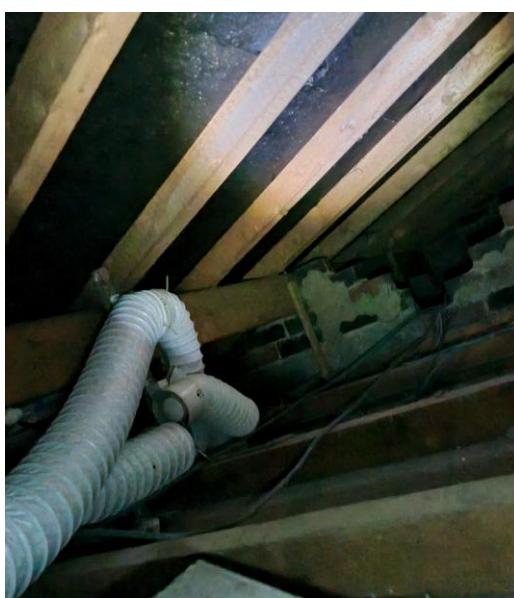
The roof void over the northeast extension was viewed from the ceiling hatch. The timbers were in good condition as was the roof underlay. Insulation quilt was not present at ceiling level.

The space was clean with no insect or dropping remains, the structure did not have any cracks or crevices with the potential to provide roost habitat for bats. No current or historic evidence of bat presence was found.

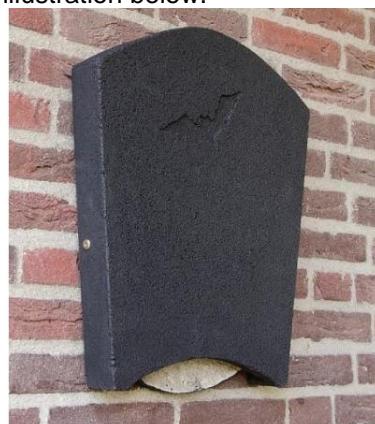
**BEAUMARIS BAT BOX**

The basic requirement being that a Sku Beaumaris (or similar) bat box be fixed to the Southeast / southwest elevation, relatively sheltered from strong winds and ideally 3-4m above ground level., in accordance with manufacturer's instructions
