# Preliminary Bat Roost Assessment Report

**59 Kemple View,  
Clitheroe,  
BB7 2QD**

**27.03.2025**

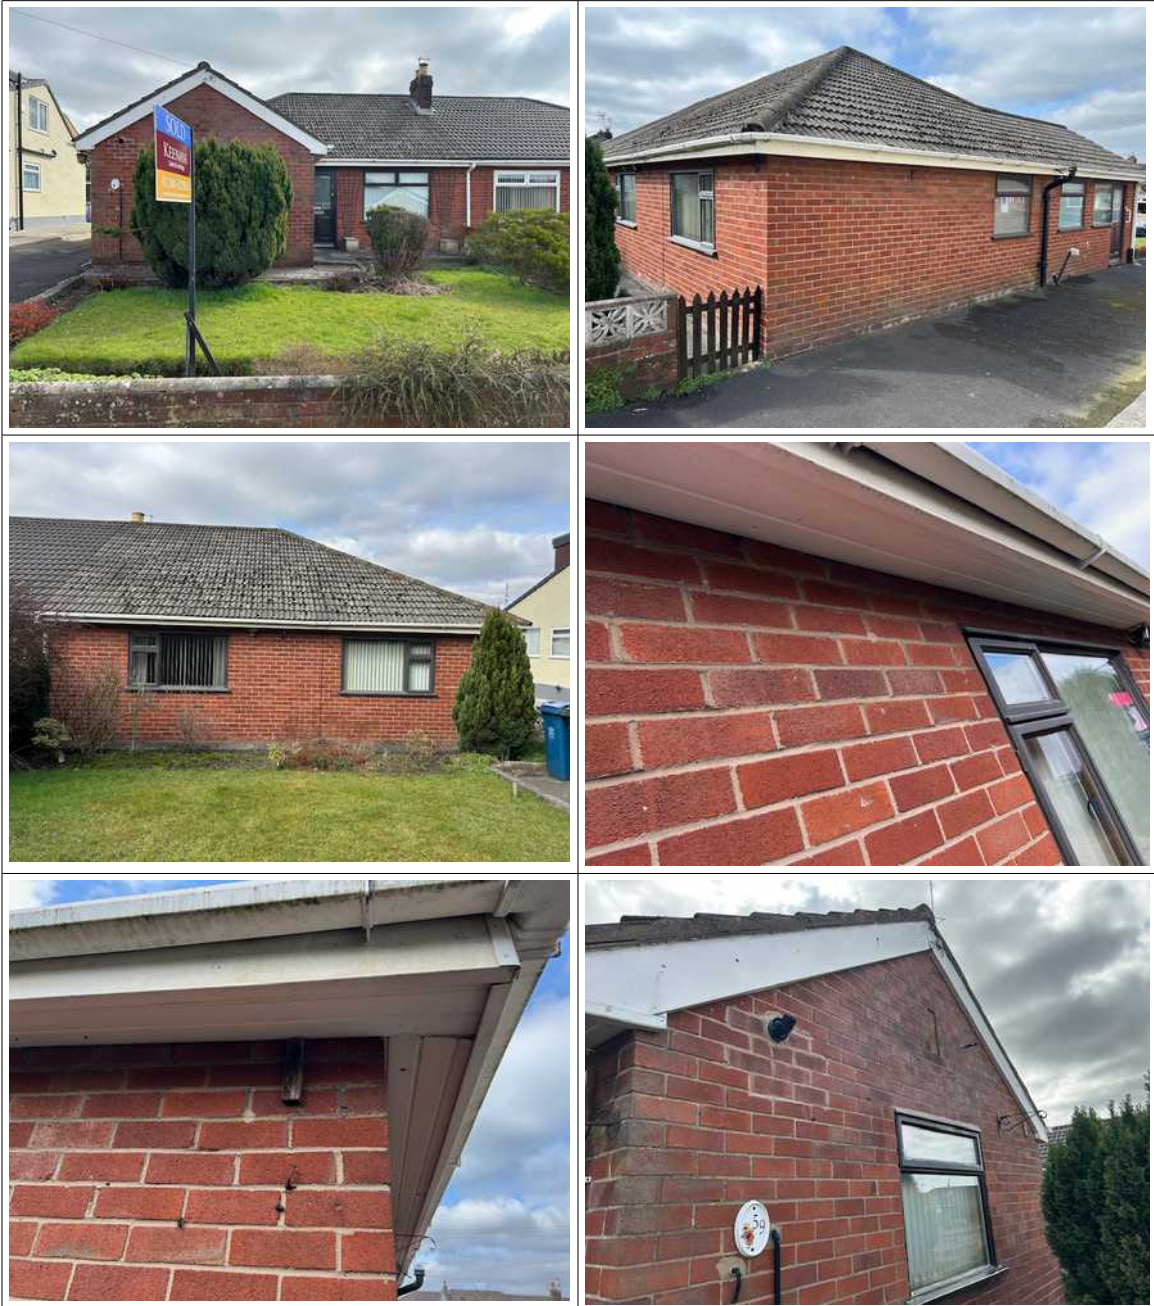
The property consists of a bungalow with a multi pitched corrugated cement tile roof.

External walls are generally well pointed and with no obvious cracks, gaps or crevices. Eaves and gable end are well sealed. Soffits are close fitting and well sealed. Roof tiles are moss covered and close fitting with no obvious lifted, missing or slipped tiles present. Ridge tiles are close fitting and sealed.

The property can be considered to offer negligible roosting potential.
