ARBORICULTURAL IMPLICATIONS ASSESSMENT

PROPOSED DEVELOPMENT

KEMPLE DOWN BIRDY BROW CHAIGLEY CLITHEROE BB7 3LR

Author: C. Salisbury
Date: 11 December 2024
Ref: TRE/KDBBCC/Rev B

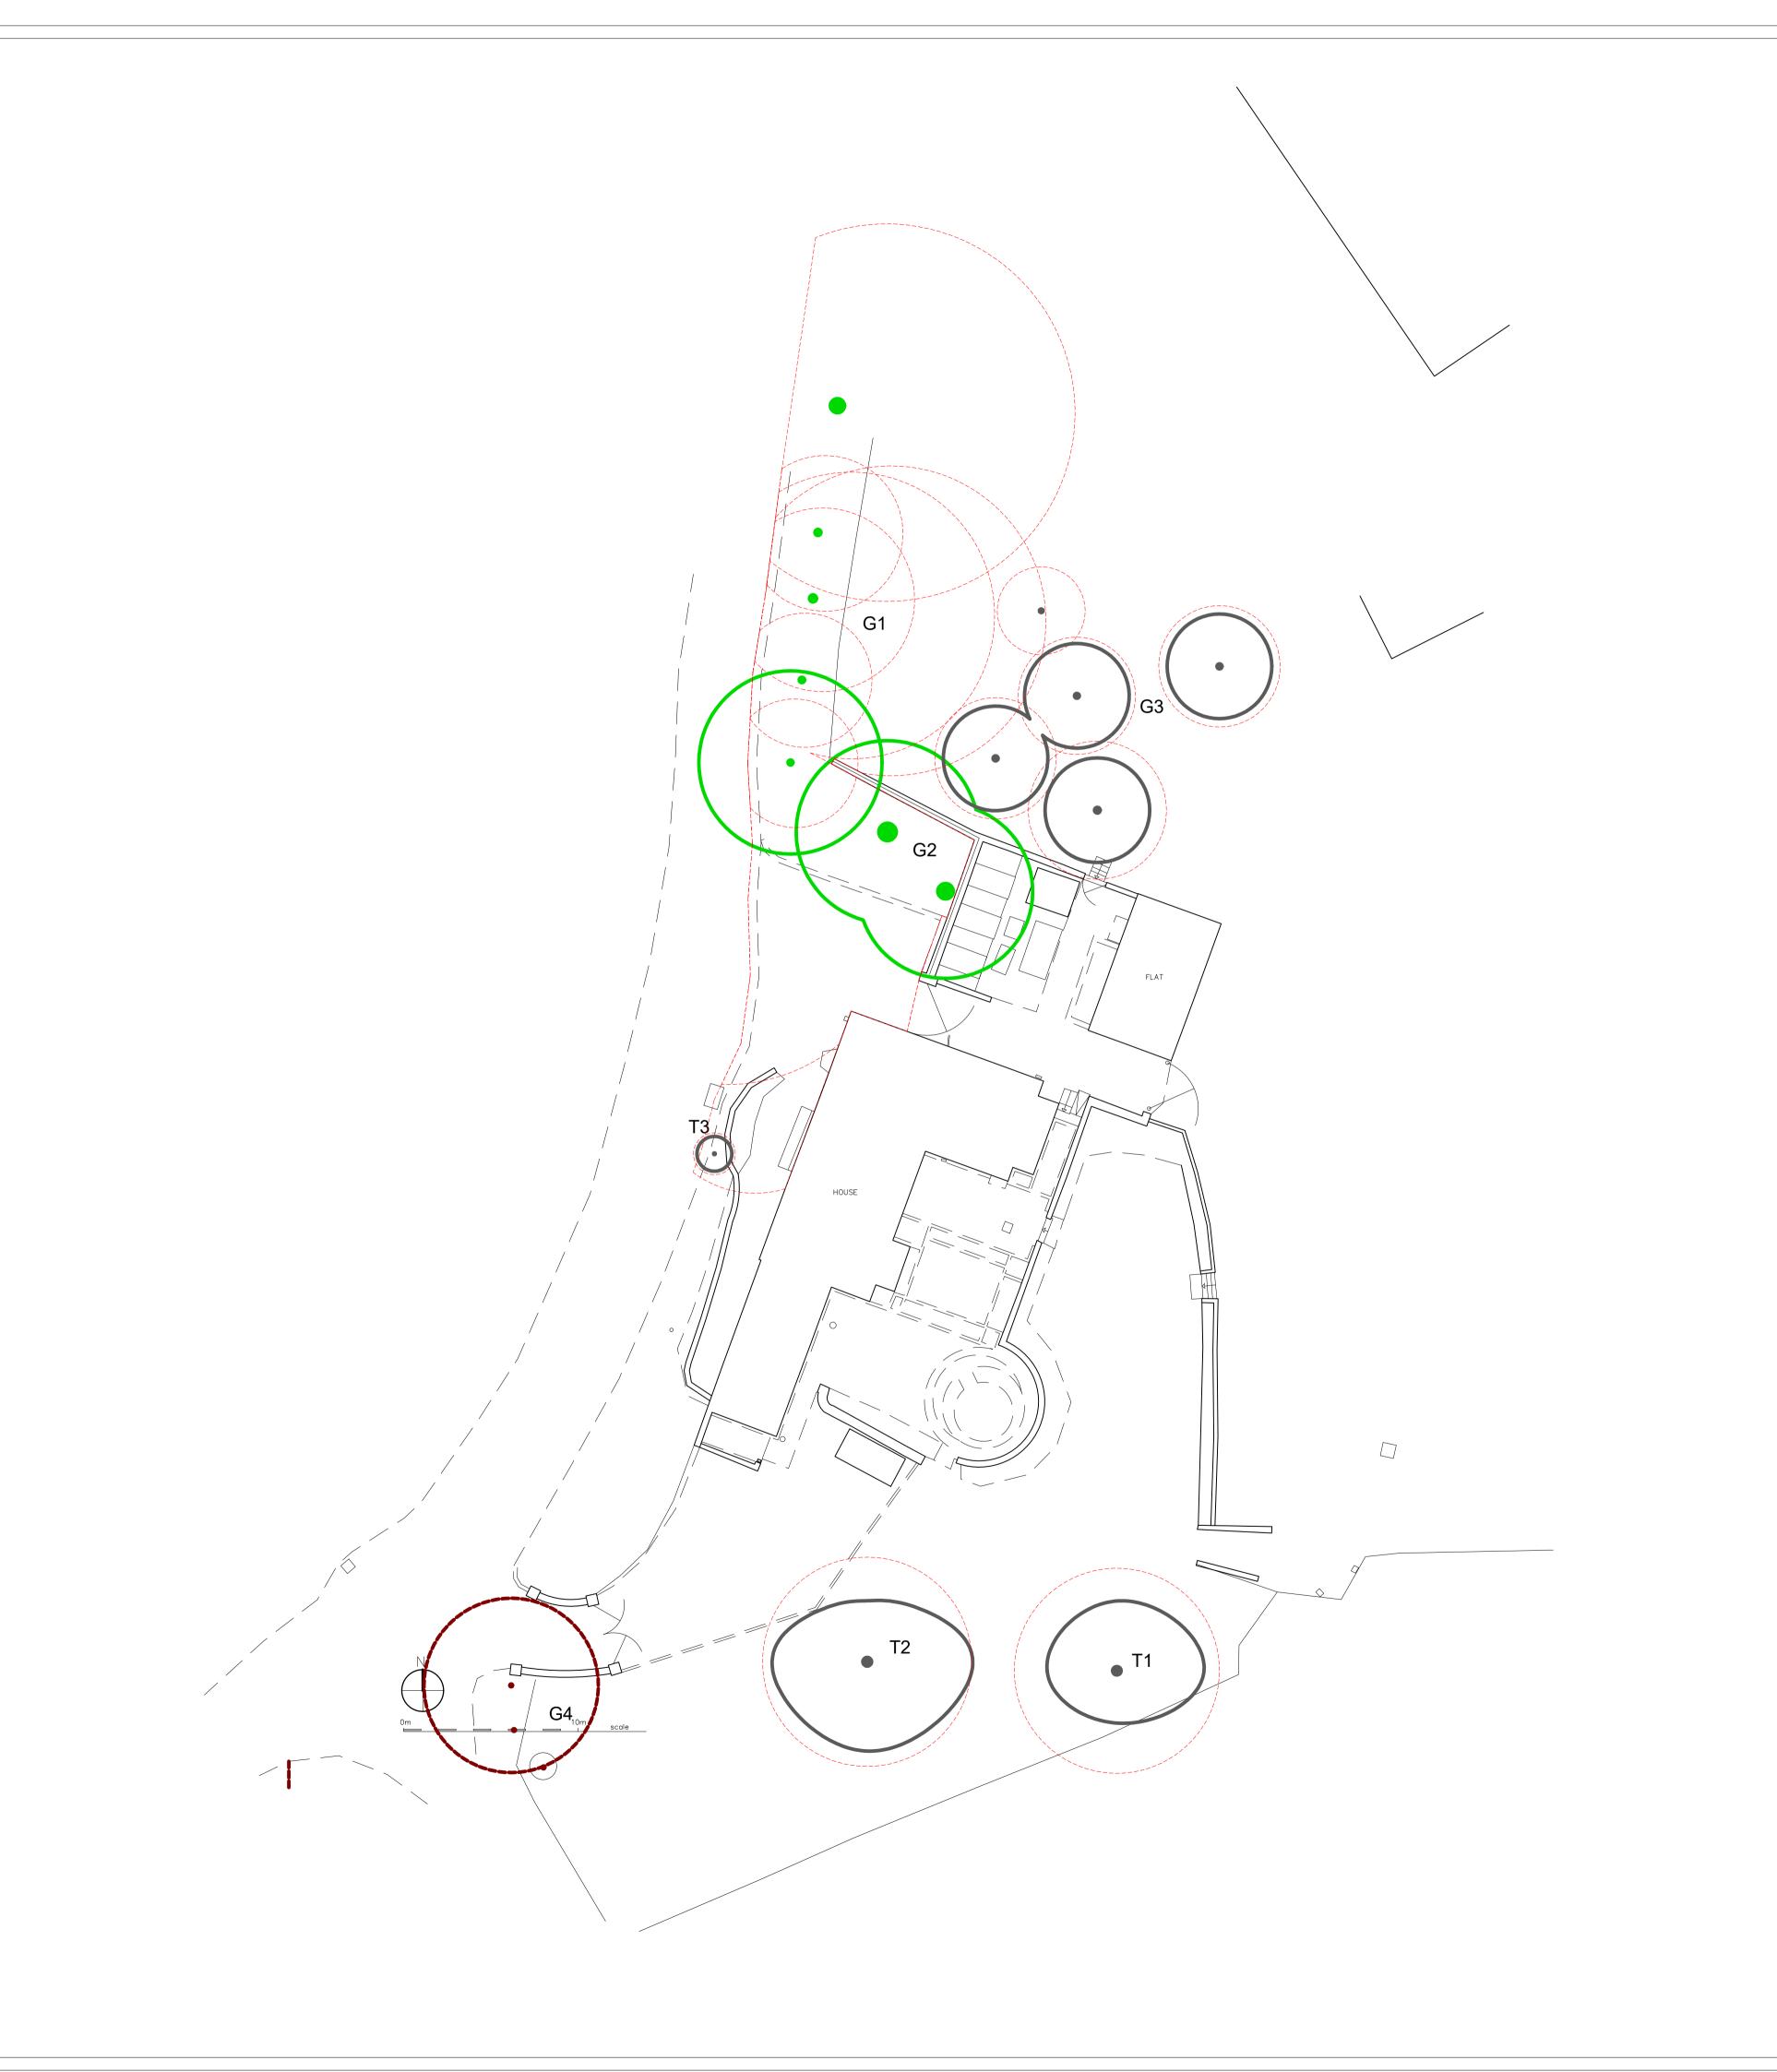
Drawing Title: BS5837 Plan

- 3.1 Due to the proposed development and its associated infrastructure there are a number of locations where the proposals are in close proximity to the trees surveyed. The Site Layout Plan within appendix three identifies the trees in relation to the proposed development.
- 3.2 In order to fully assess the impact of the proposals an Impact Table has been created detailing each tree, which shows the proximity of the associated works to the tree.
- 3.3 This can then be assessed in accordance with BS 5837:2012 to determine whether the development will have a detrimental impact on the health of each tree. Once this has been determined remedial measures can be detailed to reduce the impact the proposals will have on the treescape.

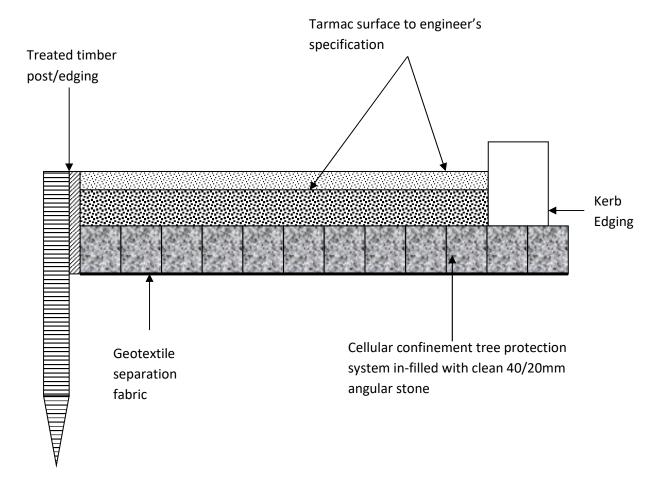
Tarmac Surface

GEOWEB BASED CONSTRUCTION – (INDICATIVE ONLY)

Depth of confinement system variable according to use- refer to manufacturer

- Surface layer to be scraped off. This can be done either by hand or by very small machinery.
- Erect protective fencing to the edge of the construction area.
- Spread a sub grade material over the length of the driveway to fill any small ruts.
- Construct edging using treated timber if required.
- Lay geotextile mat over smoothed area.
- Extend the Geoweb perforated tree root protection system over the area of the driveway with sufficient overlap such that kerbs can be constructed on top of the Geoweb.
- Fill the voids within the Geoweb with reduced fines Type 1 material working into the site over the top of the Geoweb.
- Lay kerbs and surface over the Geoweb such that the construction binds itself together.
- Construct finished surface as required in line with guidance illustrations below.
