# **Bat Survey Report and Method Statement European Protected Species (Bats)**

**Kemple Down,  
Birdy Brow,  
Chaigley,  
Clitheroe,  
BB7 3LR**

**31.08.2024**

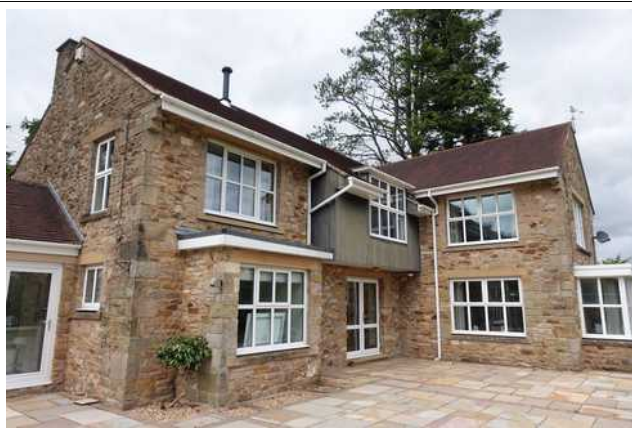
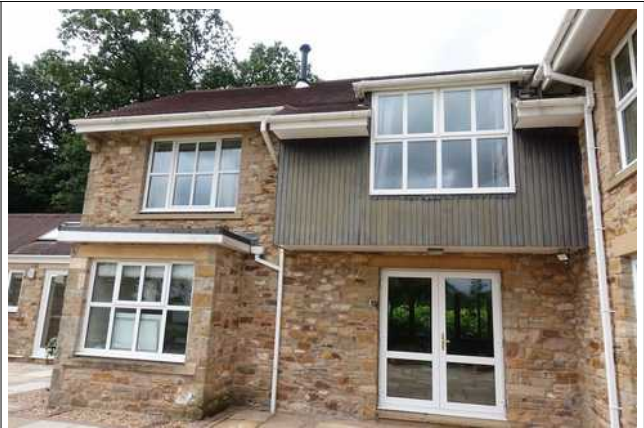
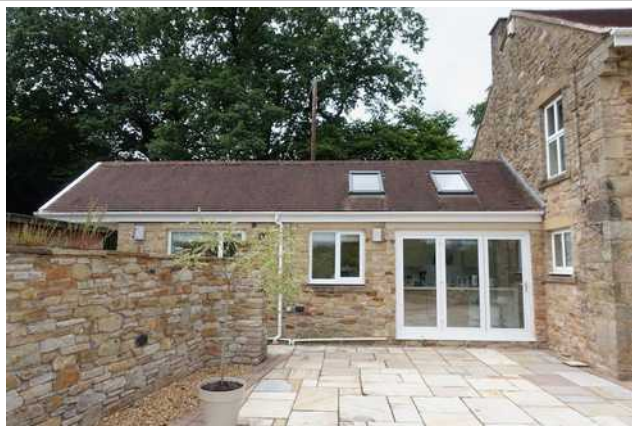
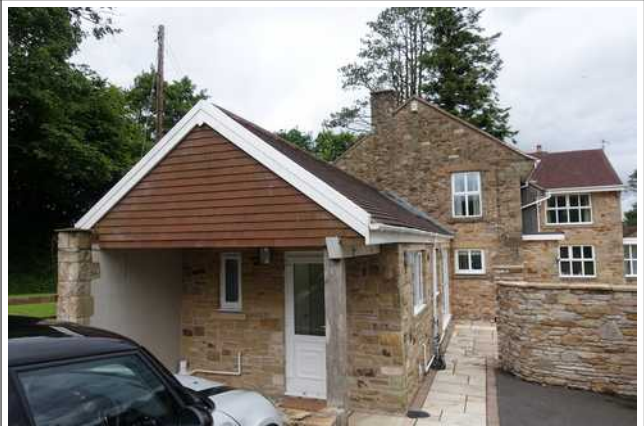
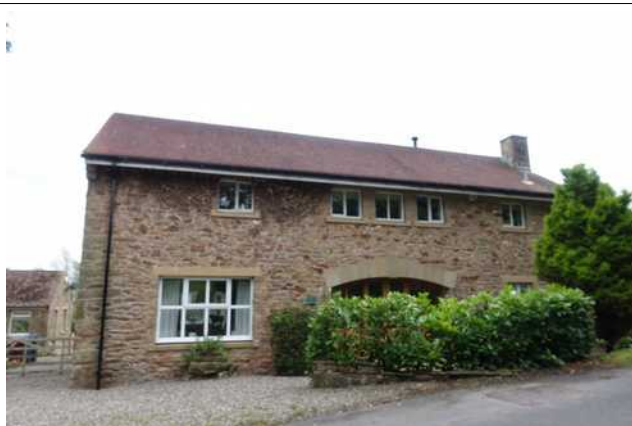
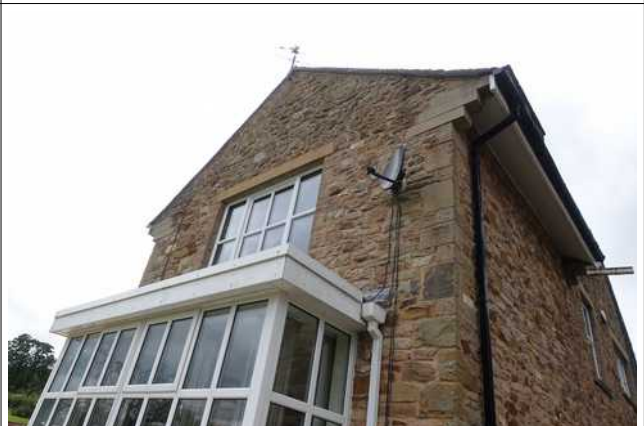
The property consists of a stone built detached two storey house with double pitched tiled roofs. A single storey extension is present on the southern gable end. A porch is present on the extensions southern gable.

Exterior walls are well pointed with no suitable cracks, gaps or crevices present. Gable ends are pointed and sealed. Upvc soffits and fascia boarding is close fitting.

Roof tiles are close fitting with no obvious slipped, missing or lifted tiles present. Ridge tiles are pointed and sealed.

The building was assessed as offering low bat roost potential when location and surrounding habitat was taken into consideration.

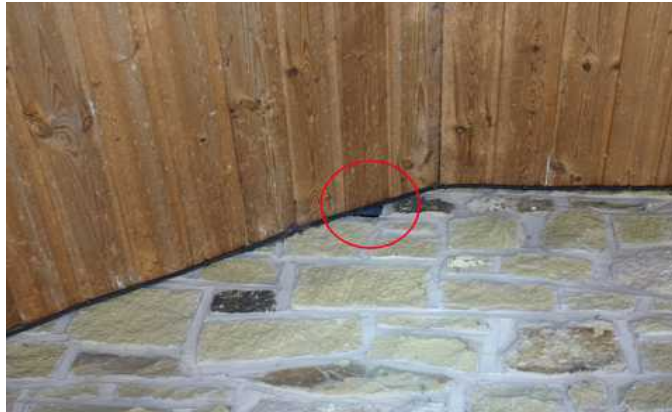
A visual search of building was carried during the preliminary bat roost assessment. A single gap was noticed below timber lining the extension porch.

Surveyors equipped with Anabat Walkabout, Anabat Chorus and Echometer Touch Pro 2 full spectrum detectors were positioned covering the building to monitor for emerging bats. A Nightfox Whisker HD Infrared video camera was positioned to monitor the identified potential roost feature below the porch.

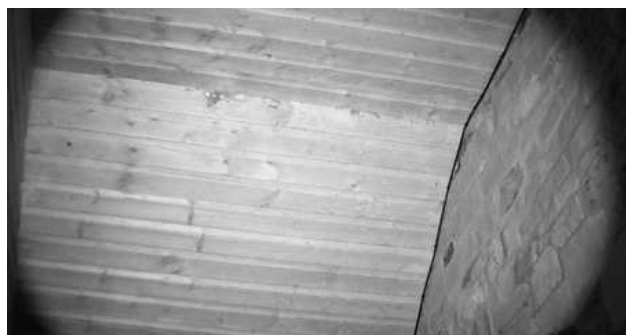
*Illumination level at end of survey*
