NOTE: All replacement timber window and door frames match the original in terms of section size, glazing and fitting position within openings.

| Job Title<br>Window and Door Details<br>Whitefield House Barn<br>Birks Brow<br>Thornley | | |
| Drawing Title<br>Photograph Sheet and Details<br>Showing Original and Replacement Frames | | |

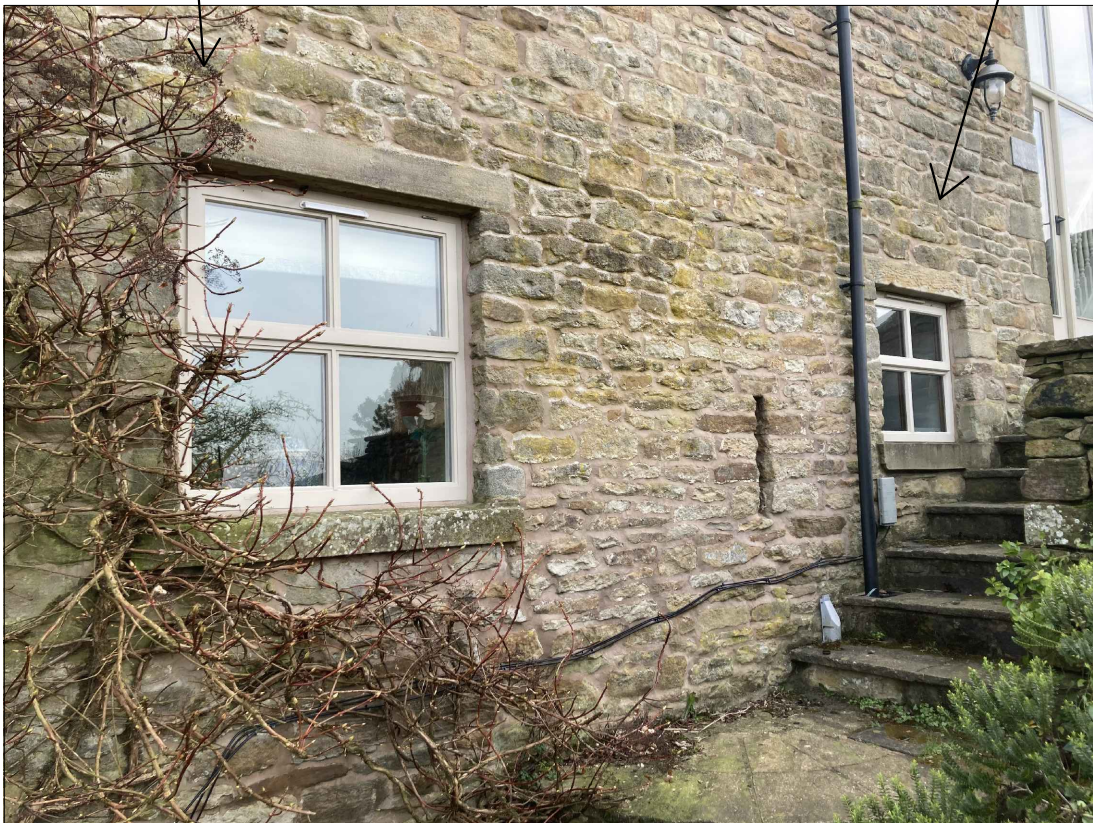
Photograph showing part of North west elevation

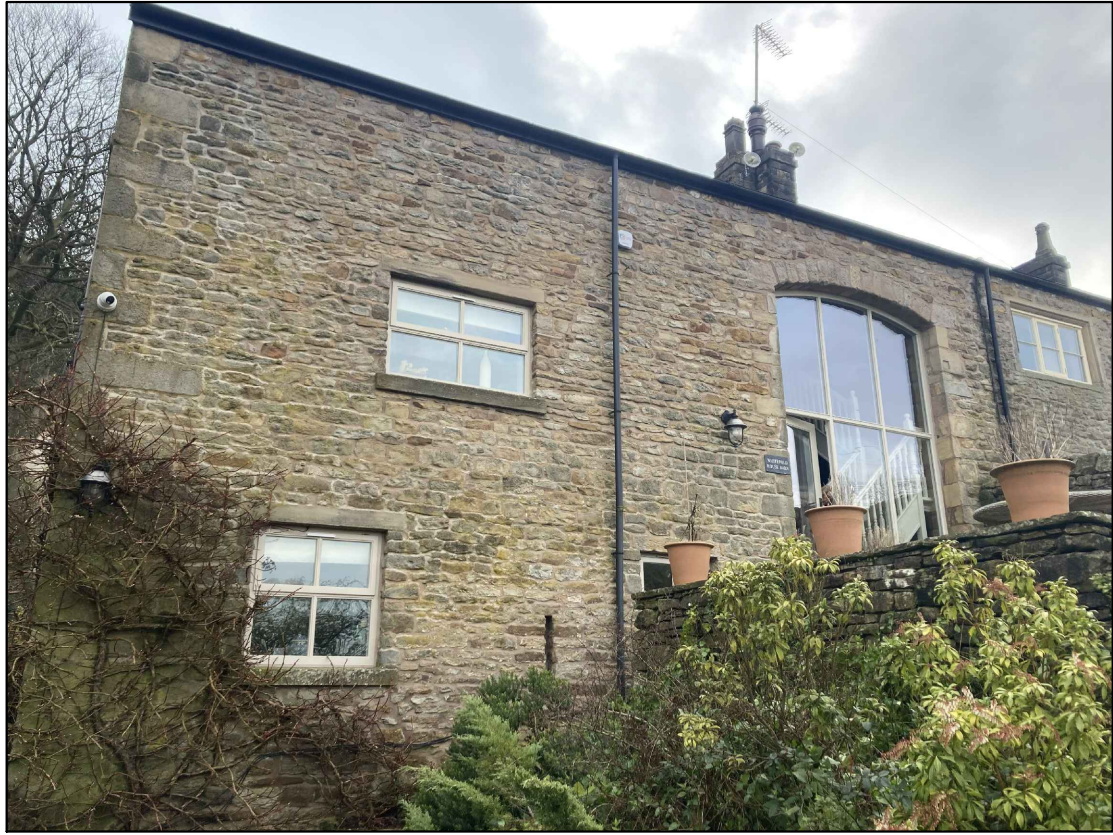
Photograph of North west elevation

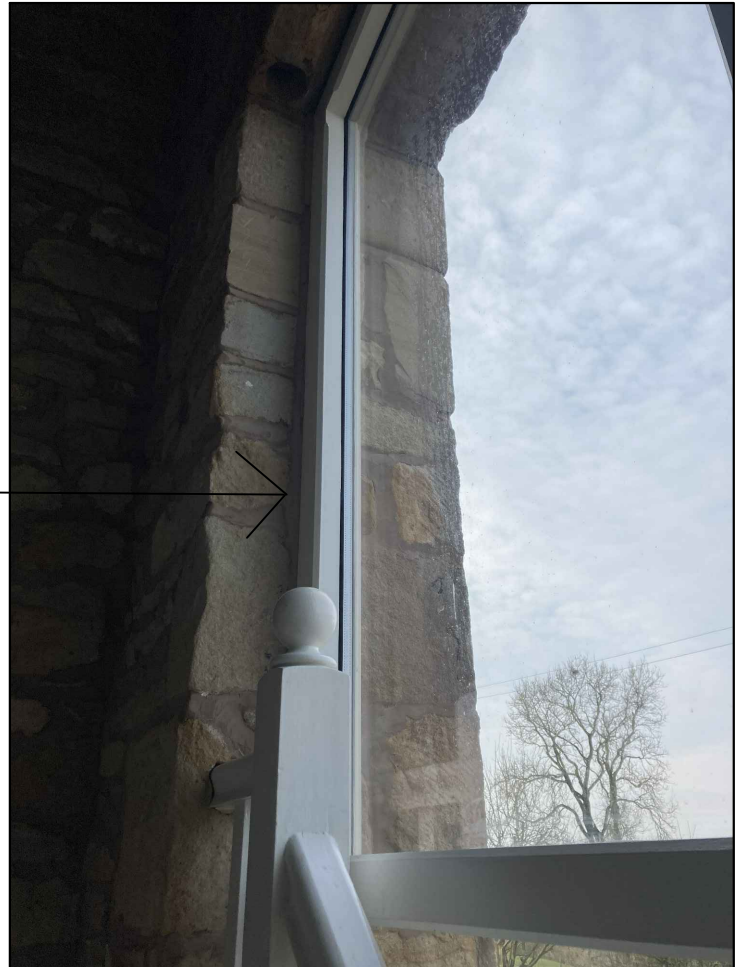
Internal photograph of door and glazed frame within Cart opening DF1, showing replacement frame fixed in the same position as the original frame

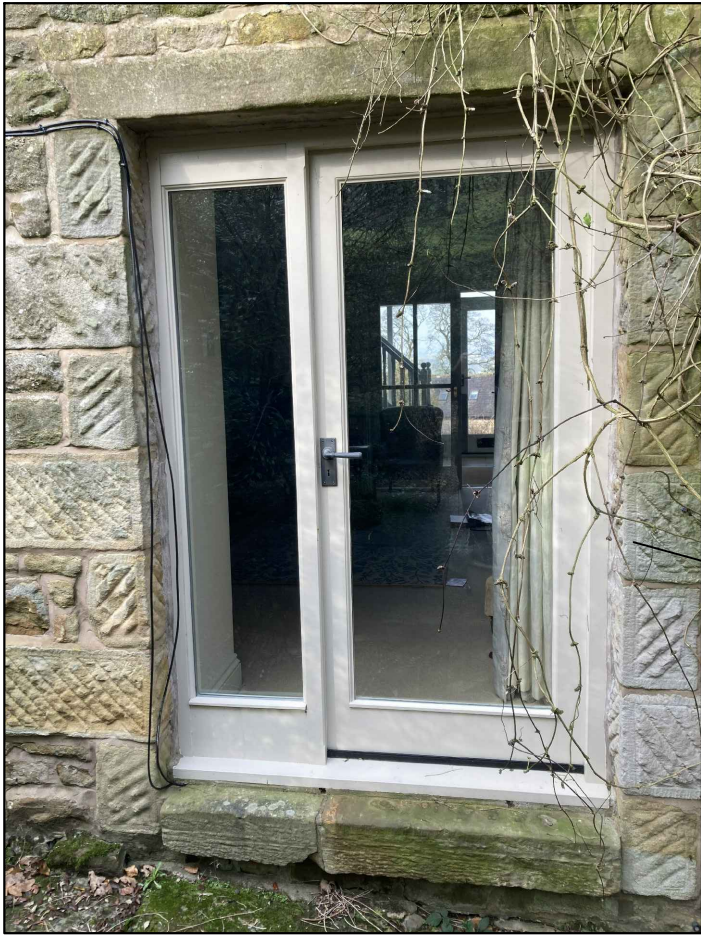
Photograph showing DF2

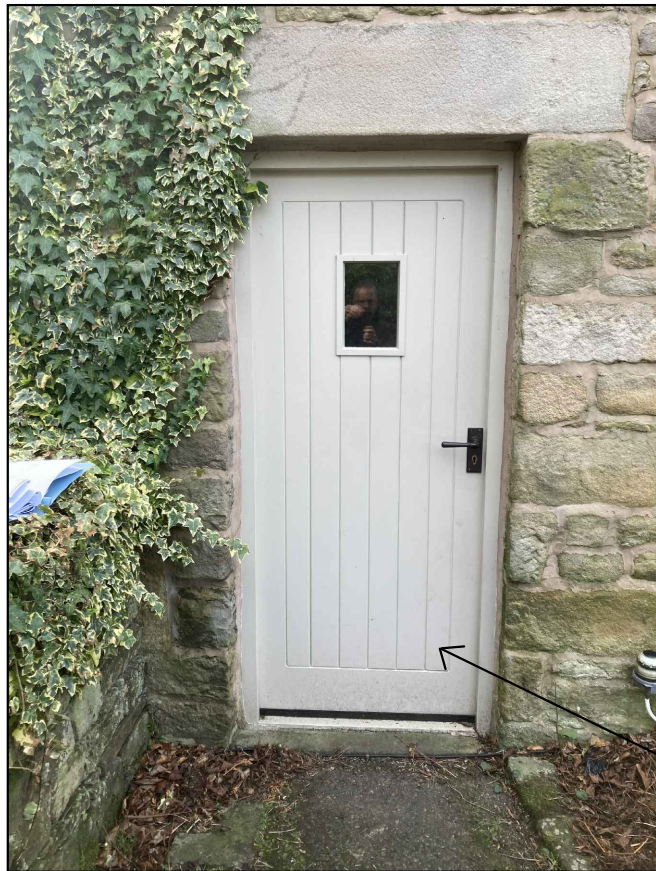
Photograph showing DG1
