# Bat Survey Report and Method Statement European Protected Species (Bats)

## Reasonable Avoidance and Mitigation Measures

Mellor House,  
Primrose Hill,  
Mellor,  
BB1 9DL

05.08.2024

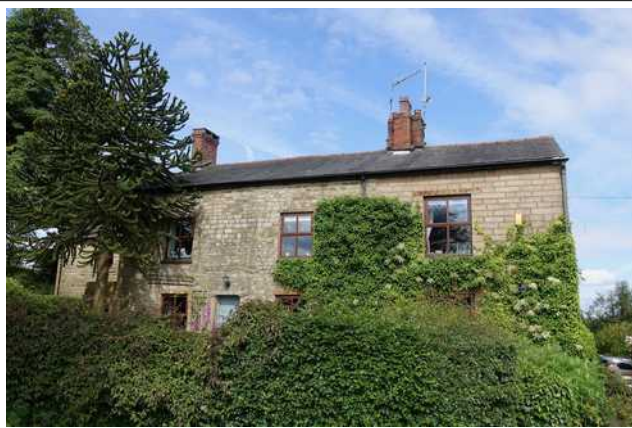
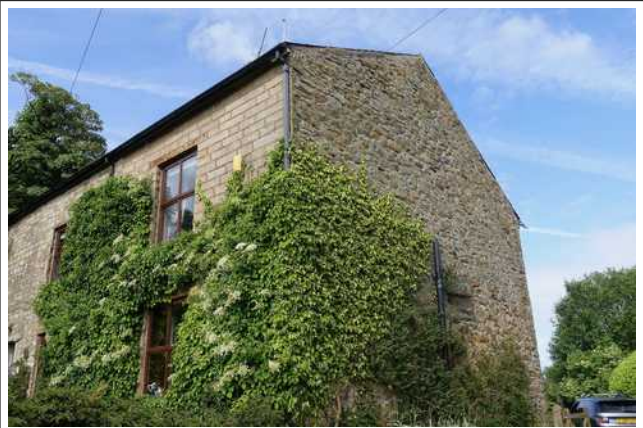
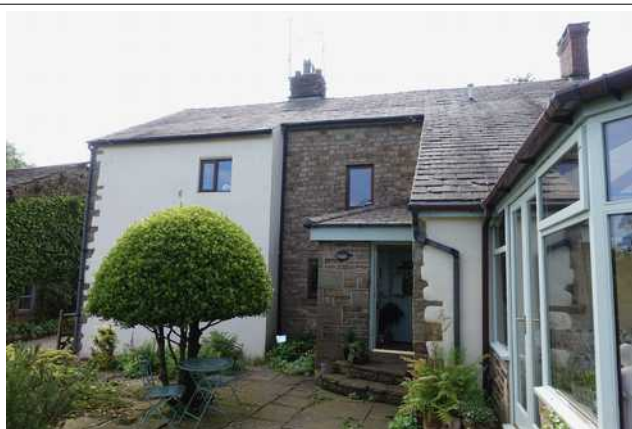
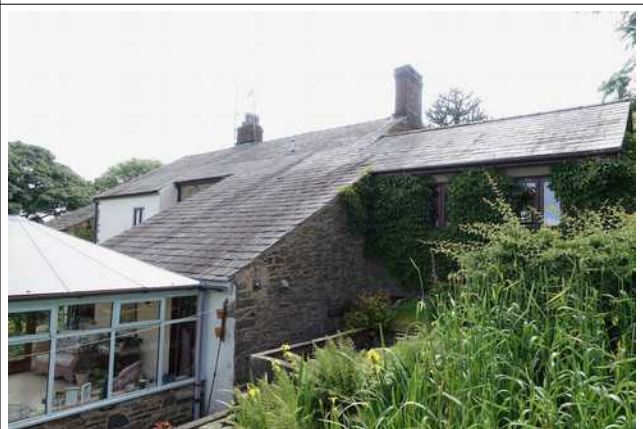
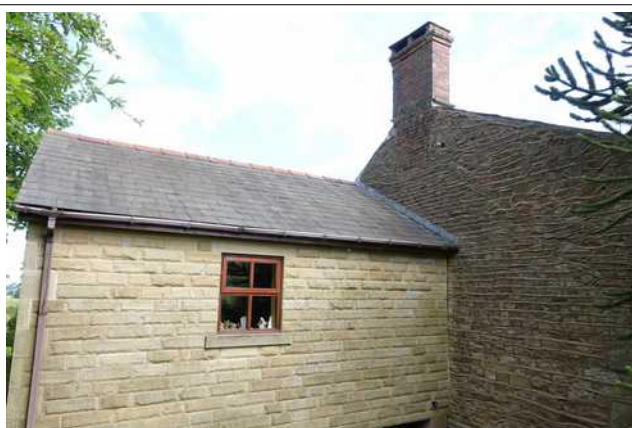
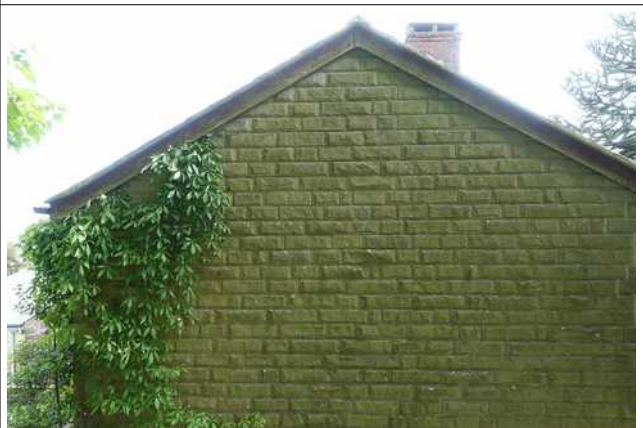
The property consists of Mellor House a stone built two storey house with a double pitched slate roof, single storey extensions are present to the rear and on the south western gable end. A single storey conservatory adjoins the rear extension. A separate stone and brick built barn is present to the north east of the house.

Stone walls are generally well pointed with o cracks, gaps or crevices present. Fascia boarding is generally close fitting. Gable ends are pointed and sealed.

Roof slates are close fitting with no obvious lifted, slipped or missing slates observed. The ridge is close fitting and sealed. Lead flashing where present is close fitting.

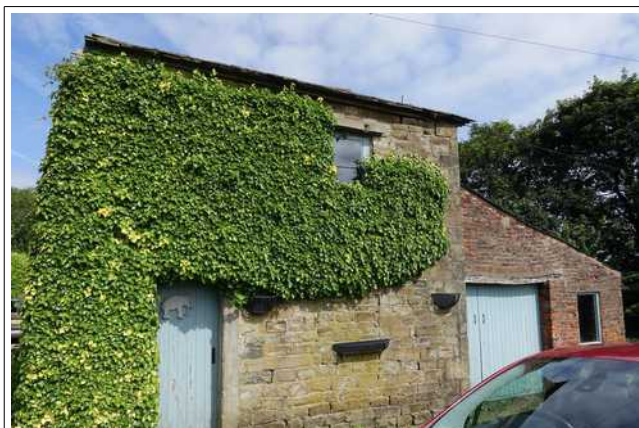
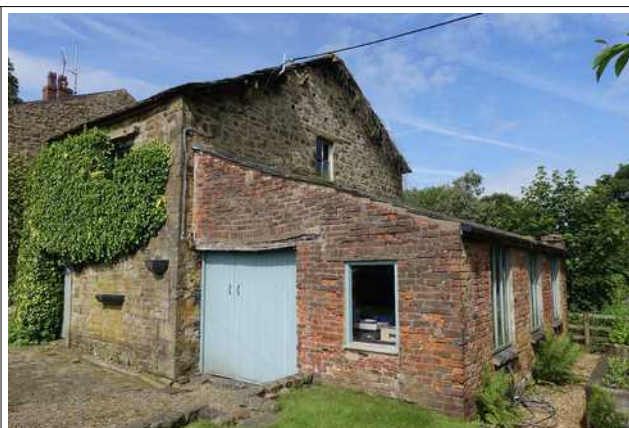
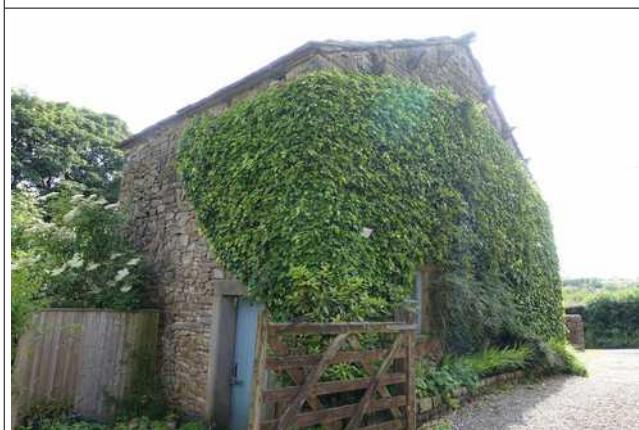
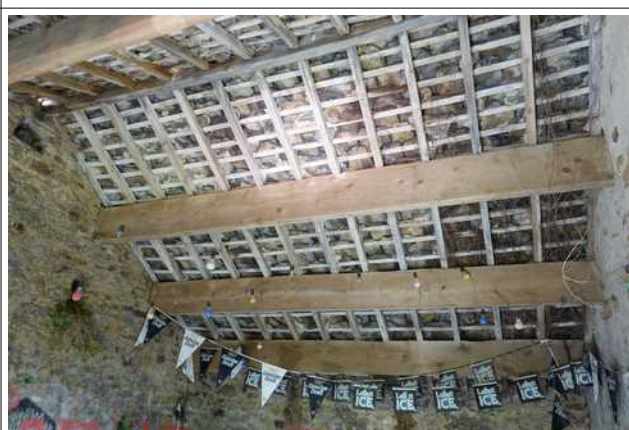
The stone barn is two storey with a double pitched stone slate roof, a single storey extension is present on the north eastern gable end.

Whilst walls are generally pointed, large gaps were noted on gable ends at the wall tops. Roof slates were generally close fitting and are unlined to the interior. The south western gable has a heavy covering of ivy which ends to the rear of the building.

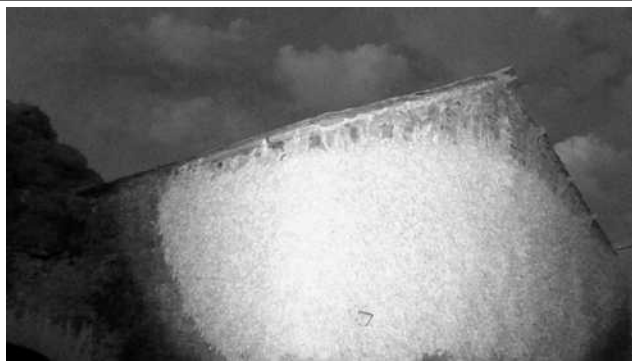
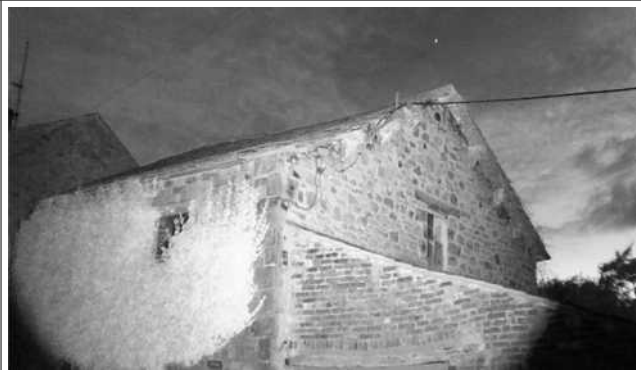
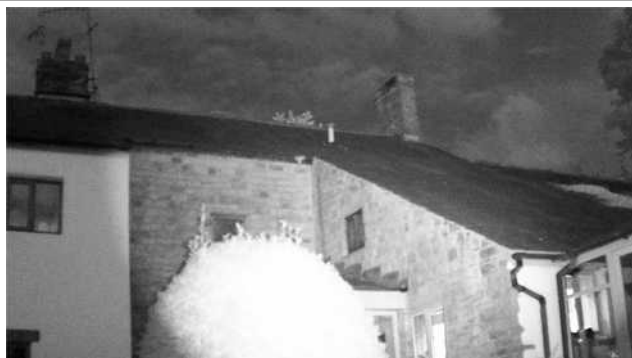
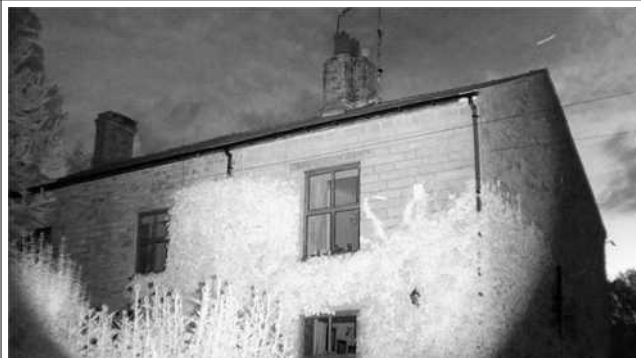
**IR Video Coverage and Illumination level at end of survey.**

Surveyor points equipped with Anabat Walkabout, Anabat Scout, Anabat Chorus, and Anabat Swift full spectrum detectors aided with Canon XA50, XA25 and Nightfox Whisker video cameras with infrared flood and spot lights were positioned around the building to monitor observed potential roost features for emerging bats.
