Re: Development at 86 Whalley Road, Langho, Lancashire BB6 8EQ

Thank you for your request for a bat survey for the above property.

We understand that the proposal is for an extension and alterations to an existing dwelling house.

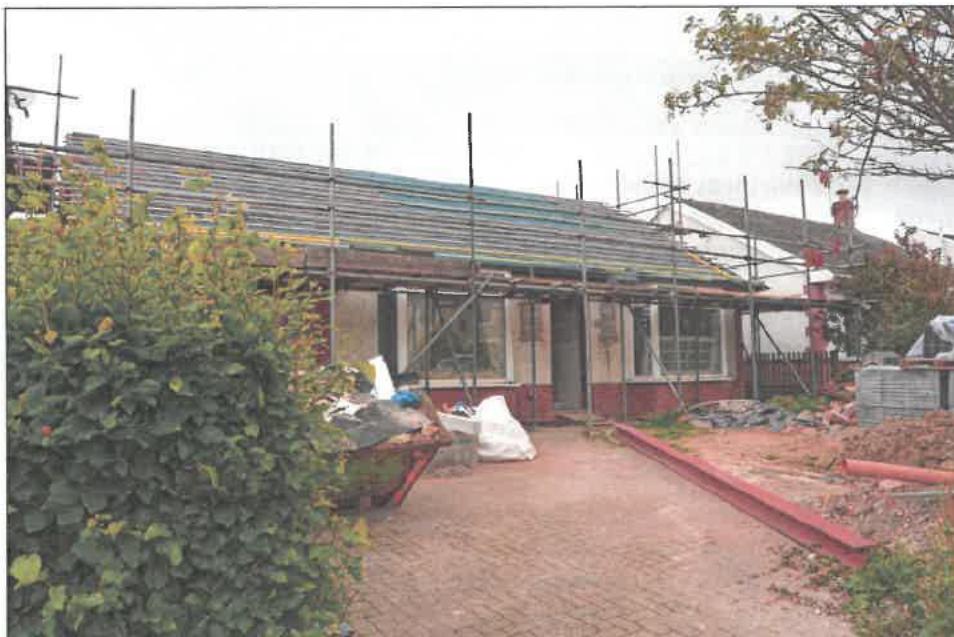
View of 86 Whalley Road from roadside to northwest. At the time of survey, the building was scaffolded and the northwest roof pitch was covered in a modern roof membrane and tile battens only.

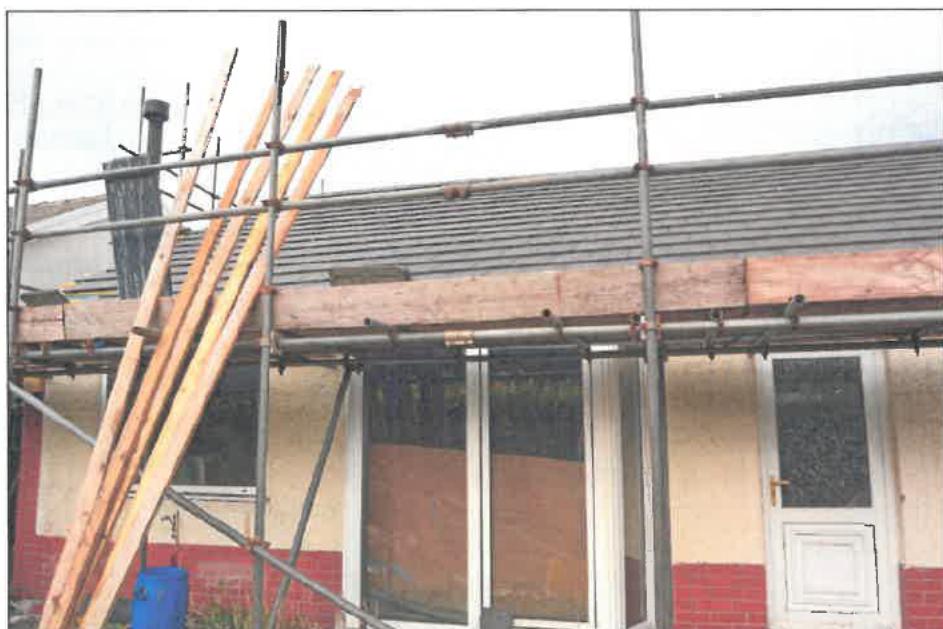
View of 86 Whalley Road from garden to southeast. At the time of survey, this part of the building was scaffolded, and the southeast roof pitch was newly-covered in interlocking cement roof tiles.

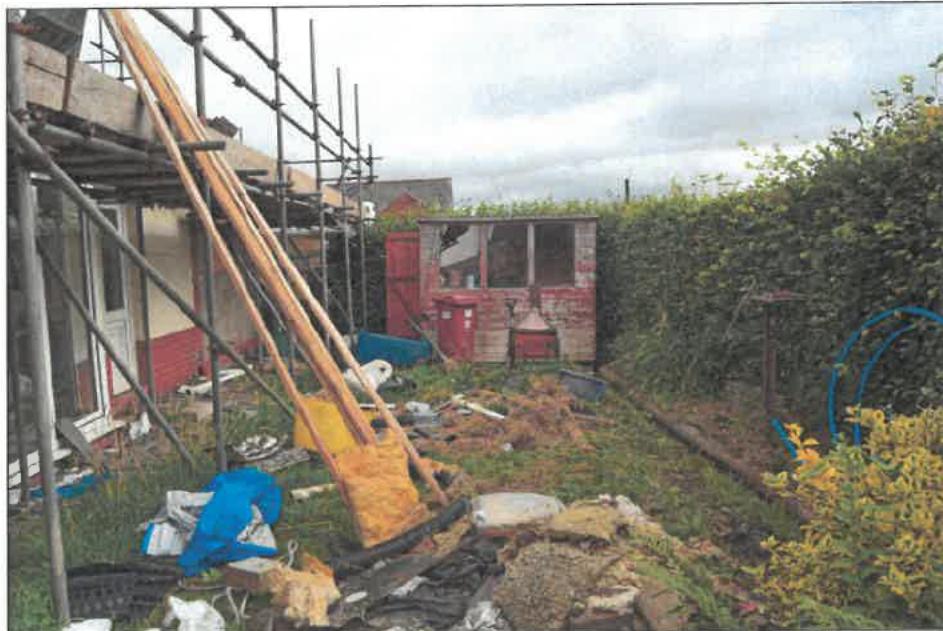
View of 86 Whalley Road garden to northwest of the dwelling house. A small wooden garden shed and broadleaved hedgerow were present.

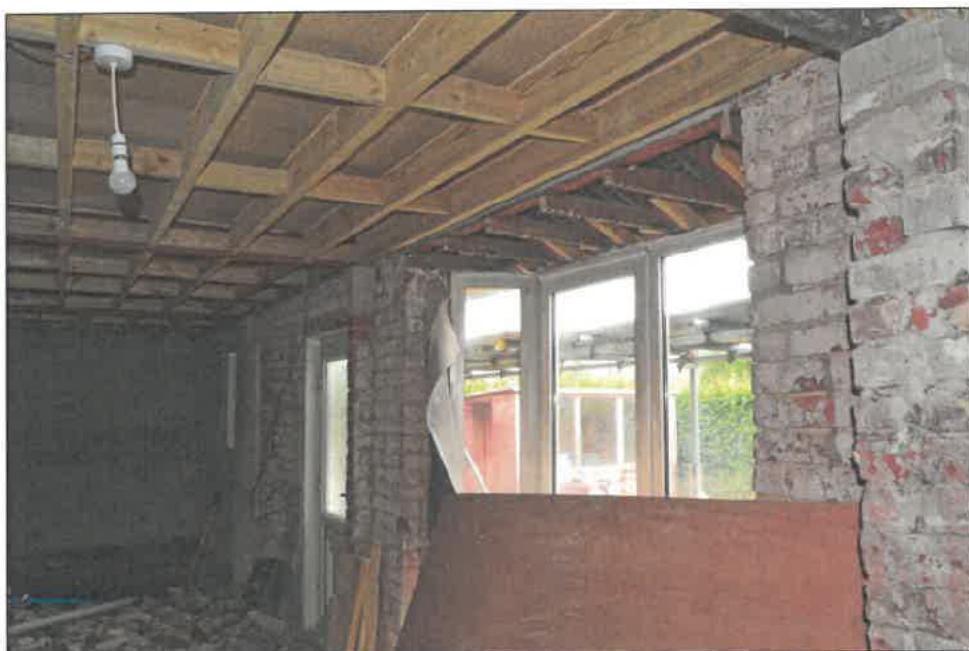
Internal view of 86 Whalley Road. At the time of survey, the building was undergoing extensive refurbishment, which included stripping of walls and installing of new floors.

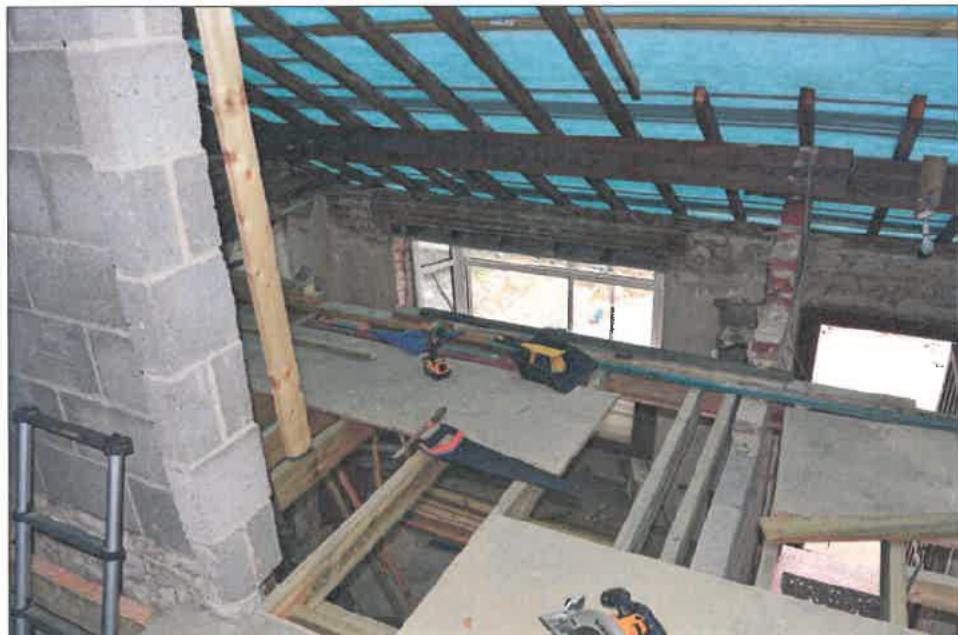
Internal view of 86 Whalley Road first floor. The image shows extensive refurbishment work, natural light spillage and a lack of dark sheltering places for bat roosting.

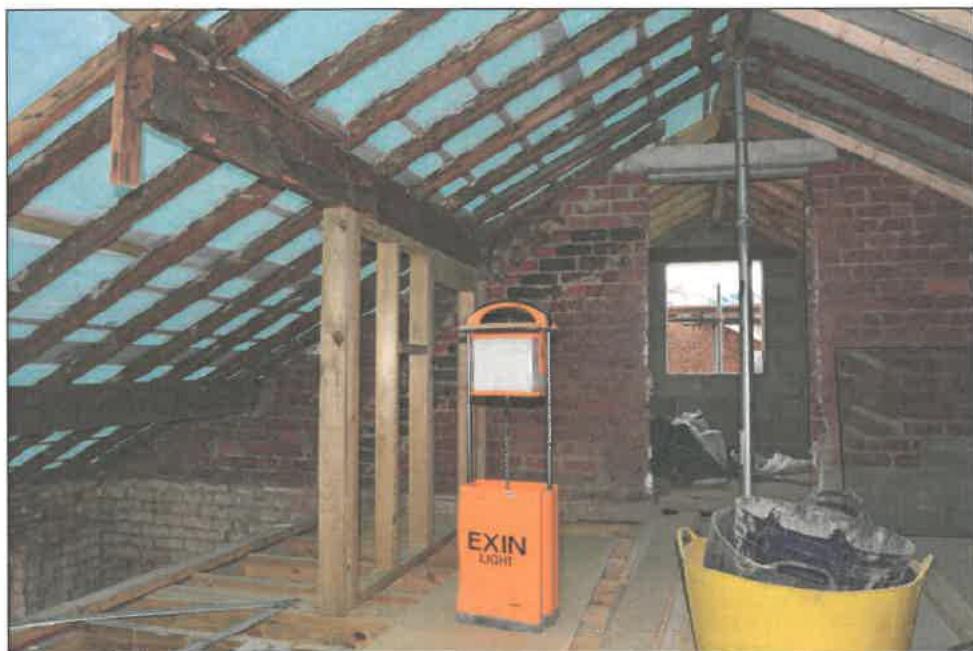
Internal view of 86 Whalley Road first floor. The image shows extensive refurbishment work, natural light spillage, an uncovered window and a lack of dark sheltering places for bat roosting.
