HORROCKSFORD HALL FARM WEST BRADFORD ROAD CLITHEROE

HERITAGE STATEMENT

**Kathryn Sather & Associates
Heritage Conservation Consultants**

May 2025

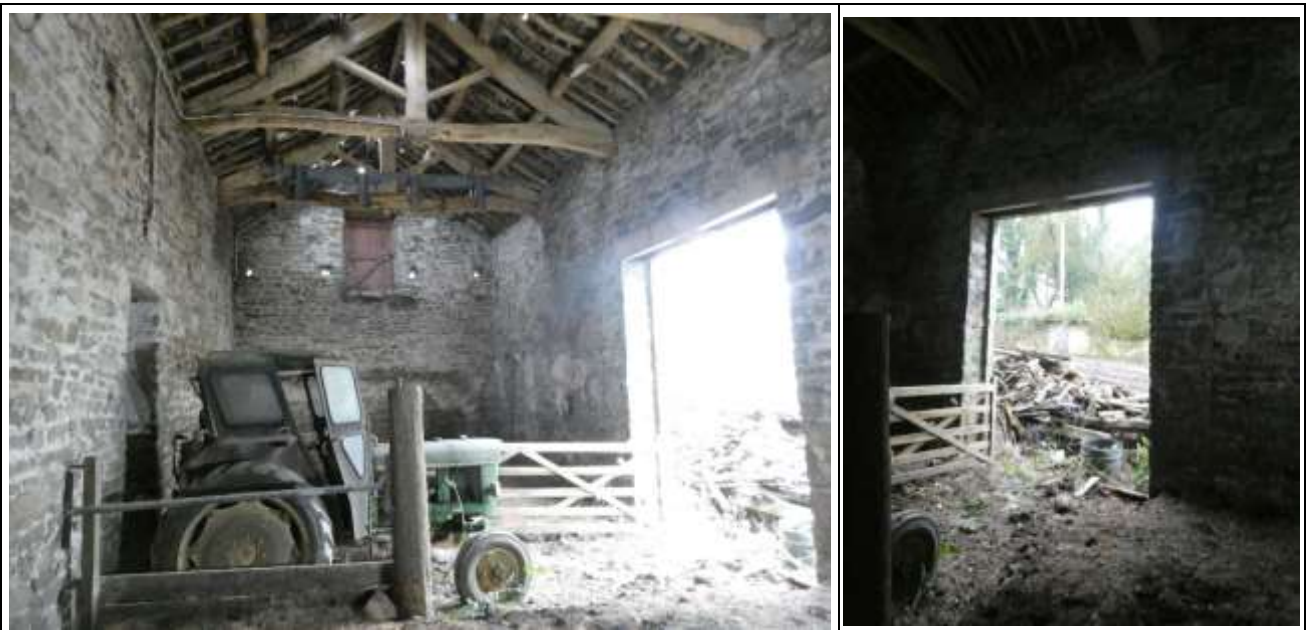
The interior features a timber roof structure of four king post trusses and purlins. There is evidence of a former loft floor, including a loft door to the south. One truss has been repaired with several metal supports.

<i>Looking Towards Gable-end</i>	<i>Tall Cart Entry</i>

<p><i>Gable-end, Loft Access, Later Addition Metal Truss Support to the King Post</i></p>	<p><i>Base of Gable-end</i></p>

<p><i>Entrance at the East Wall</i></p>	<p><i>Traditional Purlins, Missing Slates</i></p>

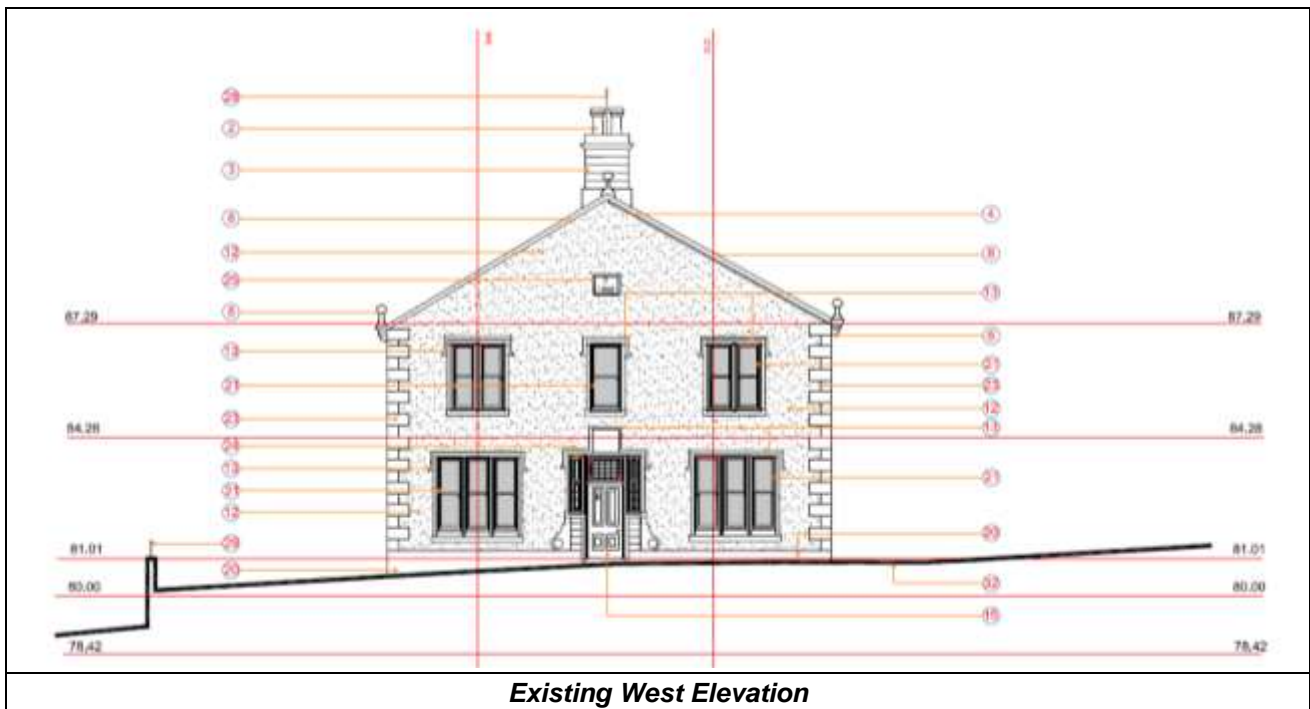
The west elevation has a painted central timber door with side lights and transom of stained glass. The door is surrounded by a stone architrave with scrolls to the base and surmounted by a hoodmould. Either side of the entrance there are tripartite sash windows under stone hoodmoulds. The elevation has dressed quoin features, with coping stones to the gable, finished with ball finials. At the first floor there is a stone date tablet of E 1898 above the single central window at the first floor. Either side of the central window there is a double sash window also under a hoodmould. Most of the windows are broken and boarded up. To the front of the west elevation there is garden enclosed with a green painted metal fence.

The existing timber window frames around the door (containing the stained glass window) will be retained and repaired and painted white, and the timber door will be retained and repainted white. The other windows to this elevation will be replaced with UPVC windows in white to match existing UPVC windows. The existing stained glass windows will be repaired where necessary and retained in situ. The existing dressed stonework and dashed finished render will be cleaned.

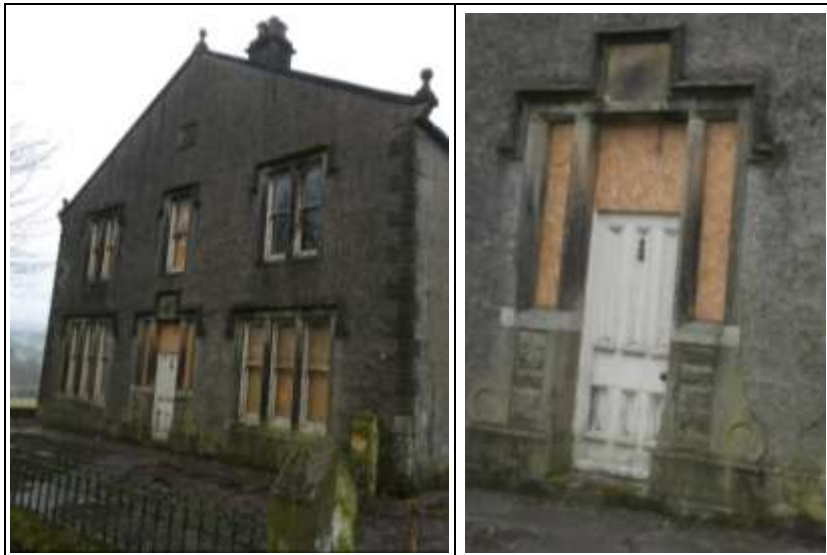
Painted Timber Door and Dressed Stone Surround, with Stained Glass Windows (Boarded Up)

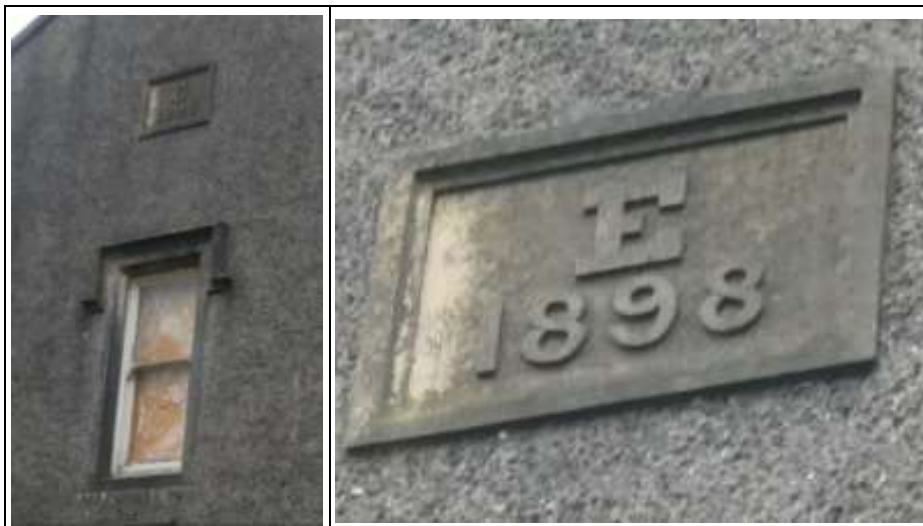
Stone Date Tablet Above Central Single Window

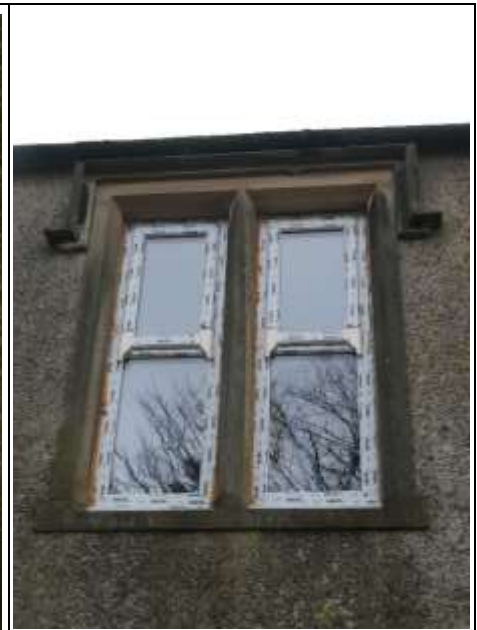
Double First Floor Window with Replacement Window Frames

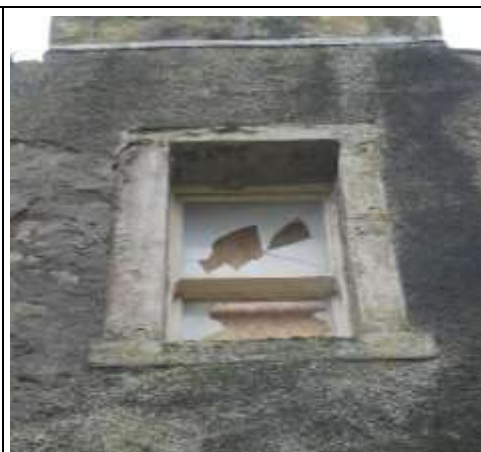
Timber Frame, Broken Pane

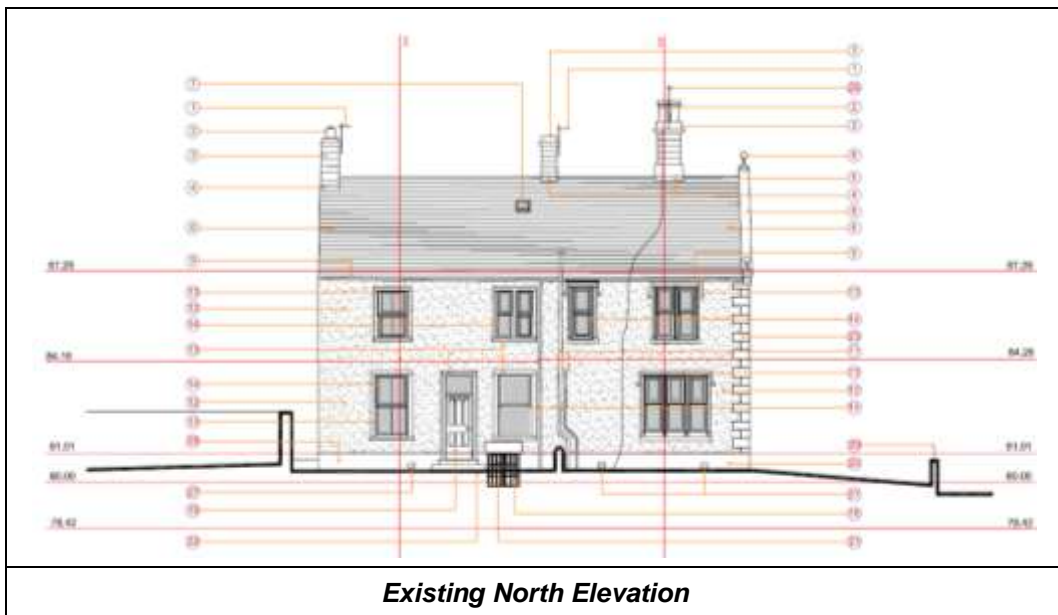
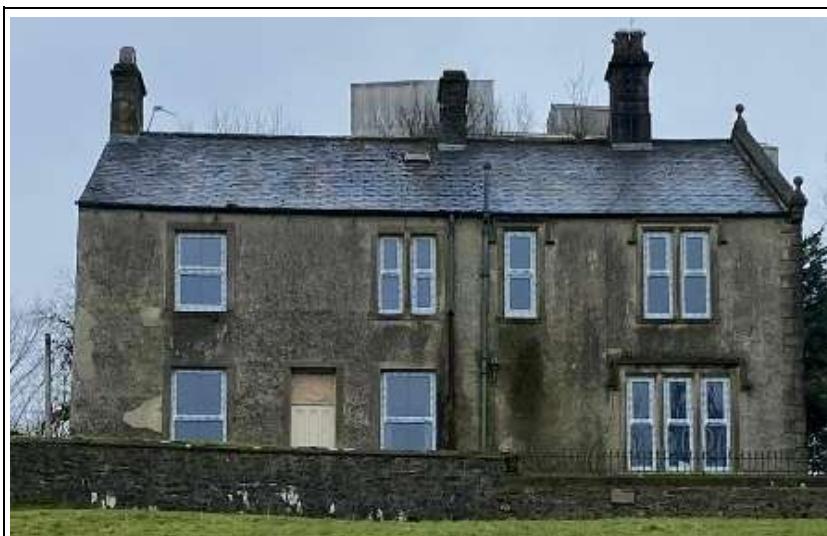
North Elevation

This elevation reflects the south elevation in style, with quoins and coping stones to the west elevation. The western half includes three windows, each with a hoodmould. All the windows at this elevation have been replaced with UPVC frames, following the vandalism of the windows and timber frames being broken. The western half includes a triple sash window to the ground floor, and a double and single sash window to the first floor. To the east side, at the basement level there is a timber framed window with painted metal window bars and stone lintel. At the ground floor there are two windows one either side of a timber painted door with stone surround and boarded up transom. To the first floor of the east side there are two windows with stone surrounds, one with two frames. The north elevation has a rooflight.

There are two down pipes located just off centre of the elevation, one is plastic, and one is a cast iron downpipe at the centre. There is a stone wall attached to the elevation at a right angle which divides a former garden area into two gardens, with a metal gate through to the eastern section. The render has water damage in addition to the general poor condition of the render. At the plinth there are painted cast iron vents.

The existing timber door will be repainted white. The existing timber window at the semi-basement will be replaced with a UPVC window to match the existing UPVC windows. The glazing bars will be repainted white. A new pre mental glad rooflight will be installed into the existing opening. New lighting will be installed above the door (in black). New UPVC round profile waste pipes to be installed (in black).

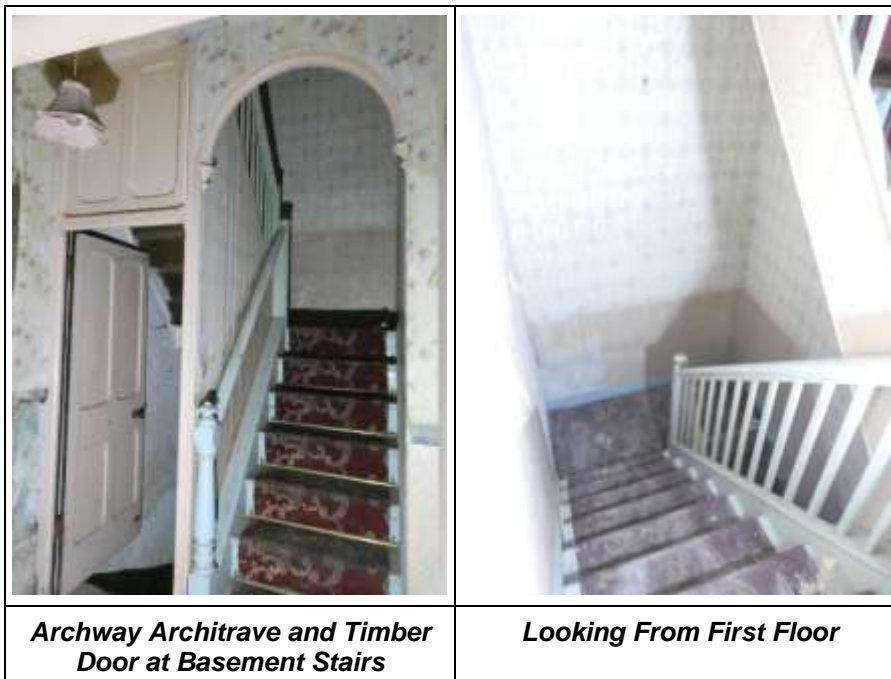
Stair 2

Slender Square Balusters, Some Missing

- Repairs to cast iron work supporting stone floor slabs to be retained;
- Retention of period floor tiling;
- Retention of period balustrading to stairs;

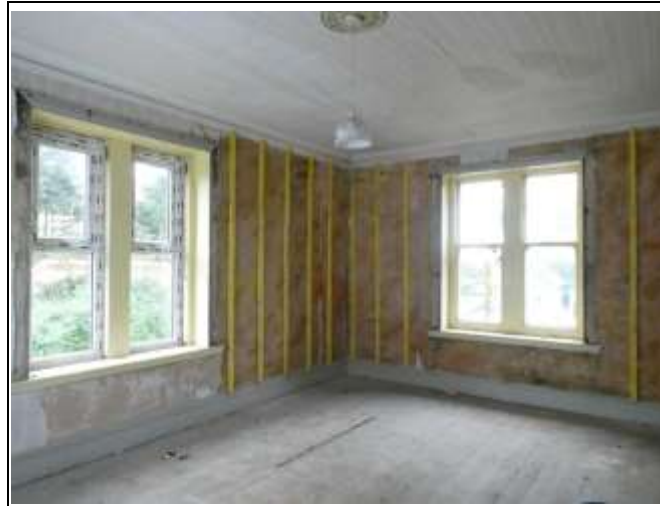
***Corner of Room, Dual Aspect
Replacement Window to the North and Timber
Frame Window to the West***

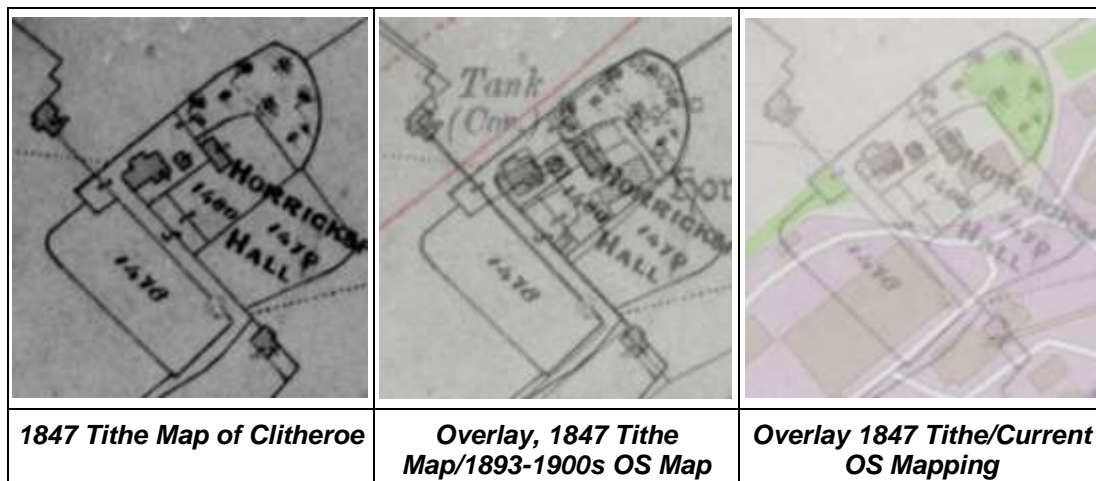
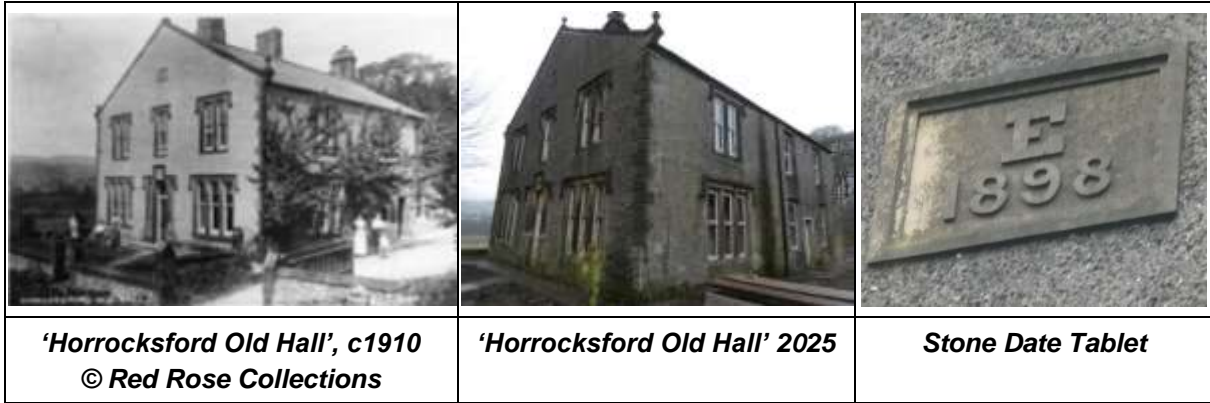
Recent Vandalism Damage at the Farmhouse

The Farmhouse is in a poor state of repair as it has been vacant for the last five years. A recent break-in at the farmhouse has resulted in damage to the majority of the windows at the property. Window glass and window frames were broken. The house has also been broken in at other times as well. Following the vandalism and break-ins, the owners have commenced replacing the windows with new frames, coloured to match the previous damaged windows, but in a different material, using upvc in place of timber.

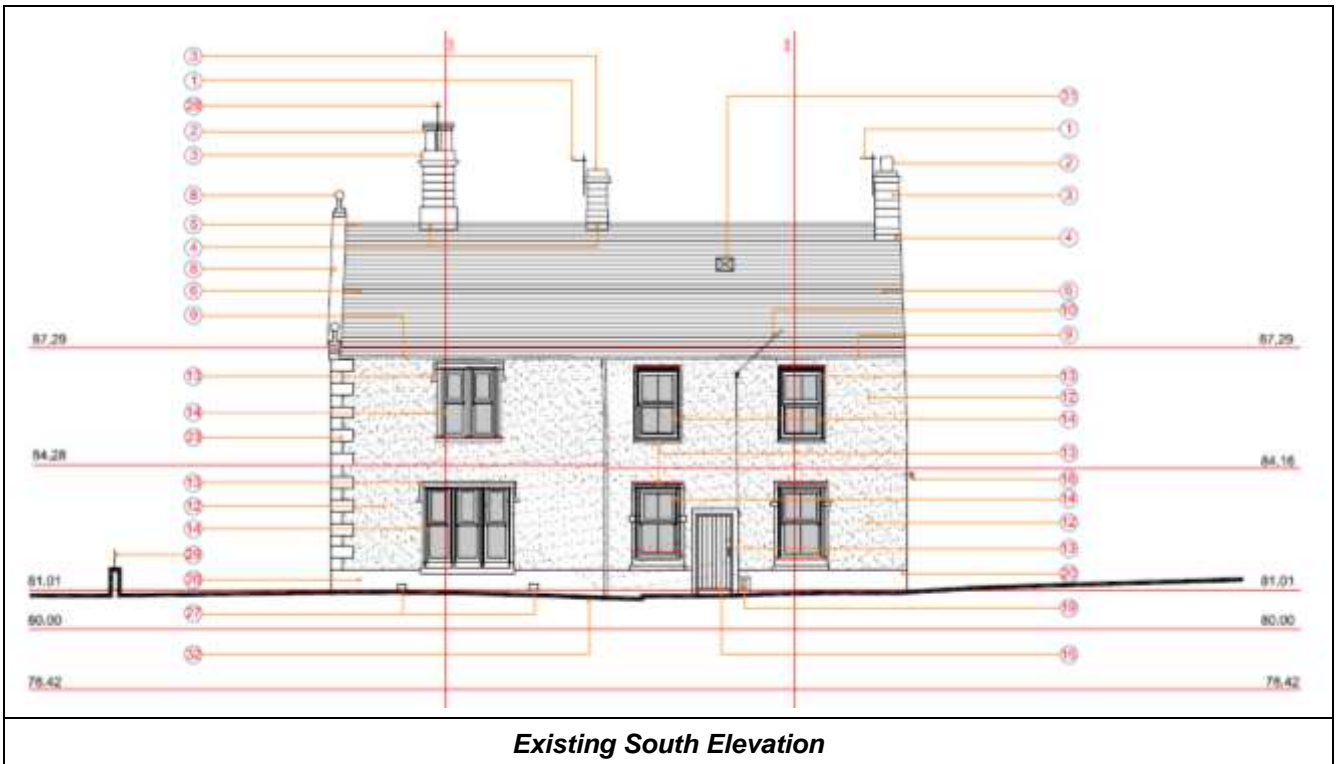
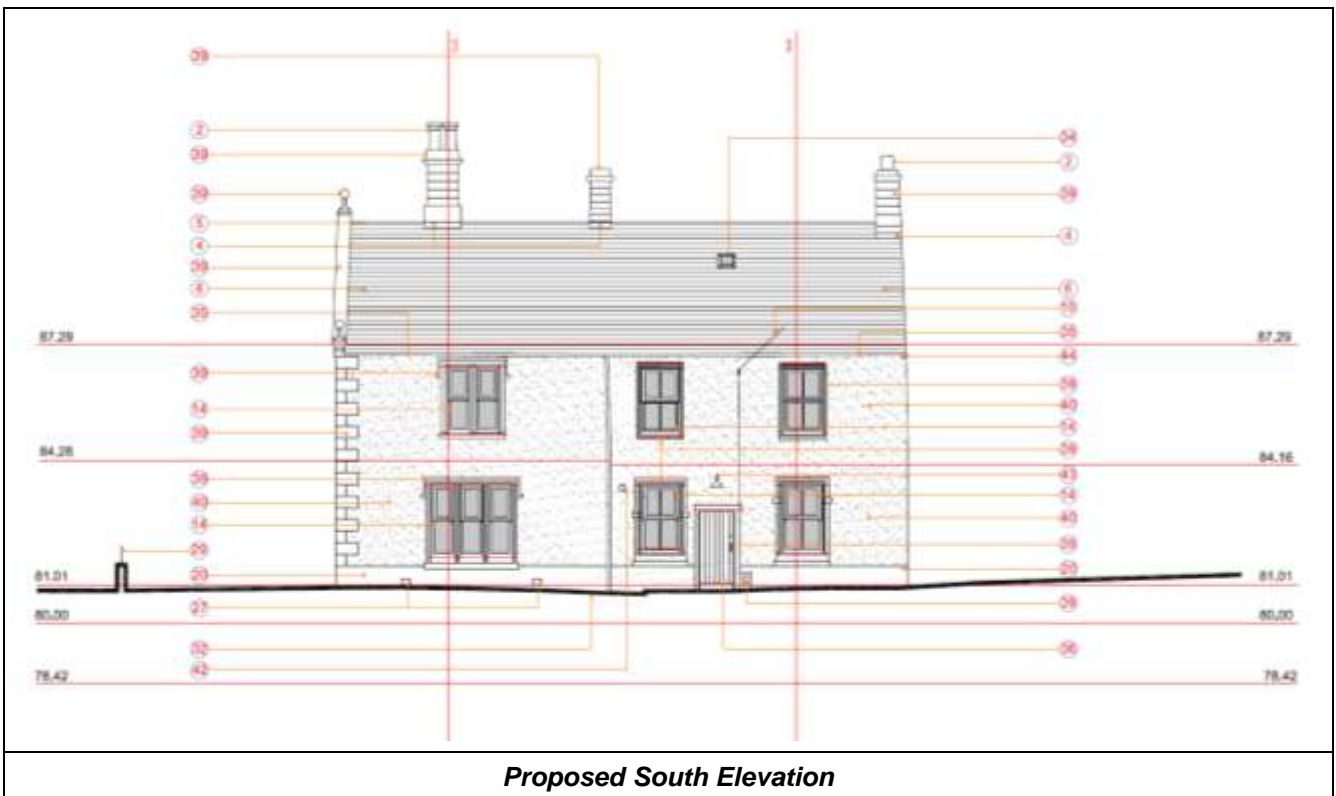
Proposed South Elevation

Repairs will be made to the roof and a new pre metal glad rooflight will be installed into the existing opening. Existing timber door will be repainted white. New lighting and extract fan terminals will be installed above the door (in black).
