# WRITTEN STONE FARM, WRITTEN STONE LANE, LONGRIDGE, PRESTON, LANCASHIRE

Archaeological Building Recording

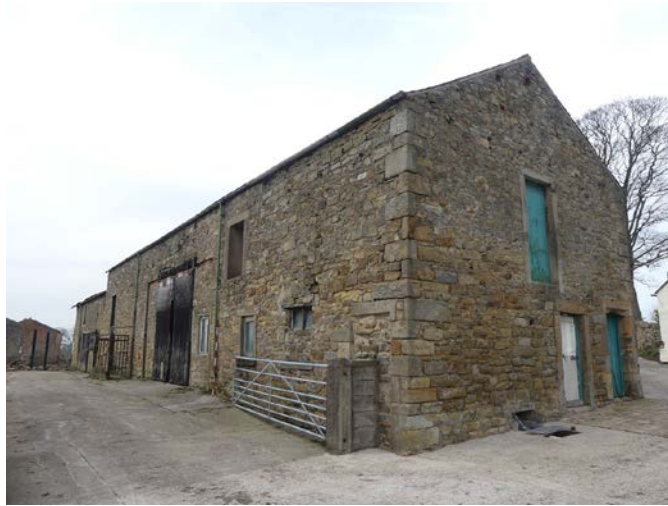
Plate 13: General view of the barn from the east

4.2.1 **Arrangement:** the barn is orientated approximately north-east/south-west and fronts the south-east with lower extensions to the south-west and to the north-west (Plate 13).

4.2.2 **Fabric:** the barn is built from local yellow gritstone in roughly dressed blocks in fairly good courses. Details around the doors and windows are dressed in the same material, although some brick is used in places. It has a grey slate roof with sandstone ridge tiles and corrugated concrete to the rear (north-west) section. The lower south-west end has flagstone roof with stone ridge. It has plastic rainwater goods. Internally, the timber is a mix of sawn and hand-finished and concrete is used in the floors and for the stalls.

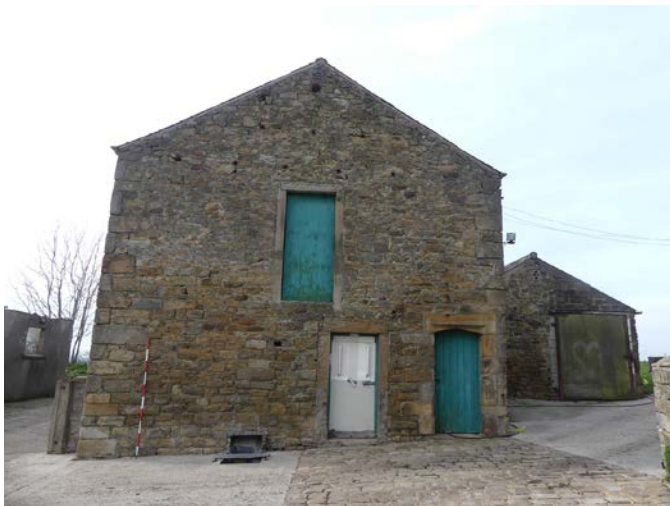
Plate 14 (left): North-east external elevation of the barn, viewed from the north-east

4.3.1 **North-east external elevation:** the north-east elevation forms the gable end with dressed quoins forming the main part (Plate 14). There is an inserted chute at floor level south-east of centre with a timber surround leading to a hole in the floor. There are two doorways to the north-west (Plate 15). The one to the south-east was probably a window originally that has been extended as the lower parts of the jambs are concrete. It now houses a plain modern panel door and has dressed stone surrounds. The north-west door has dressed, chamfered (stop-chamfer on the north-west side) quoins and moulded head of 17<sup>th</sup> century or earlier type and is presumably reused. There is a doorway to the upper floor in the centre of the elevation, which is also probably extended from a window as the lower part of the jambs and step are concrete. It otherwise has dressed stone surrounds. There is a row of six vents above, and three more over formed by ceramic drain pipes, and an owl hole in the apex formed by a larger ceramic pipe.

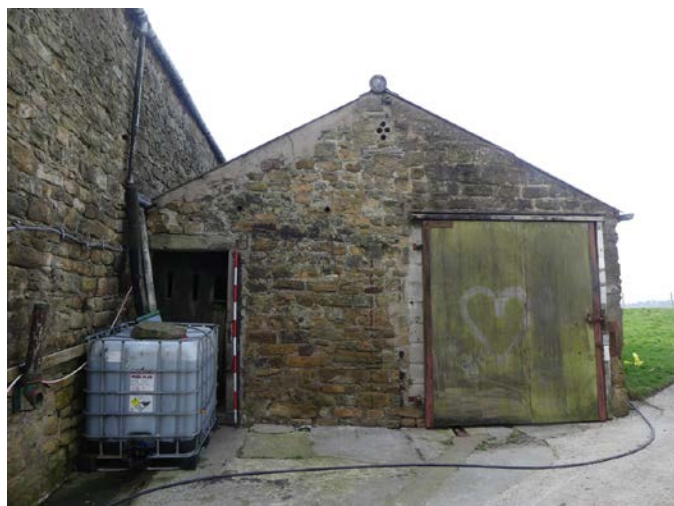
4.3.2 The elevation is extended to the north-west by a lower gable (Plate 16). There is a pedestrian doorway on the south-east side with dressed stone surround. The south-east jamb is formed by the adjoining wall. It houses a tongue and groove door with three slots and has chamfered jambs to the south-east. There is a wider doorway to the north-west with a modern panel door and concrete blocks in the south-east jambs (Plate 17). There is a vent at the apex formed by a group of four ceramic pipes.

Plate 16 (left): North-west side of the north-east external elevation of the barn, viewed from the north-east

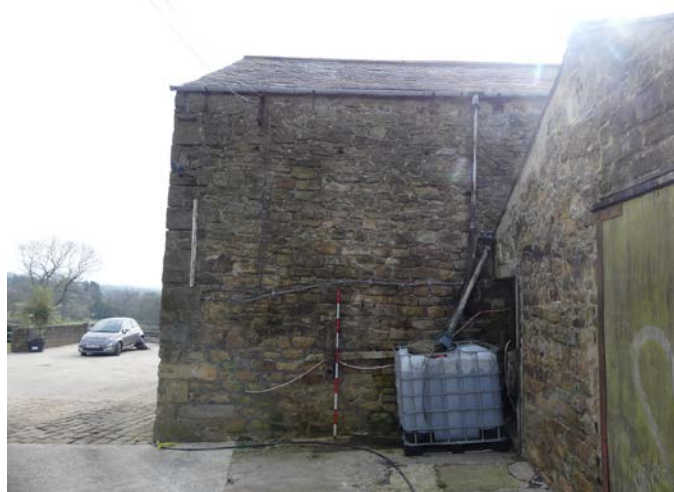
Plate 18 (left): North-east end of the north-west external elevation of the barn, viewed from the north-west

**4.3.3 North-west external elevation:** the north-east end of the main barn is plain, quoined at the corner, and has a row of four ceramic pipe vents at upper level extending over the roof of the extension (Plate 18). The elevation of the main barn is otherwise mostly obscured by the later, lower, addition to this side (Plate 19). The extension is a fairly rough build compared to the main barn, although there is some difference between the upper and lower halves. There are two windows with square stone surrounds, both of which are blocked with concrete blocks (Plate 20 and Plate 22) and the quoins are particularly neat at the south-west end where it returns to the main elevation. There is a possible blocked opening or rebuilt section near the centre (Plate 23). After the return is a lower section relative to the main barn. It is initially concrete rendered with a small window at high level covered with a corrugated metal sheet. There is a slight step to the south-west of this and then the elevation is roughly coursed stone with thick pointing and two three-pipe vents at high level and good quoins at the south-west end.

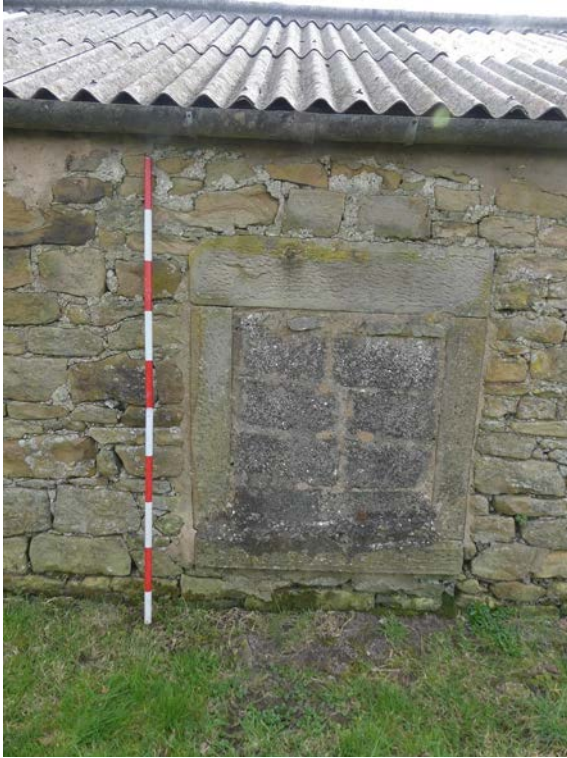
Plate 20 (left): Blocked window on the north-east side of the lower extension to the north-west external elevation of the barn, viewed from the north-west

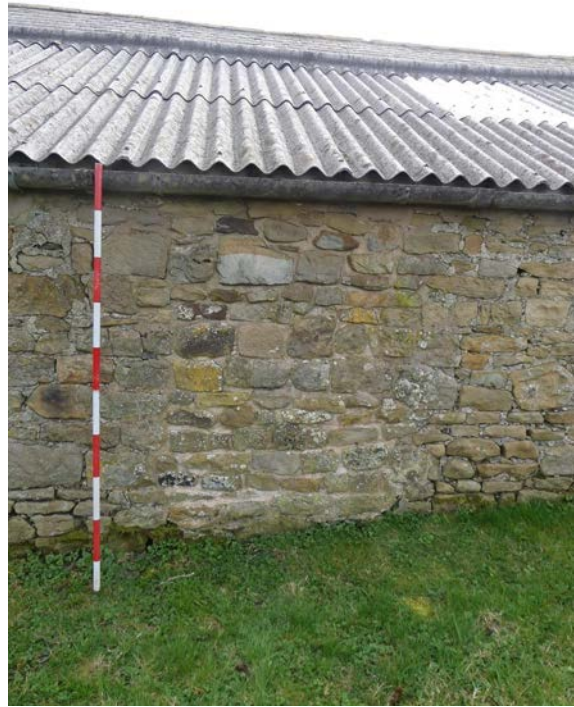
Plate 21 (right): Blocking/rebuild in the centre of the lower extension to the north-west external elevation of the barn, viewed from the north-west

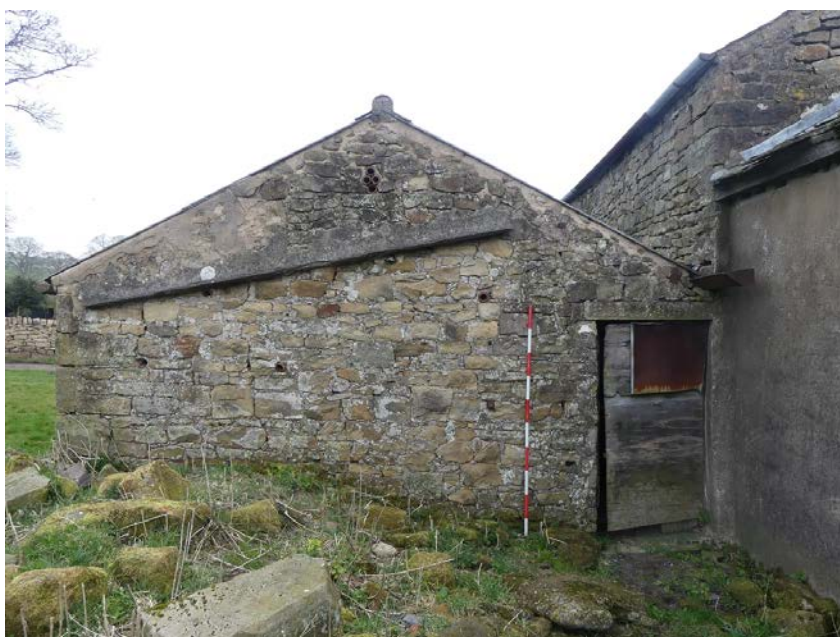
4.3.4 **South-west external elevation:** the north-west side of the south-west external elevation comprises the gable of the lower addition. It is quoined at the north-west end and has six pipe vents in two rows of three and a group of four at the apex (Plate 24). There is a concrete scar of a mono-pitch roof across it. The doorway on the south-east side has a rough north-west jamb and dressed stone lintel and the south-east jamb is formed by the adjoining wall of the main barn, which is concrete-rendered (Plate 25).

**Plate 24 (left): North-west extension of the south-west external elevation of the barn, viewed from the south-west**

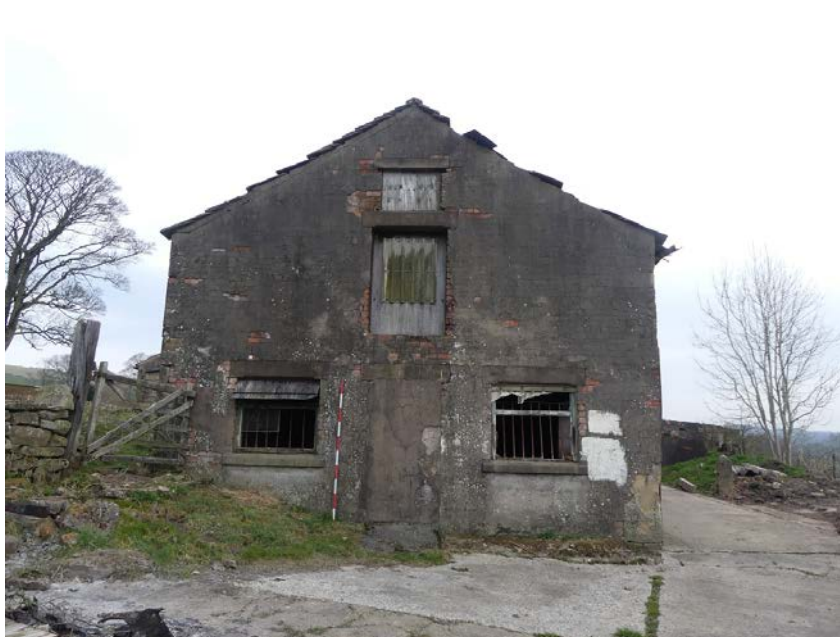
4.3.5 The south-east side of the elevation comprises the gable of the lower extension to the south-west end of the main barn (Plate 26). It has a patchy concrete render over brick of fairly late machine-made type and stone quoins remaining. There are two windows on the lower level with concrete sills and stop-chamfered concrete lintels and remains of two-light hinged-top casements in each and iron bars on the interior (Plate 27). There is also a central doorway, which has the same style lintel and is blocked. The loading door over has the same lintel and modern panel door and plastic corrugated sheet over a central window. There is a smaller opening over that, with a plain concrete lintel, that is filled by a timber sheet. There is a massive upright stone quoin on the south-east side at the base on the corner.

**Plate 26 (left): Main part of the south-west external elevation of the barn, viewed from the south-west**

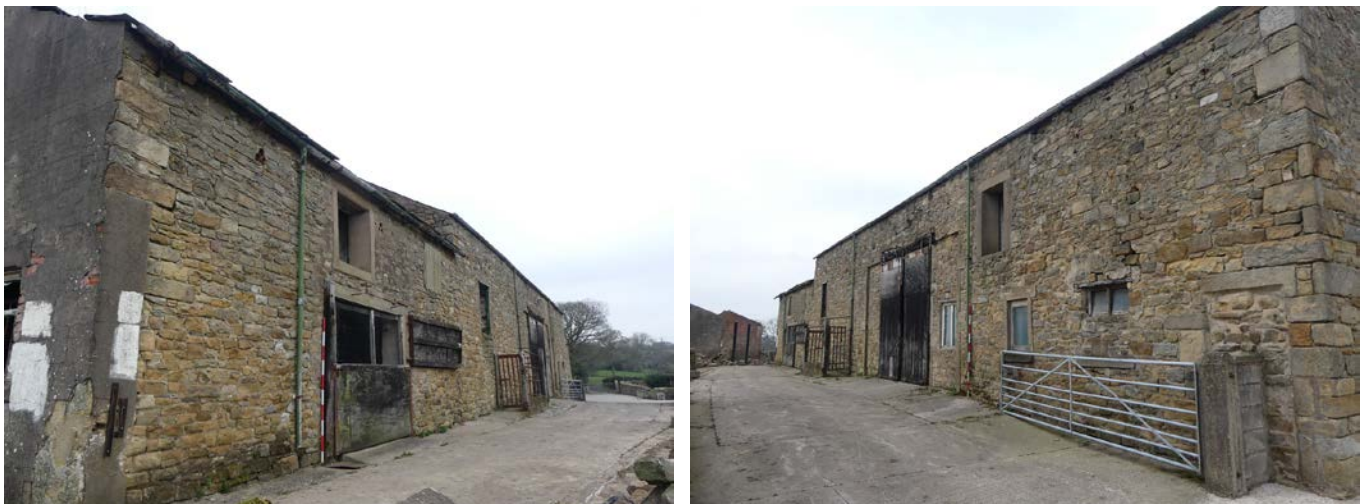
**4.3.6 South-east external elevation:** this comprises a single long elevation across the 'front' of the building (Plate 28 and Plate 29). There is a skim of concrete over the lower part of the south-west corner of the south-east external elevation, which is otherwise roughly dressed stone in rough courses with two three-pipe vents in the top. There is a wide doorway at low level, with concrete jambs and modern panel door with a metal mesh in the top (Plate 30). There is a single light window over, which also has concrete jambs. There is a lot of repointing in the wall at this point. There is a further round window at upper level to the north-east, with stone surround and pintles and catch for a shutter, but it is now covered by corrugated plastic. There is an obvious butt joint with the main barn to the north-east, but only fairly small quoins apparent (Plate 31). The main barn has an upper-level opening inserted on the south-west side, with a stop chamfered concrete lintel and rebuilt jambs (Plate 32). There is an attached iron and concrete pen below and two rows of pipe vents (five in the lower and 17 in the upper). There is central wagon doorway now with sliding double doors of tongue and groove planks and modern boards (Plate 33). There are recessed areas on each side with dressed stone surrounds (for the original doors) and quoins on the inner opening. The north-east recess has a window inserted into it of two-light fixed casement with a thin timber lintel. There is a massive rough timber lintel over the main opening. The datestone over reads "W.E.B. | 1892" (Plate 34). The north-east end of the elevation has an extant lower floor window with dressed surround in stone and single-light casement. There are remains of a further window to the north-east, the lower part of which has been blocked to the dressed sill and there is a small two-light casement in the top below a thin timber lintel (Plate 35). The doorway to the north-east has chamfered quoins and lintel, which may be 17<sup>th</sup> century or earlier and is presumably reused (Plate 36). The doorway is blocked with stone and the end of the elevation now has a concrete block wall and gatepost against it. The upper-level window this end has a concrete lintel and jambs and tongue and groove plank door.

**Plate 28 (left):** General view of the south-east external elevation of the barn, viewed from the south

**Plate 29 (right):** General view of the south-east external elevation of the barn, viewed from the east

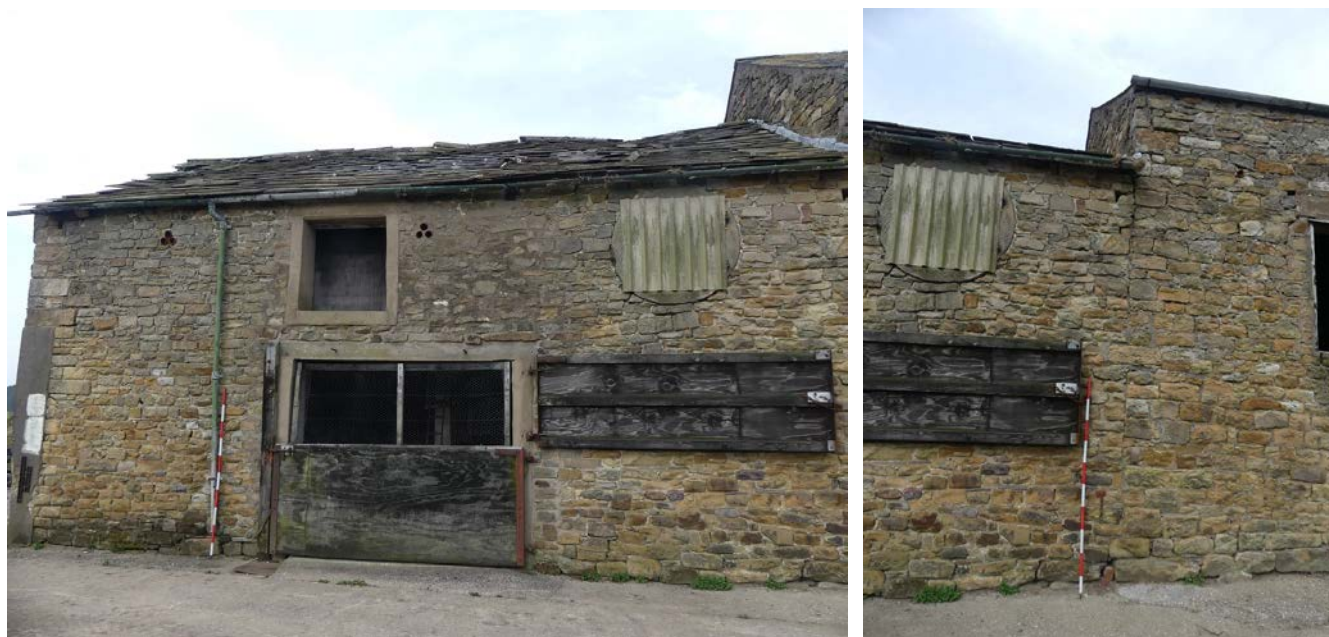
**Plate 30 (left): South-west end of the south-east external elevation of the barn, viewed from the south-east**

**Plate 31 (right): Junction between the south-west extension and main part of the barn evident in the south-east external elevation, viewed from the south-east**

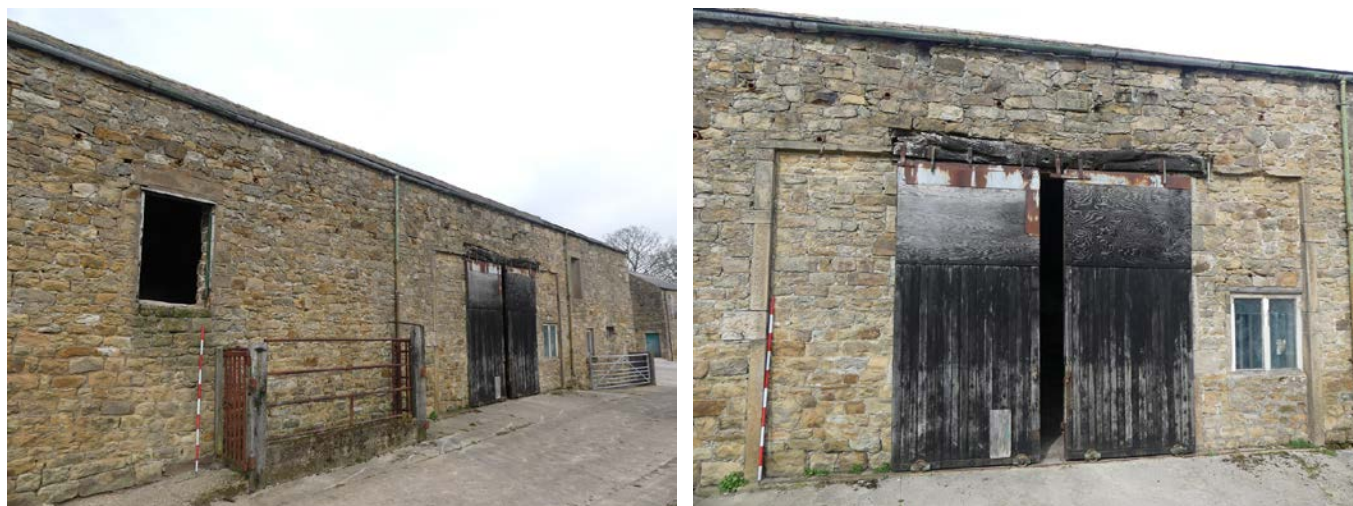
**Plate 32 (left): Centre and north-east end of the south-east external elevation, viewed from the west**

**Plate 33 (right): Wagon doorway in the south-east external elevation, viewed from the south-east**

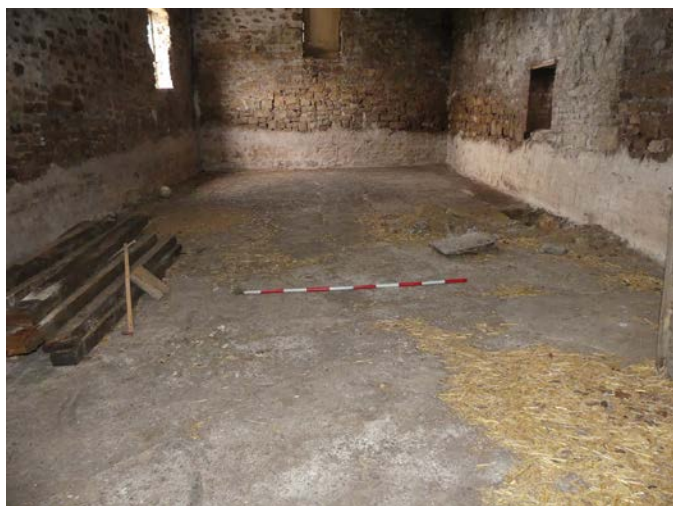
**Plate 37 (left): Concrete floor in the south-west end of Room G1 of the barn, viewed from the north-east**

**4.4.1 Ground floor Room 1 (G1):** this room, at the north-east end of the main barn, has a concrete floor. The south-west end is flat (Plate 37), with two test pits excavated through it exposing the underlying natural clay (Plate 38), while the north-east end steps up to the timber stalls below the hay loft (Plate 39). Just the posts remain on the south east side (Plate 40), some of which are stop chamfered (Plate 41), but the planks of the sides of some of the stalls are present on the north-west side of the room (Plate 42), and a small 'porch' constructed from further planks added around the posts, with a sliding hatch on the south-west side, has been divided off in the north corner around a doorway (Plate 43). The room is open to the roof in the most part, with the hayloft at the north-east end, the sawn floorboards on beams, which are supported on sawn beams above the stall posts (Plate 44). There are additional slots in the undersides of the beams, presumably for earlier stall posts. The walls are

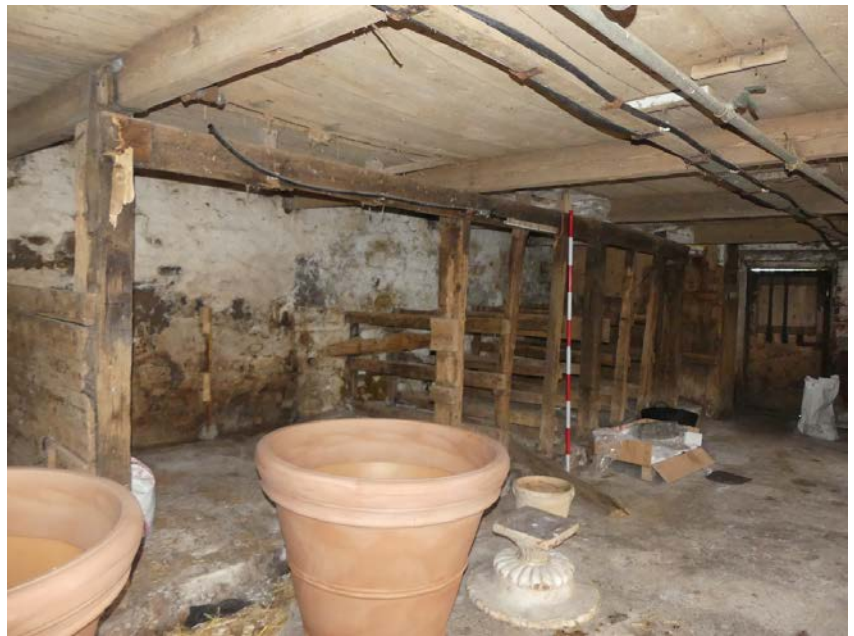
**Plate 41 (left): Detail of a stall post on the south-east side of Room G1 of the barn, viewed from the west**

**Plate 42 (right): Stalls on the north-west side of Room G1 of the barn, viewed from the south**

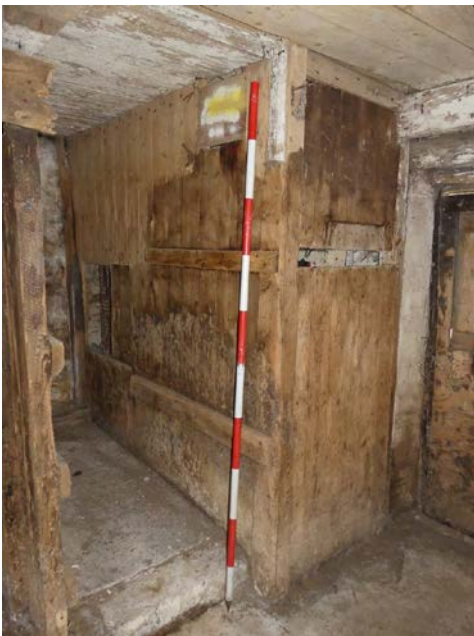
**Plate 43 (left): 'Porch' in the north corner of Room G1 of the barn, viewed from the south**

4.4.2 The north-east elevation is mostly plain. The doorway north-west of centre has a timber lintel and door and brick in the south-east jamb (Plate 45). There is another door to the north-west inside the small 'porch'. This too has a timber lintel and plank and batten door. A recess to the south-east of this, at the east corner, has a timber lintel (Plate 46). There is a metal water trough and hinged iron cover over the low opening between these. The south-east elevation has a doorway on the north-east side with a timber lintel. It is blocked with stone (Plate 47). There is a narrow window to the south-west, which is blocked below from an originally taller window (Plate 48). There are two more tall windows to the south-west, with thin timber lintels and iron bars over and stone sills (Plate 49). The wagon doorway to the south-west has dressed quoins and double plank and batten sliding doors beneath a reused, hand-finished timber lintel (Plate 50). There is one further window at the south west end, which is clearly inserted and has a stop-chamfered concrete lintel (Plate 51). The south-west elevation, the gable, is plain except for an

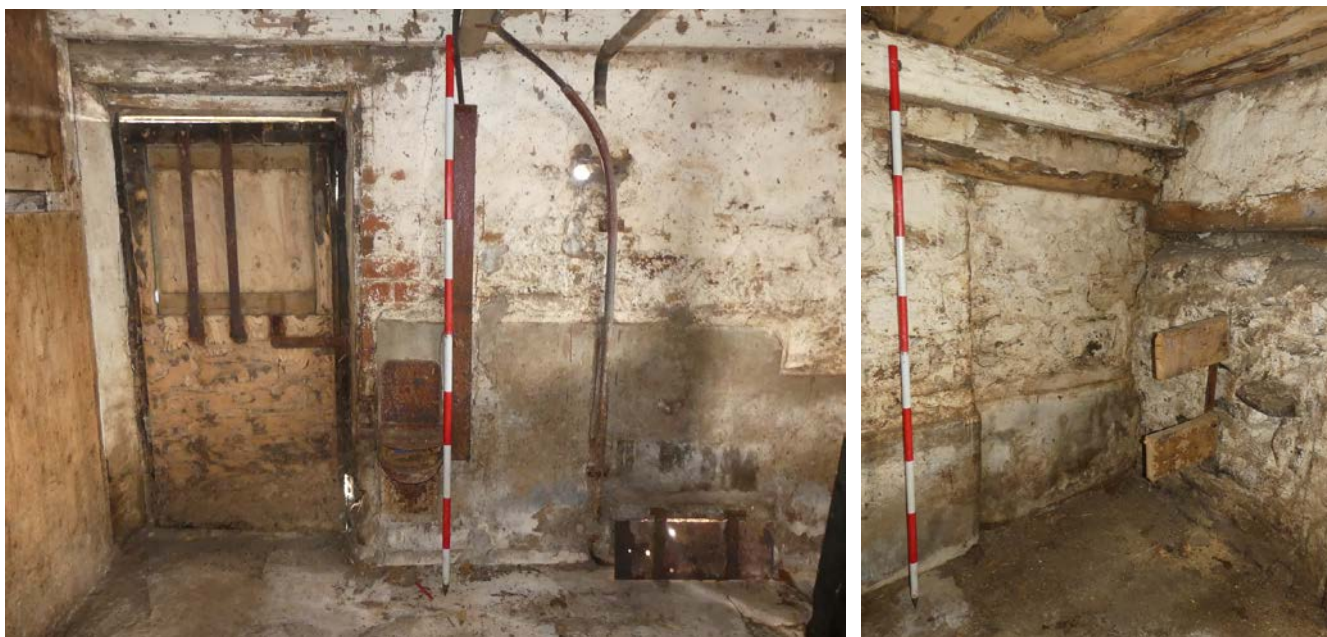
**Plate 45 (left): South-east doorway in the north-east elevation, Room G1 of the barn, viewed from the south-west**

**Plate 46 (right): Recess on the south-east side of the north-east elevation, Room G1 of the barn, viewed from the west**

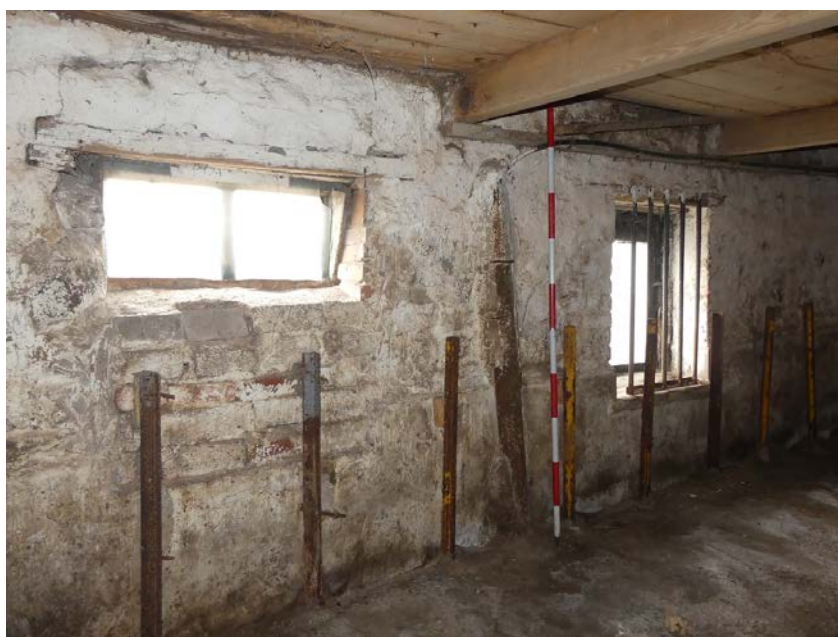
**Plate 48 (right): North-east side of the south-east elevation, Room G1 of the barn, viewed from the north**

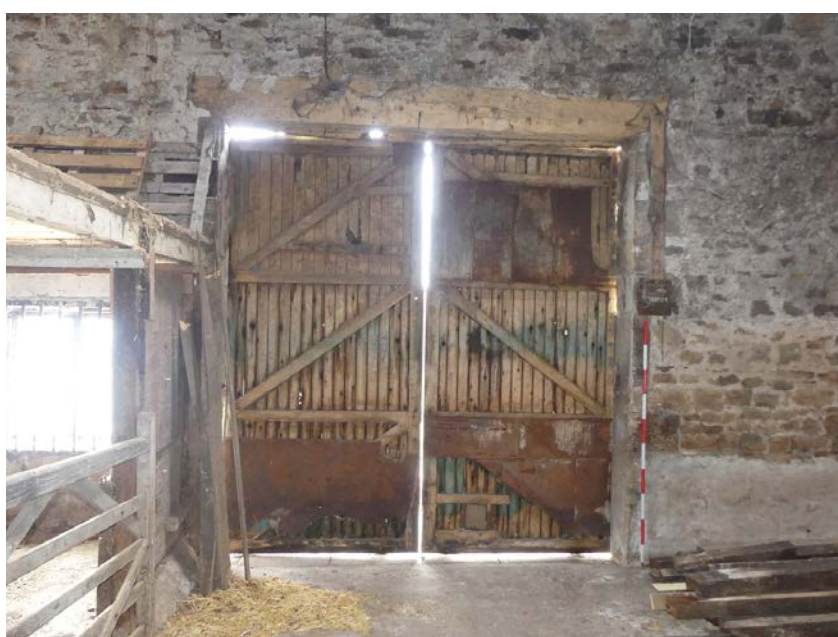
**Plate 50 (right): Wagon doorway, south elevation, Room G1 of the barn, viewed from the north-west**

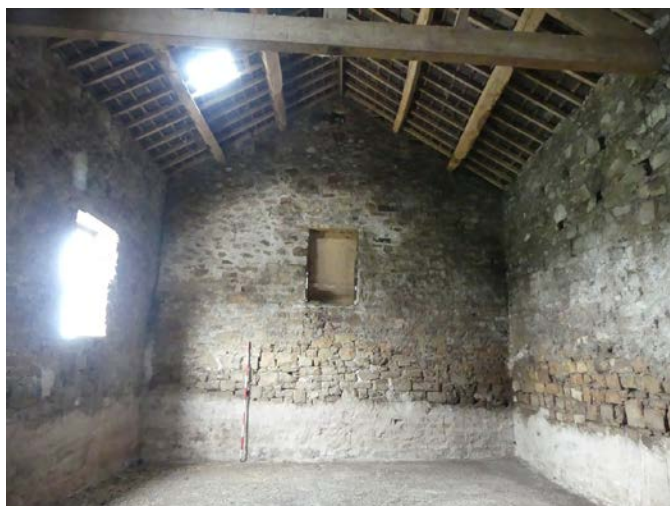
**Plate 52 (right): South-west elevation, Room G1 of the barn, viewed from the north-east**

upper-level doorway with a thin timber lintel and modern board door and owl hole at the apex (Plate 52). The north-west elevation is fairly plain on the south-west side (Plate 53), except for a low window on the south-west side with a timber lintel and sill (Plate 54). There are handmade bricks in the jambs. There is a wider doorway to the north-east with two stone steps (Plate 55) and an iron rail in the base for a sliding door, that continues into a recess to the north-east (Plate 56). There are concrete blocks in the north-east jamb against the original quoins. There is a recessed area to the north-east for the original door and iron I-beam lintels over the door and quoins to the south-west. There is a reused stone with a long groove incorporated into the wall on the south-west side, perhaps a rail for a stud wall. The wall effectively returns north-east of this at the hay loft, where there is a metal gate, but are otherwise plain within the area of the stalls (Plate 57).

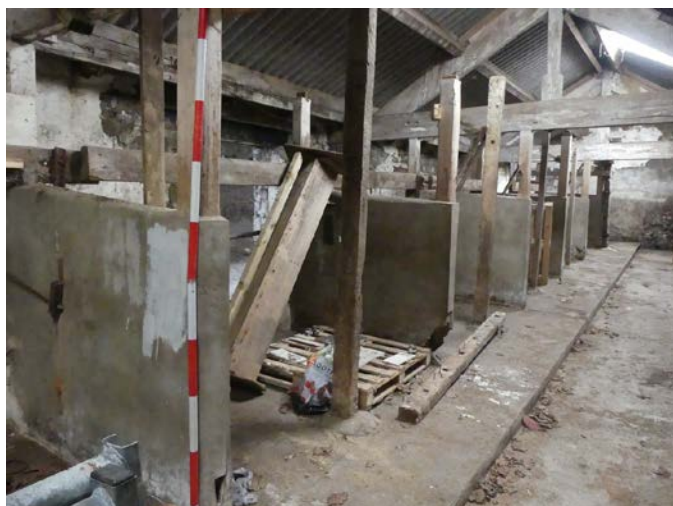
**Plate 58 (left): Stalls on the south-east side of Room G2 of the barn, viewed from the north**

**4.4.3 Ground floor Room 2 (G2):** the extension to the north-west has a concrete floor that is raised in the middle to house seven concrete stalls on the south-east side of the Room (Plate 58 and Plate 59), some of which are clad around earlier stop-chamfered posts (Plate 60 and Plate 61). These are either below the trusses or sawn-off beams, the ends of which are still present in the north-west and south-east walls. The stalls have some iron tethers and iron water troughs remaining (Plate 62) and there is an access passageway along the south-east side of the stalls (Plate 63). The roof is supported by three trusses, all of king post type with sawn timbers (Plate 64 and Plate 65). They support a single purlin per pitch and there is an additional horizontal beam on the south-east side. There is a corrugated sheet roof over with four corrugated plastic sheet skylights in the north-west side. There is a massive iron gutter in the valley on the south-east side supported on a row of roughly dressed stone corbels (Plate 66 and Plate 67). The walls are finished with remnants of limewash over the stone to the south-east and concrete skim to the north-east, north-west and south-west.

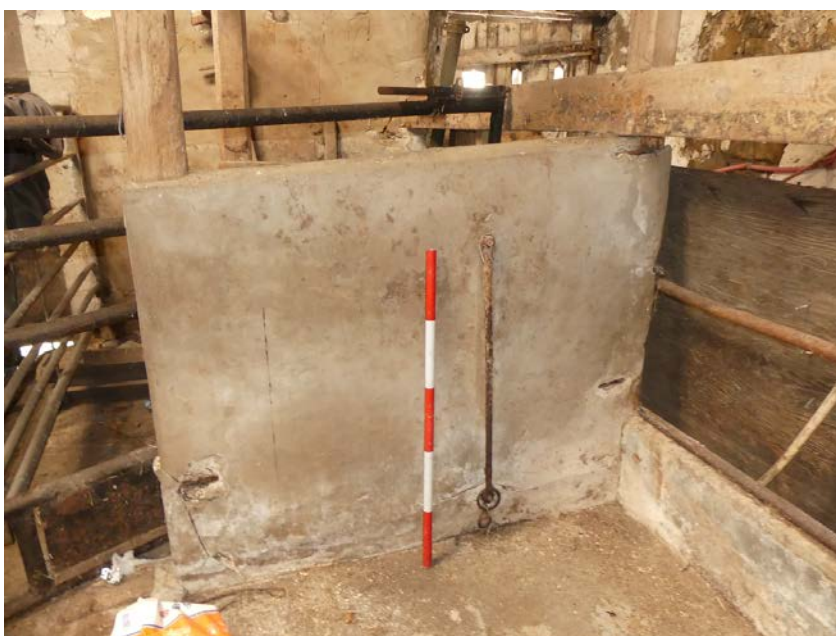
**Plate 61 (right): Detail of stall partition, Room G2 of the barn, viewed from the south-west**

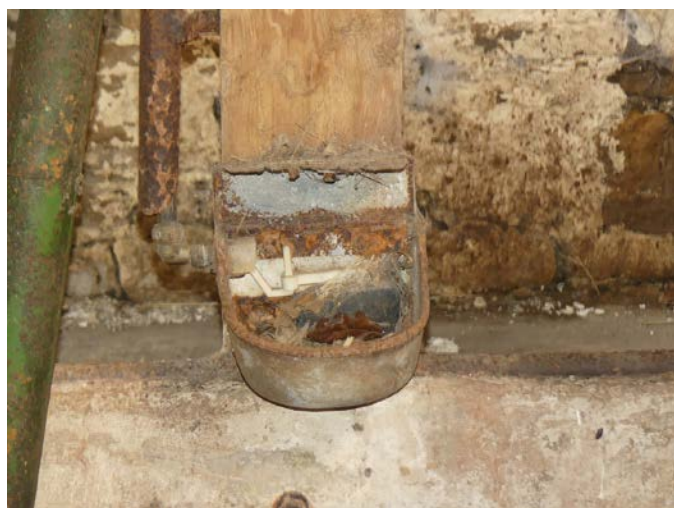
**Plate 62 (left): Metal water trough attached to the north-east end of the stalls, Room G2 of the barn, viewed from the north-west**

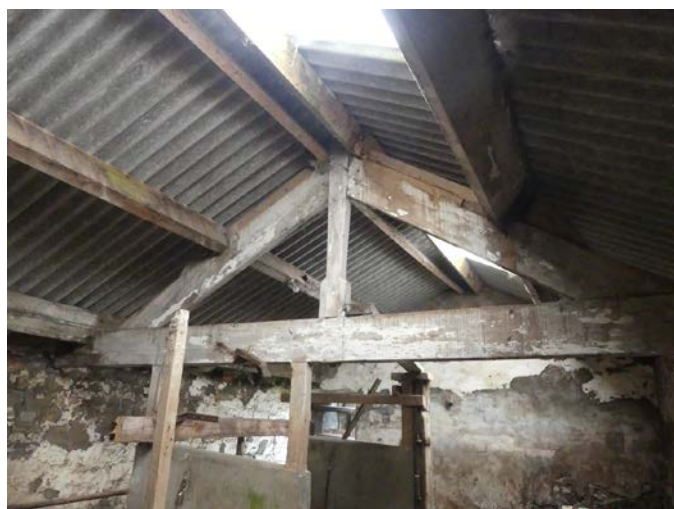
**Plate 64 (left): South-west truss, Room G2 of the barn, viewed from the north-east**

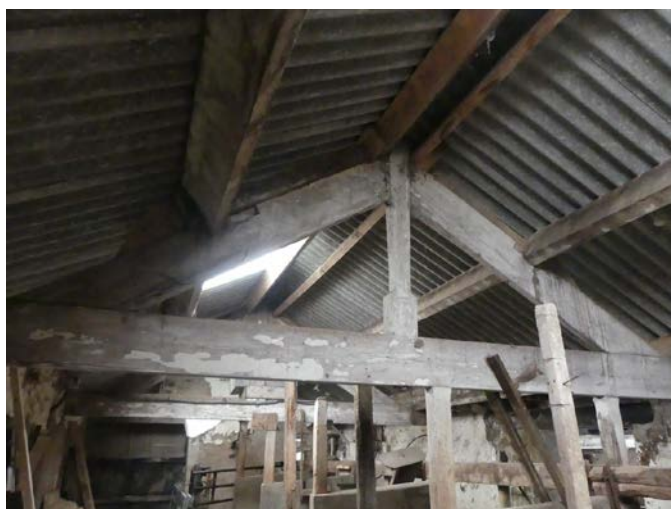
**Plate 65 (right): North-east truss, Room G2 of the barn, viewed from the south-west**

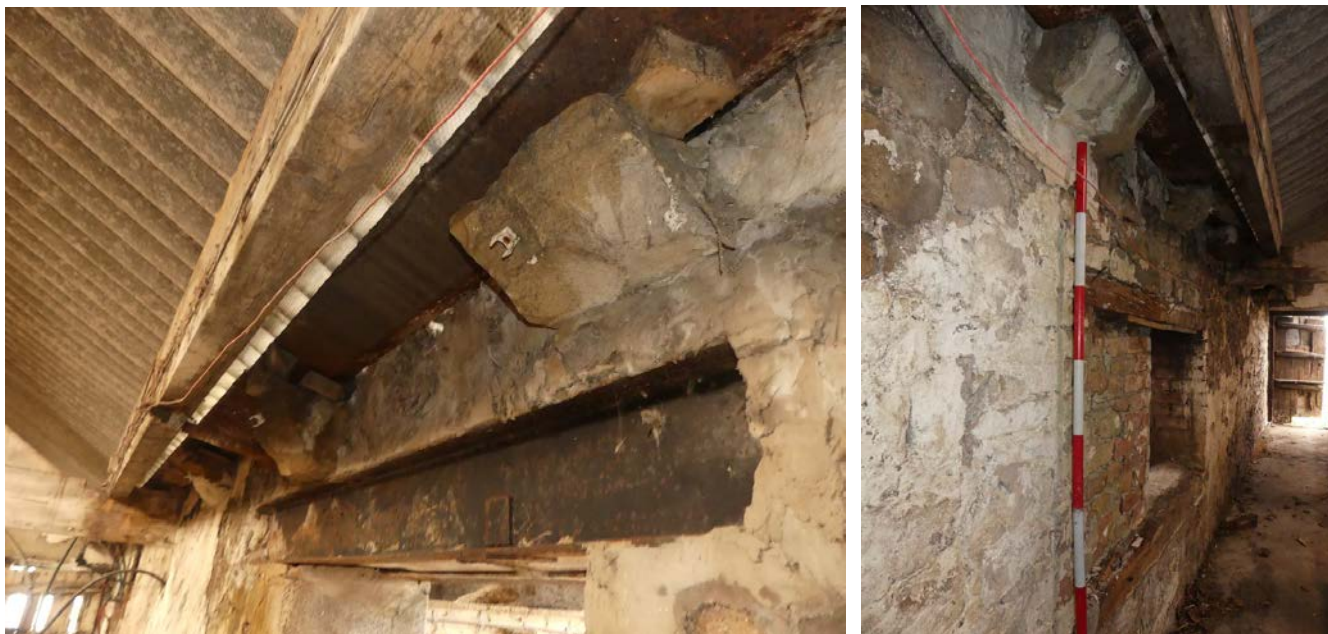
**Plate 66 (left): Corbels supporting the gutter along the south-east side of Room G2 of the barn, viewed from the west**

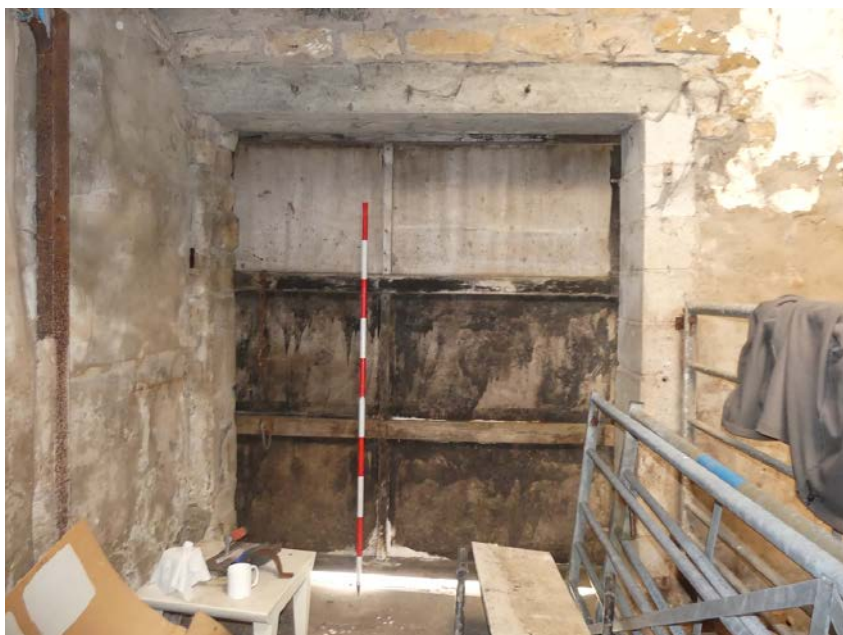
4.4.4 The north-east elevation has a wide doorway on the north-west side, housing a panel door, with concrete lintel and concrete in the jambs and rebuild over (Plate 68). There is a smaller doorway to the south-east with a plank and batten door and timber lintel (Plate 69). The south-east elevation is mostly plain with a central doorway with concrete blocks on the north-east side and iron I-beam lintel (Plate 70). The window to the south-west has handmade brick in the jambs and extends into the recess on north-east side beneath a long timber lintel (Plate 71). The south-west elevation has a doorway on the south-east side with remains of a plank and batten door and thing frame below a thin timber lintel (Plate 72). The north-west elevation has three blocked windows in it (Plate 73). The north-east one has blocks visible whereas the others are concreted over, the south-west leaving an alcove (Plate 74 and Plate 75).

**Plate 68 (left): Doorway on the north-west side of the north-east elevation, Room G2 of the barn, viewed from the south-west**

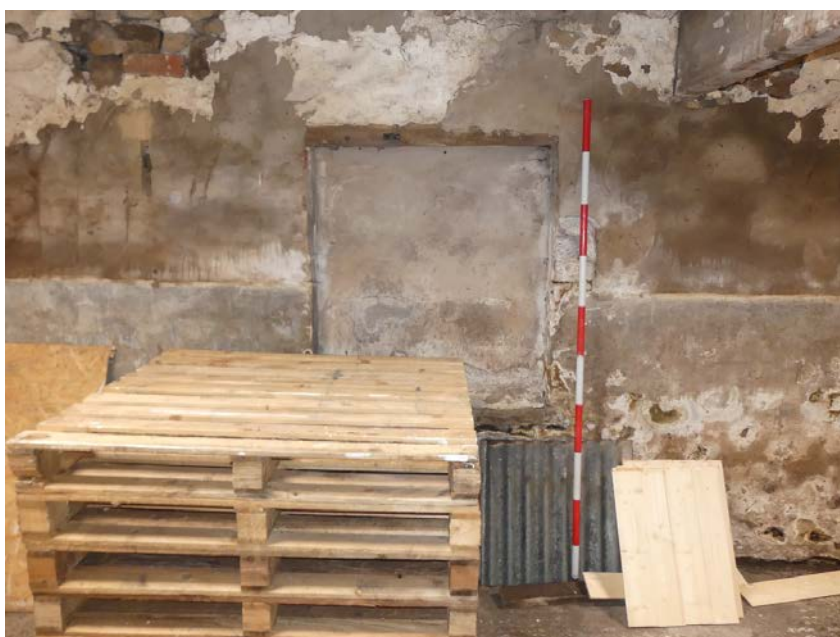
Plate 74 (left): Blocked window, south-west side of the north-west elevation, Room G2 of the barn, viewed from the south-east

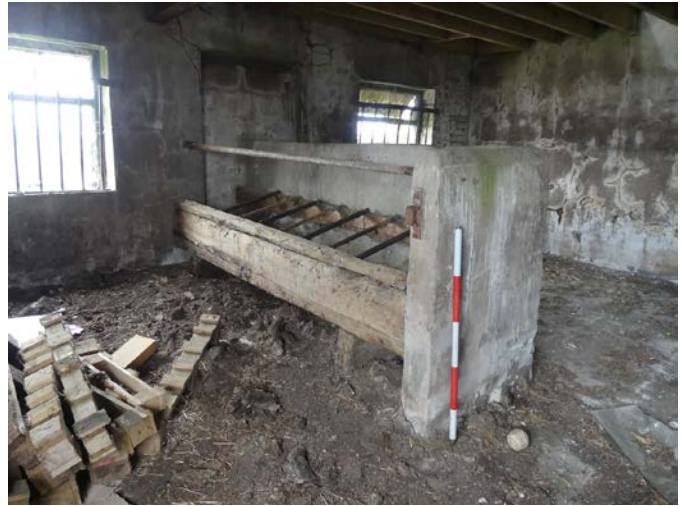
**Plate 77 (right):** Feed trough on the south-west end of the north-west side of Room G3 of the barn, viewed from the east

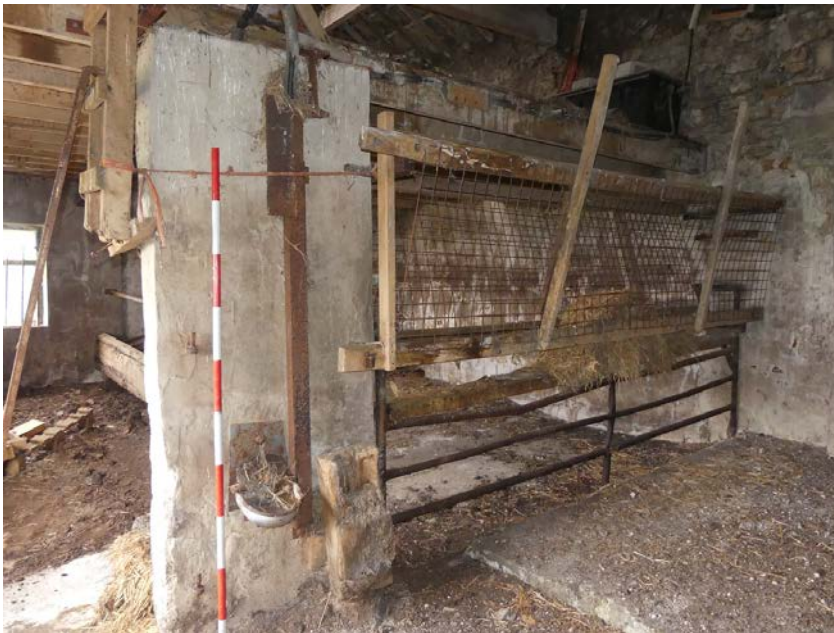
**Plate 78 (left):** Concrete division and hay rack on extending across the centre of the north-west side of Room G3 of the barn, viewed from the east

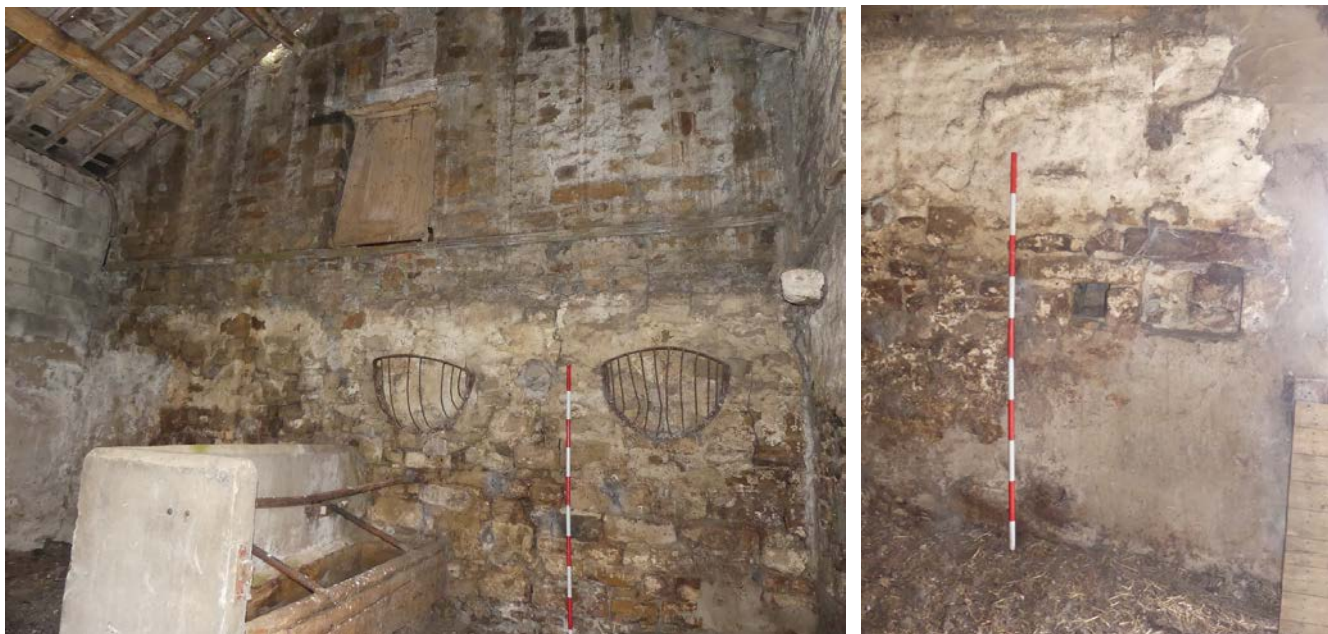
4.4.6 The north-east elevation has a row of three stone corbels but is otherwise essentially plain. Two semi-circular hay racks are attached on the south-east side (Plate 80). The south-east elevation has a corbel high on the north-east side and two square alcoves with stone lintels to the south-west (Plate 81). There is a wide doorway beyond with concrete over the jambs and concrete lintel (Plate 82). The south-west elevation has two windows with iron bars attached, one either side of the blocked central doorway (Plate 83 to Plate 85). The north-west elevation is plain on the south-west side, although the north-east side is evidently rebuilt in concrete blocks and skimmed with concrete (Plate 86).

**Plate 80 (left): North-east elevation, Room G3 of the barn, viewed from the south-west**

**Plate 81 (right): North-east side of the south-east elevation, Room G3 of the barn, viewed from the north-west**

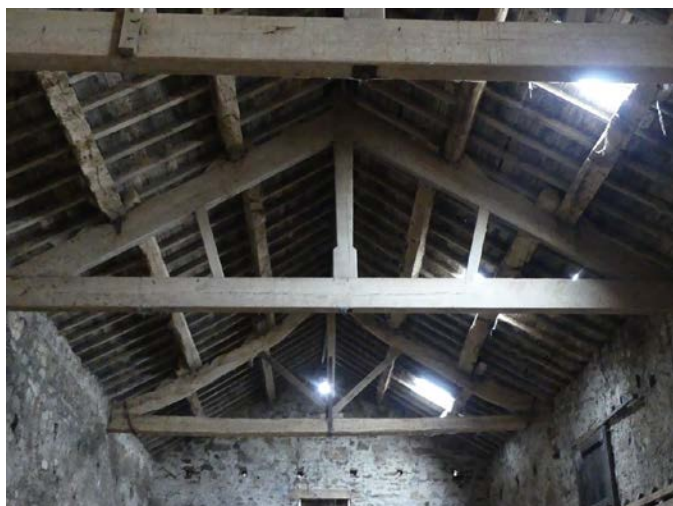
**Plate 87 (left): Central truss, Room F1 of the barn, viewed from the south-west**

4.4.7 **Upper-level Room 1 (F1):** the upper floor of the main barn comprises a board floor for a hayloft at the north-east end. It is open to the roof and there are four trusses, three of sawn timber and king post type, with the king post bolted to tie beam and pair of angled queen braces and timber wedge cleats against the purlins (Plate 87). The north-east truss is anomalous and presumably earlier as it is being hand-finished with longer sawn queen braces coming from the king post and an iron strap between the tie beam and king post. The principal rafters are very curved, and are perhaps reused crucks (Plate 88). There are two purlins per pitch, all hand-finished and overlapping at the trusses, timber wedge cleats, a housed ridge plank (Campbell 2000, 47-49), and sawn rafters. There are five skylights in the south-east side. The walls are exposed stone with mortar.

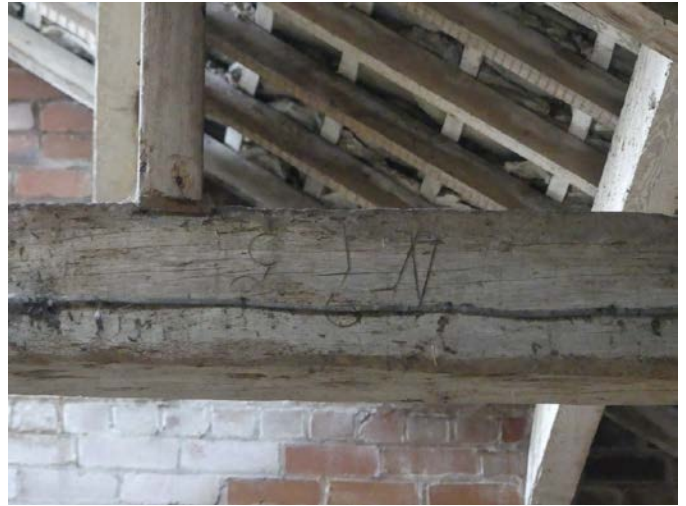
**Plate 92 (right):** Baltic marks on the north-east face of the south-west tie beam, Room F2 of the barn, viewed from the north-east

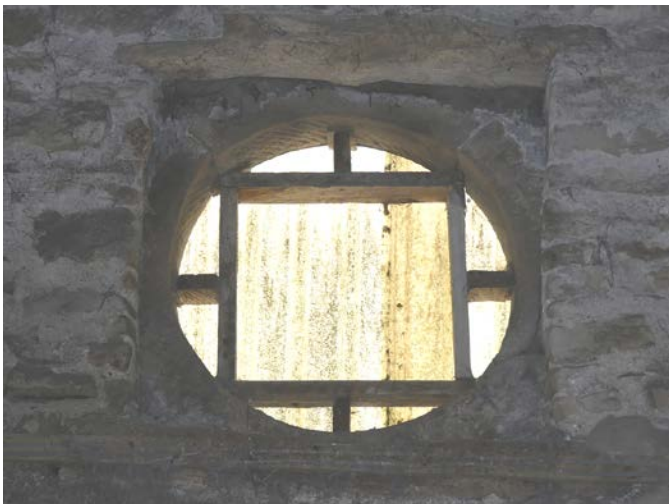
**Plate 93 (left):** Circular pitching window in the south-east elevation, Room F2 of the barn, viewed from the north-west

4.4.10 The north-east elevation is plain except for the central pitching door, which has a rough, reused timber lintel (Plate 80). The south-east elevation has a circular pitching window to the north-east with a stone surround in a square inner opening with a timber lintel (Plate 93). The second pitching door to the south-west is covered by a plain panel door. The south-west elevation is exposed brick, with a lower pitching door with an iron I-beam and lintel and smaller opening above also with an I-beam lintel (Plate 94). The bricks are handmade and in English Garden Bond in a ratio of five rows of stretchers to one row of headers. The north-west elevation has two square vents on the south-west side. The north-east end steps out to form a column below the truss of concrete block construction as per the rest of the elevation to the north-east. There is a single window in this part with a concrete lintel.

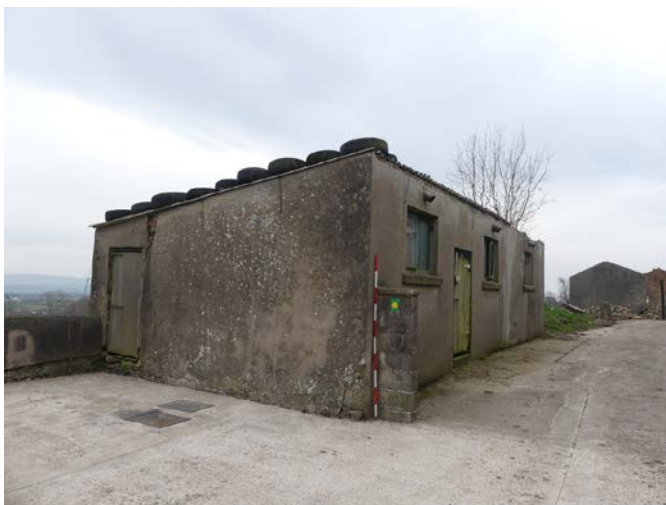
Plate 95: General view of the exterior of Outbuilding 1, from the east

4.5.1 **Arrangement:** this small, single-storey mono-pitch structure is orientated approximately north-east/south-west, with roof sloping down to the south-east (Plate 95).

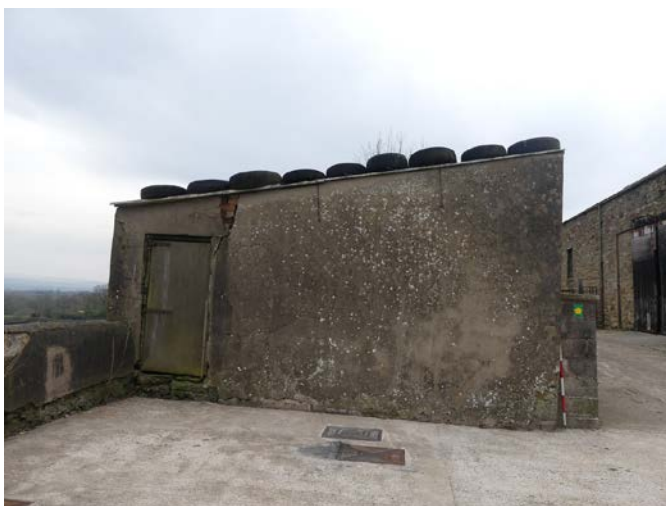
Plate 96: North-east external elevation, Outbuilding 1, viewed from the north-east

4.6.1 **North-east external elevation:** the north-east external elevation is mostly plain concrete render with iron straps for the roof and some brick exposed below the roof on the south-east side and stone exposed elsewhere. There is a single doorway on the south-east side, with a plain, modern panel door on strap hinges in a thin frame. The elevation is extended by a concrete block wall to the north-west side.

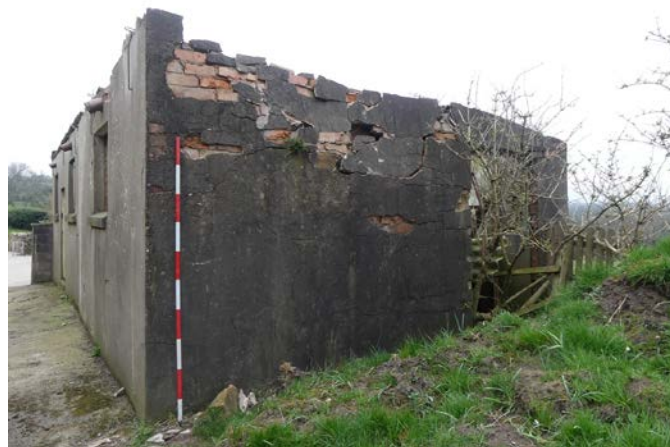
Plate 99: South-west external elevation, Outbuilding 1, viewed from the south-west

4.6.3 **South-west external elevation:** the south-west elevation is partly collapsed and shows machine-made brick construction. There is a doorway on the south-east side, but no door.

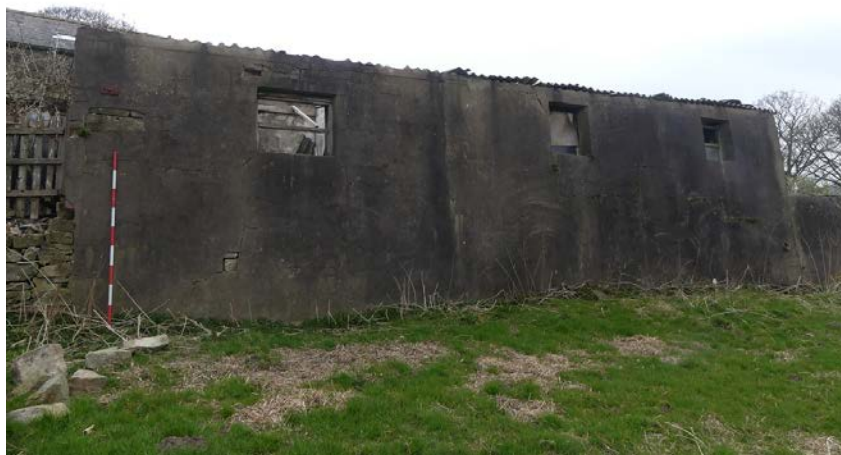
4.6.4 **South-east external elevation:** the south-east external elevation has a row of high-level small windows with the remains of two-light timber hinged casements. There is a pipe projecting low down on the north-east side. The brick evident on the south-west side is clearly clad over the underlying stonework and sat on top of the retaining wall.

Plate 100 (left): South-east external elevation, Outbuilding 1, viewed from the south-west
