# WRITTEN STONE FARM, WRITTEN STONE LANE, LONGRIDGE, PRESTON, LANCASHIRE

Archaeological Building Recording

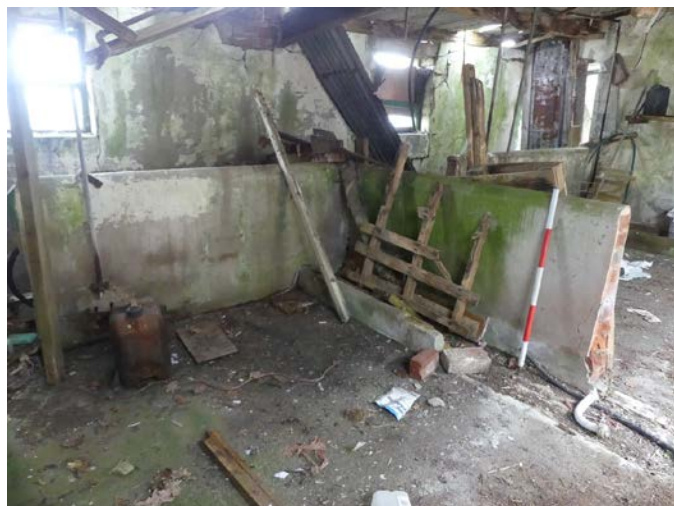
Plate 102 (left): Internal dividing walls, Room G1 of Outbuilding 1, viewed from the north-west

4.7.1 **Ground floor Room 1 (G1):** this room has a concrete floor with low brick dividing walls finished with concrete skim across the centre and along the south-east side (Plate 102), with a small timber gate remaining (Plate 103) and an attached metal water trough (Plate 104). There is a concrete trough with ceramic top along the north-west/south-east dividing wall and against the north-west and south-west walls (Plate 105). The room is open to the corrugated concrete roof, which is supported by machine sawn purlins north-east/south-west on an iron I-beam north-west/south-east (Plate 106). The walls are painted over the concrete skim.

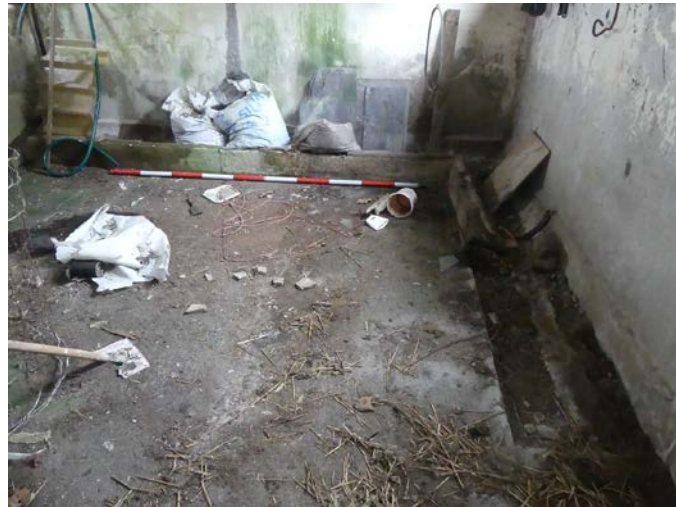
**Plate 105 (right): Ceramic trough against the north-west and south-west elevations, Room G1 of Outbuilding 1, viewed from the north-east**

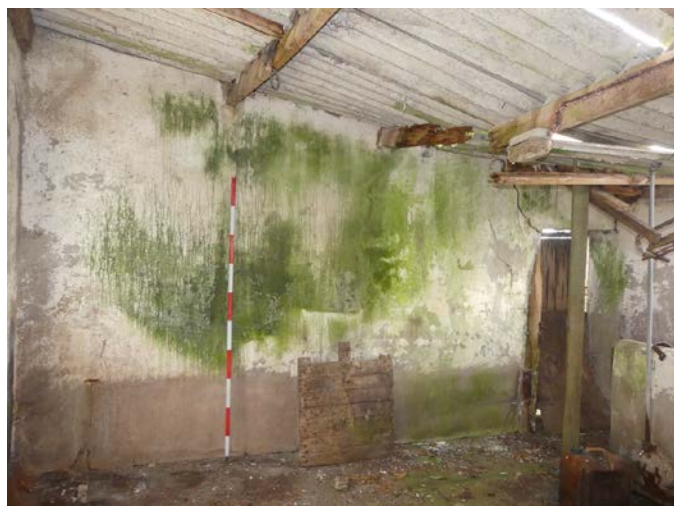
Plate 107 (left): North-east elevation, Room G1 of Outbuilding 1, viewed from the south-west

4.7.2 The north-east elevation is plain apart from the doorway on the south-east side with a modern panel door (Plate 107). The south-east elevation has two windows, with the remains of two-light hinged casements (Plate 108). The south-west elevation is plain with a doorway on the south-east side, blocked with various materials (Plate 109). There is a shelf on iron brackets to the north-west. The north-west elevation has a window on the south-west side, with a two-light hinged casement (Plate 110). The doorway to the north-east has a plank and batten door. A second window to the north-east is the same as the one to the south-west. Both have concrete lintels and are recessed into the wall.

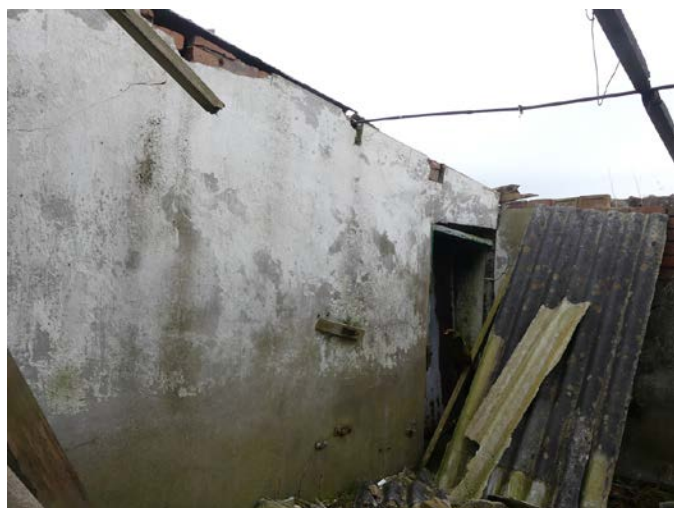
**Plate 111 (left): North-east elevation, Room G2 of Outbuilding 1, viewed from the west**

4.7.4 The north-east elevation has a doorway on the south-east side of which the thin frame remains (Plate 111). There is a single window on the south-east elevation with a concrete lintel and remains of a two-light hinged casement (Plate 112). Patches of brick are visible to the north-east of these where some of the concrete render has come away. The south-west elevation has a door on the south-east side (Plate 113). The north-west elevation has a central window.

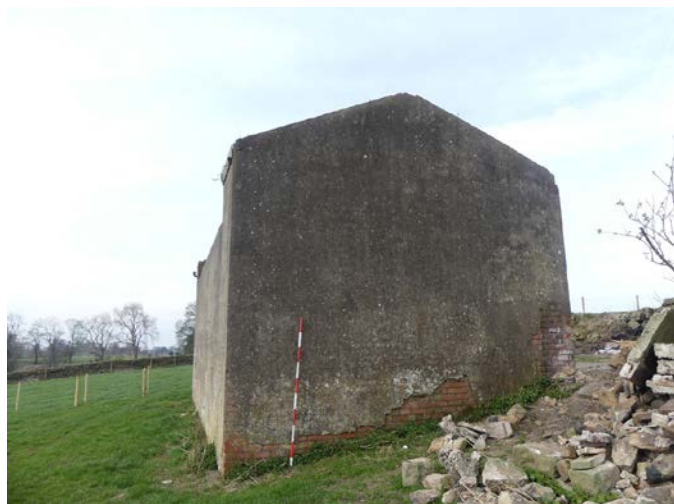
Plate 114 (left): North-east external elevation of Outbuilding 2, viewed from the north-east

4.8.2 **Fabric:** this outbuilding is of 20<sup>th</sup> century machine-made brick construction, principally in English Garden Bond in a ratio of five rows of stretchers to a single row of headers. The exterior to the south-east is concrete rendered and it has two iron I-beam columns on its open (north-west) side. Internally the walls are exposed brick, with buttresses on the south-east side corresponding with the positions of the columns to the north-west, which presumably originally supported two trusses (Plate 119 to Plate 121).

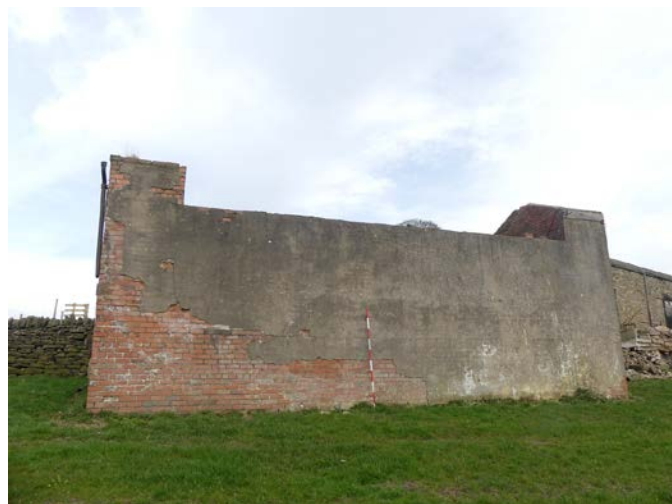
Plate 115 (right): South-east external elevation of Outbuilding 2, viewed from the south-east

4.8.1 **Arrangement:** the building comprises a small, now roofless, structure, is open on its north-west side and with a monopitch roof (Plate 115 to Plate 118). Internally it is clearly a single room.

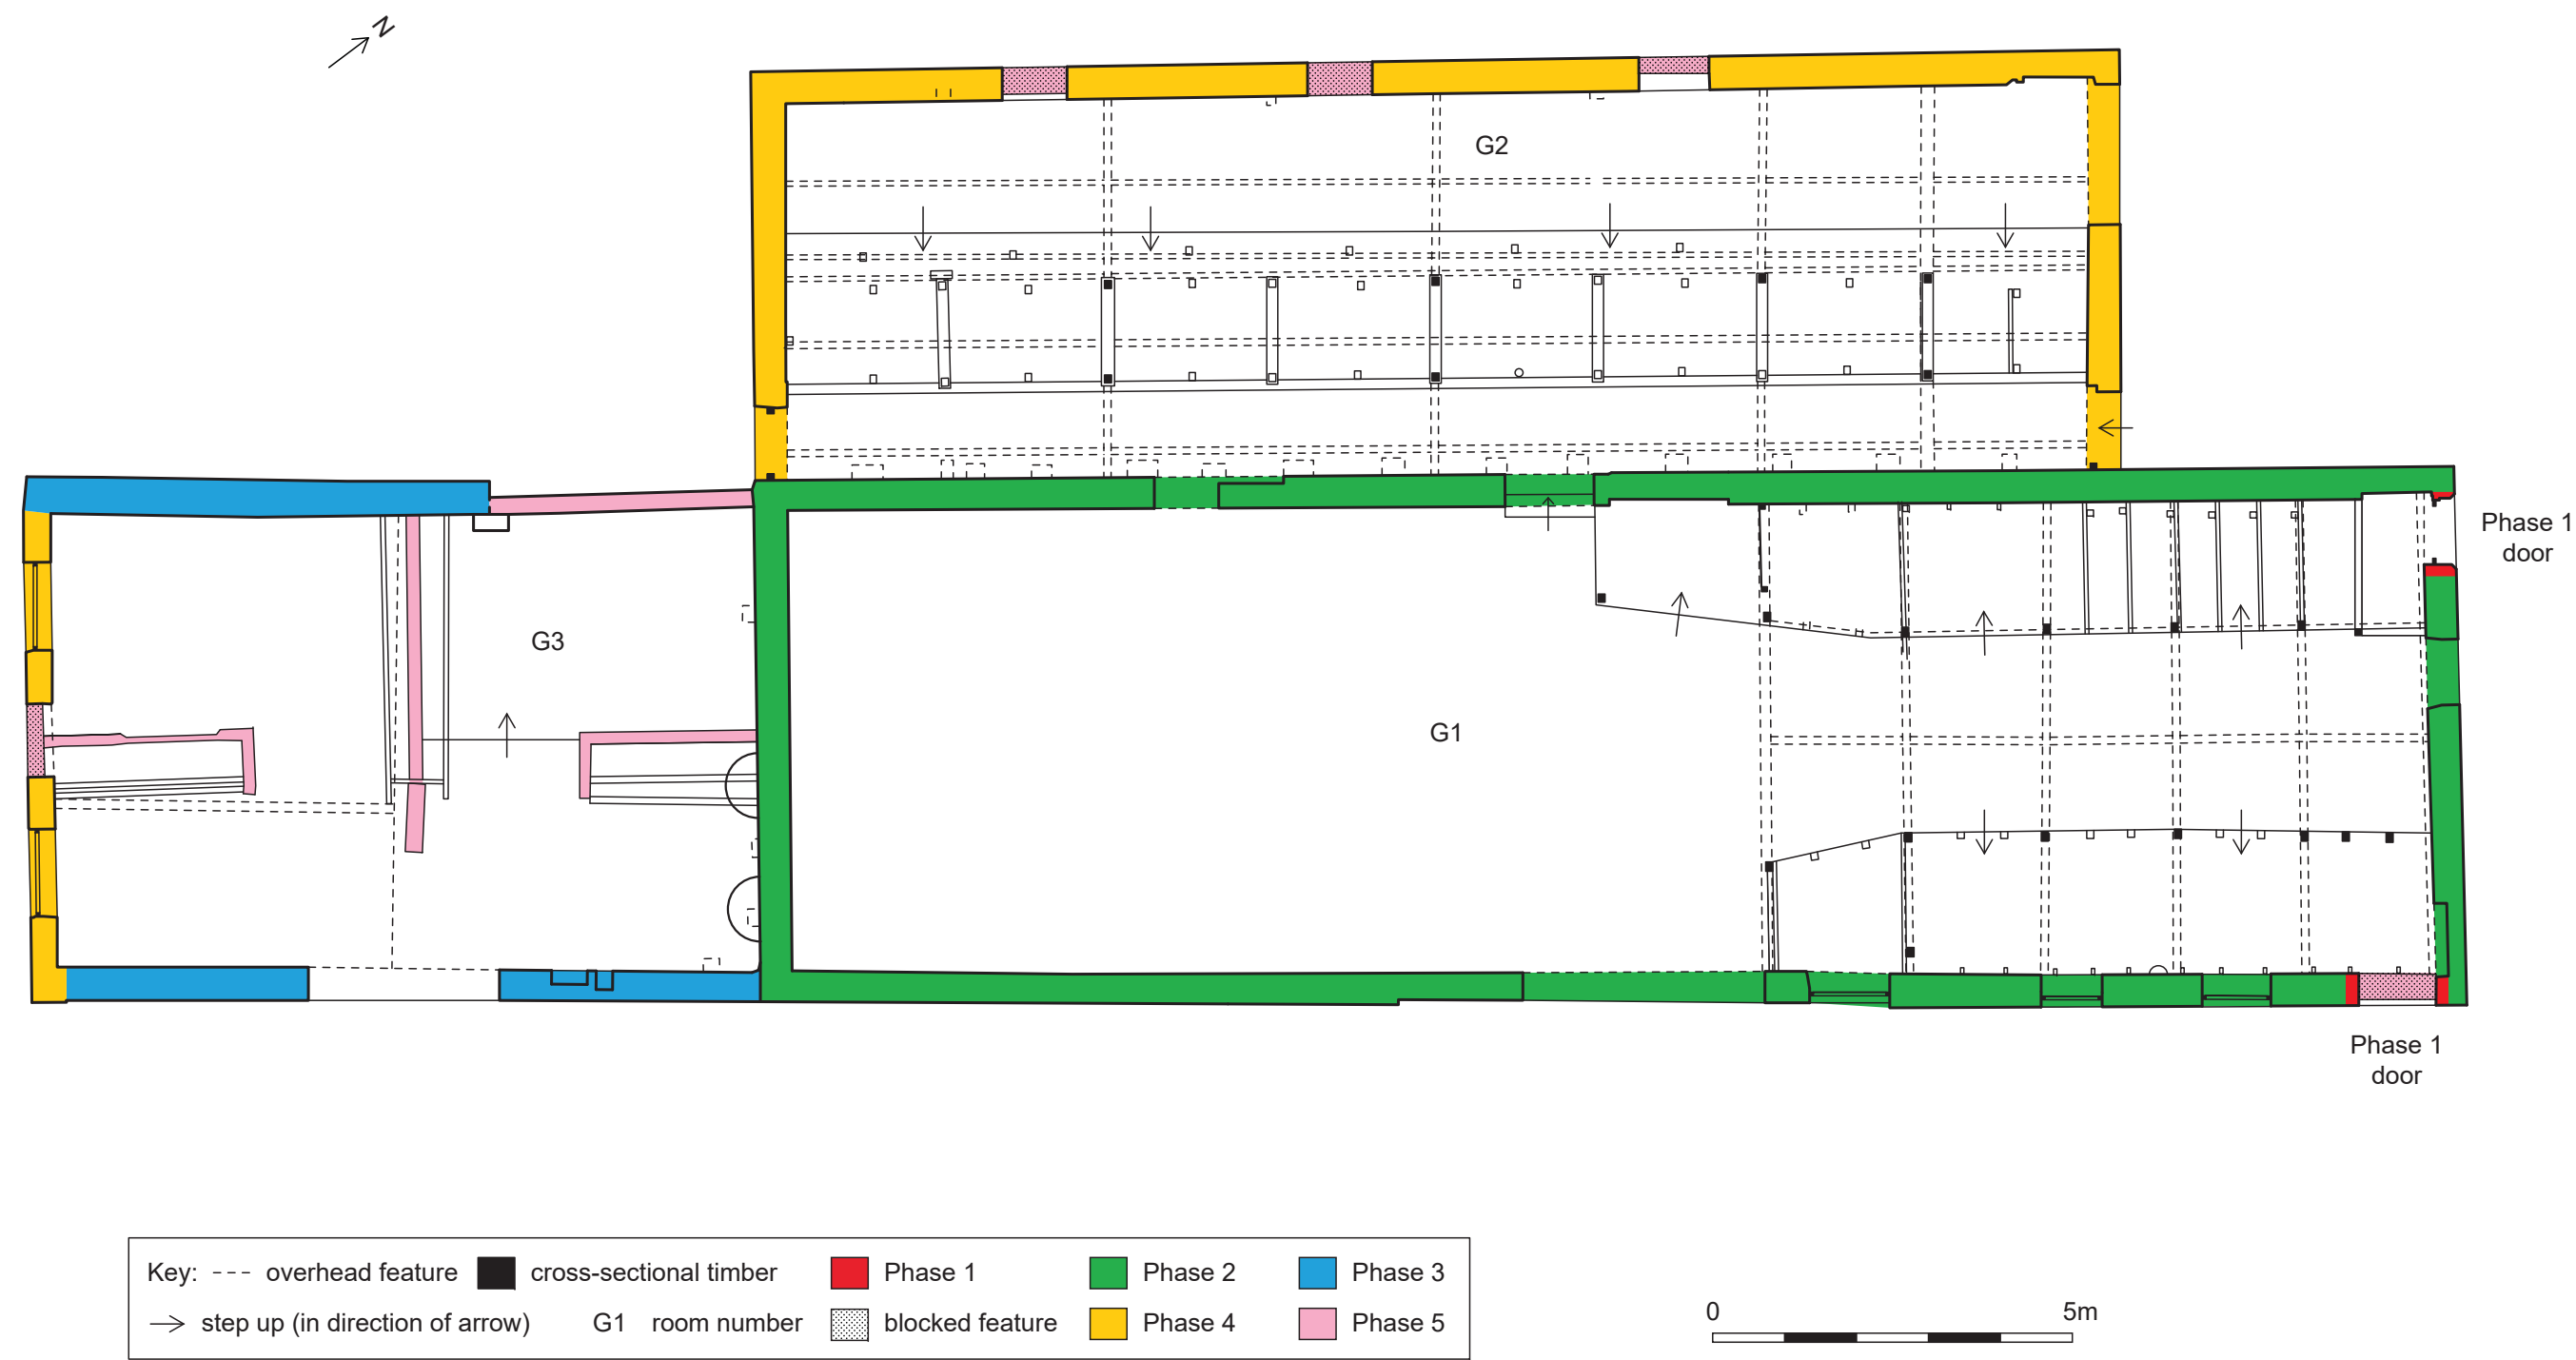
5.2.5 **Phase 4 (late 19<sup>th</sup> century):** the north-western part of the barn (Room G2) was clearly also a later addition, with the map evidence showing that it was constructed before 1895. This too was evidently constructed to provide additional housing for cattle, with a central row of stalls accessed by doorways to a passageway along the south-east side. This phase also saw the addition of Outbuilding 1. The purpose of this is unclear as it was substantially altered in later phases, but it too was probably related to the keeping of cattle, perhaps forming loose boxes for calves or for dairying purposes. Such increases in dairy production were widespread during the late 18<sup>th</sup> and throughout the 19<sup>th</sup> century as the

Figure 10: Phase plan showing the development of the barn
