YEW TREE AND GARDENS

– Land at Pendle Street East, Sabden, Lancashire.

ARBORICULTURAL IMPACT ASSESSMENT  
FOR PROPOSED DWELLINGS

Prepared by  
Antony Wood Cert Arb RFS  
Yew Tree+Gardens

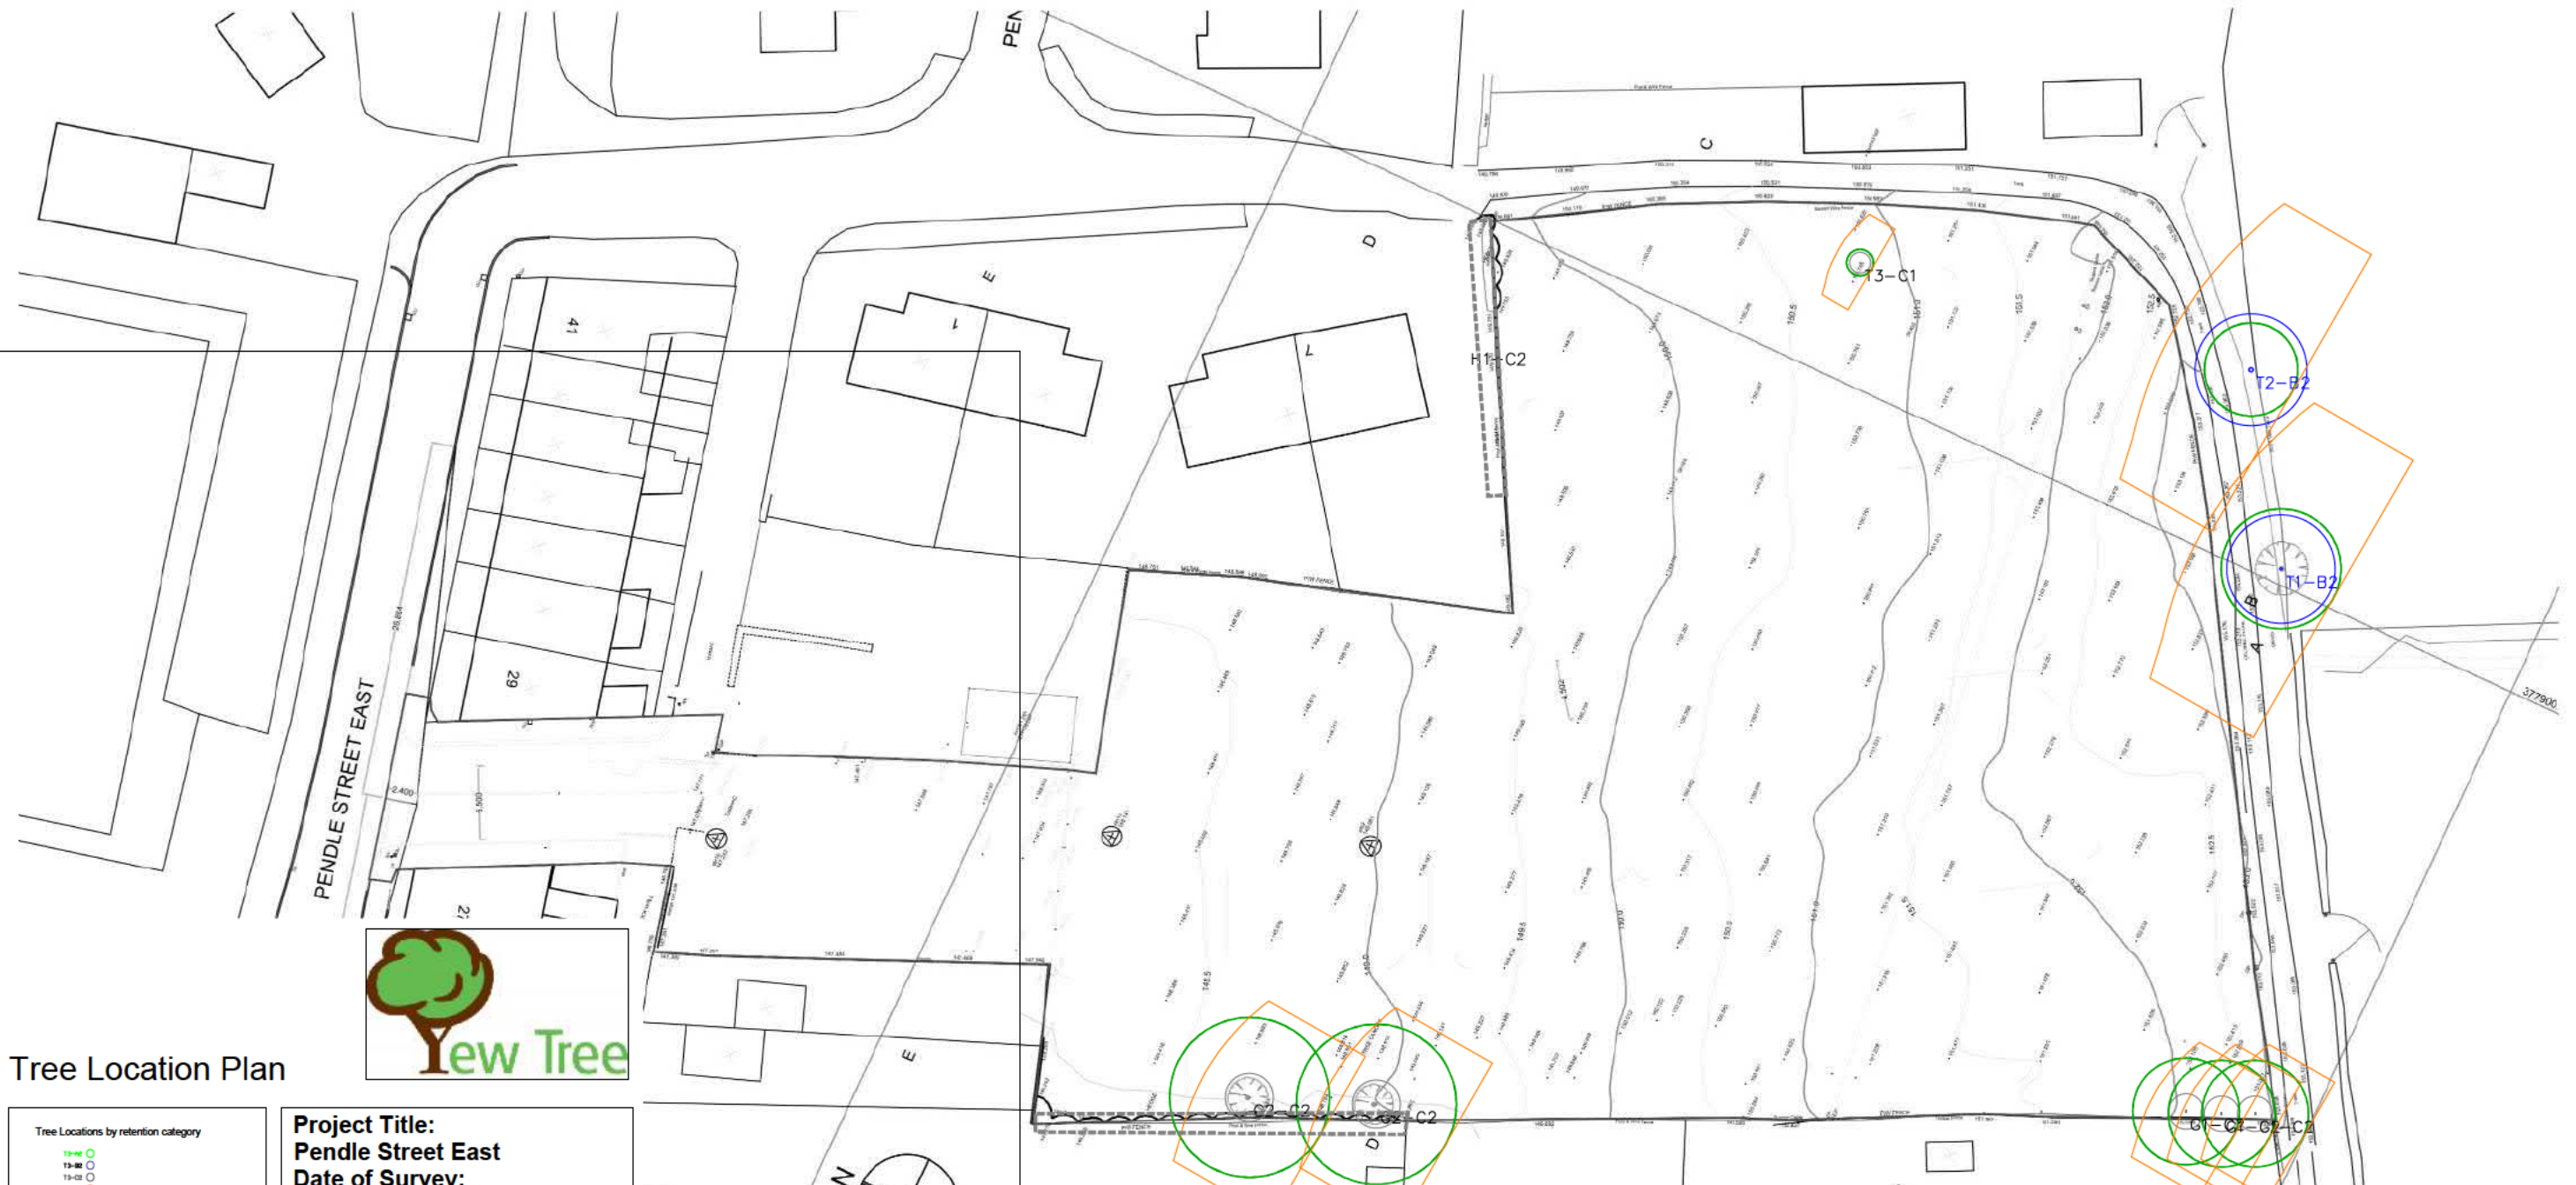
Tree Location Plan

RPA only indicated for significant trees. Small garden trees and juvenile specimens may not be indicated  
 Retention Categories:  
 As defined in BS5837: 2012  
 RPA:  
 Plotted from individual RPA sheets.  
 Where restricted rooting conditions are present  
 RPA is also plotted as an area polygon

1. Trees which are located within or adjacent to the development site boundaries are detailed in the schedule Appendix 1 and are as follows.
2. Trees within the site are Group G1, G2 and tree T3. None of these groups or trees are significant mature individuals. G1 is comprised of semi mature Common Beech and Goat willow, G2 is comprised of two Goat Willow, two Apples and a boundary hedge, T3 is a young Norway Maple in the eastern section of the site.
3. Tree reference T2 is an early mature Oak located to the south of the public footpath, T3 is an early mature Common Beech located on the same footpath boundary.
4. No other trees are located within or adjacent to the development area. Further small trees are located along the southern edge of the public footpath but these are outside of any development zones.

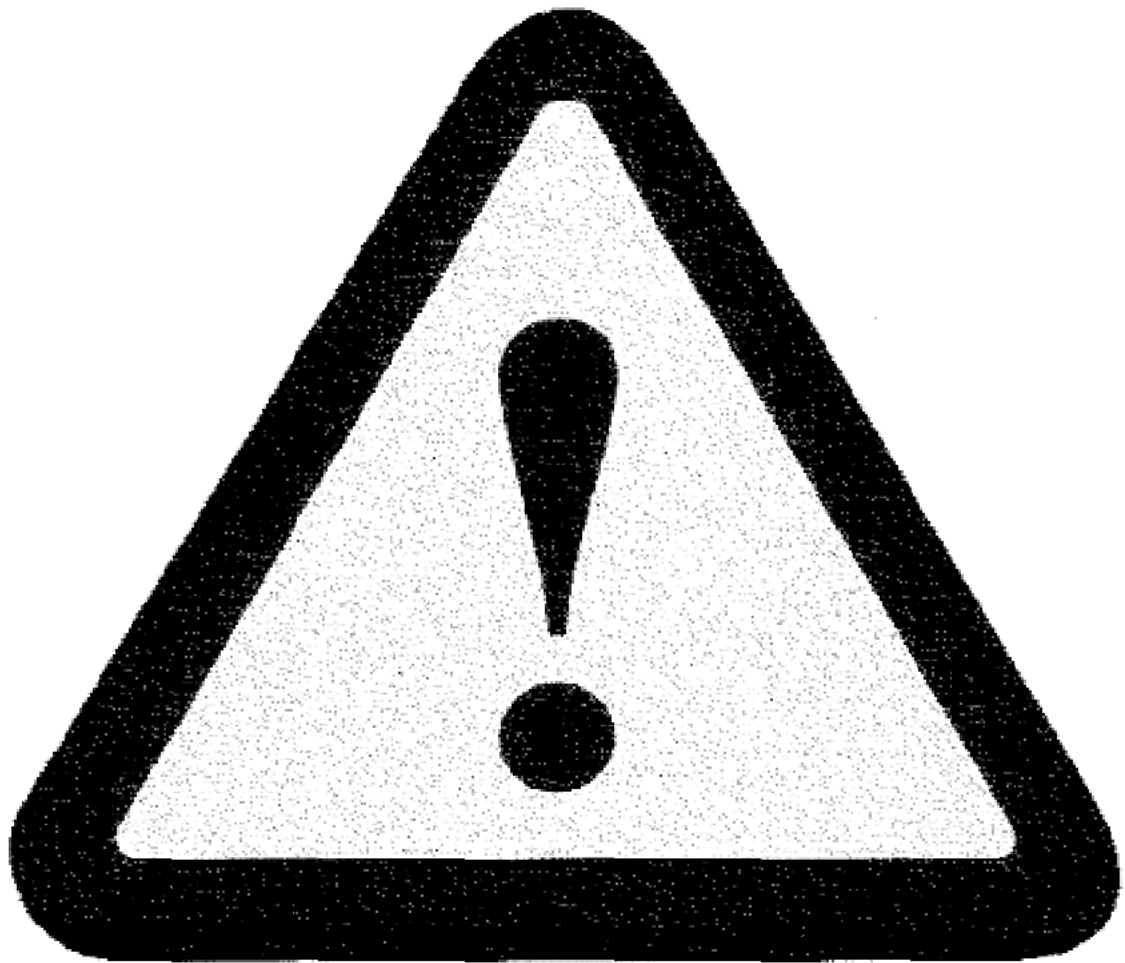
**TREE PROTECTION  
AREA  
KEEP OUT!**

**ANY INCURSION INTO THE PROTECTED AREA MUST BE WITH THE  
AGREEMENT OF THE LOCAL AUTHORITY OR ARBORICULTURAL  
CONSULTANT**
