# **Preliminary Bat Roost Assessment Report**

**3 Hayhurst Road,  
Whalley,  
Clitheroe, BB7 9RL**

**09.05.2025**

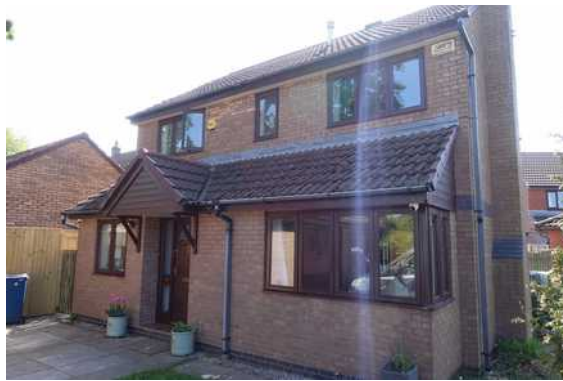
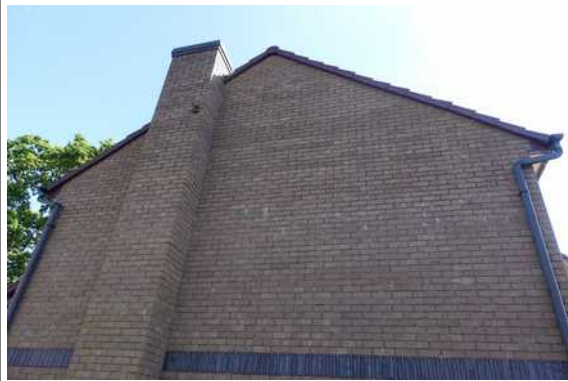
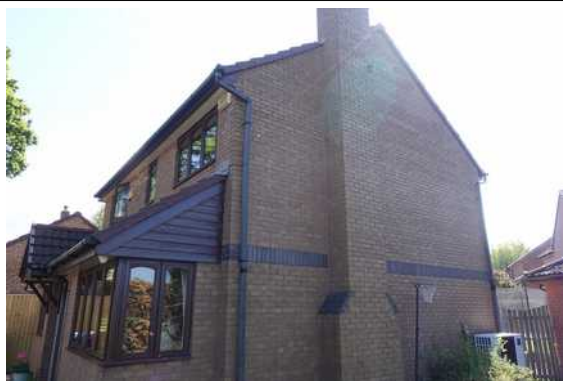
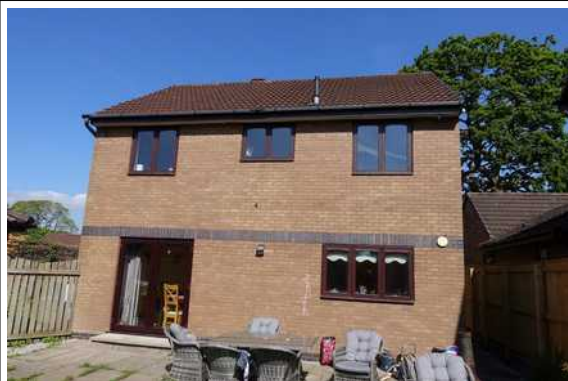
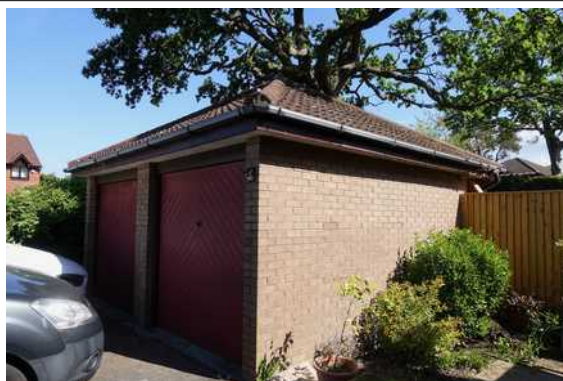
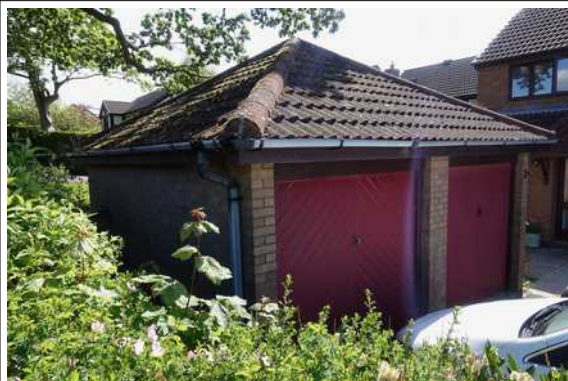
The property consists of a detached two storey brick built house with a double pitched tile roof, a single storey extension is present to the frontage. A double garage with hipped tile roof is located to the front of the property.

External walls well pointed with no cracks, crevices or cavities present. Gable ends are pointed and well sealed. Soffits and fascia boarding is close fitting and well sealed.

The roof is in good general condition with close fitting roof tiles, the ridge tiles are pointed and sealed.

The property can be considered to offer negligible bat potential.

The property is well maintained, well sealed and was assessed as offering negligible roosting potential with no obvious gaps or crevices suitable for roosting bats.
