Houlker Farm, Read

Bat Survey Report

June 2025

Report Title: Houlker Farm, Read
Bat Survey Report

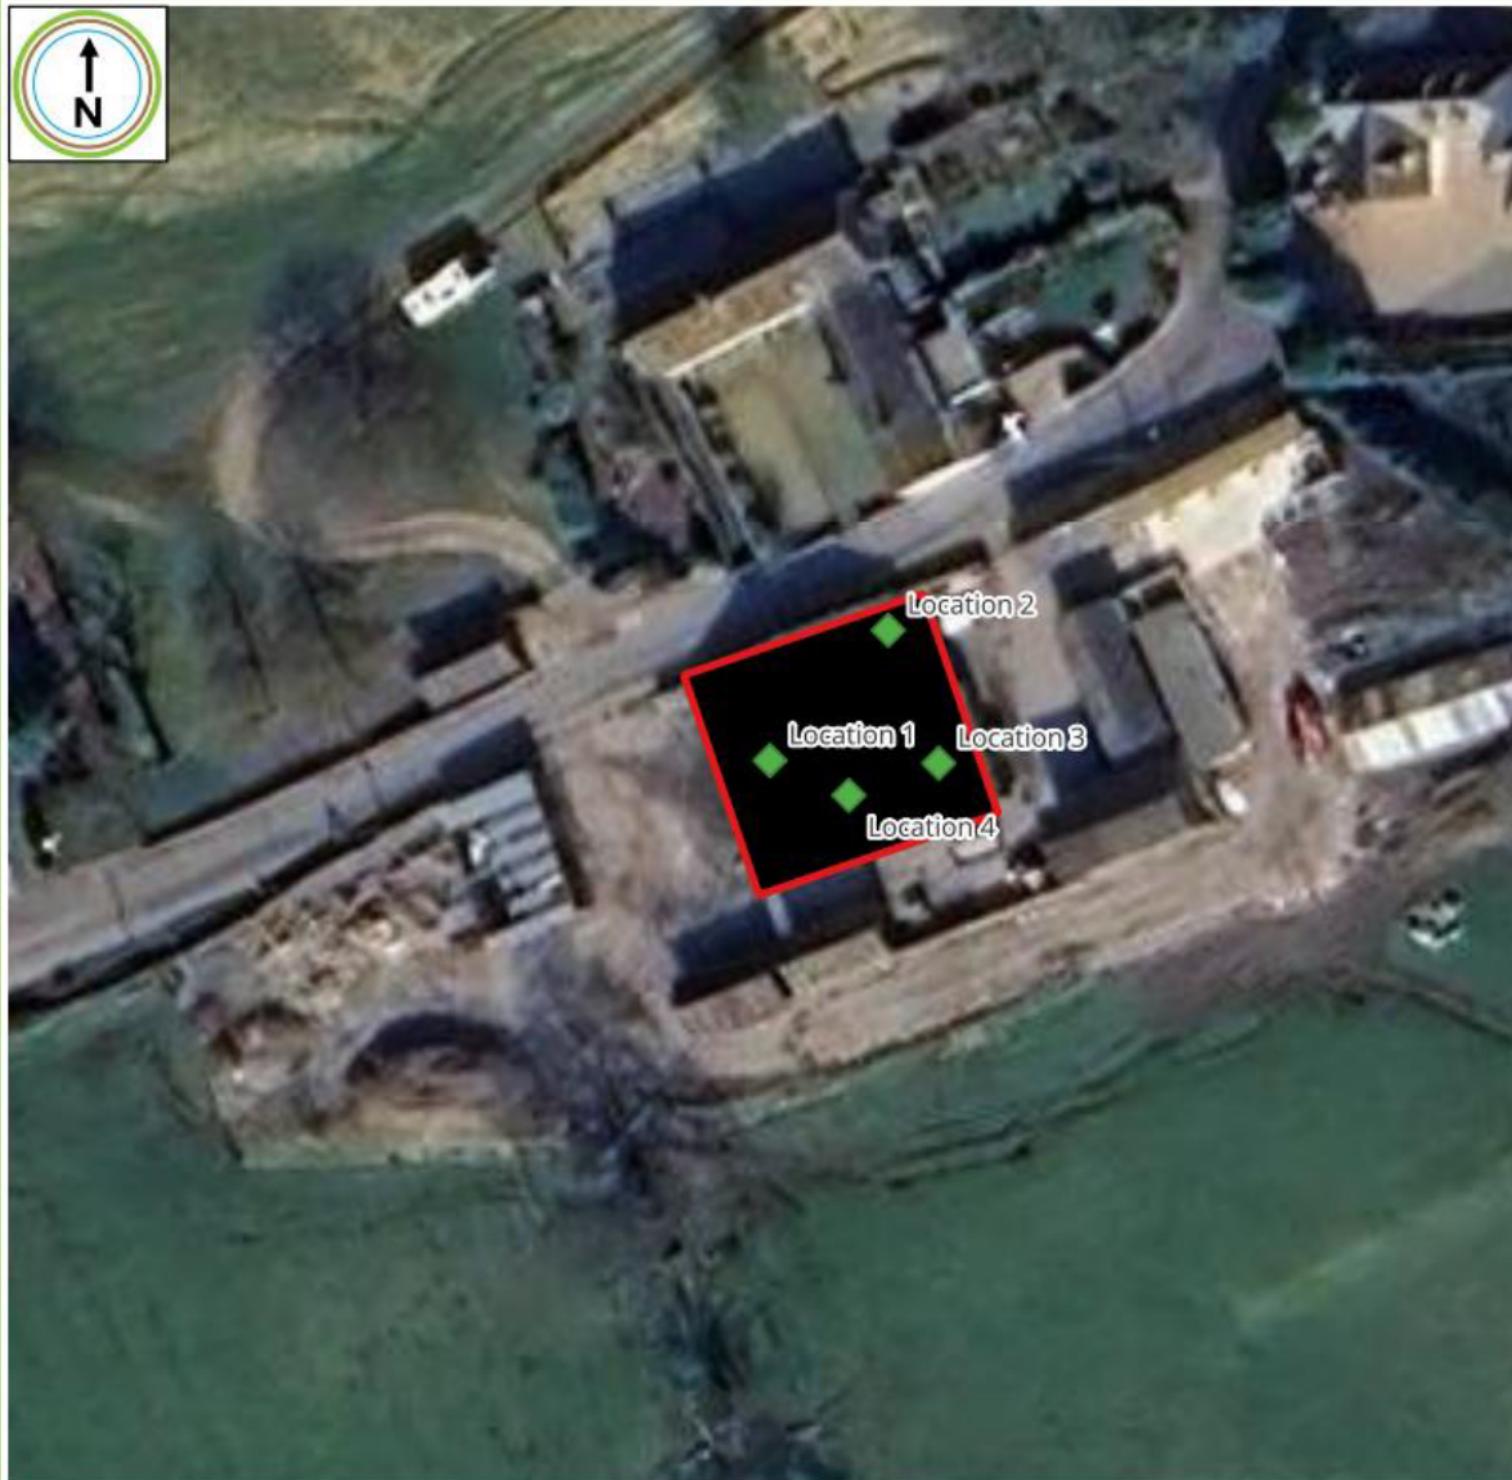
- 3.3.1 The three periods of automated static bat detector monitoring undertaken between January and March 2025 found no evidence of hibernating bats.
- 3.3.2 Bat detectors were placed in four locations within the Barn. These locations are displayed in Figure 2 and comprise: Location 1 – Above door between Main Barn and Western Room; Location 2 – Northeastern Room; Location 3 – Southwestern Room; Location 4 – Main Barn (Hay Loft).
- 3.3.3 No bat calls were recorded on any of the four detectors deployed throughout each of the three monitoring periods. Each detector recorded series of noise files, indicating that the detectors were working throughout each survey period, however no hibernating bats were recorded.

Locations of Static Bat Detectors During
Hibernation Monitoring

2.2.1 As the Site displayed 'Low to Moderate' suitability for hibernating bats, the hibernation surveys were accompanied by the monthly deployment of four static bat detectors: an Anabat Chorus detector with an omnidirectional microphone, in accord with good practice guidance (Collins, 2023). The static bat detectors were placed in four locations within the Barn, with the microphone facing outwards i.e. into the Barn, so as to record bat activity from within the proximity of their location (Figure 2).

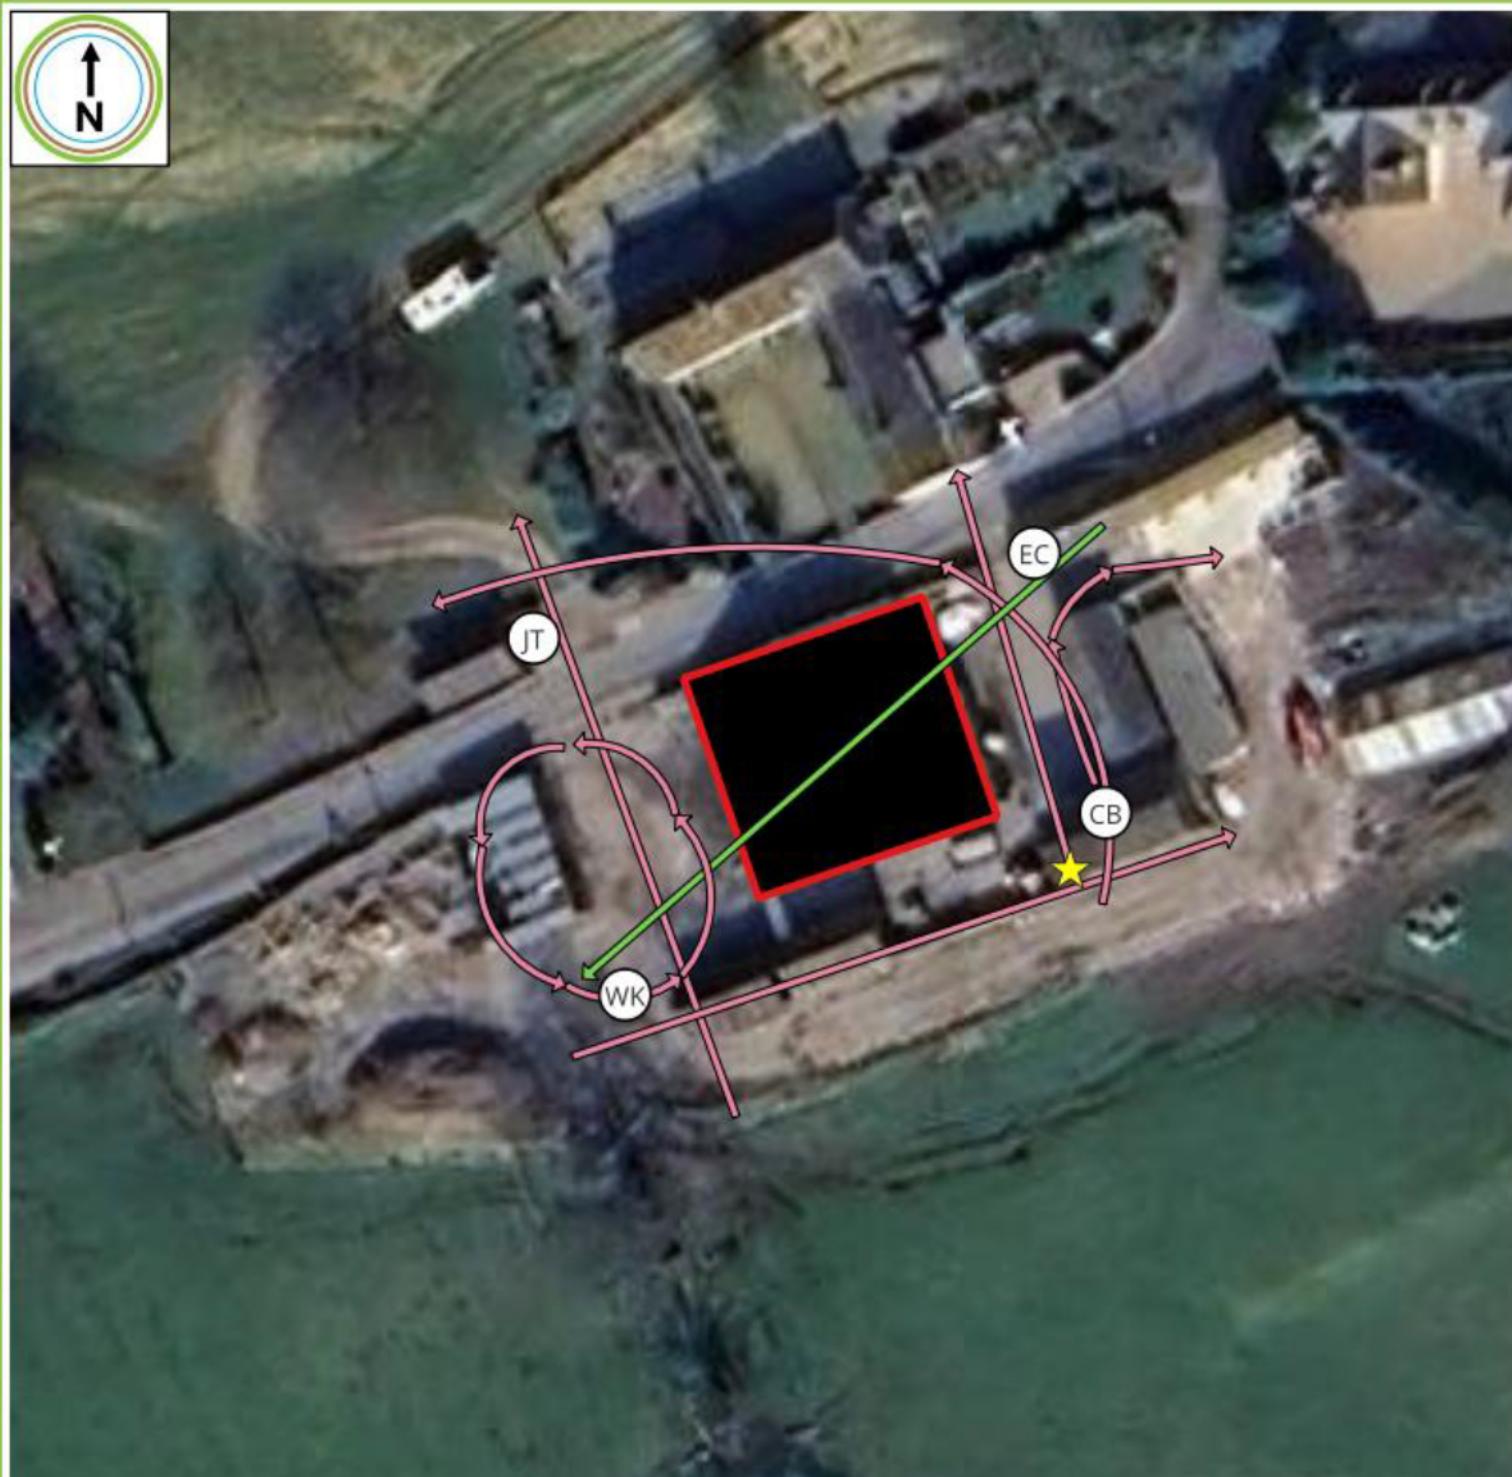
Figure 3.1
Nocturnal Bat Survey Results
Survey 1 - 7th May 2025

- 3.4.1 No roosting bats were recorded within the Barn during the first survey (Figure 3.1).

- 3.4.2 The earliest bat recorded was a noctule at 21:11 hrs (14 minutes after sunset), this was recorded by two of the surveyors however this was not observed by either surveyor. Common pipistrelle and noctule were recorded throughout the survey. The individuals observed in flight were most regularly seen foraging around courtyard areas of the farmyard, however not associated with the Barn itself. The final bat was recorded at 22:09 hrs (78 minutes after sunset) pertaining to a noctule which was not seen by the surveyors.

- 3.4.3 A single common pipistrelle was seen associated with the building immediately southeast of the Barn and is considered a potential roost record. The surveyor was positioned in front of this building and recorded a single common pipistrelle flying out of the large open outbuilding. However, as the surveyor nor camera were focused on this separate building, it cannot be confirmed whether the individual emerged from the building, or briefly entered and exited the building from off-Site locations.

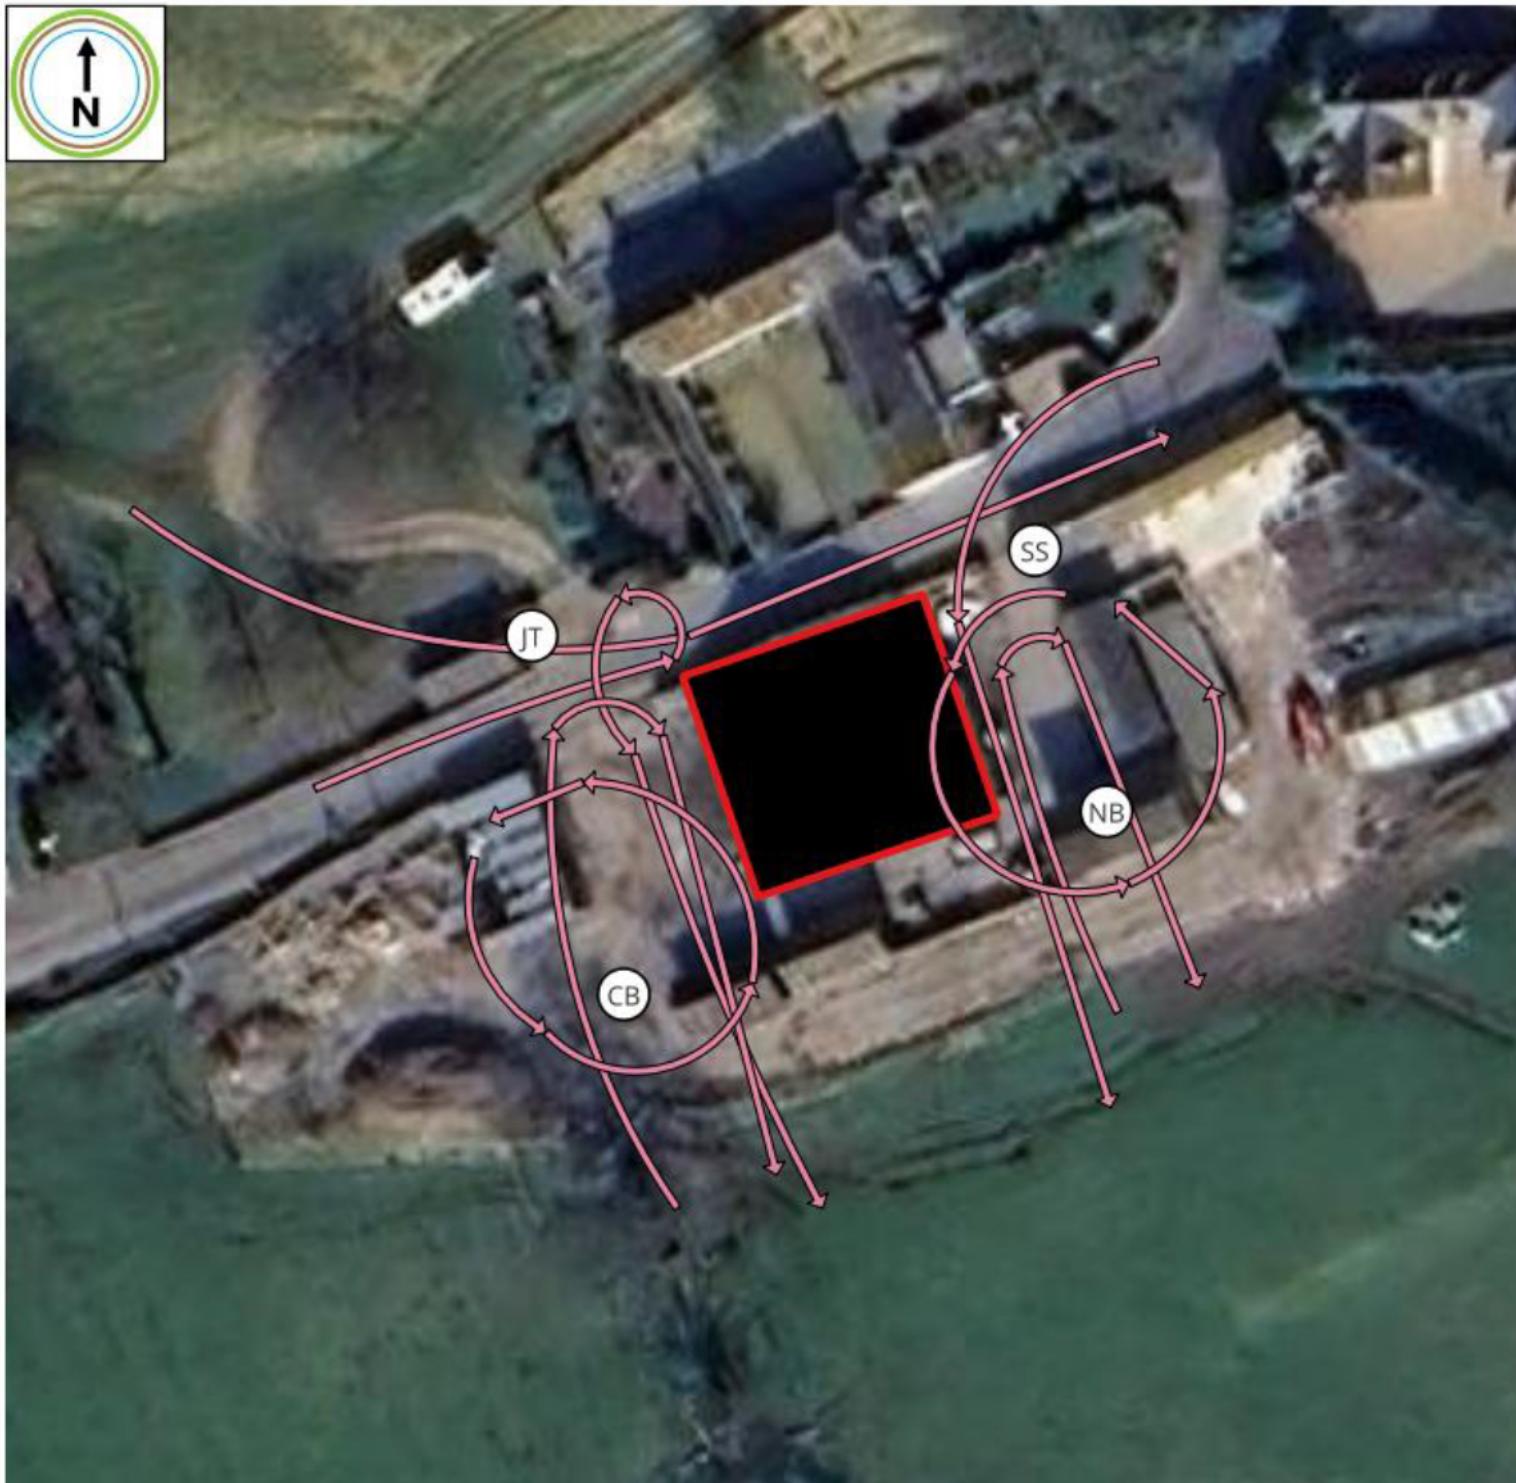
Figure 3.2

- 3.4.4 No roosting bats were recorded within the Barn during the second survey (Figure 3.2).
- 3.4.5 The earliest bat recorded was a noctule at 21:44 hrs (nine minutes after sunset), this was recorded by two of the surveyors however this was not observed by either surveyor. Common pipistrelle, noctule and soprano pipistrelle *Pipistrellus pygmaeus* were recorded throughout the survey. The individuals observed in flight were most regularly seen foraging around courtyard areas of the farmyard, however not associated with the Barn itself. The final bat was recorded at 23:08 hrs (78 minutes after sunset) pertaining to a soprano pipistrelle which was not seen by the surveyors.

Nocturnal Bat Survey Results
Survey 2 - 12th June 2025
