## **PRELIMINARY ROOST ASSESSMENT FOR BATS**

**9 THE DENE, HURST GREEN,  
RIBBLE VALLEY, BB7 9QF.**

**JUNE 2025**

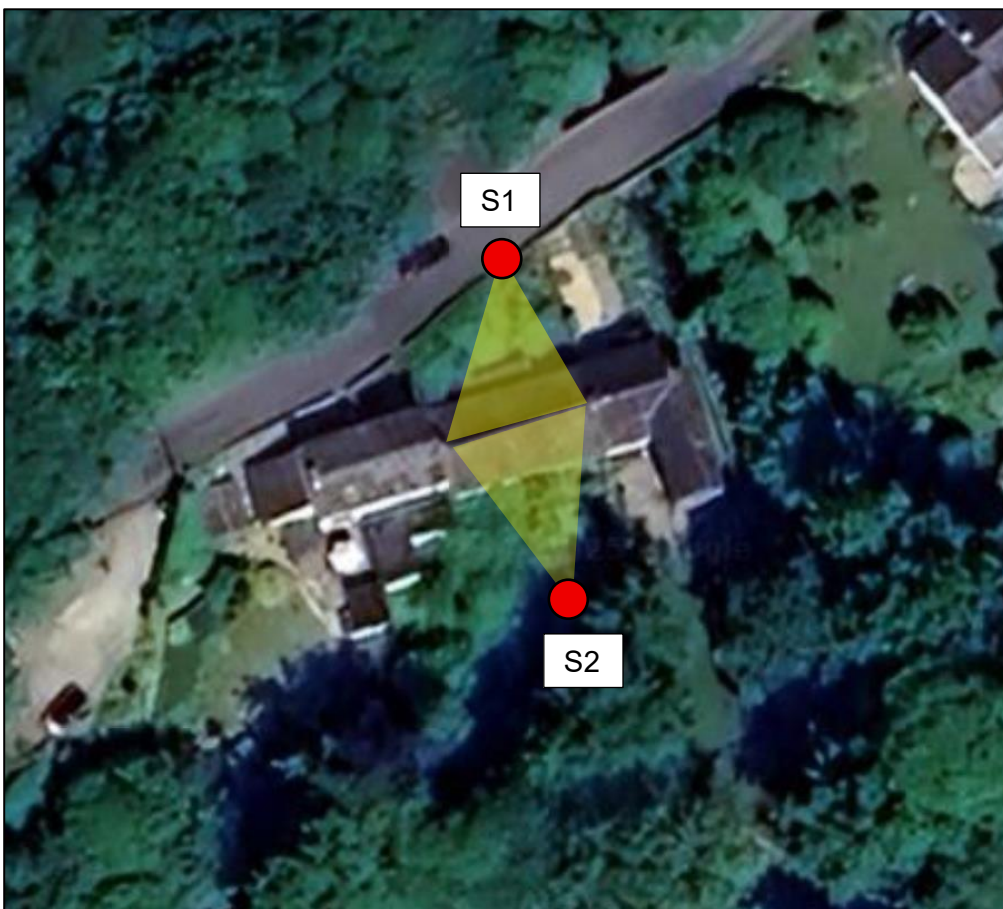
*Figure 5.1 - Suggested surveyor locations (four required per survey).*

The building was deemed to be of **moderate roost suitability** to support roosting bats. It is therefore recommended two dusk emergence surveys are undertaken in accordance with the Bat Conservation Trust's Bat Surveys for Professional Ecologists Good Practice Guidelines (Collins *et al.*, 2023).

The surveys will need to be conducted during the main active season of bats (i.e., between May and August inclusive). Following the completion of the surveys further recommendations will be made in respect of any issues in relation to bats.

Suggested surveyor numbers (two) and locations (surveyor 1 (S1), surveyor 2 (S2)), are provided below in Figure 5.1 below.

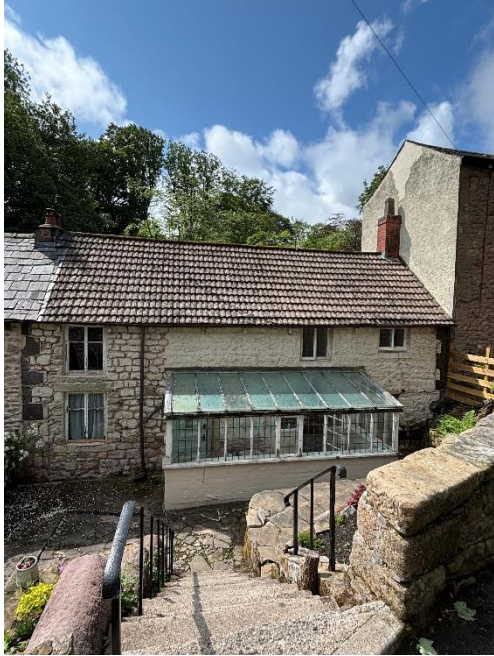
Photograph 1: Overview of northern aspect.

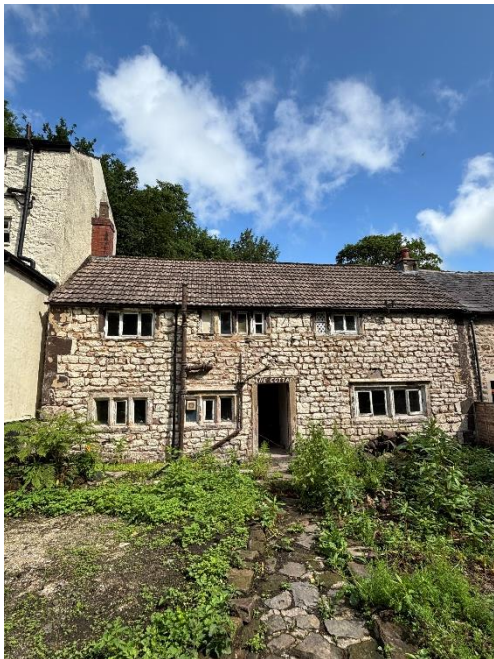
The building is the middle property of a row of three terrace houses. The external walls were constructed of stone. The south facing elevation was once rendered but the render has all been removed. The northern elevation is mostly rendered with a small area on the north eastern corner of the property missing. There are cavities between the stone bricks on the northern elevation which appeared to be superficial. The southern elevation also had several larger cavities between the stone bricks with some shining light though into the building potentially providing direct access for bats. There is a small lean-to extension with a glass roof attached to the northern aspect of the building.

Photograph 3: Overview of southern aspect.

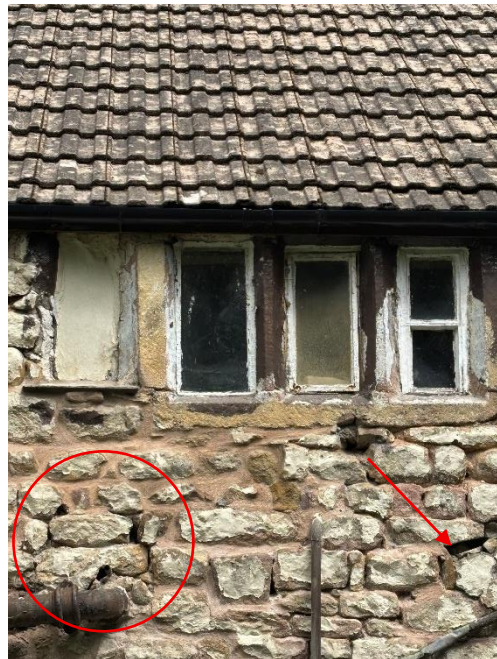
Photograph 4: Cavities between stone bricks on southern aspect.

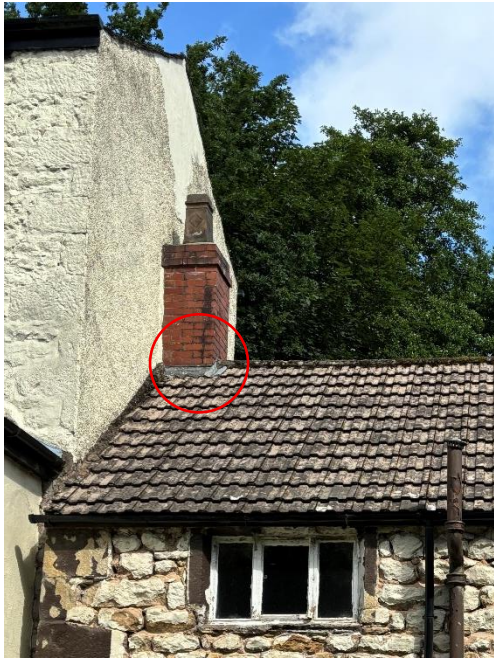
The building had a pitched roof made from interlocking concrete roof and ridge tiles. The roof was in good condition with no raised or missing roof/ridge tiles identified. The chimney on the western part of the roof (south facing aspect) had lead flashing around the base which was slightly raised creating a gap that bats could potentially use to access the roof or ridge tiles.

Photograph 5: Raised lead flashing around chimney on southern aspect.

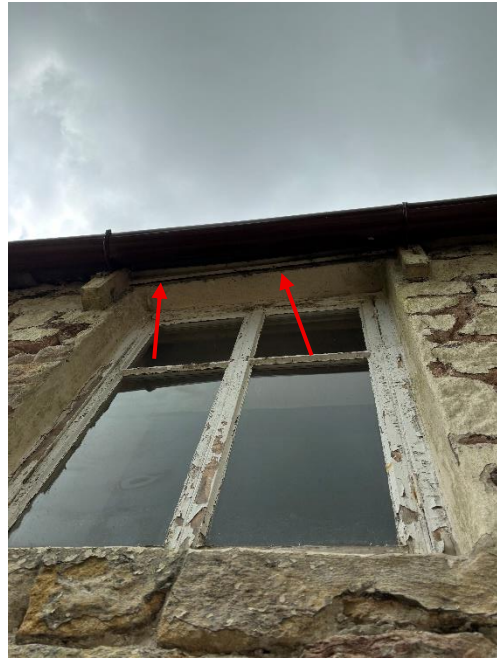
The wooden windows and fascia boards were in poor condition. Areas of the fascia boards were loose from the wall plate creating suitable gaps for bats. The windows had multiple cracks in the wood around the window frames. These cracks in the wood were not assessed to be suitable features.

Photograph 6: Areas where the fascia board has separated from the wall plate on southern aspect.

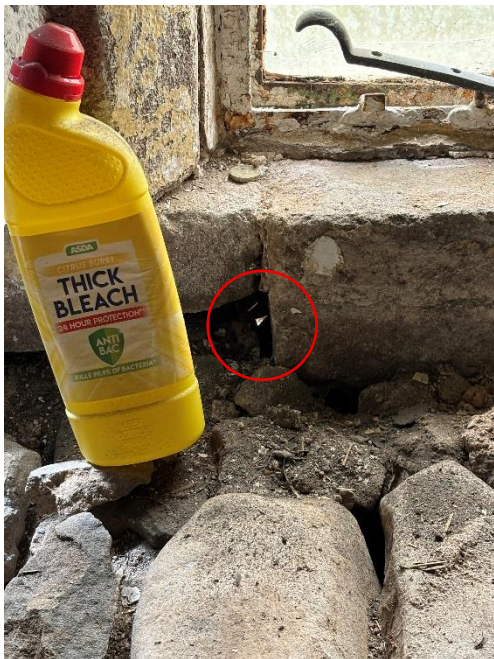
Photograph 7: Light shining through from outside between stone bricks.

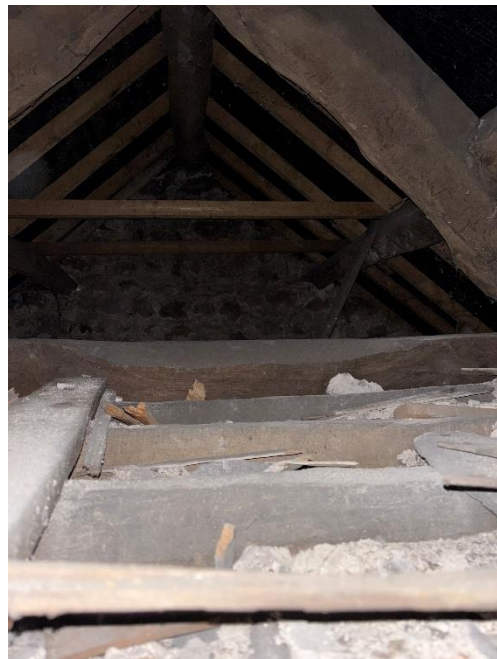
The loft space was made up of timber beams and rafters with roofing felt separating the roof tiles and the loft space. Although the loft space was not accessible, from the pictures taken, no evidence of bats was identified.

Photograph 8: Overview of timber beams and rafters in the loft space.

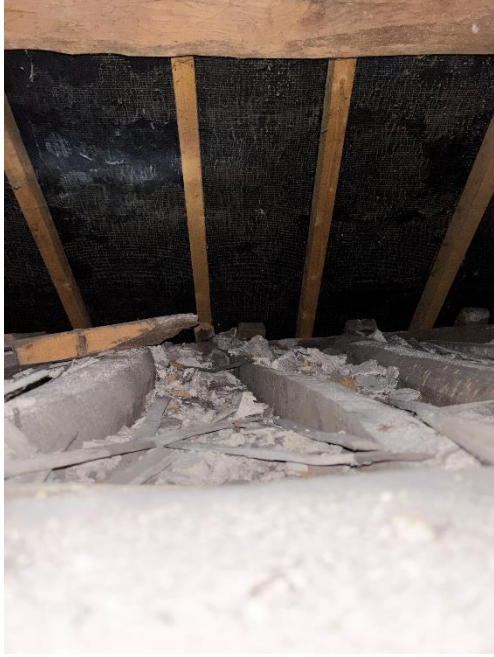
Photograph 9: Overview of the loft space.

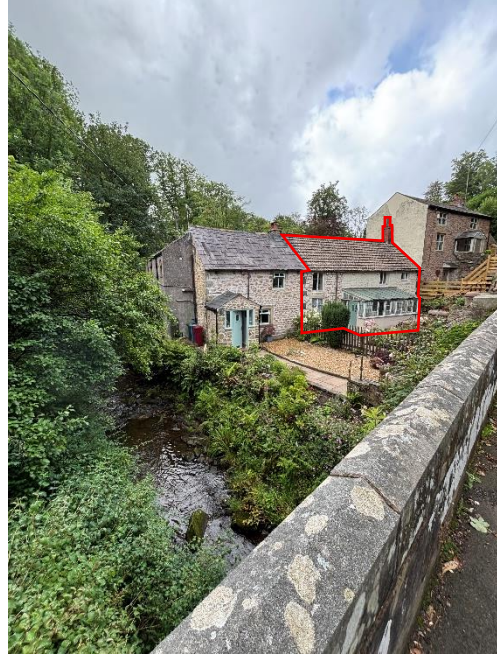
The immediate surrounding comprises mature woodland and scrub both of which are present on the eastern and western banks adjacent Dean Brook. This habitat is optimal and likely an important resource for both foraging and commuting bats as well as potentially providing tree roosts. In the wider landscape there are wooded corridors, hedgerow bound fields and watercourses that are likely to be important habitats for bats.

Photograph 10: Overview of the surrounding habitat.
