**BAT SURVEY, AT -
THE COURTHOUSE
BOLTON BY BOWLAND**

REFERENCE NO 7184

JULY 3rd 2025 EMERGENCY UPDATE

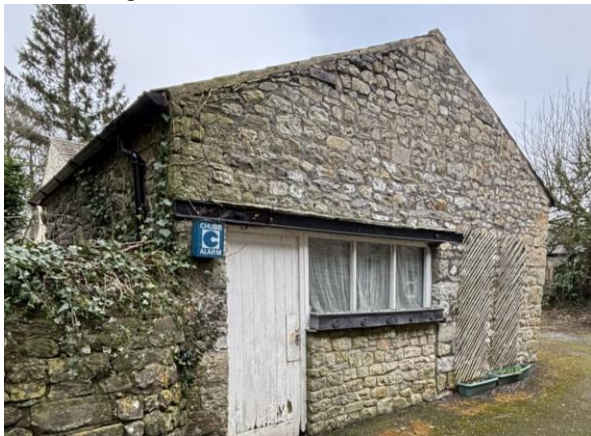
Southwest Elevation of Outbuilding

The walls are in good condition and well pointed with the exception of a section of wall on the southwest elevation where the pointing is missing.

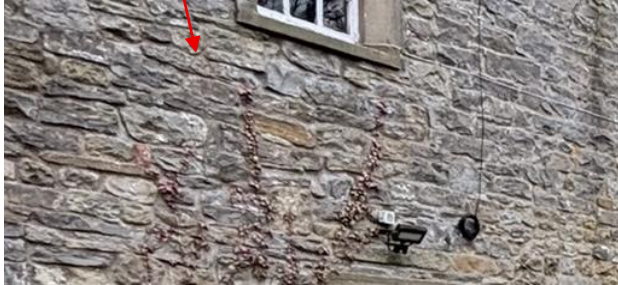
Rear Elevation

The walls are coursed pointed random natural stone with dressed stone surrounds.

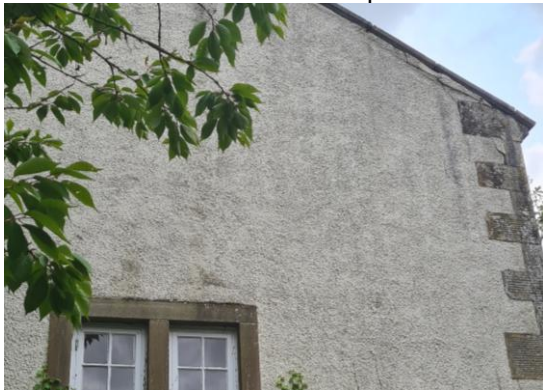
The northwest elevation has a painted render finish.

The rendered wall was in reasonable condition with no cracks in the render.

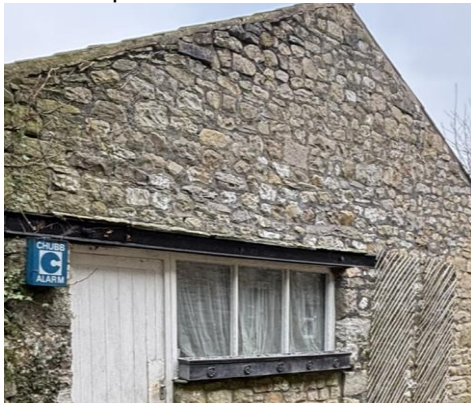
Outbuilding

Random pointed stone walls. southwest elevation.

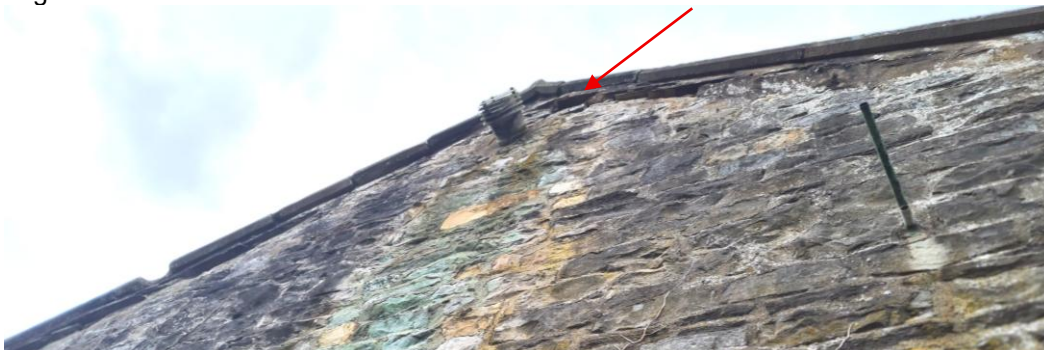
The house was generally well pointed with no significant areas of degraded mortar with the exception of the southeast gable elevation near the verge and ridge which has some significant areas of degraded mortar.

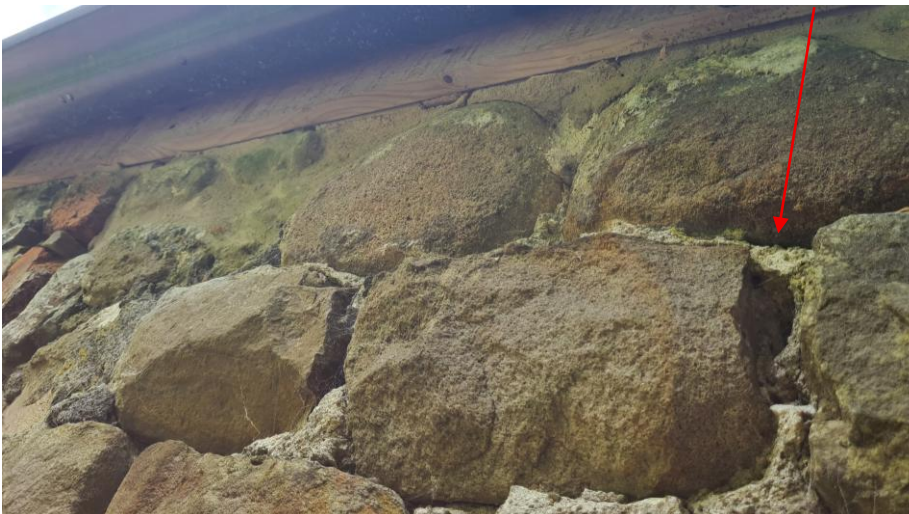
Another small section on the west side elevation near to the front corner.

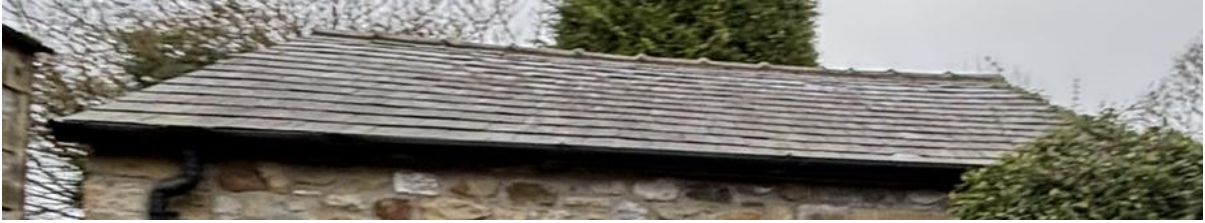
The outbuilding roof

Blue slate finish with ridge tiles. Pointed verges and gutters to the eaves fixed to timber runner.

Outbuilding The roof is in good condition with tight fitting slates and ridge tiles. The verges are pointed with no gaps.

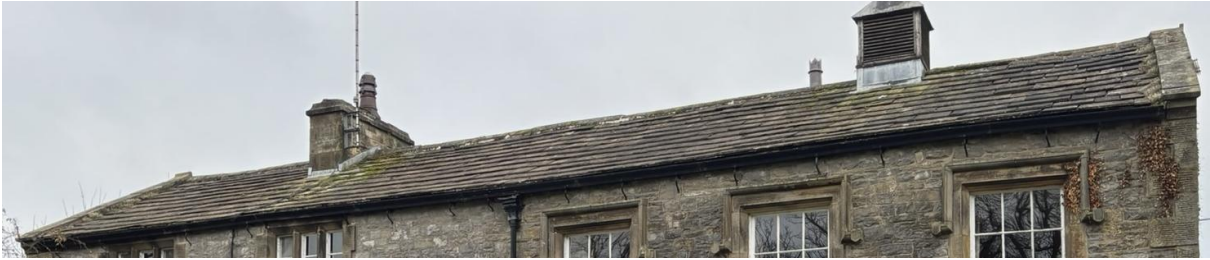
Front southwest pitch has a grey slate finish with coping stones to each gable. Gutters on brackets,

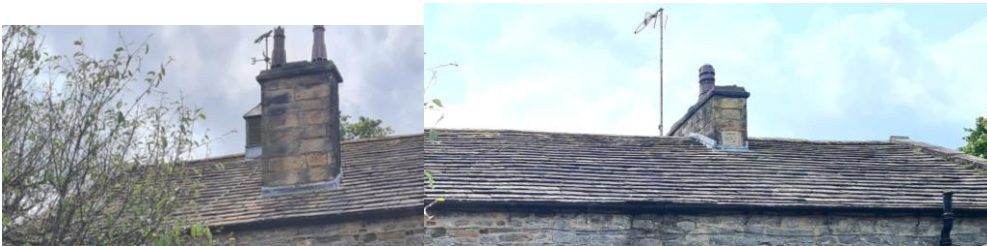
Rear northeast pitch.

The ridge pointing is degraded with sections missing. The roof did provide some potential crevice roost habitat.

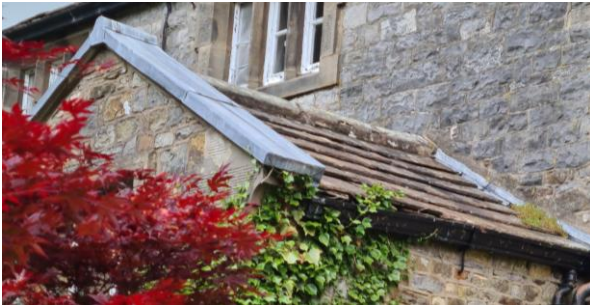
The porch roof has a grey slate finish with a lead coping detail to the front gable. Gutters on brackets.

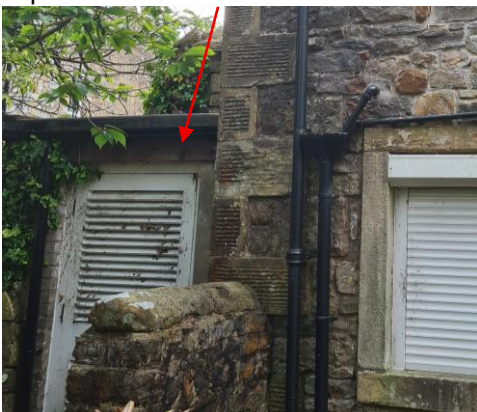
A small single storey store is located on the northeastern rear corner of the house which has an asphalt covered flat roof.

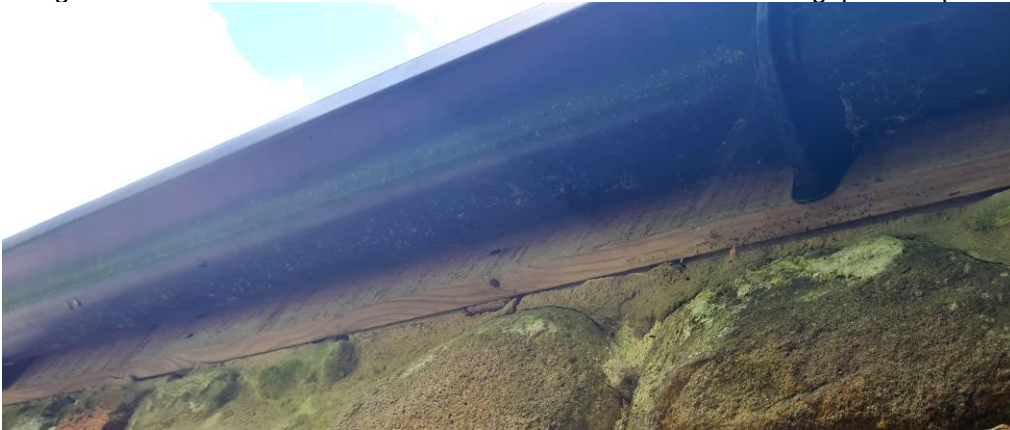
The gutters are fixed to a flush fitted timber bearers to the eaves. No gaps were present.

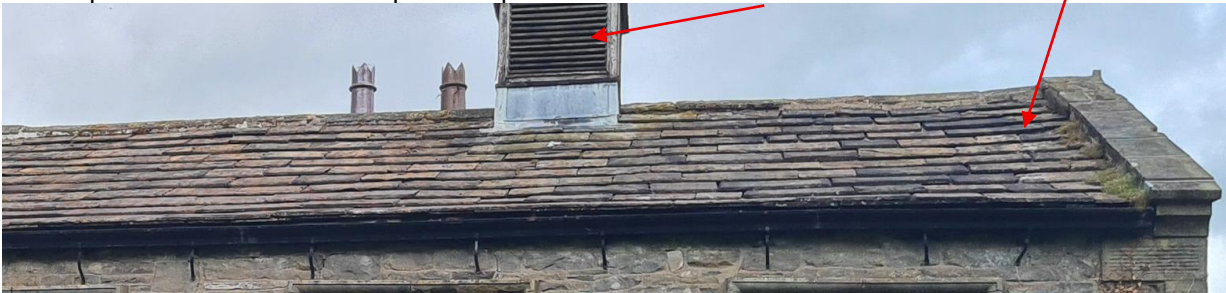
All the slates appeared to be in reasonable condition with no obvious slipped or missing slates although due to the nature of natural stone slates some minor gaps are present to the slate laps. The Cupola with its vented sides provides potential bat roost habitat.

1. Restrictions on timings of works being carried out ie.to be carried out during the Hibernation period Mid September- March/ April.
2. Hand stripping the roof.
3. Incorporating similar habitat in the re- slated roof. ie. As illustrated below above.
4. Minimise external lighting during the construction period.
5. The numerous roof structures on adjacent properties in this locality serve to mitigate with alternative roost potential whilst the work is being carried out.

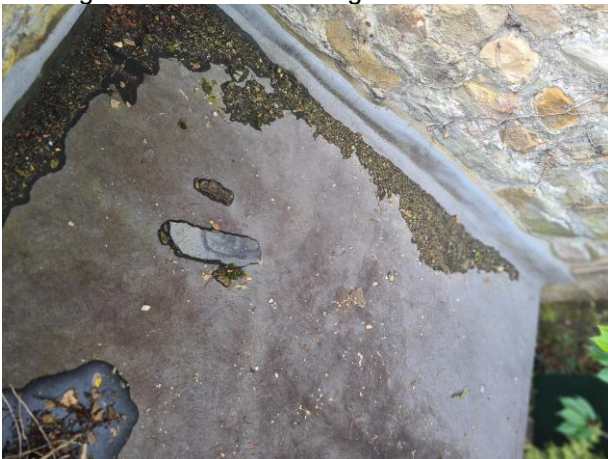
The store flat asphalt roof did not provide any potential access points or crevices, the finish and flashings to the walls were in good condition.

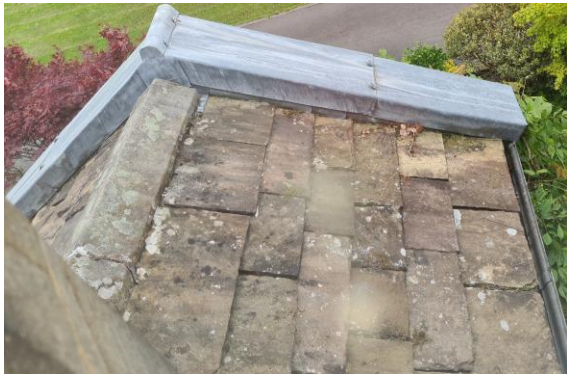
The porch roof slates, ridge tiles and lead coping detail were in good condition, no access points, cracks or crevices.

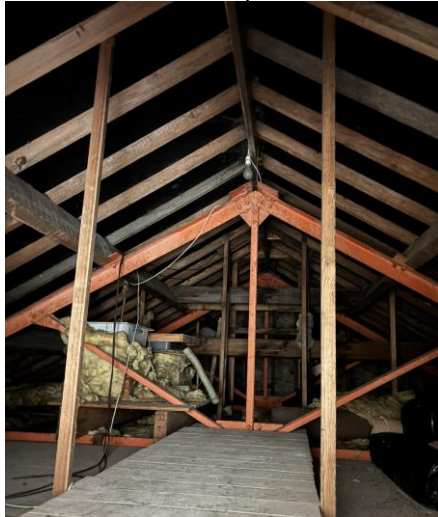
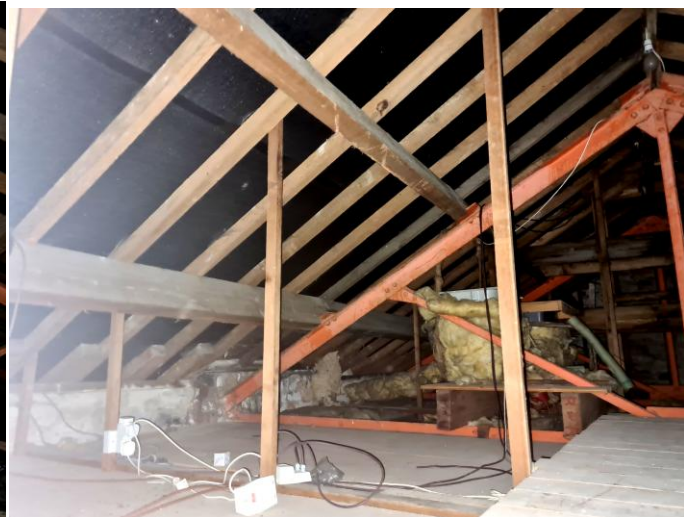
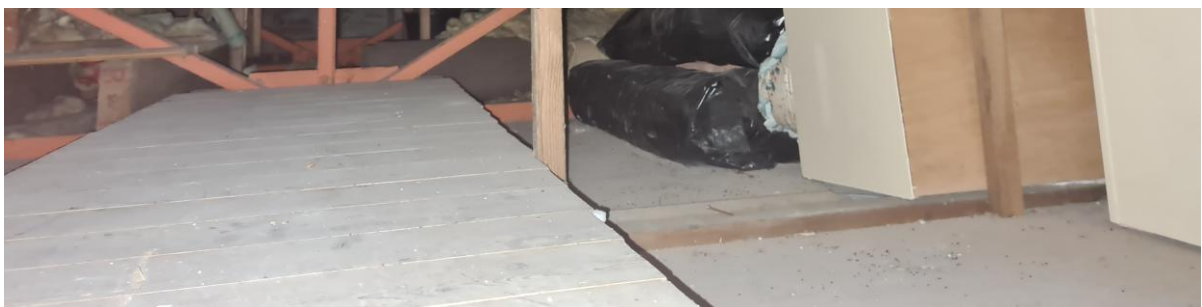
The roof void was present over the Court room and was accessed via a wall hatch in an adjoining bedroom. The timber rafters and purlins were in very good condition, as was the felt and the steel trusses. The roof structure is not original; it is a more recent addition (date unknown).

The floor is boarded; it is a clean space with no dropping or insect debris present to the floor. The remains of a wasp nest was noted.

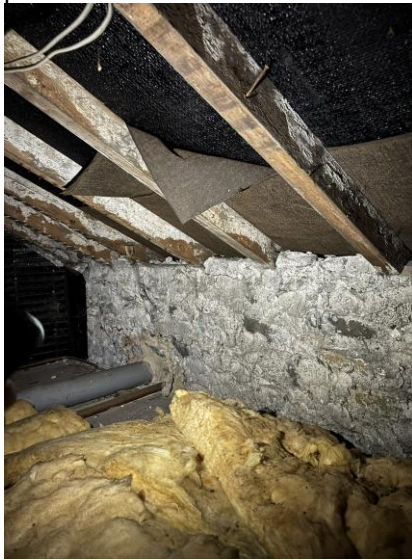
An eaves void was accessed via a wall hatch from Bedroom 3 on the second floor. The timbers are in reasonable condition and do not provide any habitat for crevice living bats. The insulation quilt present to the floor was clean and free of any dropping or insect evidence.

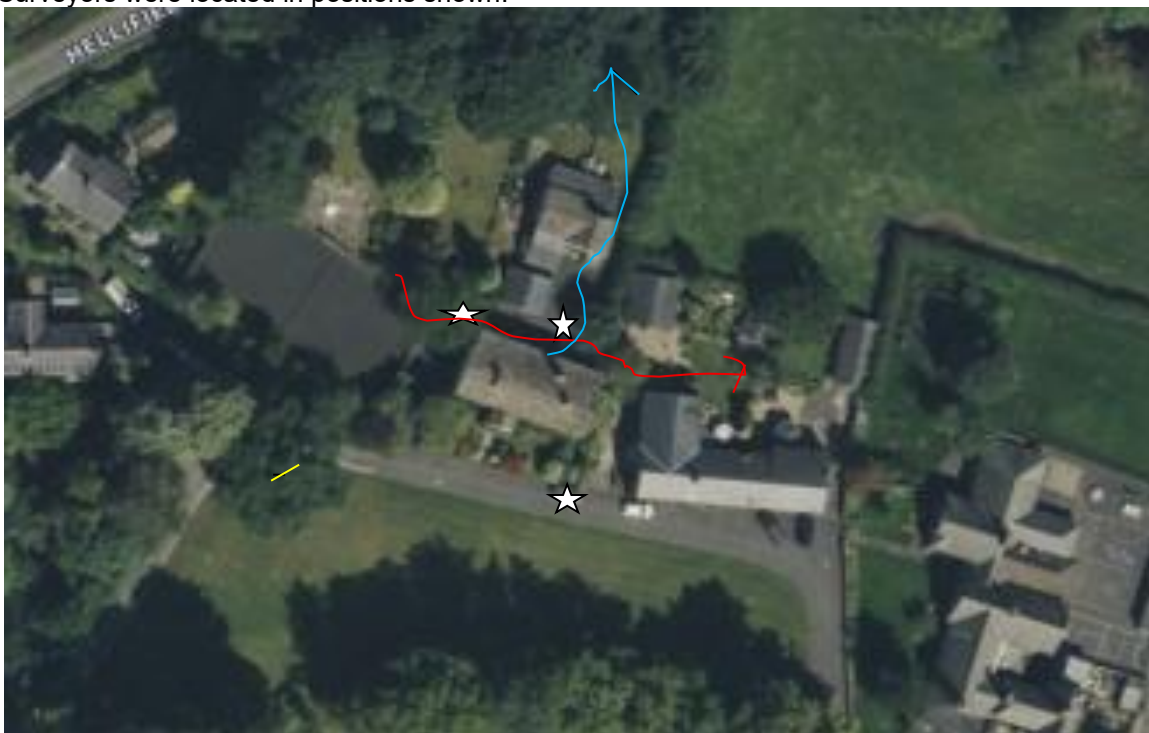
SCOPING SURVEY: Commenced at 9.00pm during perfect weather conditions for bat forage activity. Surveyors were located in positions shown.

9.35 pm – Echolocation picked up in the trees to the south of the house, no sightings.

9.45 pm - 2no Soprano Pipistrelle bats crossed parallel to the front south elevation as indicated yellow arrow.

9.50 pm - 1no Soprano Pipistrelle commuted across the rear elevation. Red arrow.

10.10 pm - 1 no Soprano Pipistrelle emerged from the roof on the rear elevation.

10.20 pm -10.30 pm 2no Soprano Pipistrelle emerged from the eaves on the rear elevation. They travelled in a northern direction. Blue arrow.

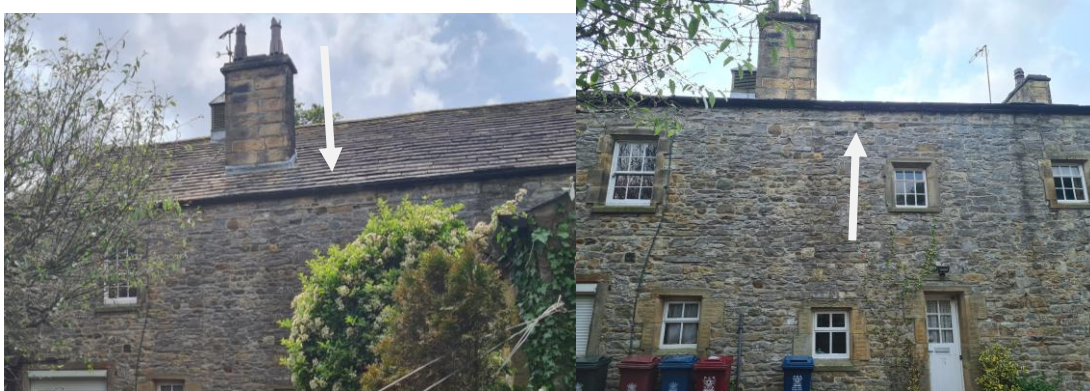
Forage activity was not recorded on the site, commute routes only.

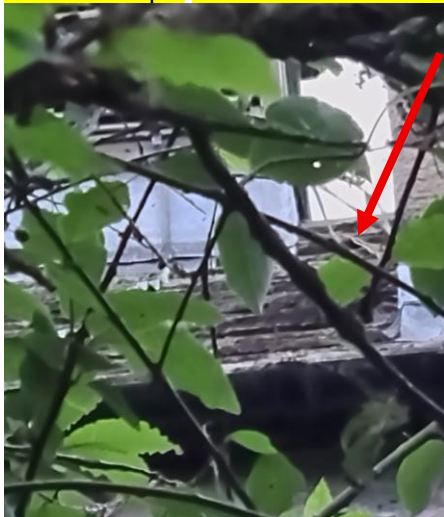
9.45 pm - 1no Soprano Pipistrelle emerged from the roof on the rear elevation between the Chimney and the Cuopla. to continue in a northerly direction as indicated by the blue arrow.

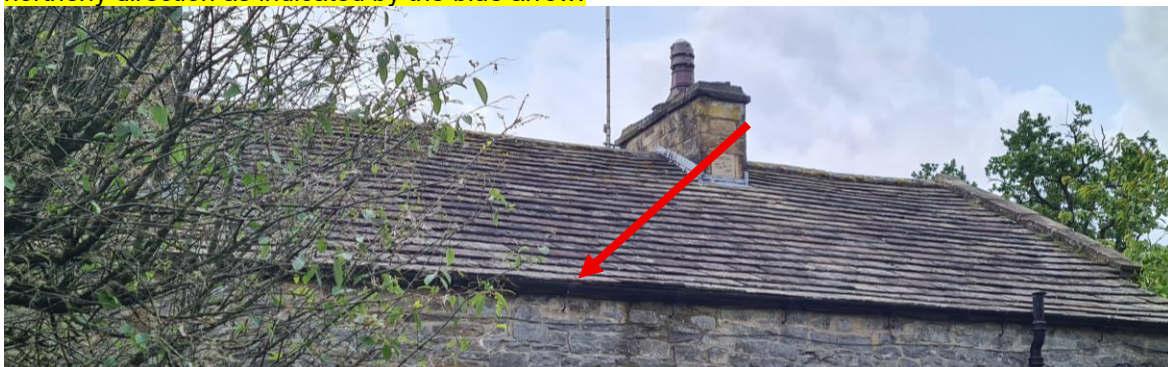
10.10 pm - 1 no Soprano Pipistrelle emerged from the eaves on the rear elevation to continue in a northerly direction as indicated by the blue arrow.

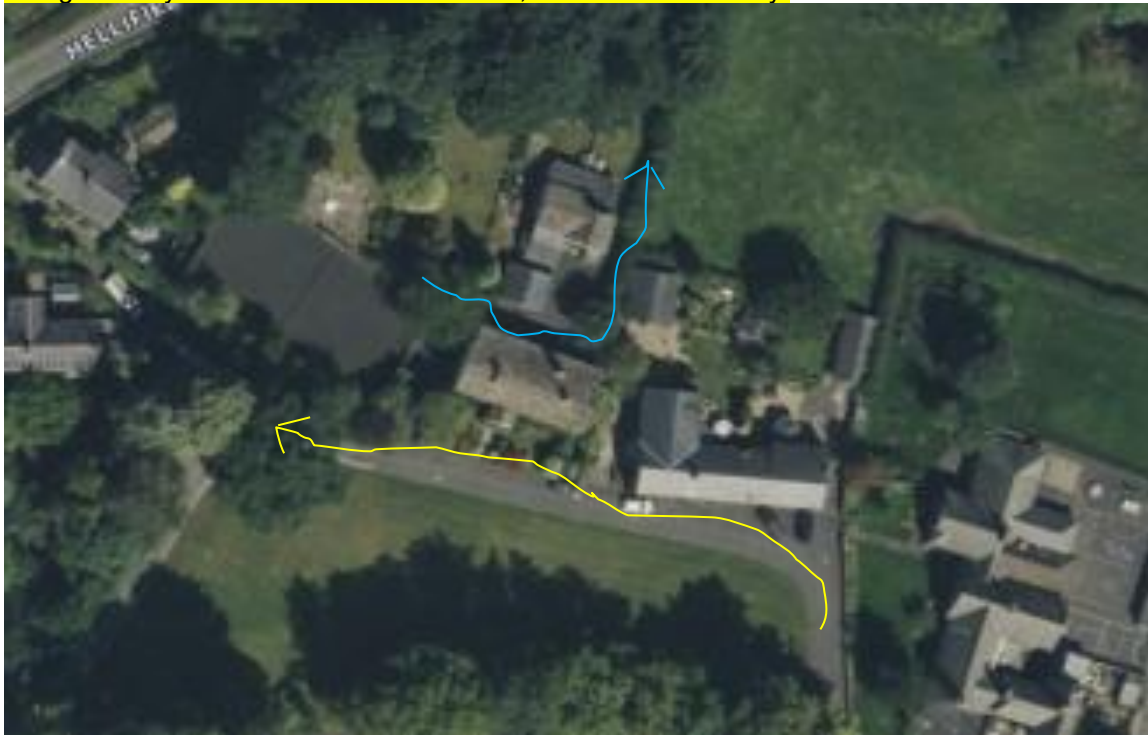
Between 10.10 pm -.10.30 pm The commute activity on the site of 2no individual Soprano Pipistrelle Bats was the same as the previous emergence survey. Traveling along the rear elevation before turning in a northern direction. Blue arrow. Forage activity was not recorded on the site, commute routes only.

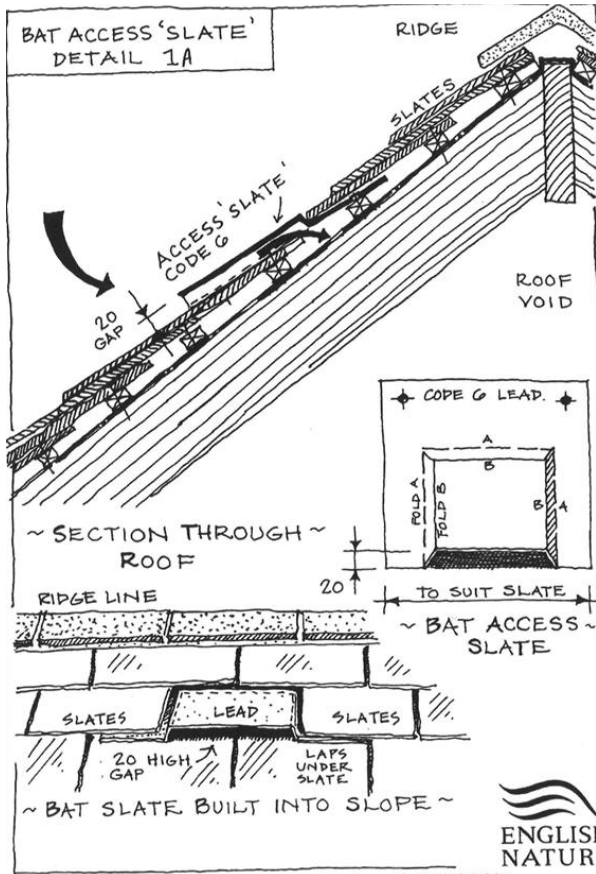
The mitigation measures are to maintain the existing roost potential of the building like for like see the illustrations below.
