## TECHNICAL NOTE: PRELIMINARY BAT ROOST ASSESSMENT

| PROJECT ADDRESS | 58 Henthorn Road, Clitheroe BB7 3AU |
| PROPOSED PLANS | Extension to dwelling |

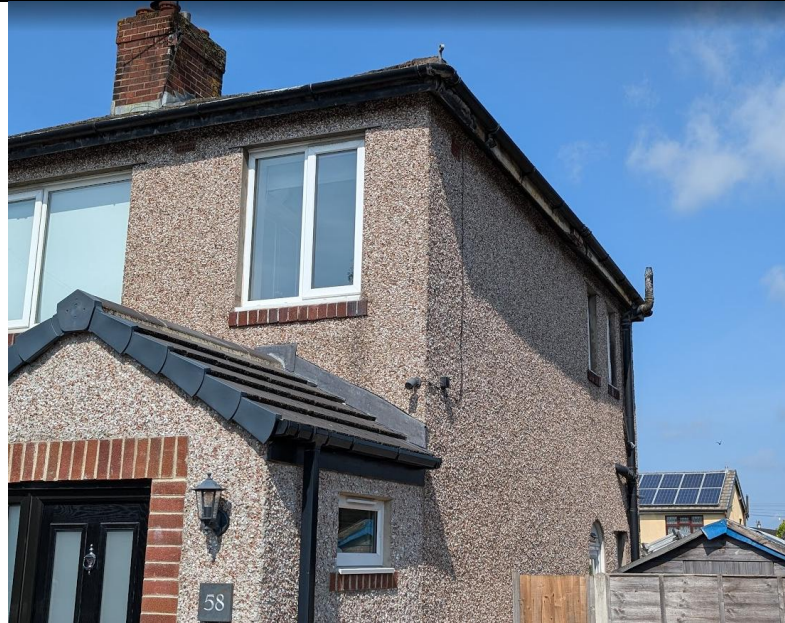
**Photo 1.**  
Front and side  
elevation (area of  
proposed  
extension).

Photos of the property are provided at the foot of this document. The property is a semi-detached dwelling which has pebbledash render on all aspects. The property has a hipped roof with modern, interlocking concrete roof tiles. The roof appeared to be in well laid and in good repair with no missing, lifted or slipped tiles. The ridge tiles also appeared to be well bedded in with pointing mortar. The brickwork on the chimney appeared to be in good repair and the lead flashing on the chimney was also well sealed.

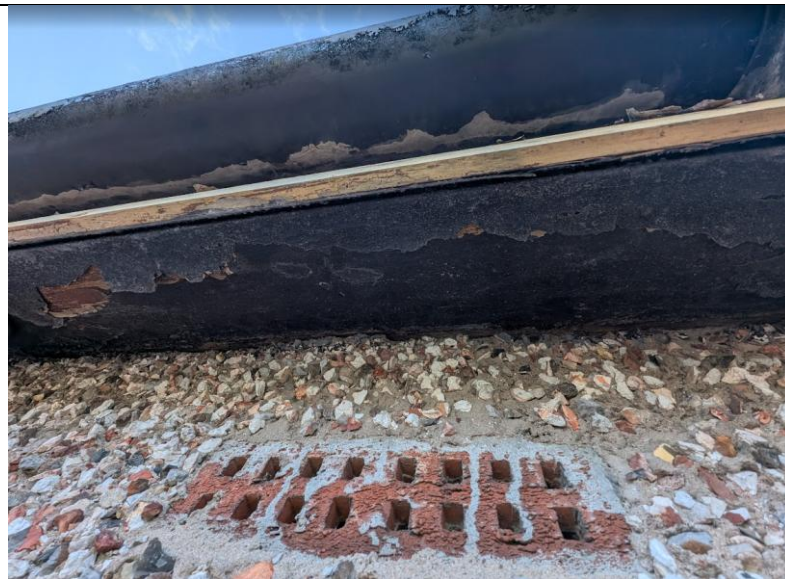
The property features timber soffit boxes throughout. The vast majority of these soffits appeared to be well sealed to the walls. There was a slight gap between the fascia board and the soffit board due to warped timbers and there was a slight gap under the soffit on the rear aspect. However, upon further close inspection, both gaps were not recessed and unsuitable for use by bats.

**Photo 4.**  
View of sealed  
soffit and slight gap  
underneath fascia  
(no suitability).

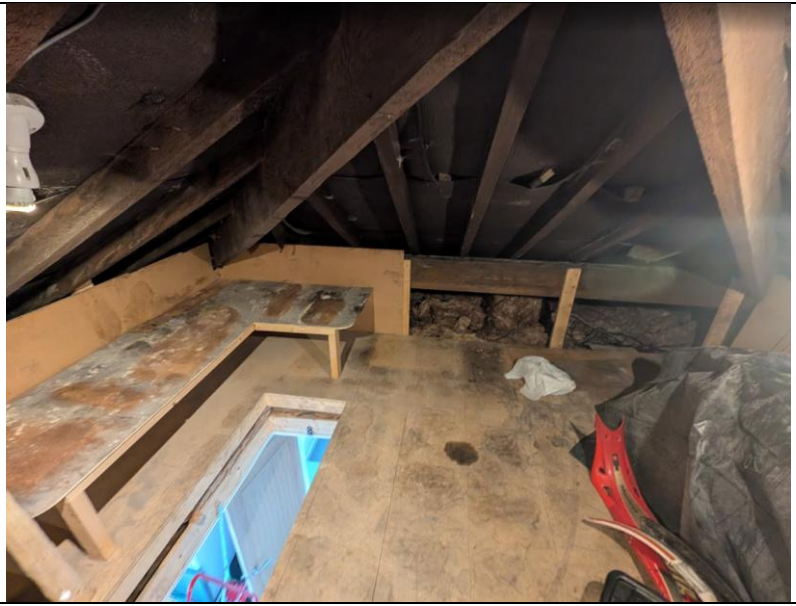
**Photo 5.**  
Loft.

The main floor space of the loft is boarded and the loft features a light fitting. The floor space was clear throughout. The roof has a bitumen-based underlining. No light gaps or suitable roosting crevices were observed in the roof.
