**BAT SURVEY AT -
6 THE GROVE
WHALLEY**

REFERENCE NO. 6439

Removal of attached garage prior to construction of new two storey side extension.

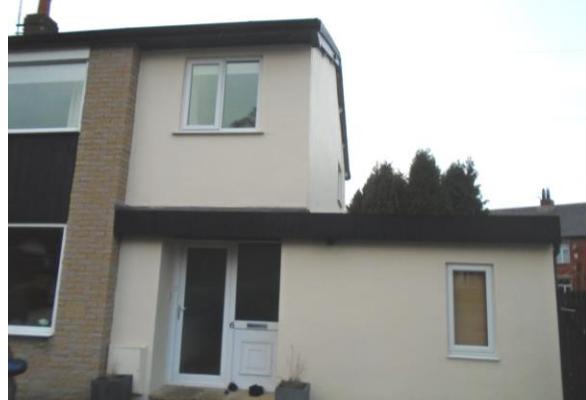
Part Front North East Elevation

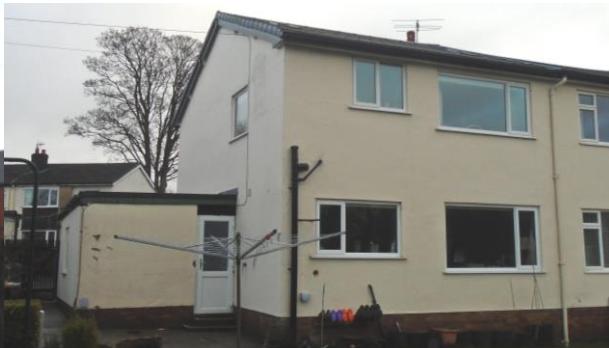
Rear South West Elevation

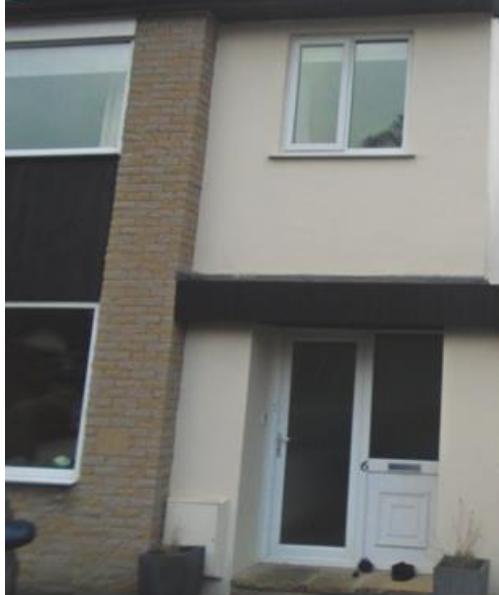
The walls are a combination of brick plinth with render above. The front elevation has a section of artificial stone and vertical boarding.

The walls are all in perfect condition with no access points. The timber boarding is in excellent and flush fitting to the wall (the boarding will not be affected by the proposed work.)

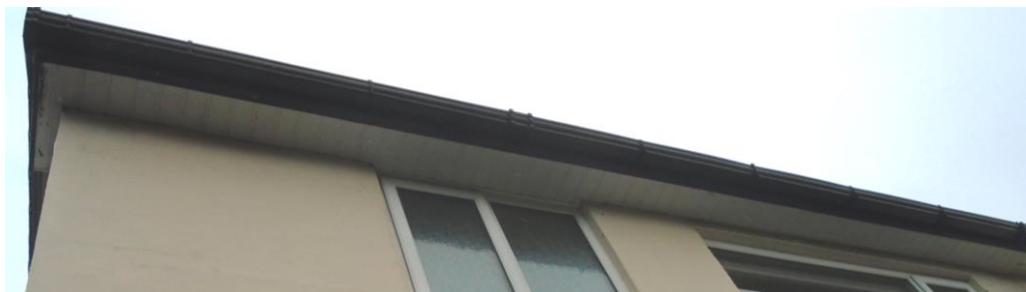
The tiles, soffits and fascia's are in excellent condition the property having been re roofed approx.18 months previously. During the work no evidence of past or current use by bats was found. There are no access points for bats. The soffits are very tight fitting with no gaps.

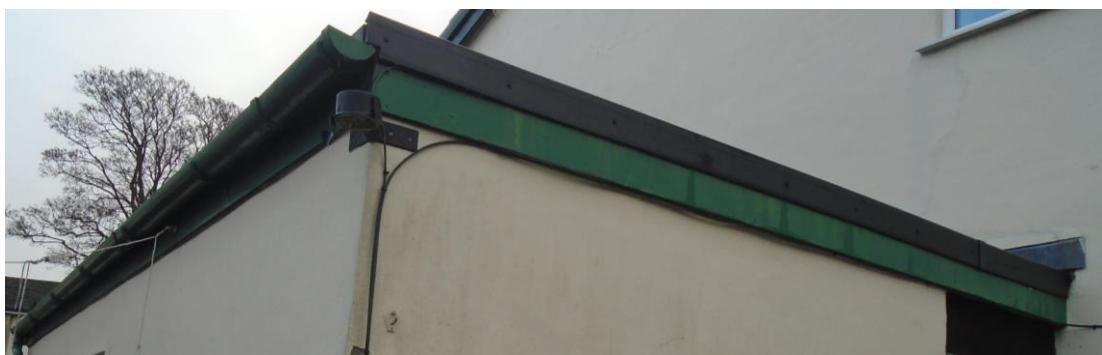
The flush fitting fascia's to the garage and the membrane laps are very tight fitting. The covering and upstand flashings are also in very good condition with no potential access points or crevices suitable for bat ingress.

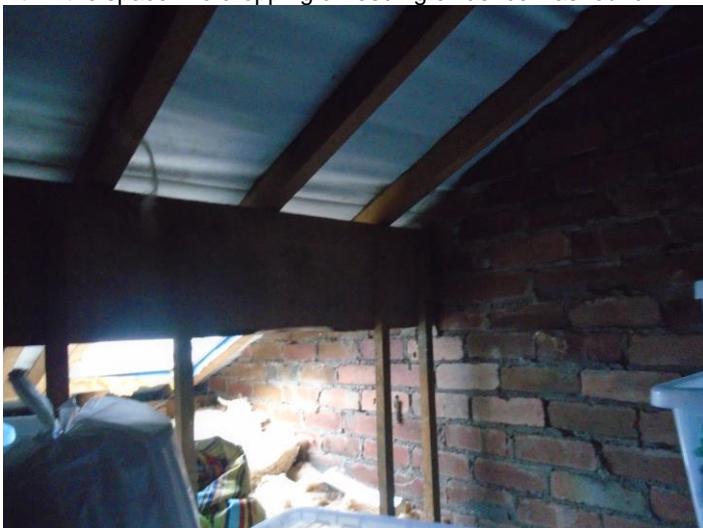
The roof space in the house was accessible via a loft ladder, the space was light due to the presence a roof light as expected the roof was in excellent condition. It was possible to closely examine all the timbers and surfaces within the space. No dropping or feeding evidence was found.

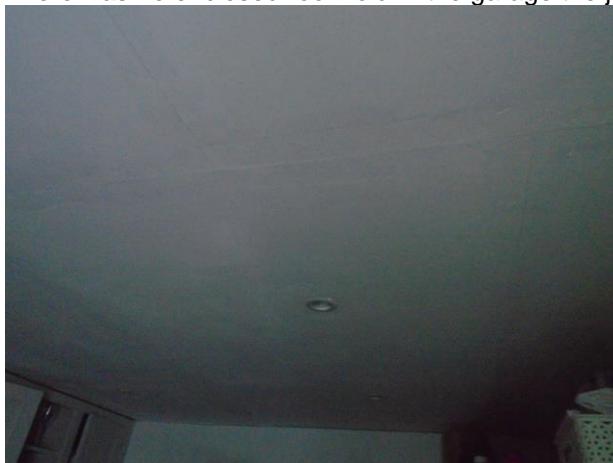
There was no enclosed roof void in the garage the joists had a plasterboard finish to the underside.
