**BAT SURVEY AT -
6 THE GROVE
WHALLEY**

REFERENCE NO. 6439

Removal of attached garage prior to construction of new two storey side extension.

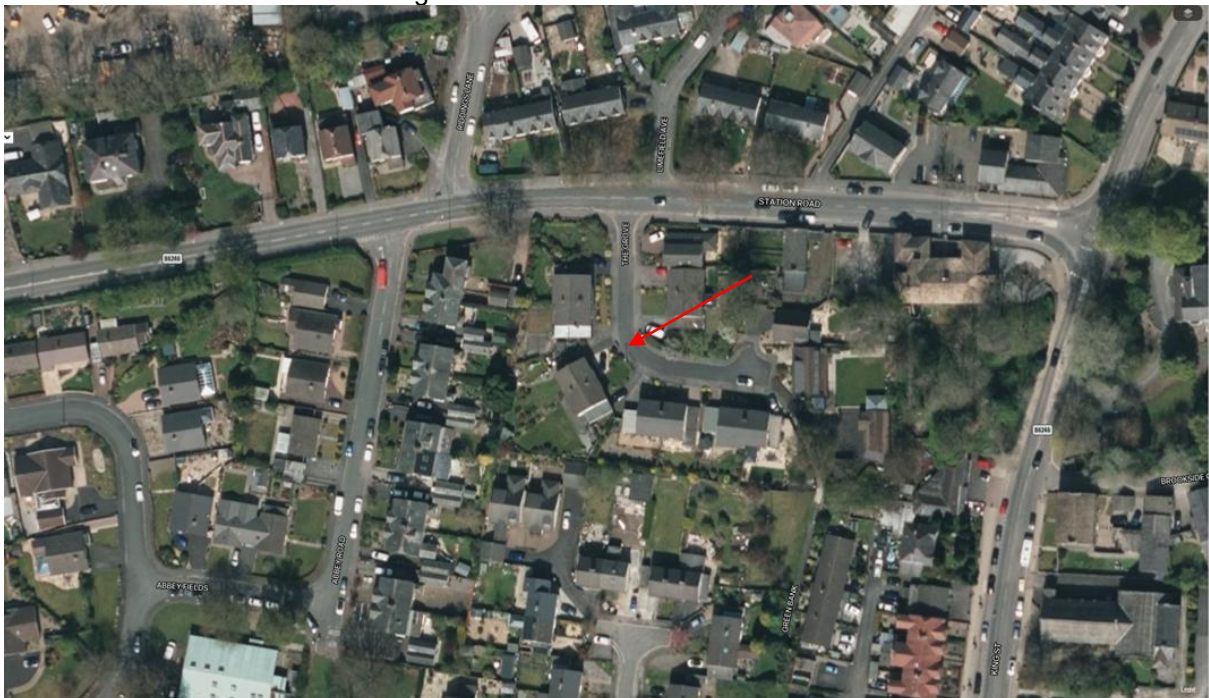
The house is surrounded on all sides with other properties all having gardens. The vegetation in the immediate vicinity of the house consists of minor domestic trees, shrubs and conifers being adjacent to the rear garden boundary. Any high potential feeding habitat is located to the East of the property it is not located on an obvious feeding corridor.

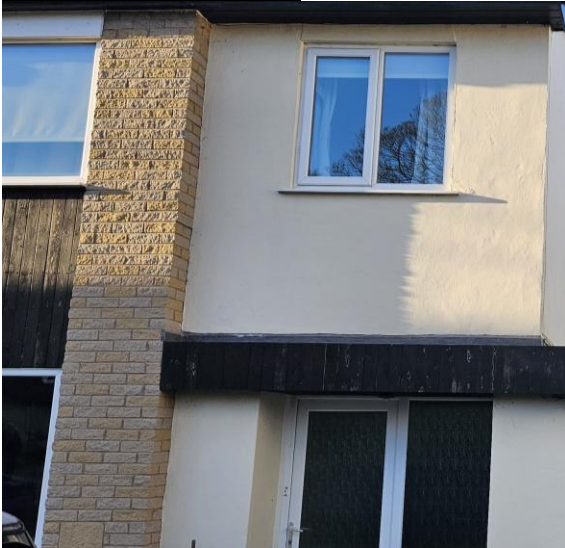
WALL CONSTRUCTION

The walls are a combination of brick plinth with render above. The front elevation has a section of artificial stone and vertical boarding.

The walls are all in perfect condition with no access points. The timber boarding is in excellent and flush fitting to the wall (the boarding will not be affected by the proposed work.)

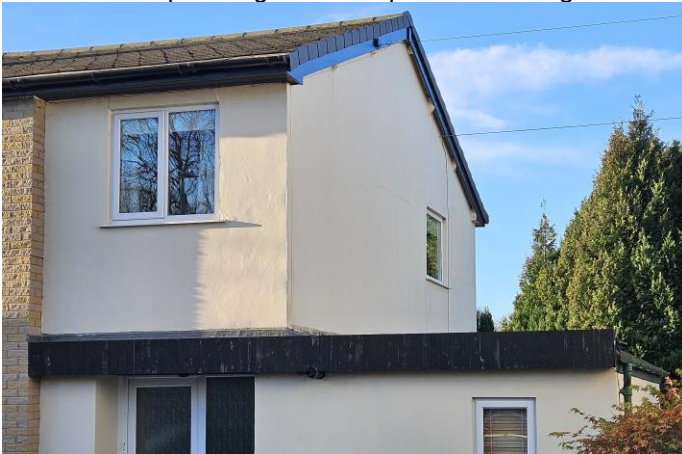
The roof structure is approx. 3 ½ years old, the house roof is a pitched tile construction with an overhang at the eaves which has a boarded soffit. The fascias and barge board are timber complete with soffits. Upvc verge detail is present to the gable.

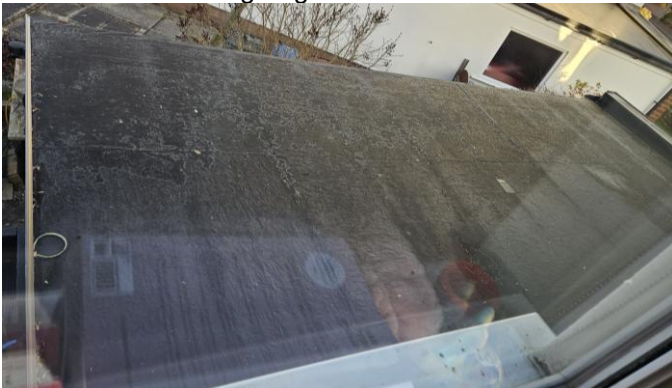
Flat roof from above

The flat roof timber garage has a membrane finish with a timber boarded fascia to the front elevation.

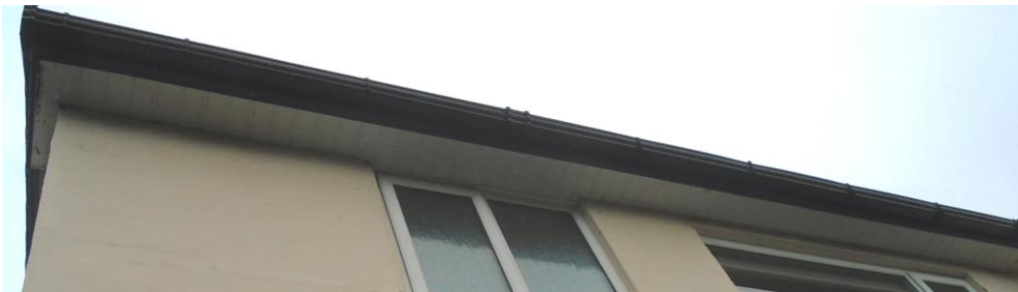
The tiles, soffits and fascia's are in excellent condition the property having been re roofed relatively recently. During the work no evidence of past or current use by bats was found. There are no access points for bats. The soffits are very tight fitting with no gaps.

The flush fitting fascia's to the garage and the membrane laps are very tight fitting. The covering and upstand flashings are also in very good condition with no potential access points or crevices suitable for bat ingress.

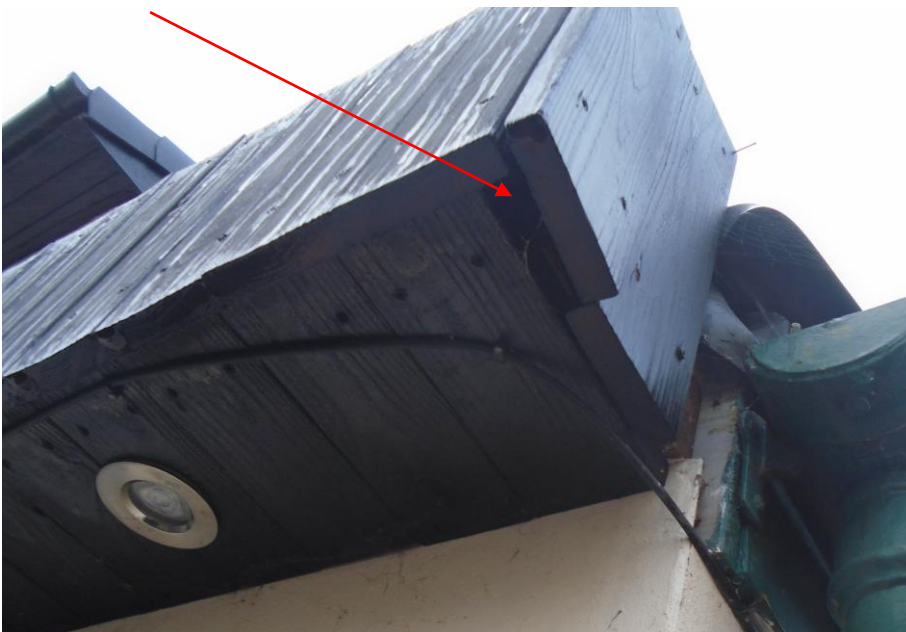
The timber boarded fascia is in good condition with no crevices or rot, the exception being a small gap see below. It was possible to inspect closely; current or historic presence was not evident.

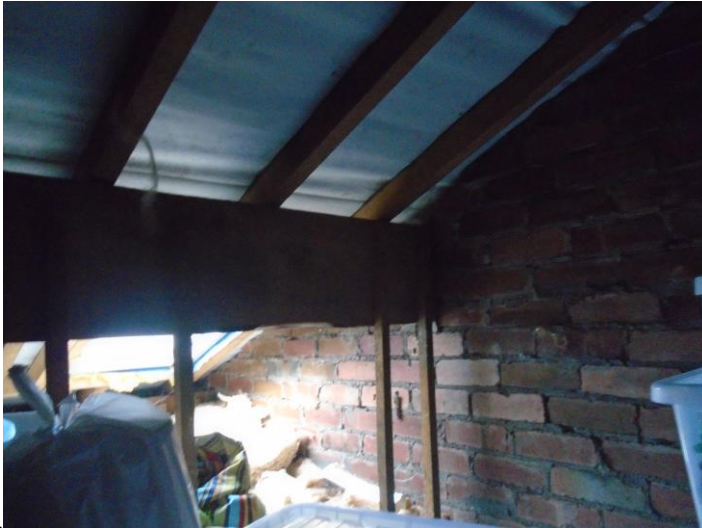
ROOF SPACE

The roof space in the house was accessible via a loft ladder, the space was light due to the presence a roof light as expected the roof was in excellent condition. However condensation was present to the surface of the felt. It was possible to closely examine all the timbers and surfaces within the space. No dropping or feeding evidence was found. the space did not provide any potential roost habitat for bats.

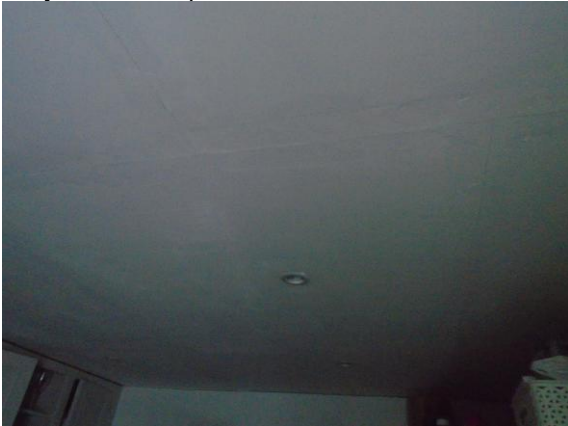
There was no enclosed roof void in the utility and study within the flat roof section of the building. the joists had a plasterboard finish to the underside.
