Beacon Fell View Holiday Park, Longridge, PR3 2TF

Bats: Building Inspection and Activity Surveys

Simply Ecology Limited

Ref: SE/GANQ003/02

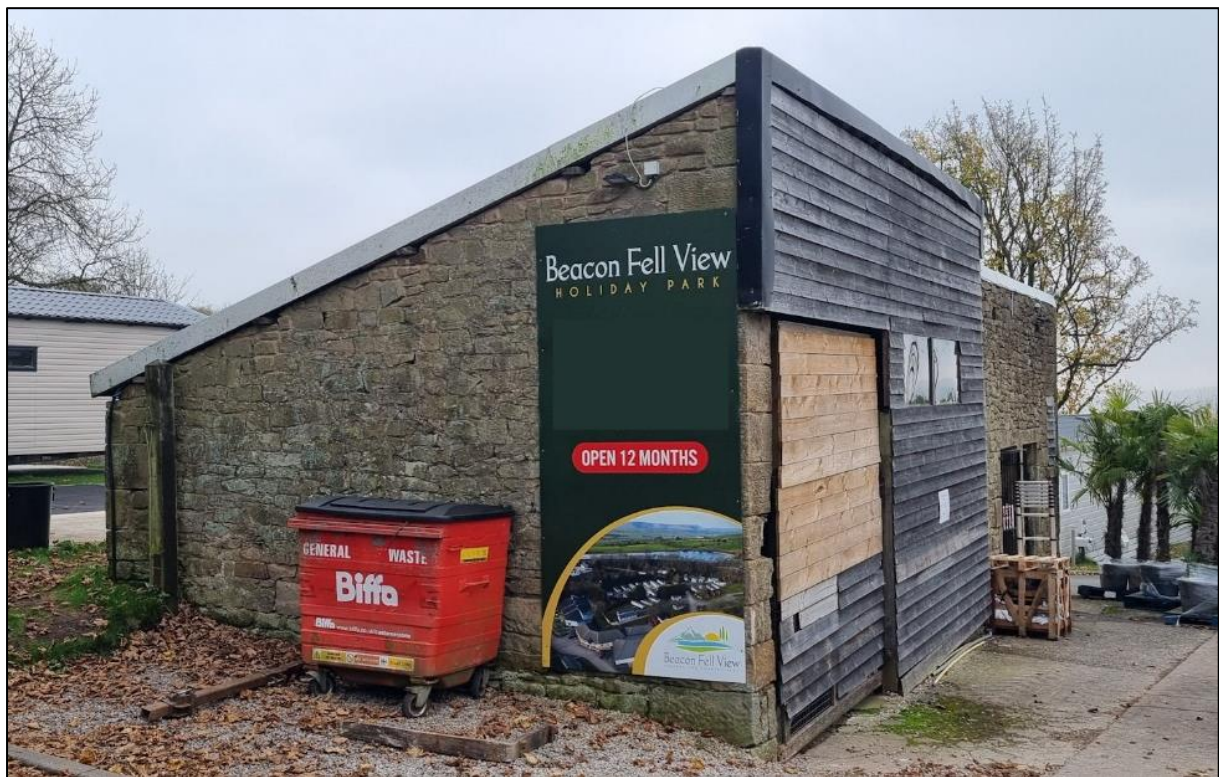
- 1.3.1 The Site is located on the eastern limits of Longridge, ~7km from Preston. The survey site was a detached stone-built workshop partially timber clad with a pitched roof of profiled sheets (see Plate 1). The surrounding area is urban, developed land to the west and agricultural land to the east, with pasture and arable fields lined by low hedges that offer linear commuting and foraging habitats. There were limited foraging opportunities with small and isolated parcels of woodland beyond the holiday park and Dilworth Upper reservoir lies to the north with the Spade Hill reservoirs to the south.
- 1.3.2 The surveys described in this report were commissioned to inform a planning application to convert the existing workshop to a holiday let (see Plan 4).

Plate 1: General view of the existing workshop.

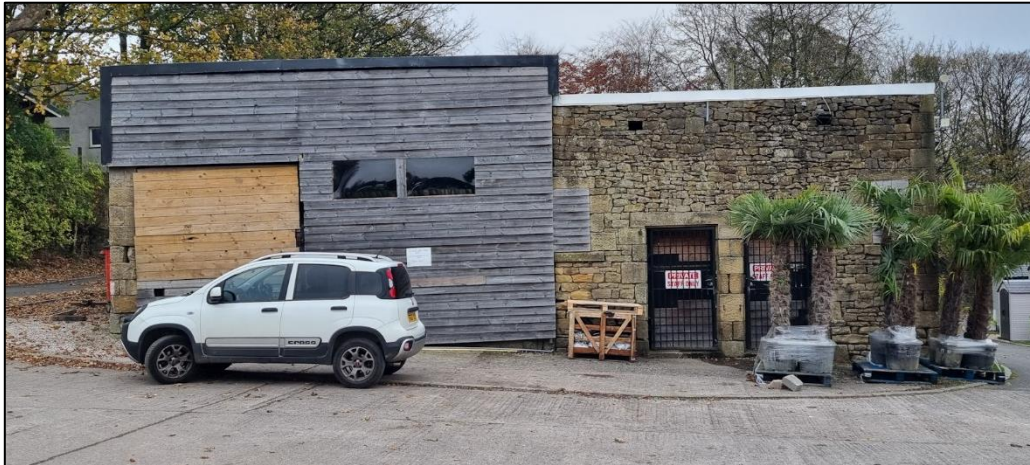
- 3.1.1 The target building was a detached workshop constructed from dressed stone partially timber clad with pitched roofs of profiled roofing sheets. The footprint of the building was approximately 40m² (see Plate 2).

Plate 2: General view of the workshop from the west.

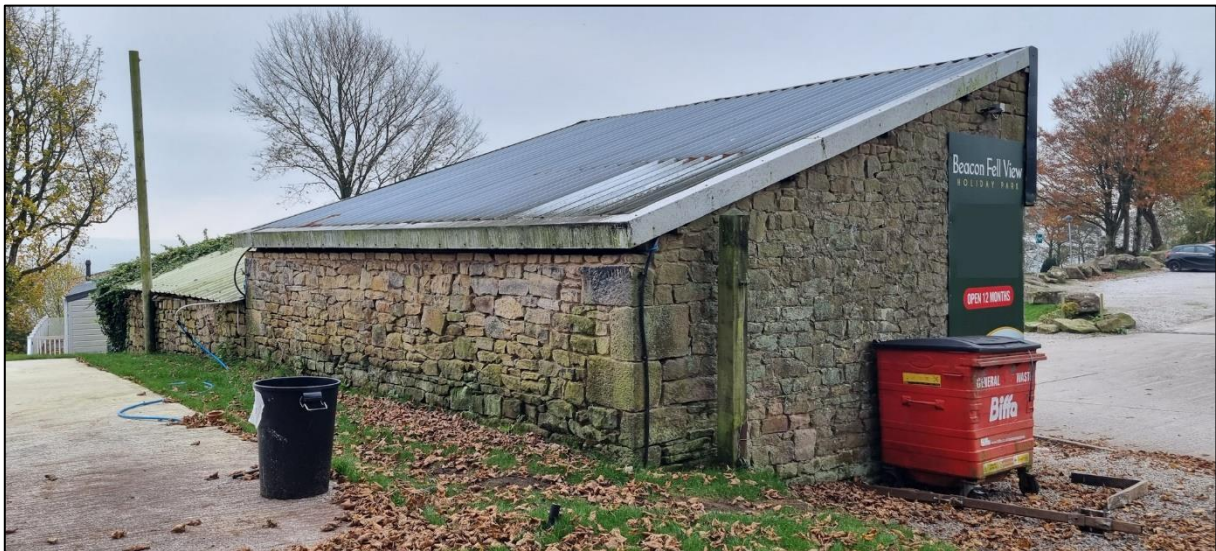
- 3.1.2 The pitched roofs of workshop were found to have profiled metal sheets with no gaps or roosting potential (see Plate 3). The capping at the edges of the sheets were found to be open and rather exposed and offered negligible roosting potential (see Plate 4).

Plate 3: The pitched roofs of profiled sheets were intact and offered no roosting potential.

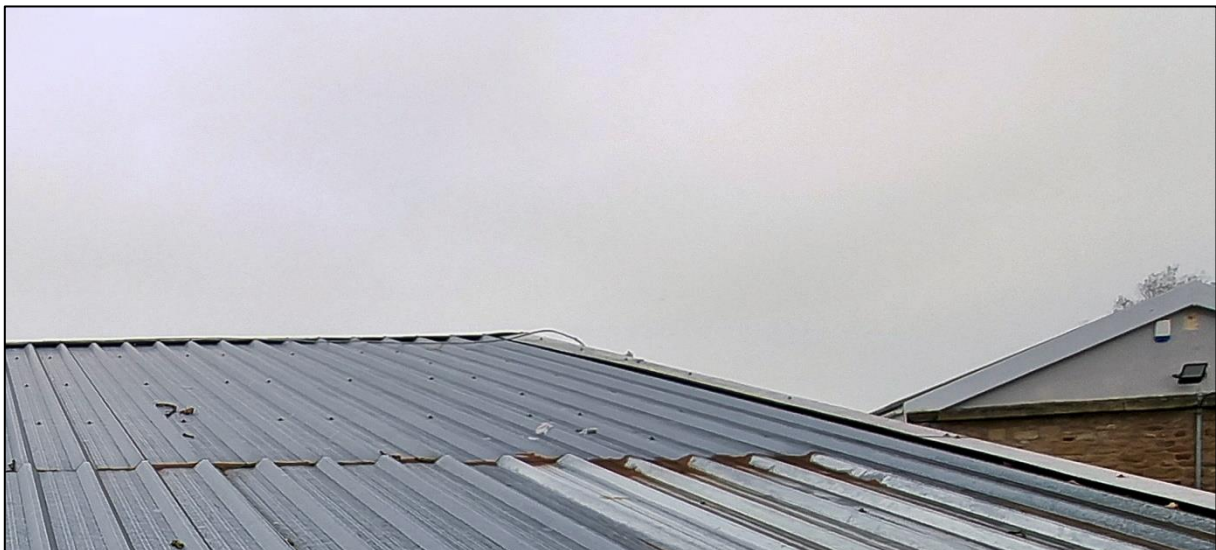
Plate 4: The profiled roof pitches had gaps beneath end and edge capping but these offered no roosting opportunities.

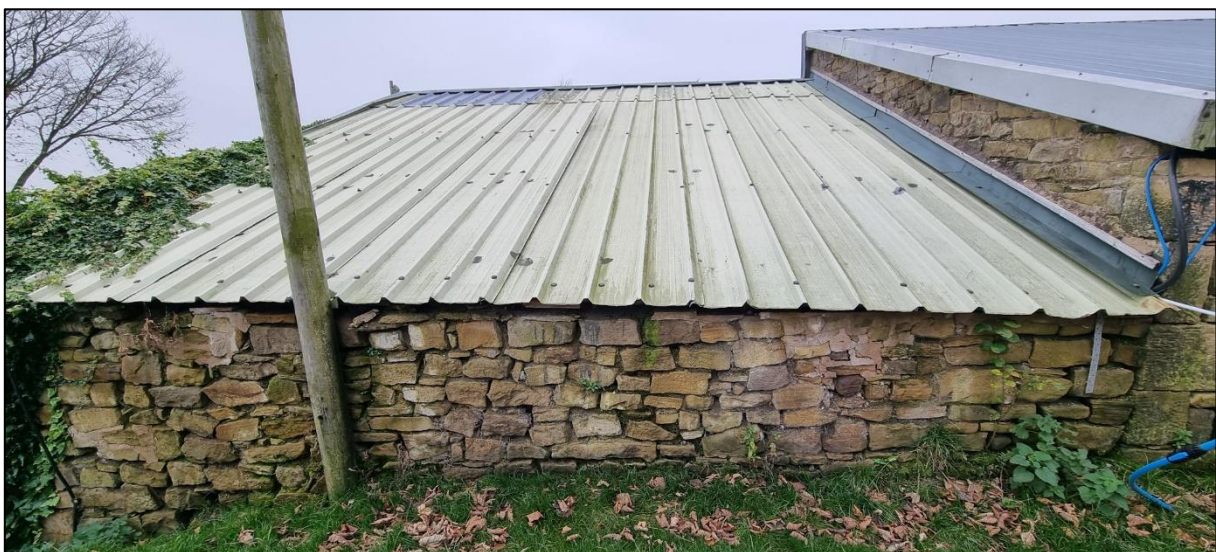
Plate 5: The lower pitch was intact with no roosting potential although gaps were noted beneath the sheet ends.

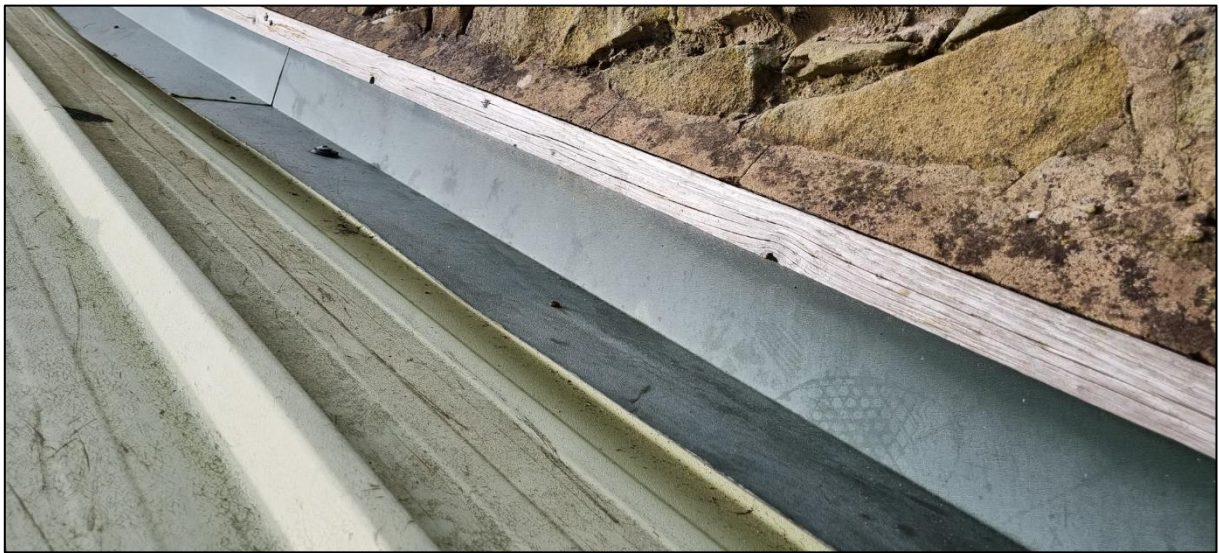
Plate 6: The apron along the lower roof was intact and offered no roosting potential.

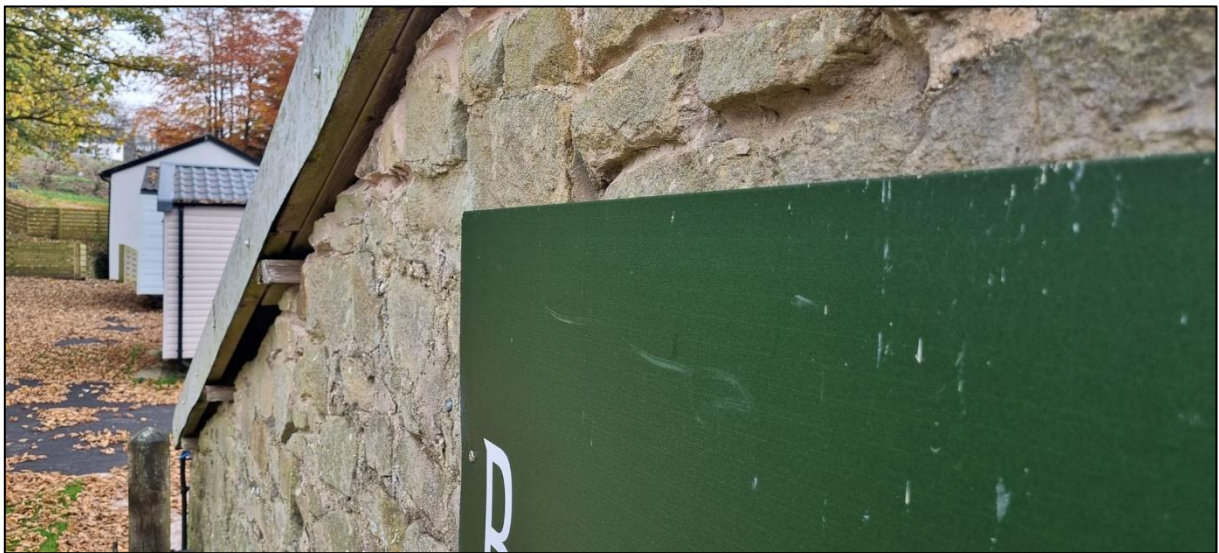
Plate 7: The dry verge capping was intact although there were significant gaps below the verges.

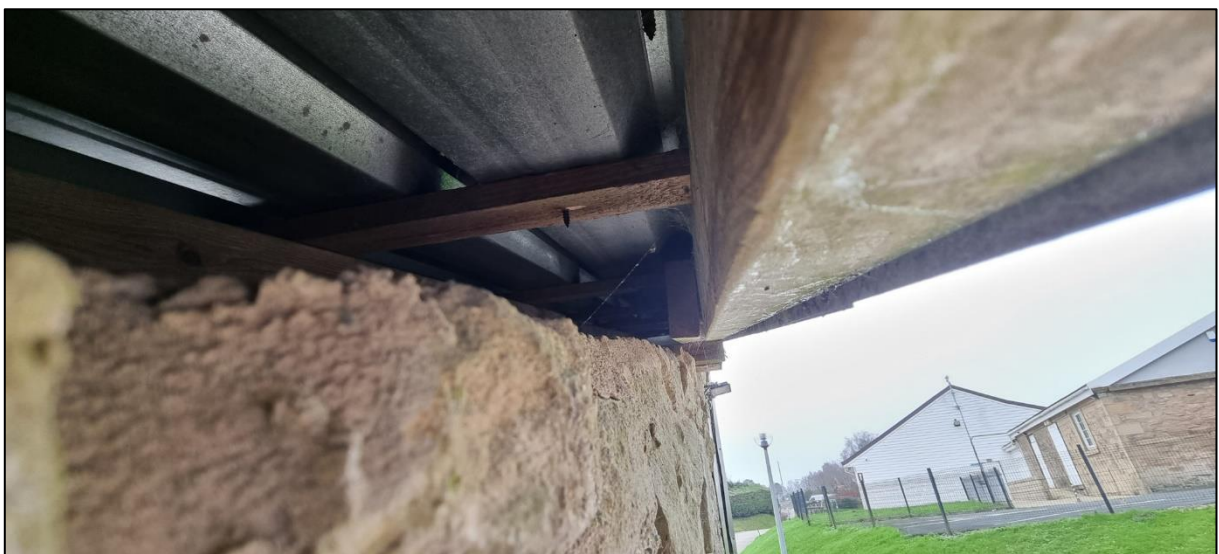
Plate 8: The gaps below the verges opened to the wall tops and offered potential access to internal voids.

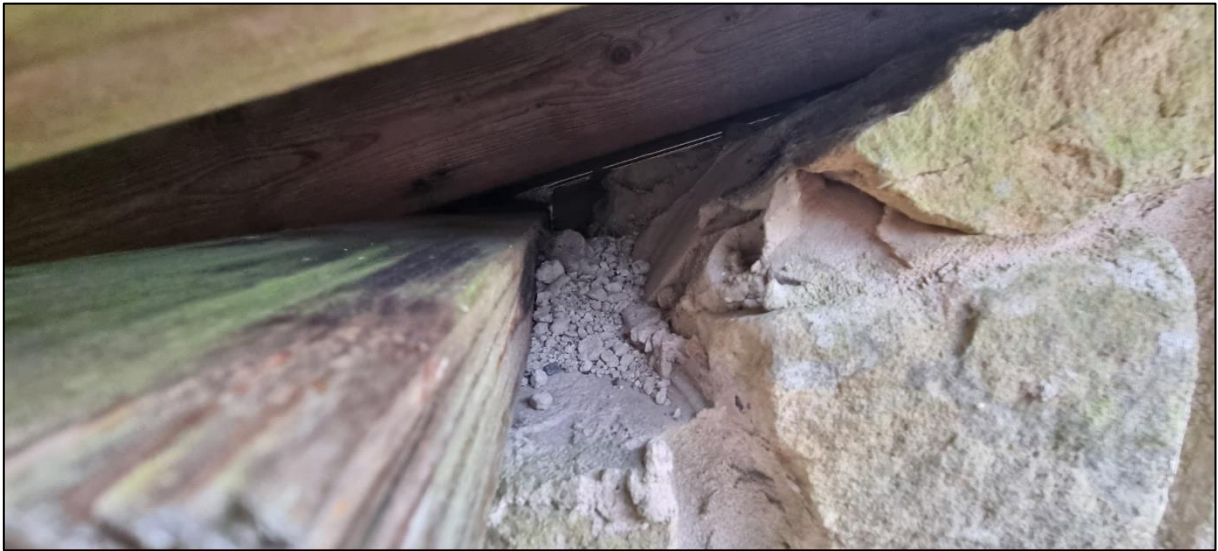
- 3.1.3 In the eaves there were gaps below the edges of the roof pitches that lead to the wall tops and to the internal void (see Plate 9 and Plate 10).

Plate 9: The gaps in the verges lead to the internal void and offered bats potential access to the wall interior.

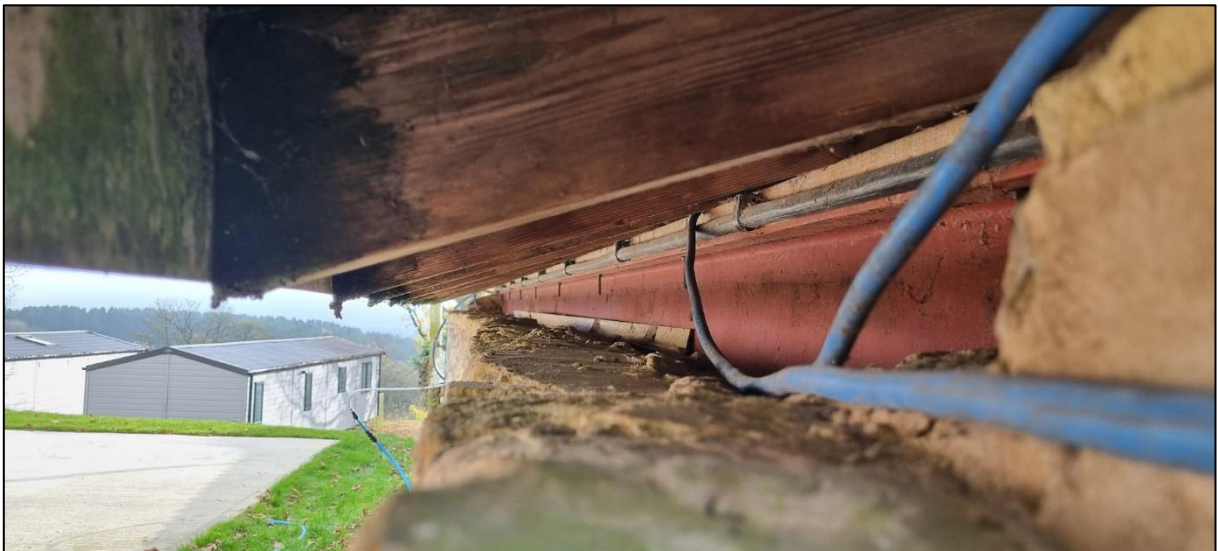
Plate 10: Below the roof edges the gap was wide and had no roosting potential but offered potential access inside the building.

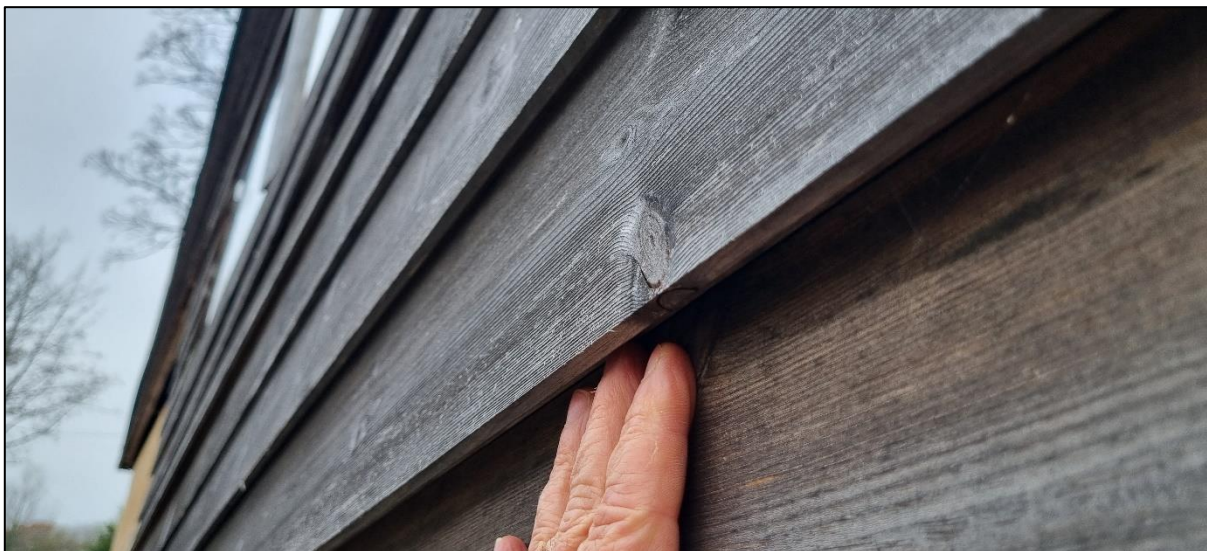
Plate 11: There were gaps behind the timber cladding and roosting potential could not be ruled out as cladding can have high suitability for bats.

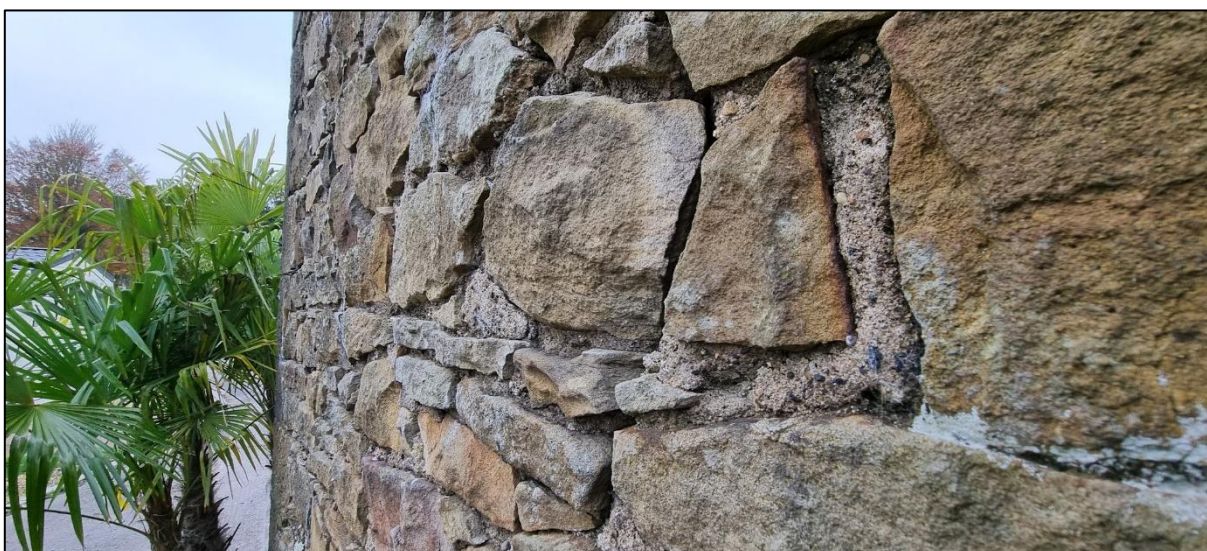
- 3.1.4 The stone walls and the timber cladding were generally intact although there were many areas of perished and missing mortar. This has resulted in gaps in the stonework (see Plate 12). There were so many that an endoscope search was impossible/meaningless. Overall, it was clear that the walls were a potential roost feature.

Plate 12: The stonework and mortar was in poor condition, with many crevices and gaps.

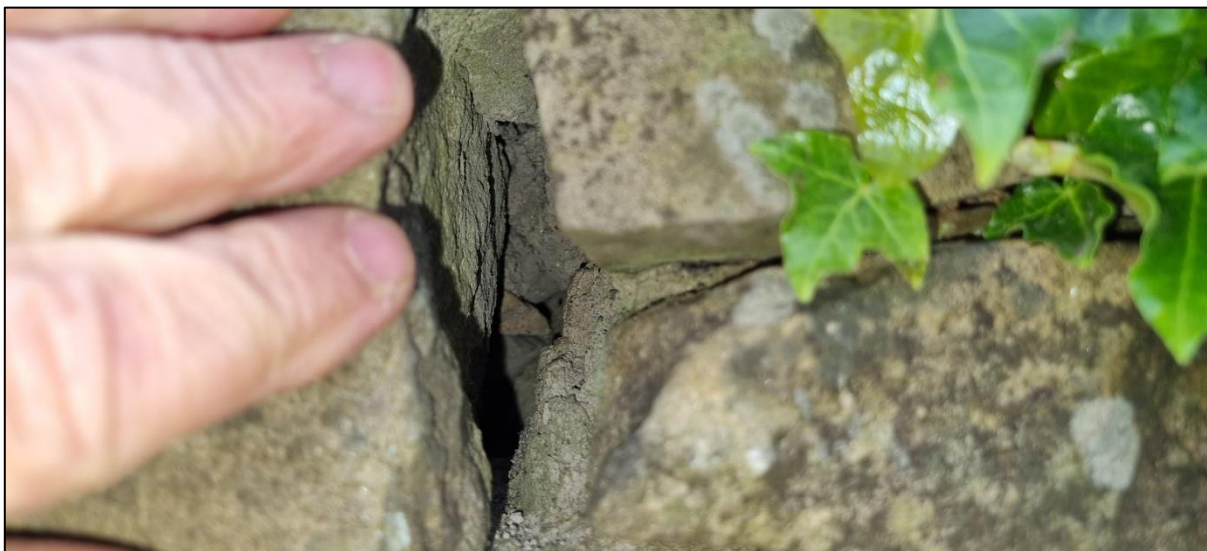
Plate 13: There were many suitable gaps in the stone rubble walls that offered roosting potential.

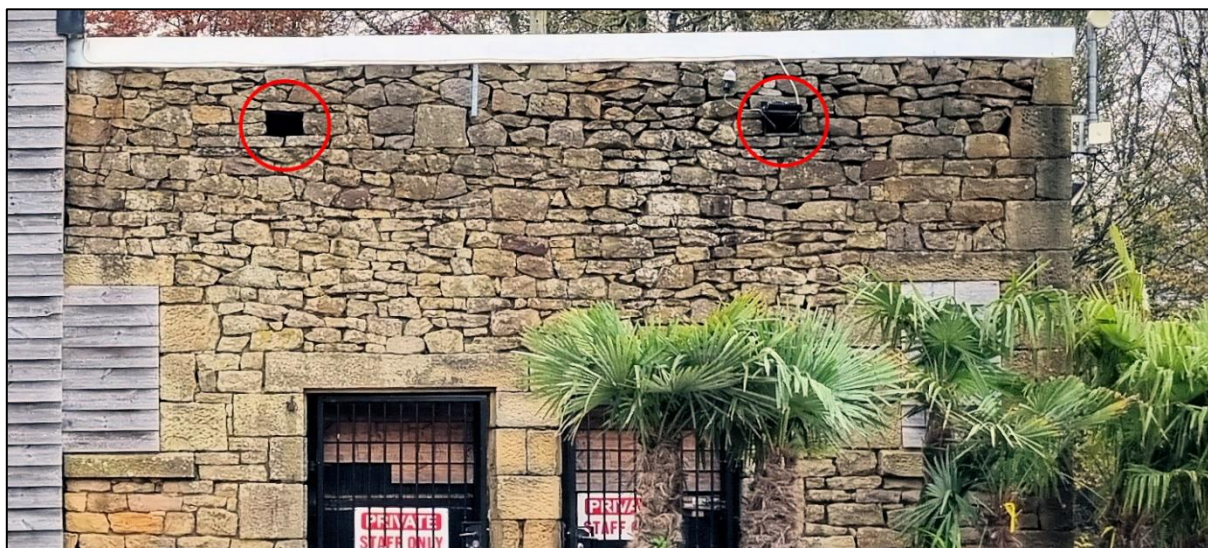
Plate 14: The doors of the workshop were well sealed but open window apertures that offered unrestricted internal access.

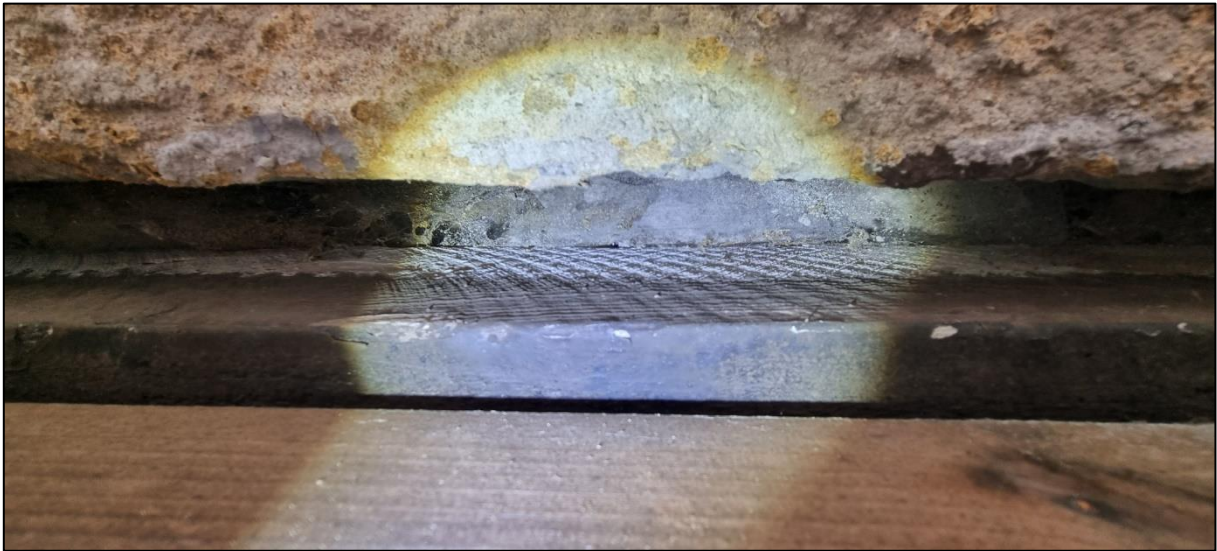
- 3.1.5 Whilst the smaller doors on the west face of the building were well sealed, the windows were unglazed and the large sliding door had large gaps and these offered further access to the internal spaces (see Plate 14). The doors have split lintels that offered roosting potential (see Plate 15).

Plate 15: Split lintels above the smaller storage room doors had a narrow crevice in them, so roosting could not be ruled out.

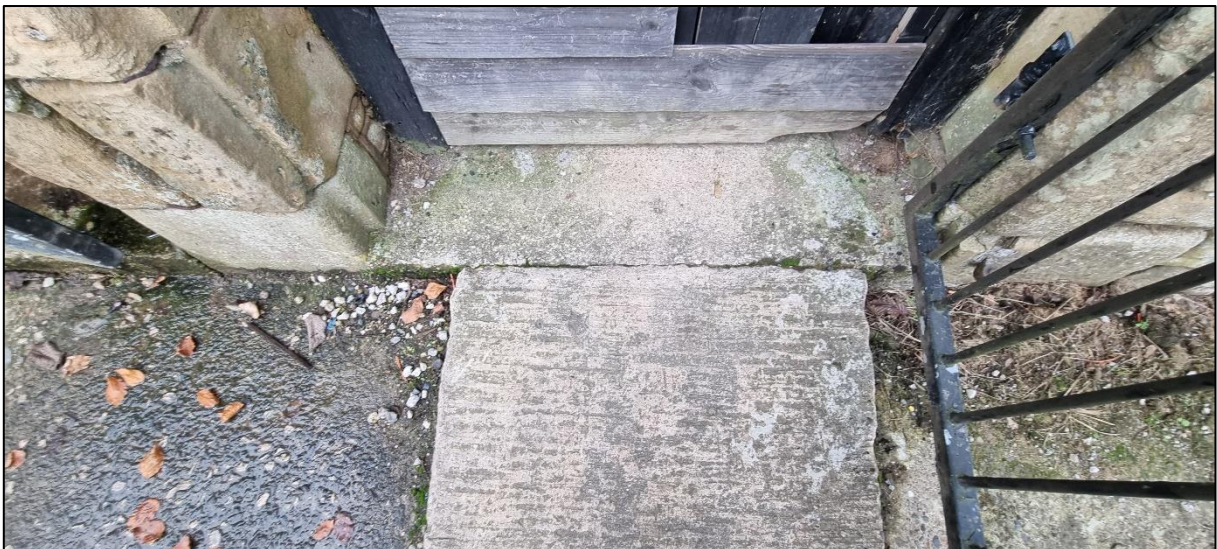
- 3.1.6 No evidence of bat activity could be seen on the walls or flat surfaces around the workshop, but the survey was carried out late in the year and the workshop is in an exposed position, so the effects of weather could well produce a false negative if this was relied upon alone when determining the overall suitability for bats (see Plate 16).

Plate 16: There was no evidence of bat activity on the walls or flat surfaces around the workshop although as this time of year, finding any droppings becomes unreliable.

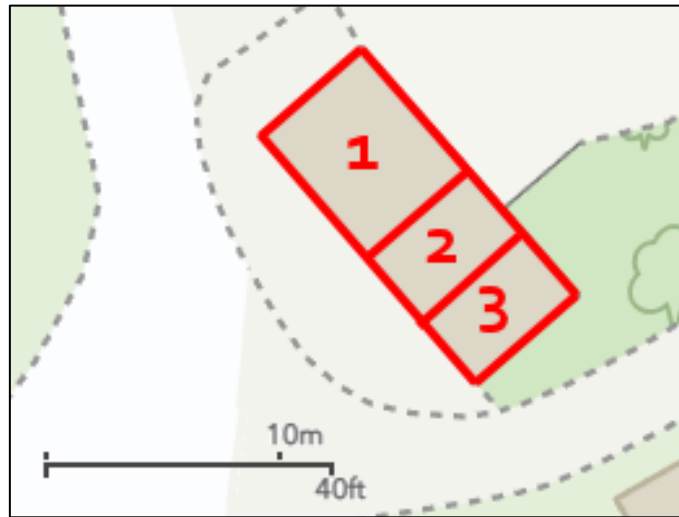
- 3.1.7 The building was subdivided to separate voids (see Plan 5) open from floor to roof with no loft voids. The building had no enclosed loft spaces; this was a key finding in relation to the building inspection. This meant that one of the typical areas used by bats for roosting was absent from these structures and the absence of a loft space tends to lower the potential for bat roosting quite noticeably.
- 3.1.8 Although the workshop three separate spaces, gaps along wall tops meant that they were ostensibly a single space (see Plate 17). The gaps in the rubble walls were large and, in the opinion of the ecologist, did not offer crevices that would have been suitable for bat roosting.

Plan 5: The workshop was subdivided into discrete spaces.

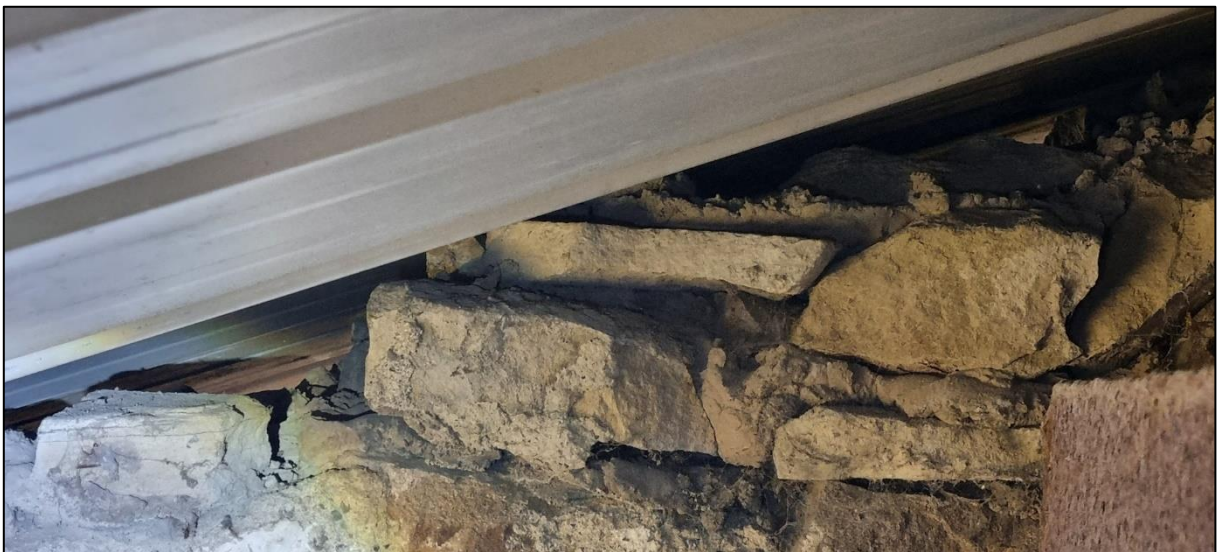
Plate 17: Gaps between the roof and the wall tops allowed for potential access from one space to another but these were 'gappy' and open voids not considered suitable for crevice dwelling bats.

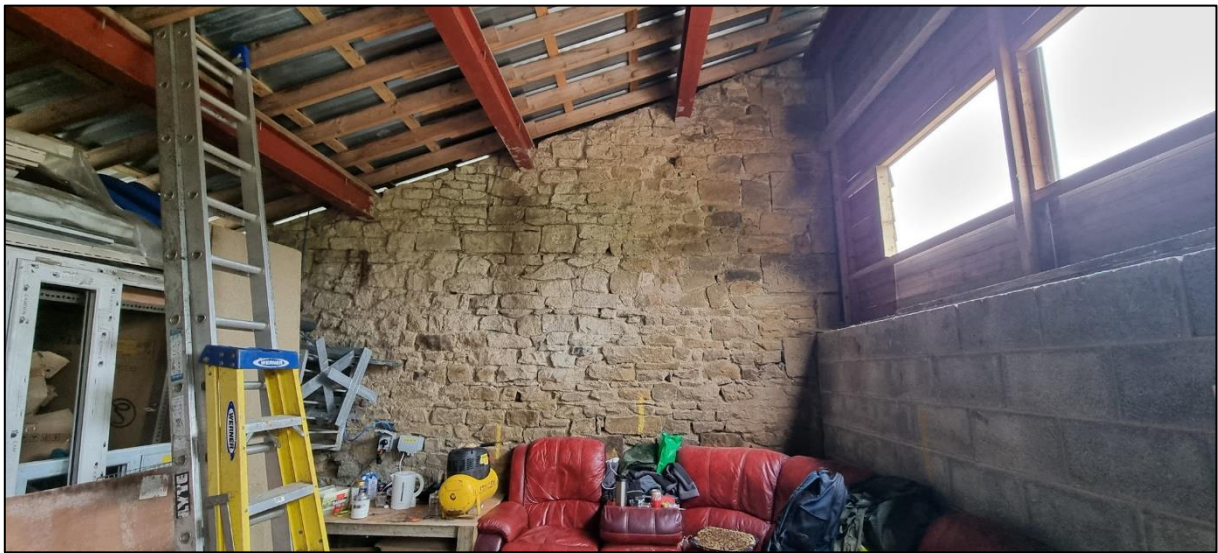
- 3.1.9 The internal spaces were all open to the roofing sheets and the support structures (see Plate 18) – these did not have any roosting potential (see Plate 18 to Plate 21).
- 3.1.10 The gaps under the roof edges observed during the external inspection clearly offered potential access to the internal spaces (see Plate 22). The high level windows offered further potential access to the internal spaces (see Plate 23).
- 3.1.11 The walls were intact with no gaps, crevices or cracks that would offer any roosting potential (see Plate 24).
- 3.1.12 Finally, a thorough search of all flat and vertical surfaces was completed in order to look for evidence of bat activity, such as droppings or prey remains but no evidence was present (see Plate 25 and Plate 26).

Plate 18: The largest of internal voids (Void 1) was open to the roofing sheets and support structures.

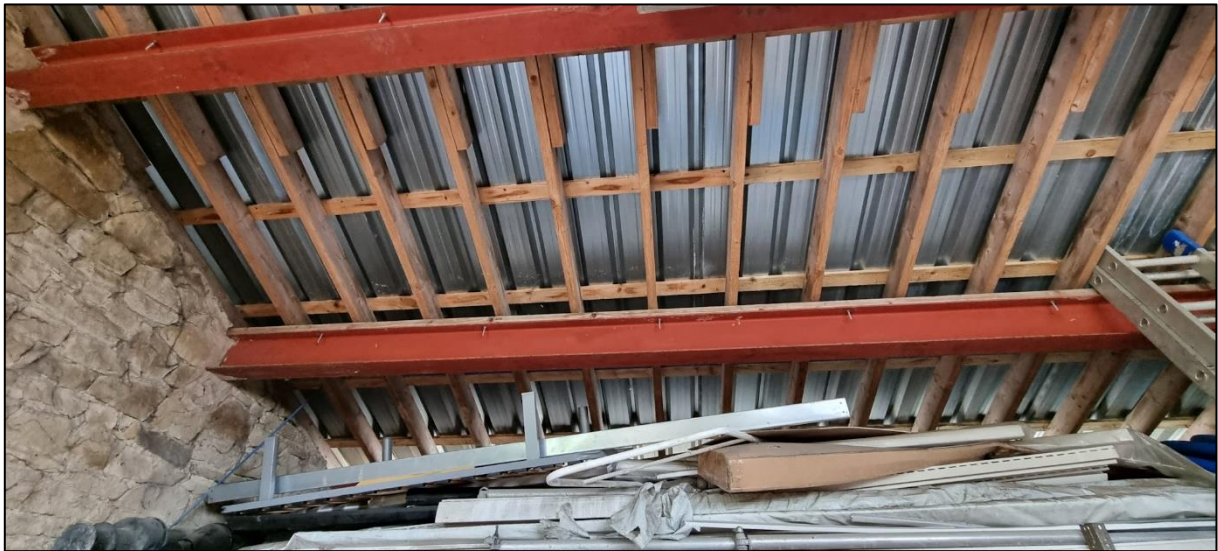
Plate 19: The roof of void 1 had no potential roost features.

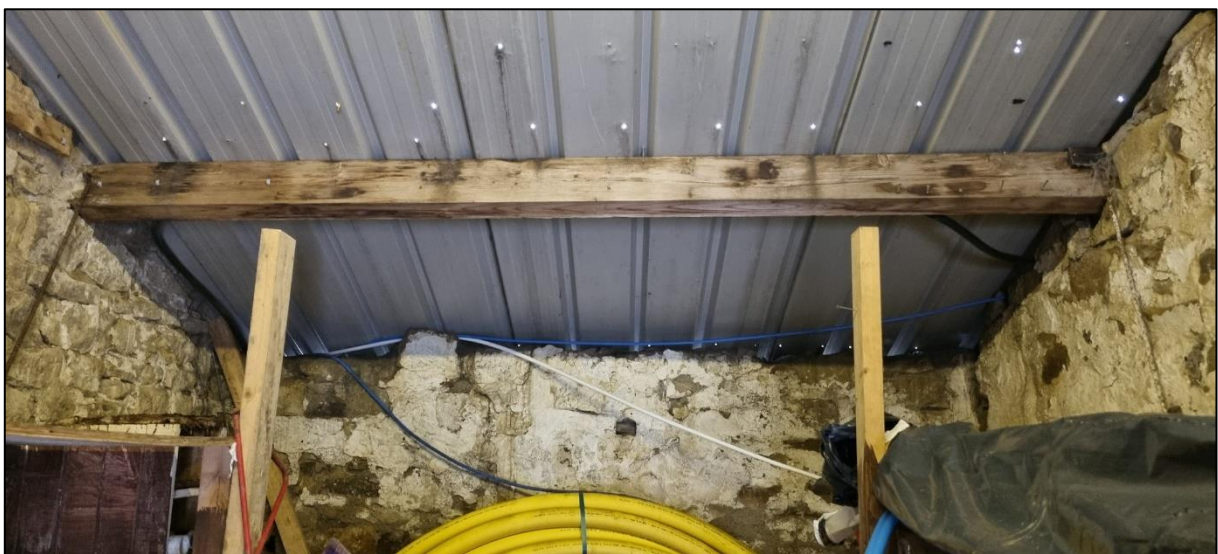
Plate 20: The roof of the central storage area (void 2) was also open to the roof and the supporting timbers.

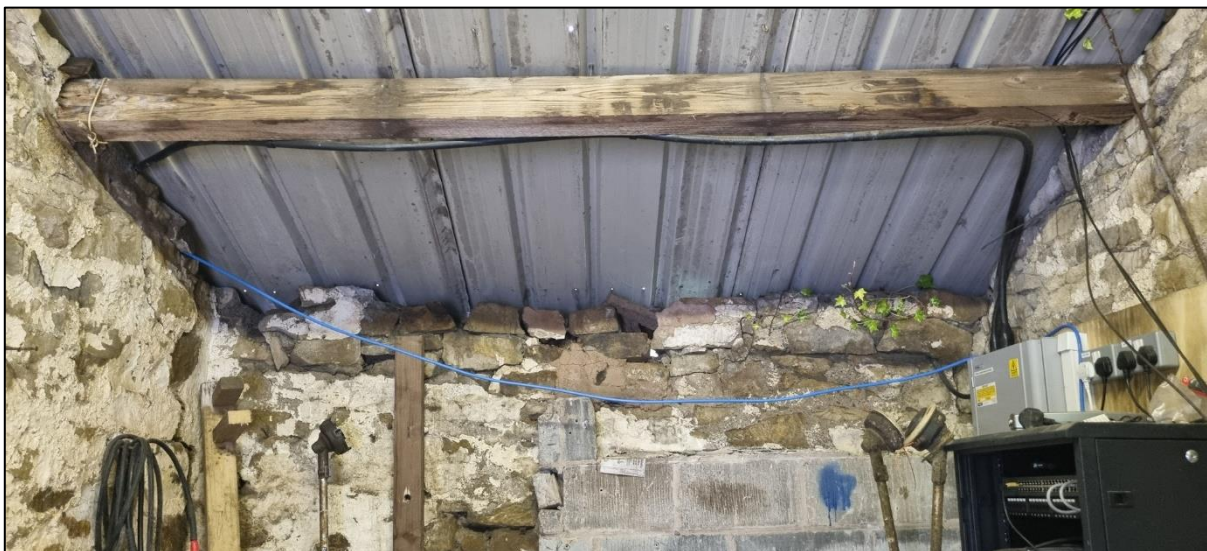
Plate 21: The roof of the remaining internal space (void 3) was intact with no PRFs and no evidence of bat activity.

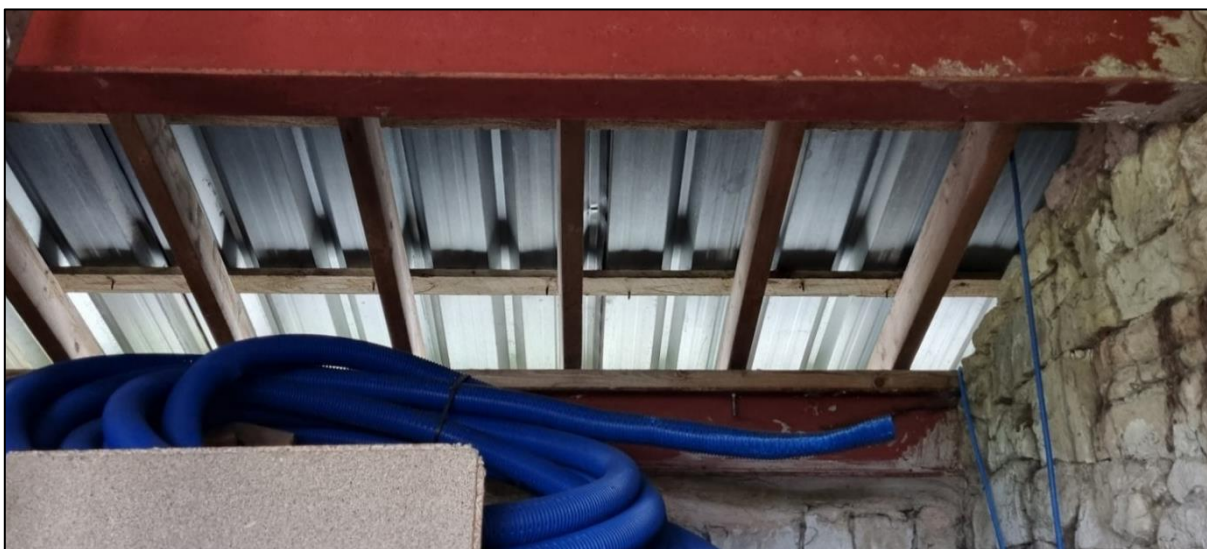
Plate 22: The gaps under the roofing sheets offered unrestricted potential access to the internal space.

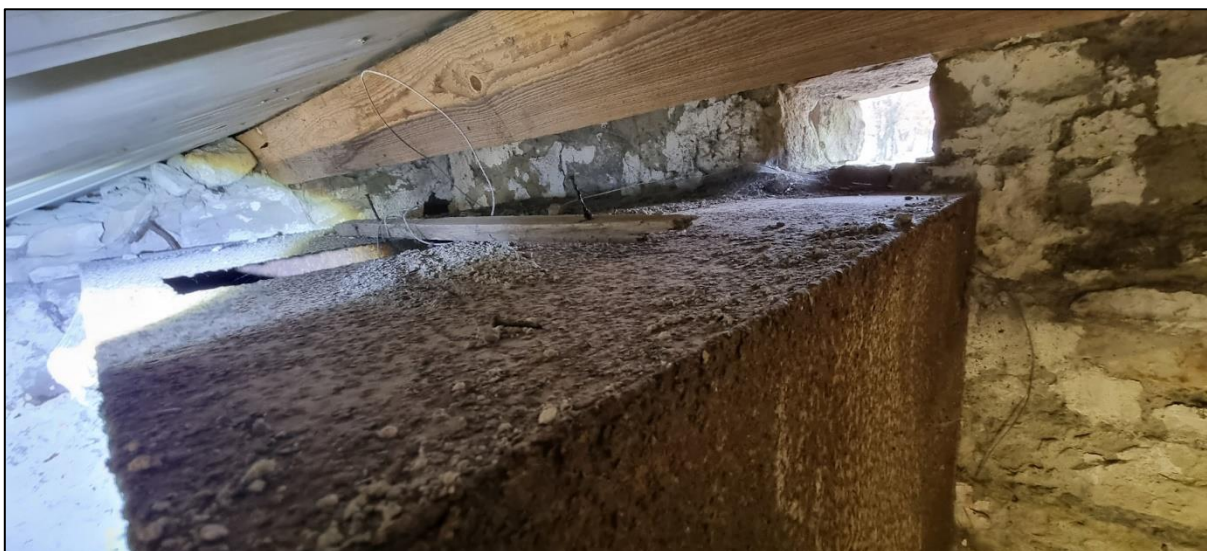
Plate 23: The high level windows allowed further unrestricted potential access to the internal spaces.

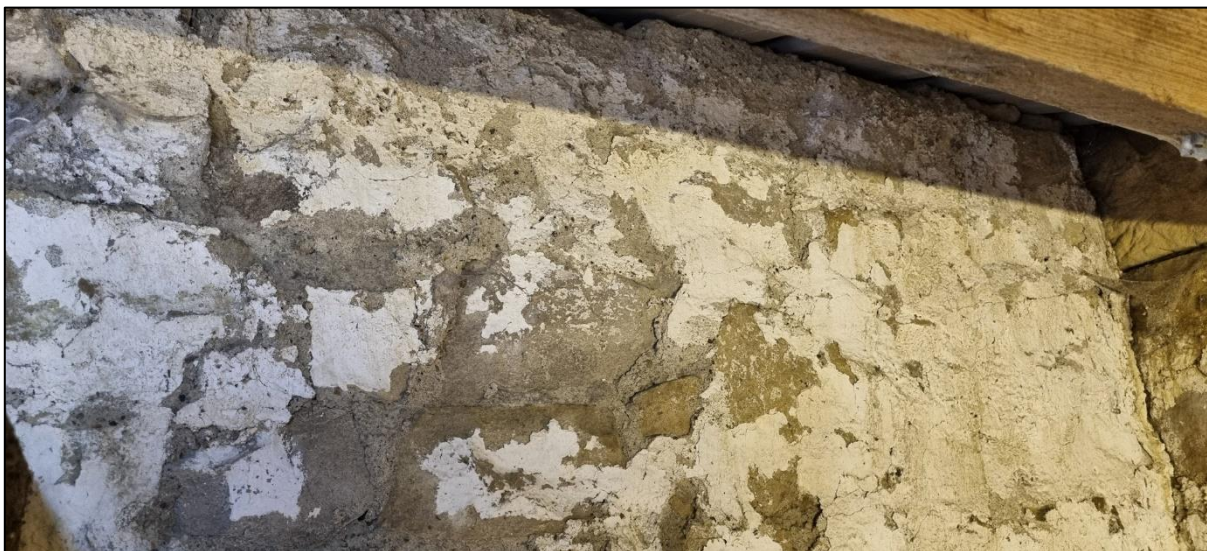
Plate 24: The internal walls were intact and had no roosting potential.

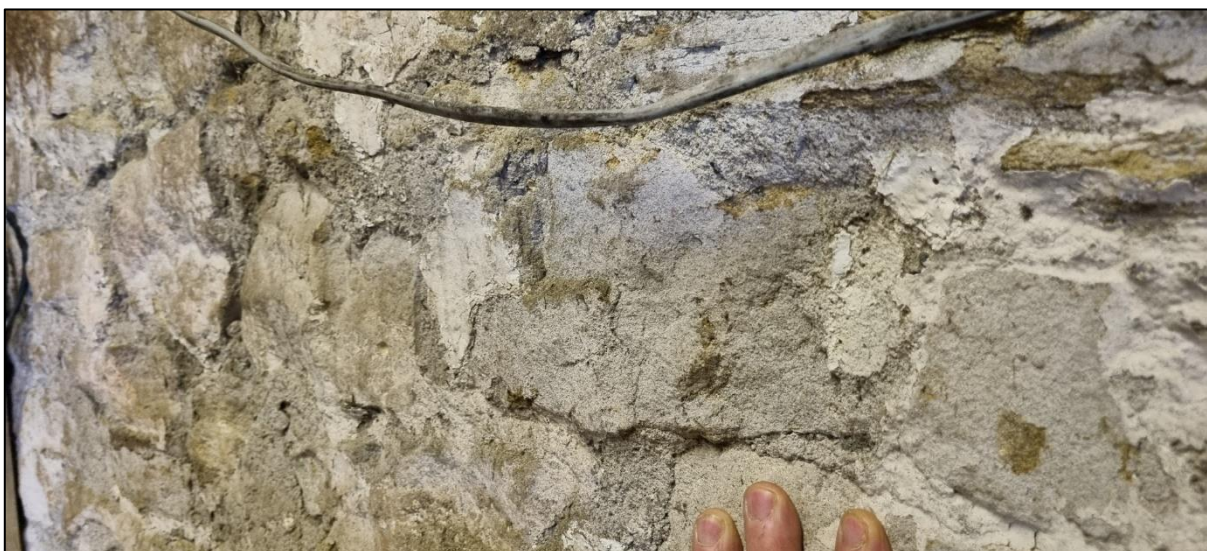
Plate 25: There was no evidence of bat activity on the internal walls.

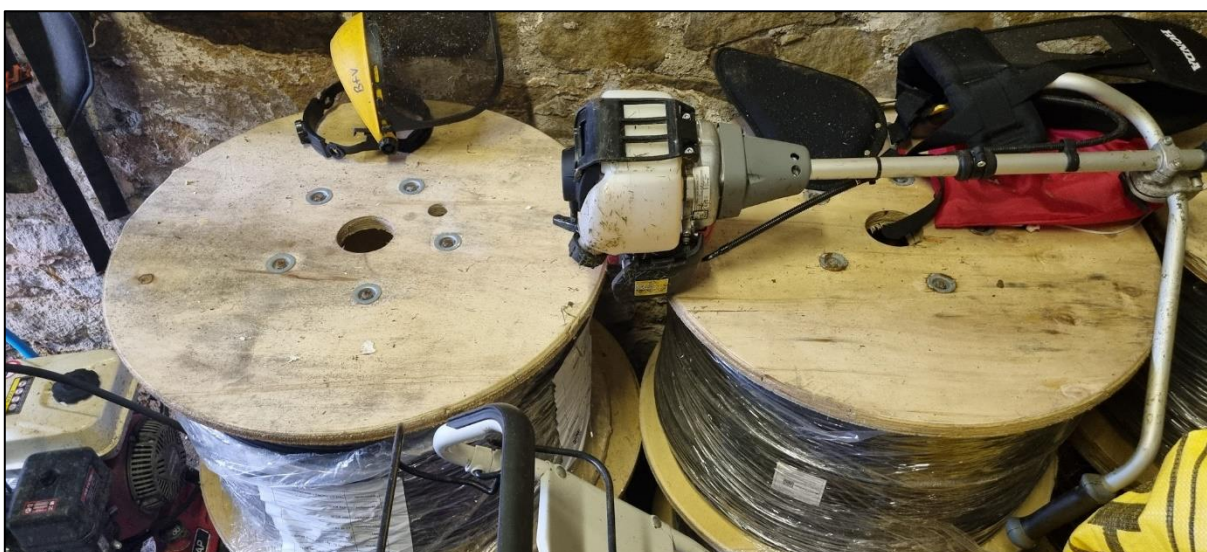
Plate 26: There was no evidence of bat activity on the flat surfaces in the workshop.

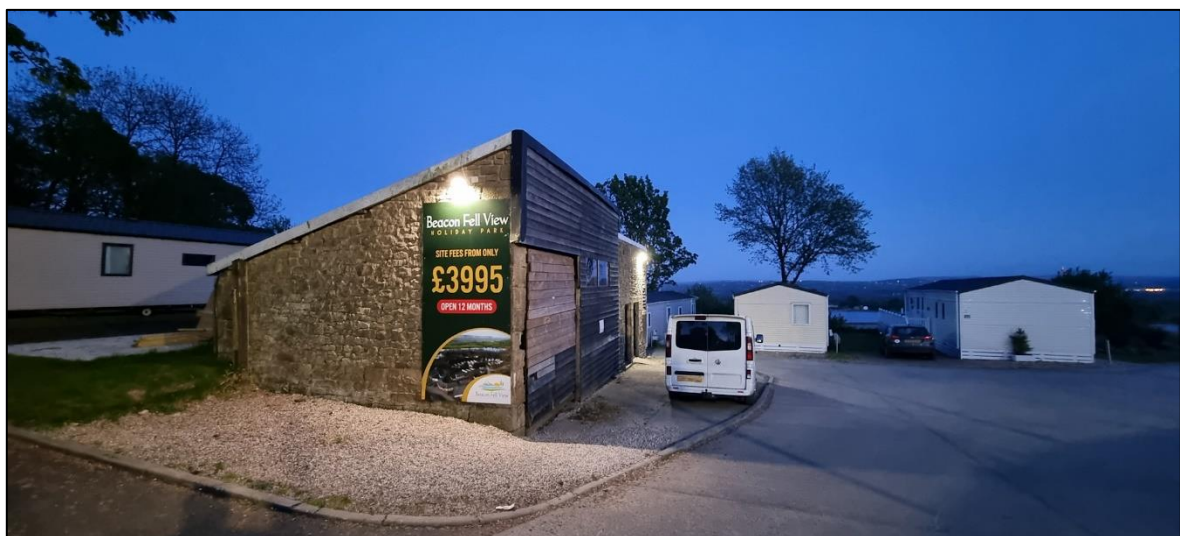
3.2.5 It was noted that the ambient light levels were high and this may partially explain the low levels of activity recorded (see Plate 27).

Plate 27: Ambient light levels were very high throughout the survey and the target building was brightly illuminated.

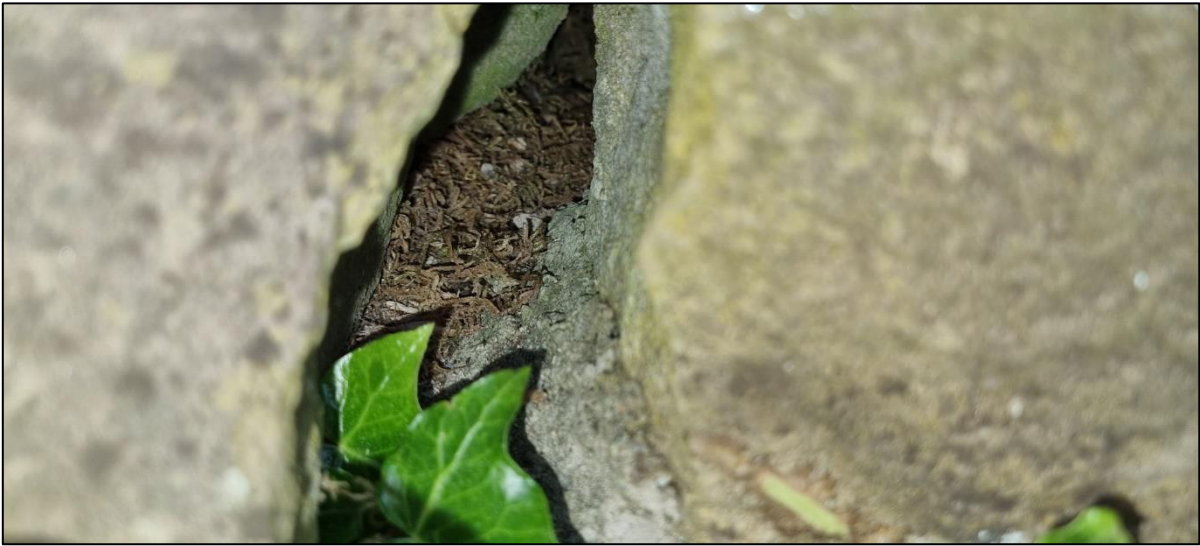
- 3.3.1 There were a number of gaps in the stone rubble walls that were suitable for nesting birds and evidence of past nesting attempts were identified in the deep-set crevices (see Plate 28).

Plate 28: There was evidence of bird nesting in the external stone walls of the workshop.

- *It is recommended* that all conversion works should be carried out outside of the bird breeding season (March to August inclusive). Where this is not possible, a suitably qualified ecologist should carry out a check to confirm the absence of nesting birds immediately prior to clearance works commencing. If a bird nest in current use is discovered, then an appropriate buffer zone around the nest should be created where clearance works can only continue after the nest is vacated. **Reason:** This will ensure that no offences are committed under The Wildlife and Countryside Act 1981 (as amended). The bird-nesting season is generally regarded to extend between March and August inclusive.

- *It is recommended* that, to mitigate for the loss of potential nesting sites **3x traditional nest boxes** (see Figure 1) with 28-32mm entry holes should be located in trees to the rear of the building, these must be located at a height at least 3m above the ground and north facing. This should be implemented by way of a Local Authority Planning Condition. **Reason:** This will enable the continued use of the site by nesting birds and will result in no overall negative effect upon biodiversity at the site. This will ensure compliance with the Local Authorities duty under The Natural Environment and Rural Communities Act 2006, as reflected in Section 11 (179 & 180) of the National Planning Policy Framework (2021) and the Local Plan.

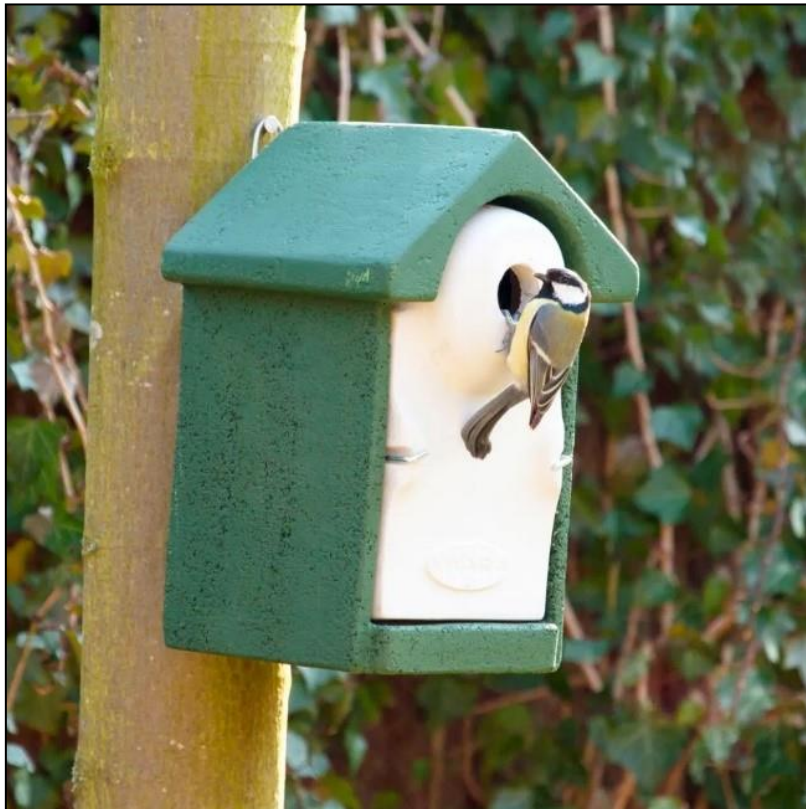
Figure 1: Example of 32mm nest box (NHBS).
