APPLICATION 3/2025/0489
PROPOSED CAR PARK
UNCOVERED STRUCTURE

7295. REVISION (02) Sept 2025

1.3 | Uncovered Structure

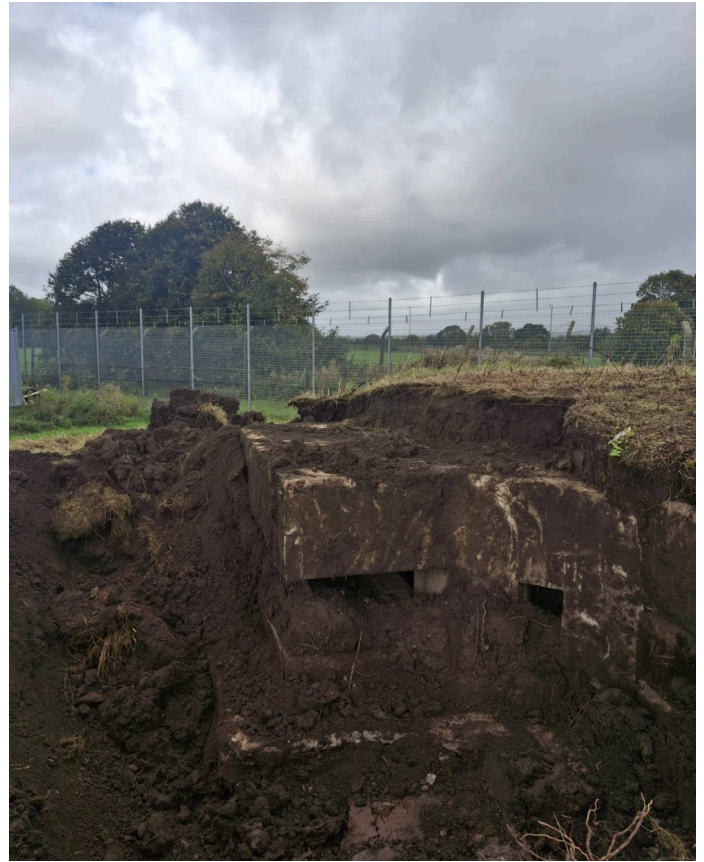
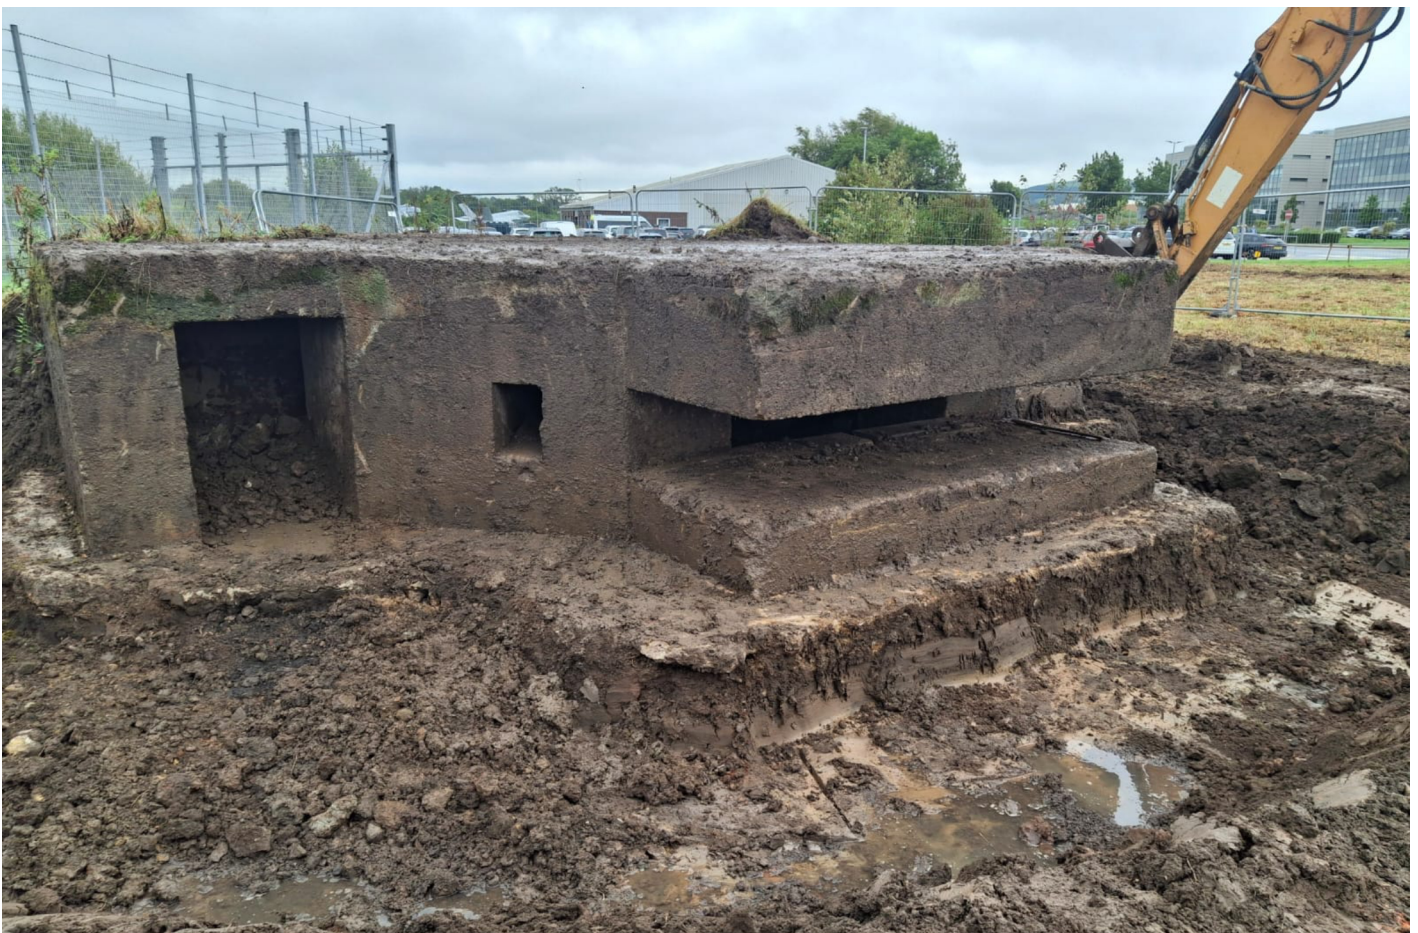
On Friday 19th September, the operative scanned for the cable and we excavated the remaining areas accordingly. This left the structure exposed (please see attached images). On the same day, it was agreed that we would de-mobilise from site, until the pest controller had been booked in. We are waiting on confirmation of dates and we will re-deploy then.”

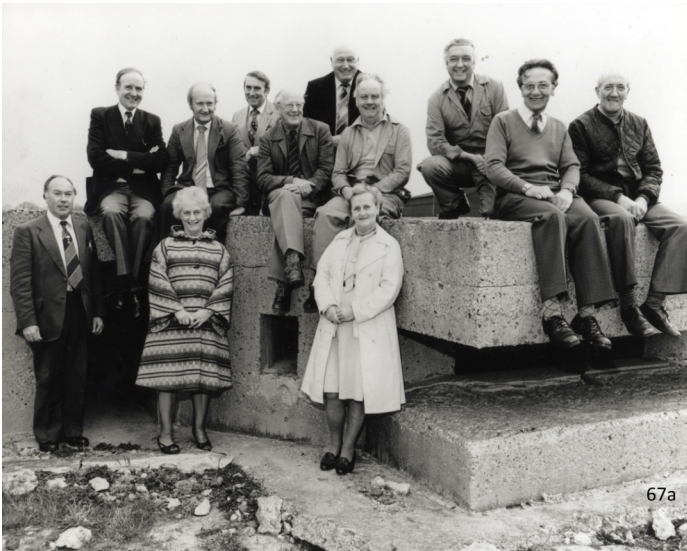
Subsequent investigation by the Client Heritage team have uncovered a historical photograph, date unknown, which appears to show employees with the structure before it's burial.

"...based on it's general size and shape, we believe it to be a Type 24 pillbox. There is an enlarged, forward embrasure, suggesting it's been adapted for use with a heavier machine gun and wider arc of fire."

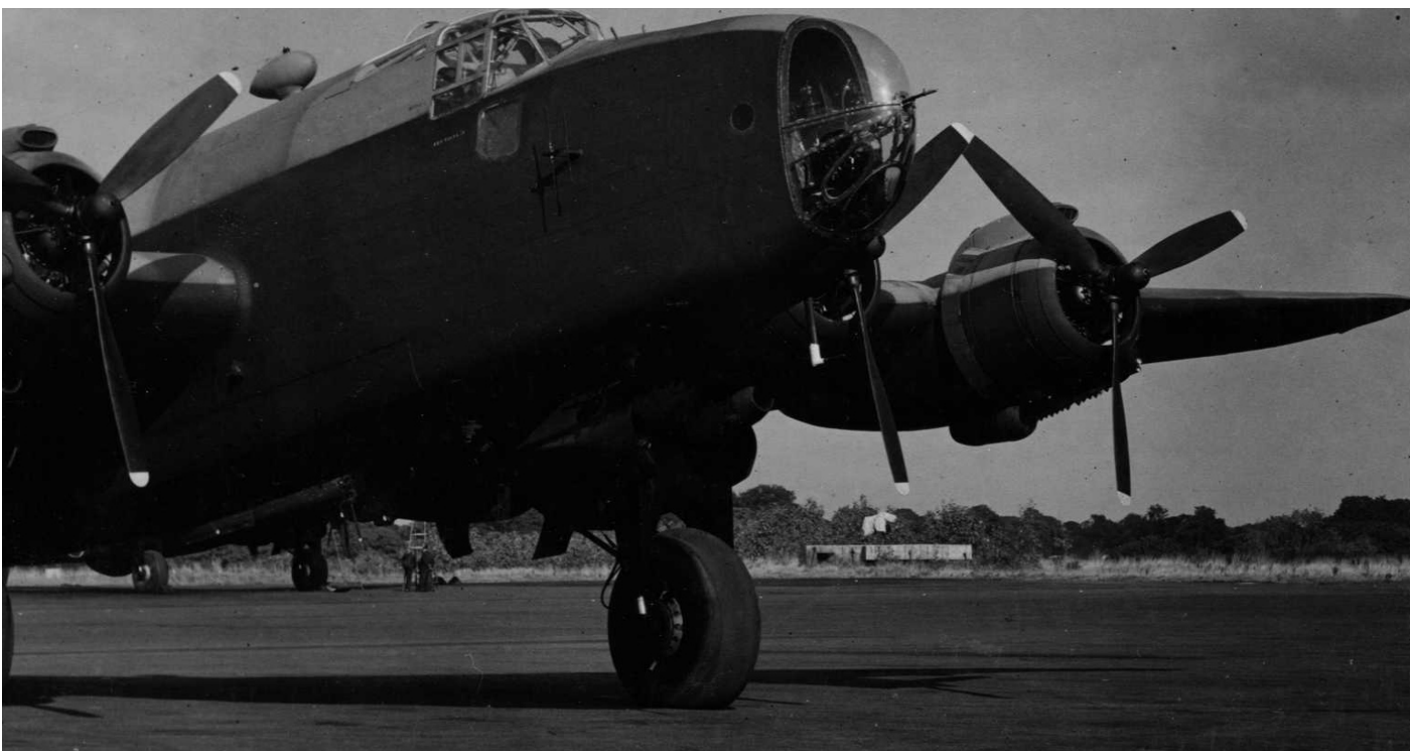
The client has also advised that the structure can be seen in the background of the below photo of a Halifax Plane which is believed to be taken circa 1943.

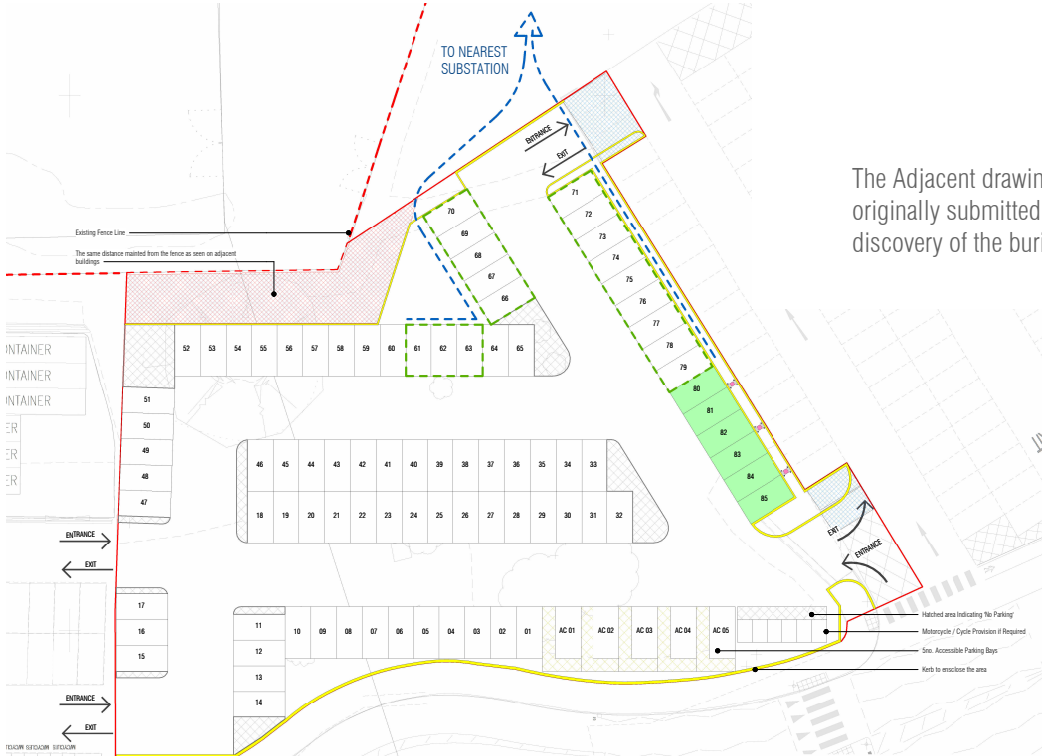
The Adjacent drawing shows the originally submitted scheme, pre discovery of the buried structure.
