**Dale Hey Bungalow,
Preston Road,
Ribchester,
Preston,
Lancashire.
PR3 3XL**

**Survey & Assessment in Respect of Bat Species
and Nesting Birds (including Barn Owl).**

15th April 2025

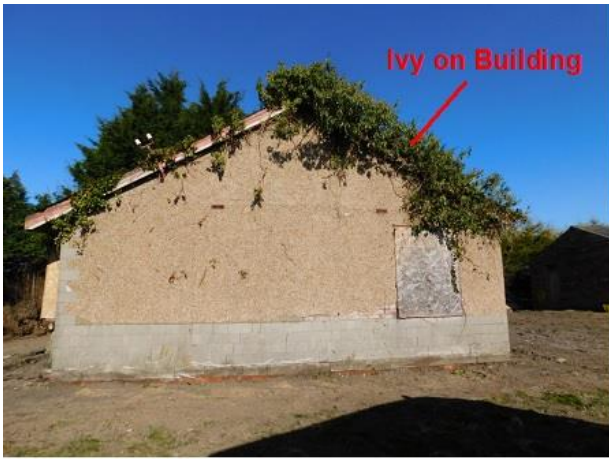
PHOTO 1
Eastern Elevation of Bungalow

- During the previous survey undertaken on 7th January 2022, there had been a dense mat of ivy (*Hedera helix*) covering most of both the bungalow's northern and eastern elevations, and the part of the roof connecting them, and also with a smaller plant growing on the walls at the south-western corner of the bungalow, however, since that survey, the majority of the ivy has been pruned and removed, but some was still growing at these locations, but in a much smaller amount. Dense ivy is considered to have a low, but significant bat roost potential, and where possible, a careful search between the remaining various parts of the ivy plant, particularly on the roof, initially by hand, torch, with the use of the endoscope camera, found neither bat droppings, invertebrate prey remains, nor bat fur staining from continual passage of individual bats between the leaves and plant stems, or bats themselves, also, a search of the ivy in the light emitted from the Darkbeam LED ultraviolet flashlight, found no evidence of bat urine staining. Nor was any evidence of past bird nesting found within the ivy, and the patch of ivy therefore, was judged to offer very low bat roosting suitability, (refer to **figs 3, 4, 5, and photos 1 - 4, 9, 17, 18, and 21 to 23**).

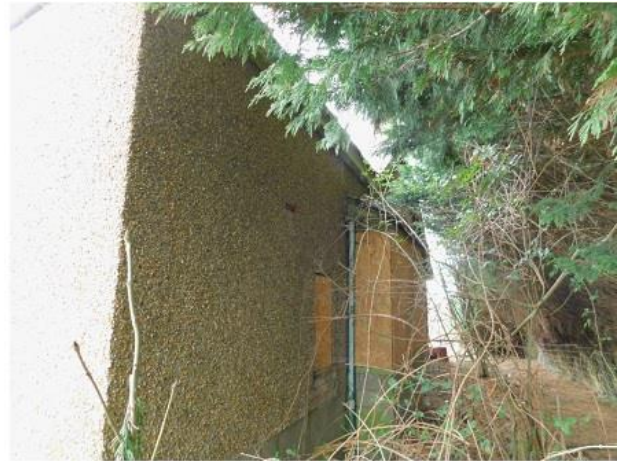
PHOTO 14
North-western View of Kitchen Elevation

There was a tall entrance porch positioned centrally within the southern elevation, with dormer windows also positioned within the southern elevation to either side of the entrance, together with another bay window attached to the western elevation. All of these were connected internally to the bungalow, but with no searchable roof voids beneath their sloping slate covered roofs, and all of these were currently boarded up, (refer to **figs 3, 4 and 5**, and **photos 1 to 15**).

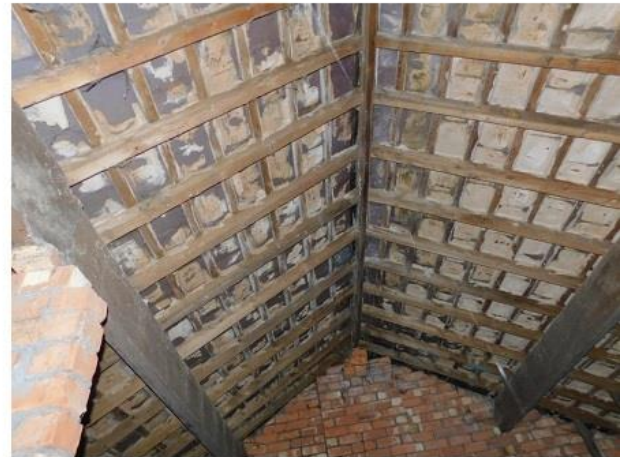
PHOTO 24
Underside of Bungalow Main Roof

The bungalow was a rectangular single-story structure, lying in a north-west to south-easterly orientation. It was constructed with an inner skin of brick, and an outer skin of concrete block, a large part of which, was covered in a pebbledash render. It had a pitched roof covered in slates but there was neither insulation nor underlining, (refer to **figs 3, 4 and 5**, and **photos 1 to 27**).

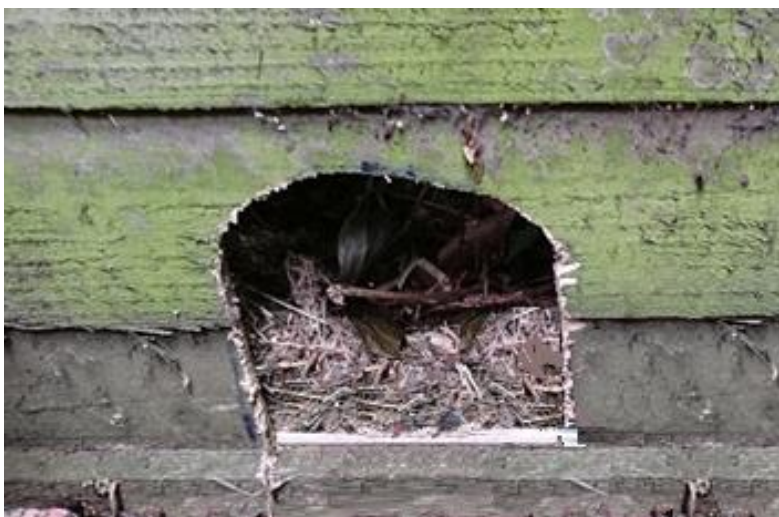
A 13cm by 13cm square hole is sufficient for any hedgehog to pass through, no matter what the wall or fence is made from. This will be too small for pets and dogs to pass through to pursue hedgehogs.

- Remove a brick from the bottom of the wall.
- Cut a small hole in your fence if there are no gaps.
- Dig a channel underneath your wall, fence or gate, to obtain enough depth.

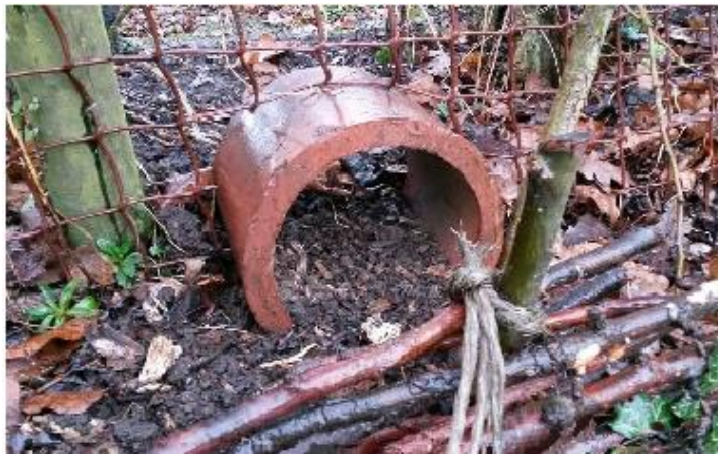
- Similarly, a 13cm diameter drain pipe would suffice through vertical fencing
