## **Preliminary Bat Roost Assessment Report**

**6 Brookside,  
Old Langho,  
Blackburn,  
BB6 8AP**

**07.07.2025**

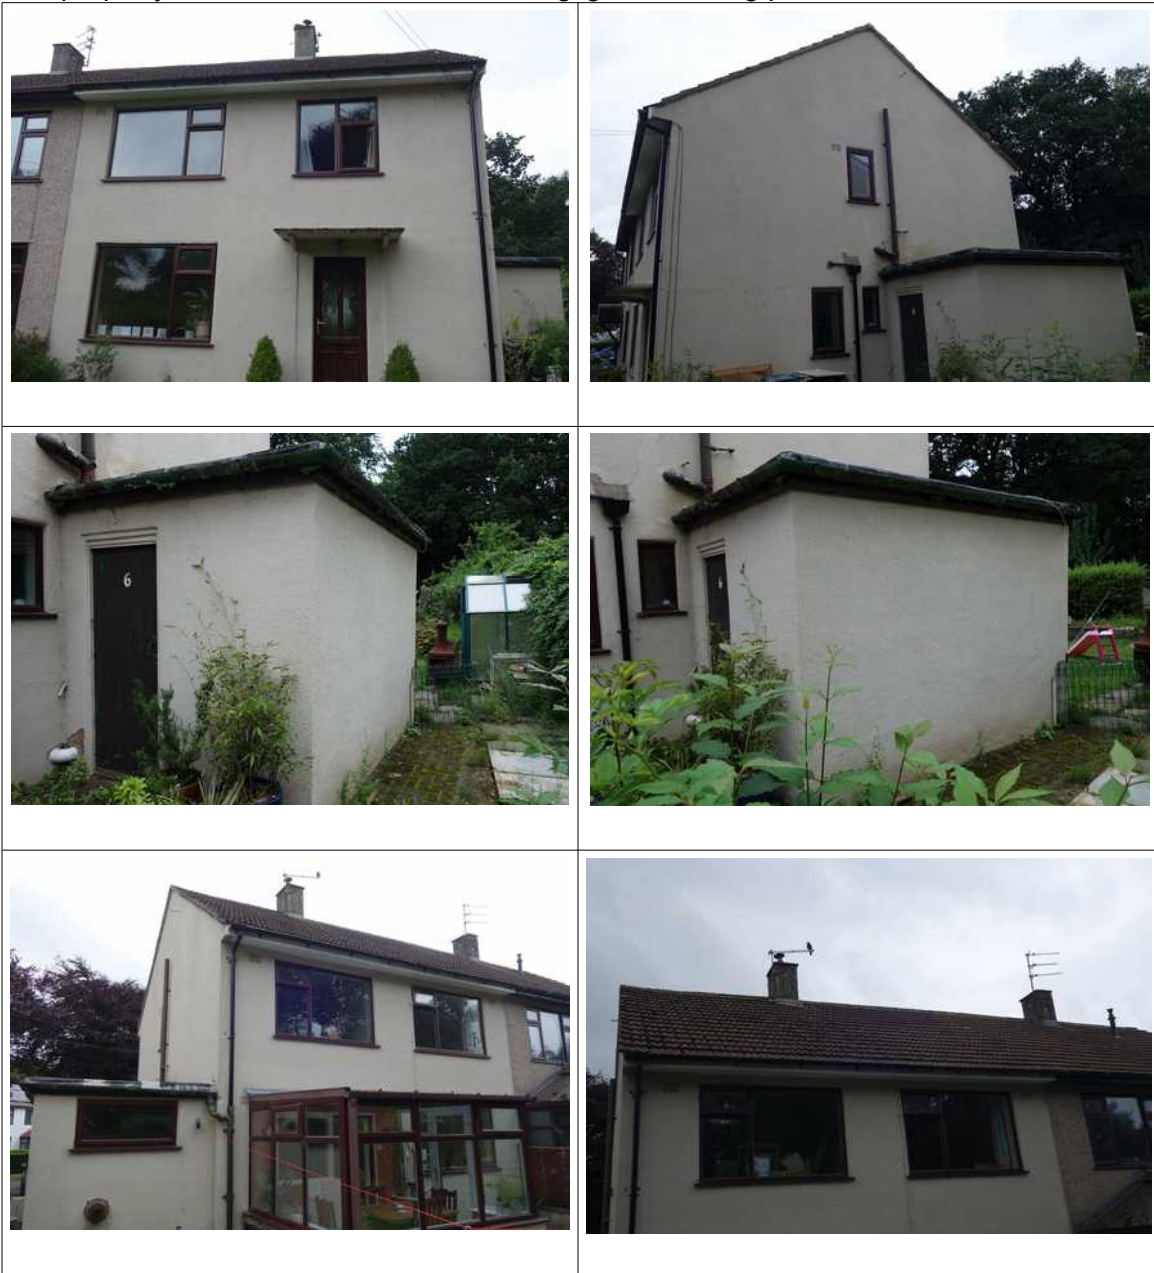
The property consists of a semi detached two storey house with a double pitched tile roof, a flat roofed single storey extension is present on the gable end.

External walls are generally well pointed and rendered with no obvious cracks, gaps or crevices present. The gable end and eaves are well sealed. Upvc soffits and fascia boarding are close fitting.

Roof tiles are generally close fitting with no slipped, missing or lifted tiles present. Ridge tiles are pointed and sealed.

The property can be considered to offer negligible roosting potential.
