**BAT SURVEY AT -
WOODTOP FARM
THORNLEY
PR3 2TS**

Demolition of dilapidated barn prior to construction of new farm workers house.

Dilapidated detached barn located near the associated working farm.

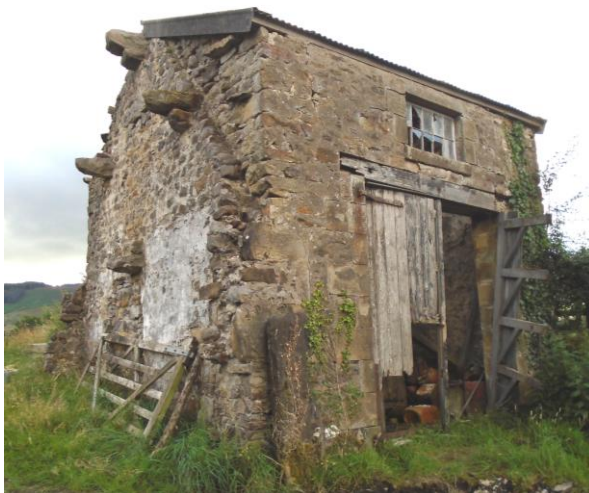
Front North west and side north east elevation

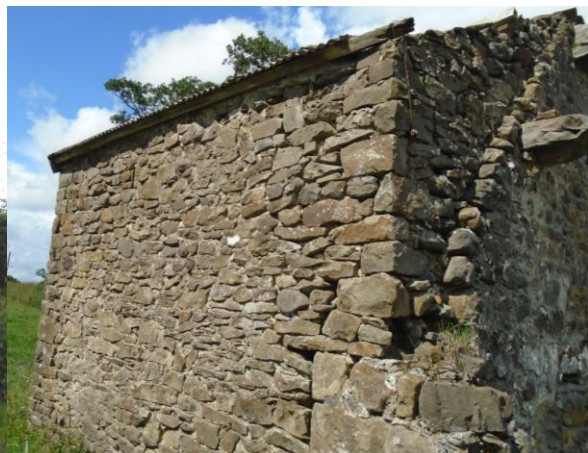
Rear South east elevation

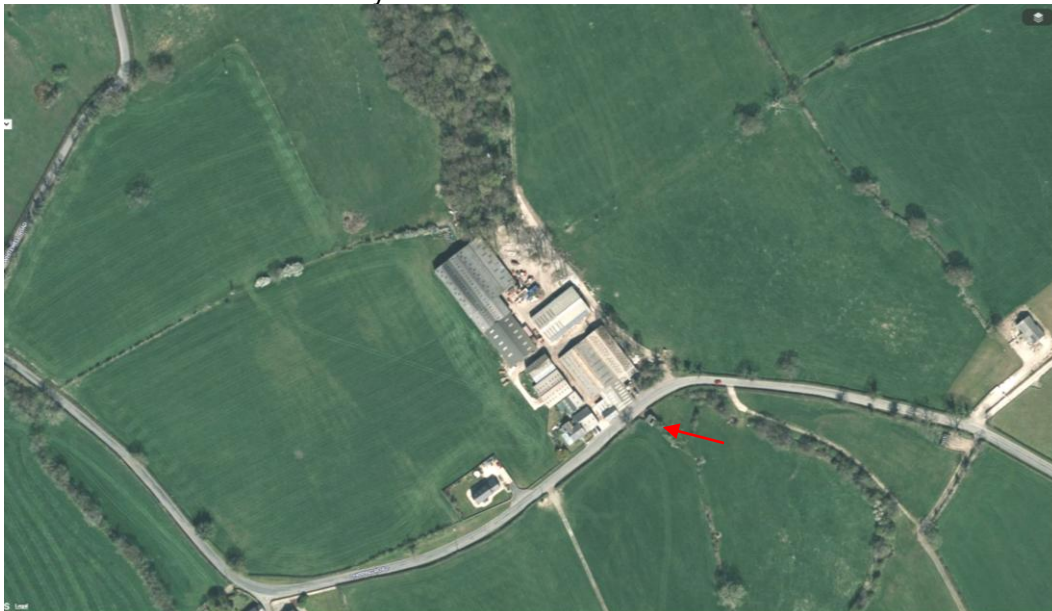
The building is surrounded by large acreage pastureland bound by hedgerow it is located in the corner of a field adjacent to the road directly opposite the farmstead.

The location provides an optimal level of forage potential for bats. A significant area of trees 'Woodtop woods' extends from the rear of the farm buildings in a northerly direction connecting to the River Hodder and further wooded areas. The greater locality has extensive tree lines and wooded areas with excellent connectivity.

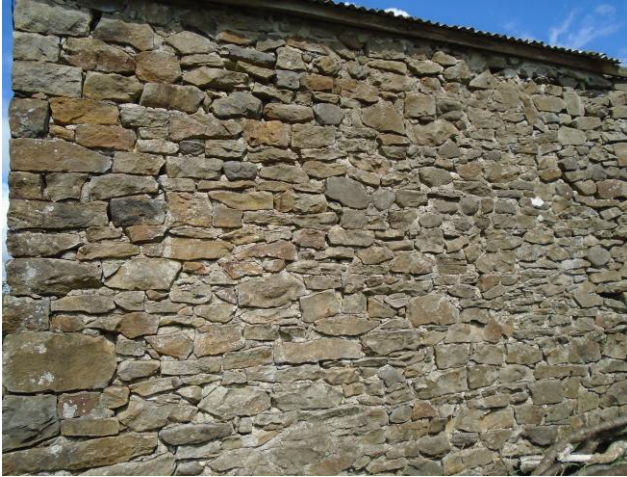
WALL CONSTRUCTION

The walls are natural random stone.

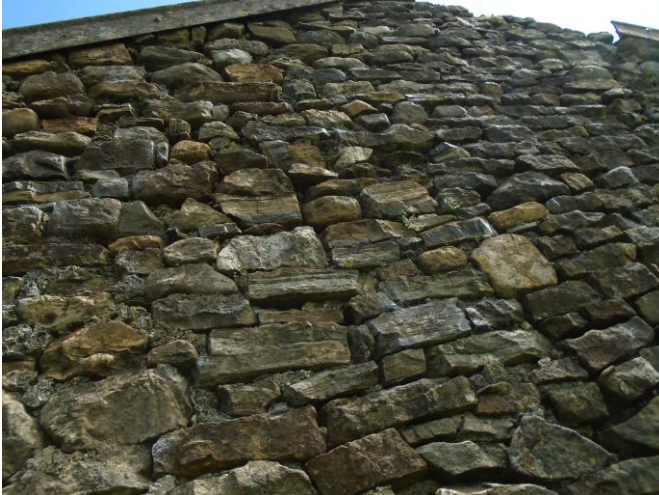
BAT ACCESS POINTS IN WALLS

There are numerous cracks and crevices in the walls mainly externally and the dilapidated condition of the building with broken windows and doors allowed the interior to be freely accessible to bats.

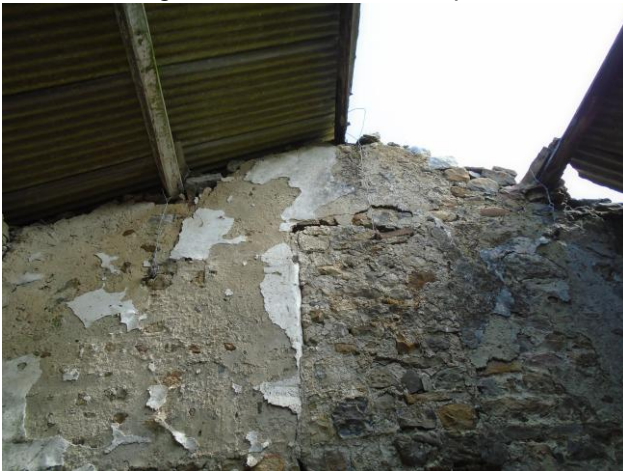
ROOF CONSTRUCTION

The remaining roof structure is timber purlins with corrugated fibre cement sheet fixed over.

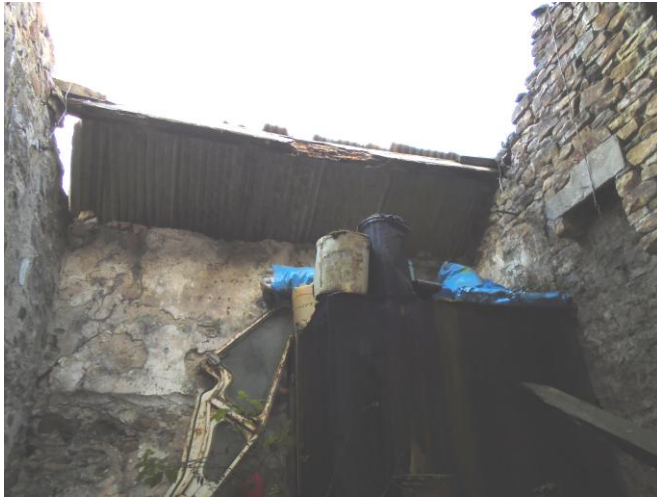
BAT ACCESS POINTS IN ROOF

A large section of roof sheet is missing on the rear pitch. Allowing free access to the interior of the building. The timbers have no cracks or crevices however some rot was noted, this said the timbers or roof sheets did not provide any potential roost habitat.

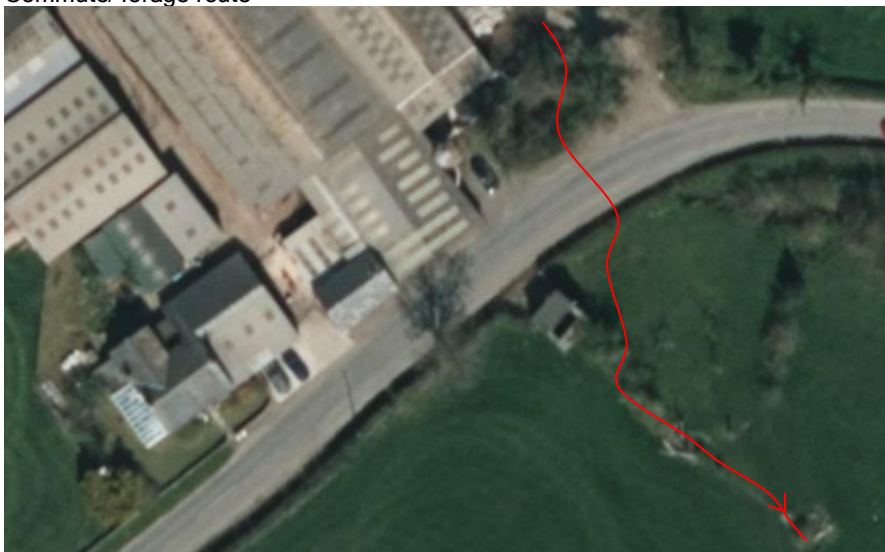
Commute/ forage route

The evening emergence survey commenced at 9.30pm during good weather conditions for bat forage activity. 2 no personnel monitored the building. Commute activity was picked up at around 10.00 pm as single Pipistrelle bats periodically emerged from the trees to the east adjacent to the farm buildings the flight path crossed the road to follow the hedgerow in a south easterly direction. during the course of the survey 4 no were observed commuting in this direction. There was no emergence from the barn nor did any bats enter the building to forage. The survey continued until it was too dark to see 11.00pm.

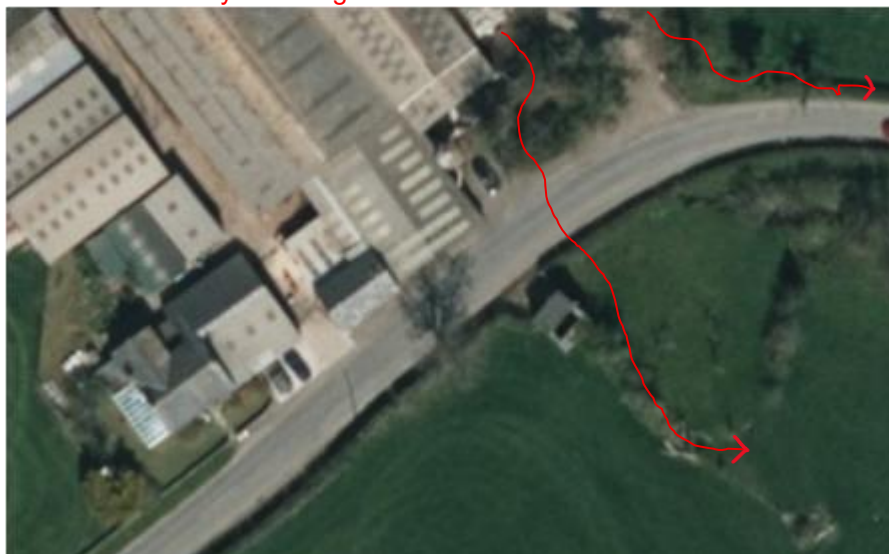
Evening emergence survey update. commenced at 9.30pm during reasonable weather conditions for bat forage activity. 2 no personnel monitored the building. 10.20pm activity was picked up (no sightings) from the trees / farm buildings adjacent to the farmhouse opposite. 10.40pm activity was seen of 2no pipistrelles crossing the road to follow the tree line. Further forage activity was recorded of 3no pipistrelles in the trees to the east of the farm.
There was no entry or emergence from the barn recorded.
