Holmes Farm, Balderstone

**BAT SURVEY &
GENERAL ECOLOGY REPORT**

July 2025

Report Ref: 233_01

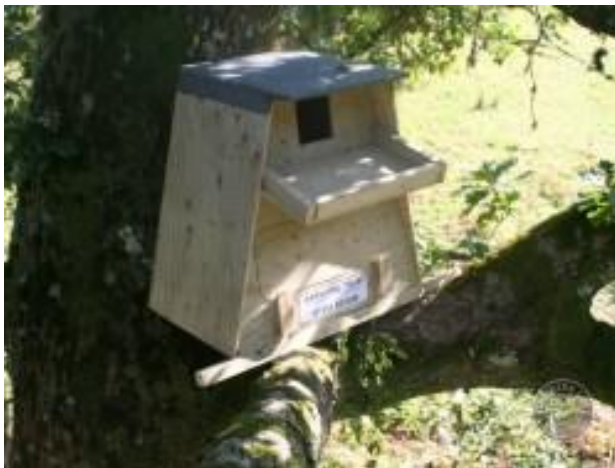
Figure 5.1. Example of barn owl (tree) box design

specific guidance. Figure 5.1 shows a box installed on a tree. Box specifications and an installation guide can be found via <https://www.barnowltrust.org.uk/barn-owl-nestbox/owl-boxes-for-trees/>.

- A mature tree with a thick trunk.
- Isolated, in a hedgerow or on the woodland edge.
- With a high canopy.
- With few or no low branches.
- Where a nest box can be placed at least 3 metres above ground level.
- Where the nest box access hole would be visible to a passing owl, even when the tree is in full leaf and seen from a distance.
- Quite close to strips or patches of rough grassland.

It is recommended to install a barn owl nest box on one of the mature trees located within the wider landholding. Barn owl boxes can be bought ready-made (<https://www.nhbs.com>) or can be built using

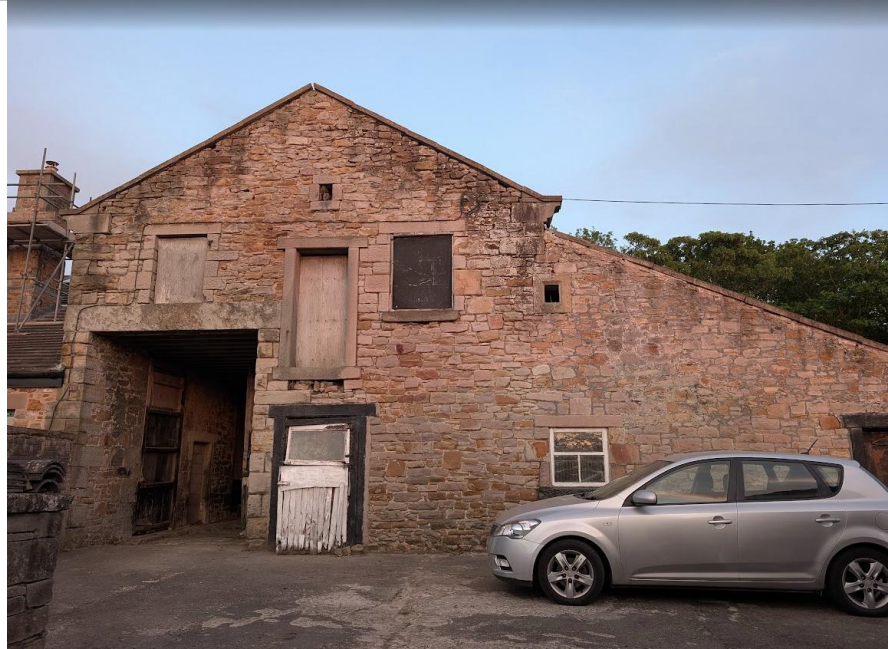
Photo 1.
North-east
elevation of barn

The barn is a stone-built structure which is attached to a converted private residence on the north-east side. The barn has two intersecting roofs and a lower mono-pitched roof which slopes down to a single storey level on the south-west aspect. The main barn area has a large entrance (with timber doors) on the north-west aspect along with upper floor window and door apertures on the second floor. These apertures were boarded.

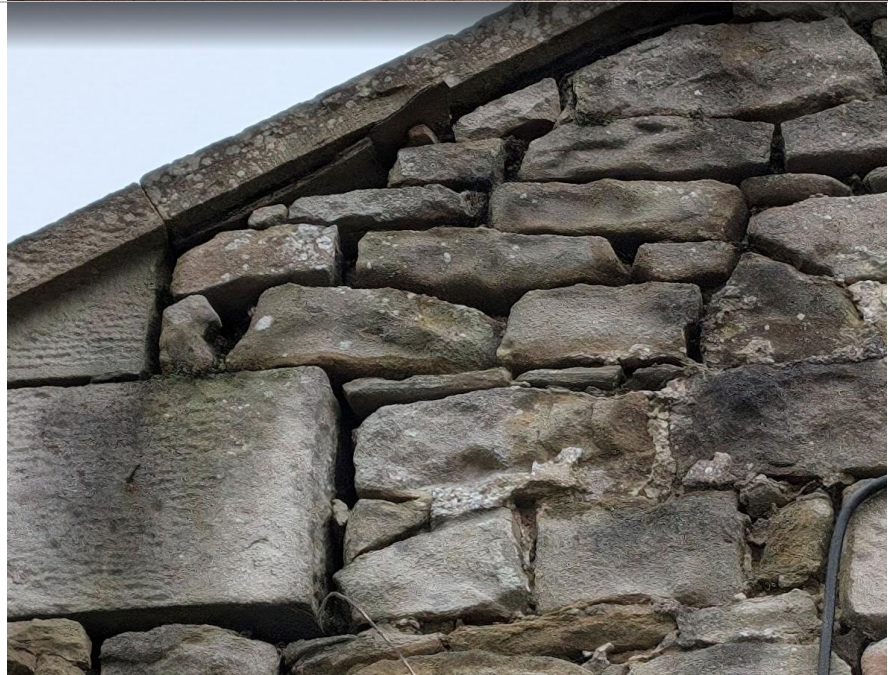
tiles. The large majority of the external stonework of the barn was in good condition. There were however several areas in the mid to upper stonework on the north-west side in which, pointing mortar had decayed or was missing. It is estimated that there were 6-8 sufficiently recessed gaps for bats in the stonework. In addition, there were gaps under the verge coping stones on the north corner of this aspect of the barn.

Photos 2a & 2b
Examples of gaps in
stonework of barn
on corner of north-
east elevation and
along main wall.

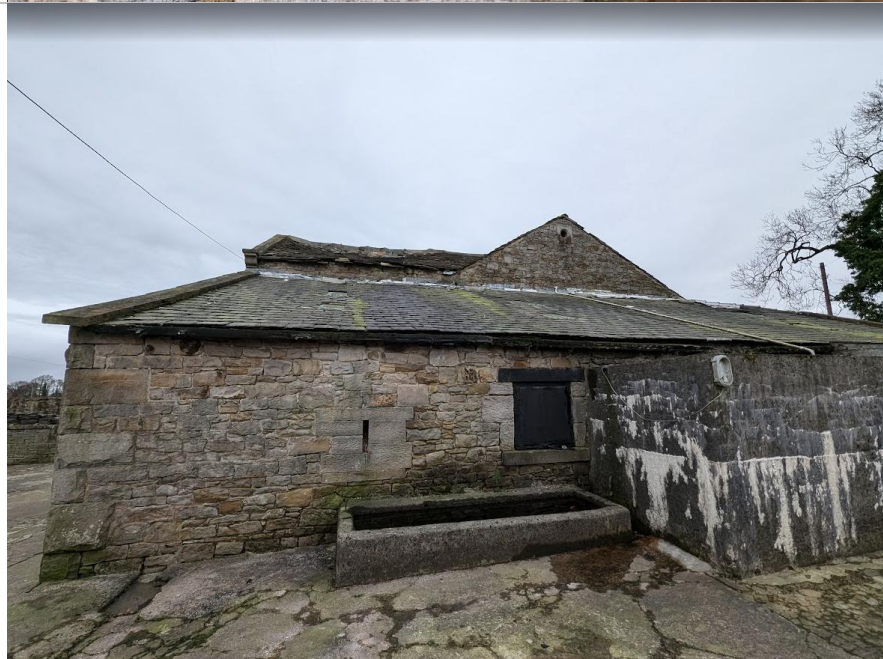
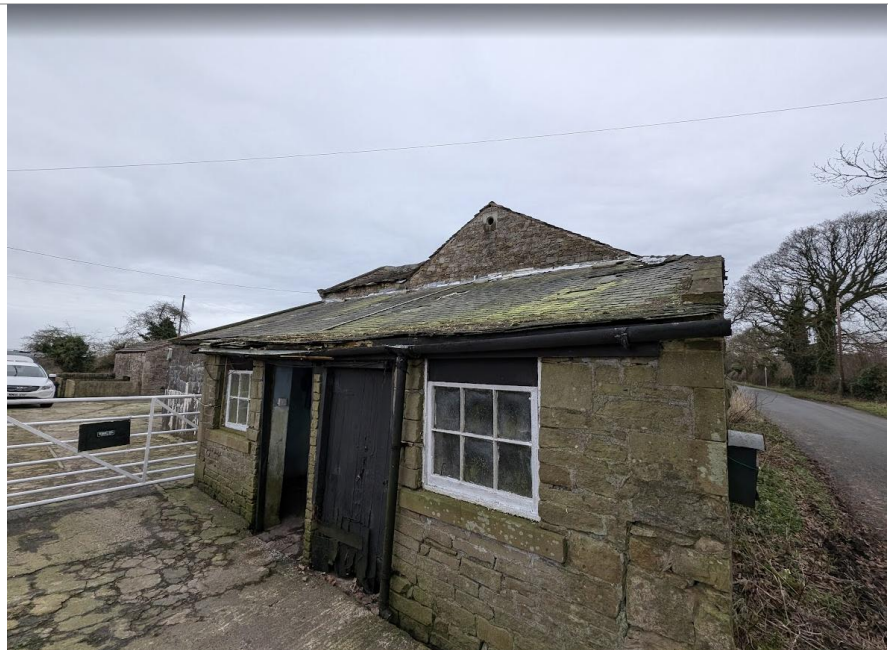
Photos 3a & 3b.

The attached stables and utility rooms were of limited height and no potential roost features were observed in these sections.

Attached stable and utility rooms on south-west aspect.

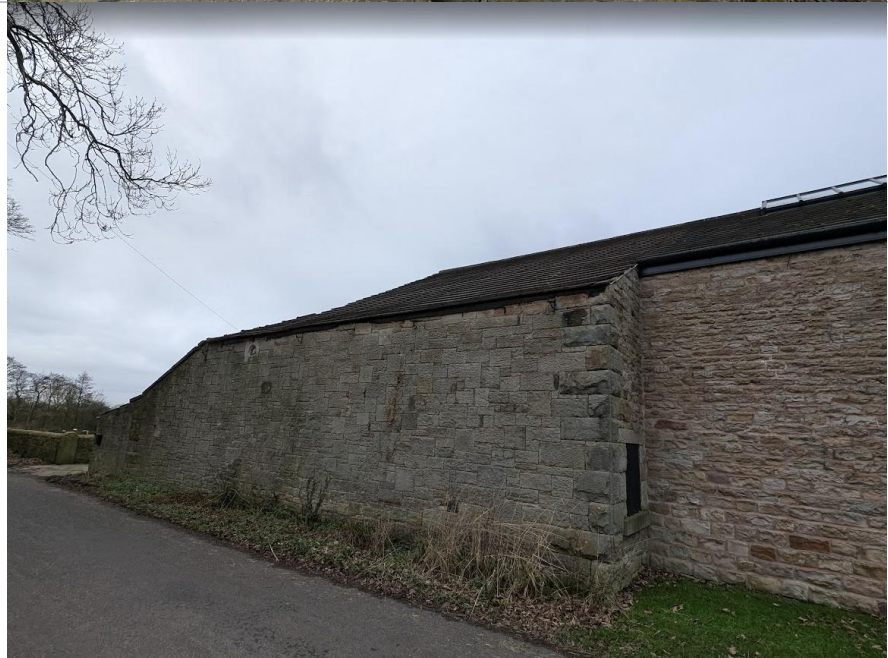
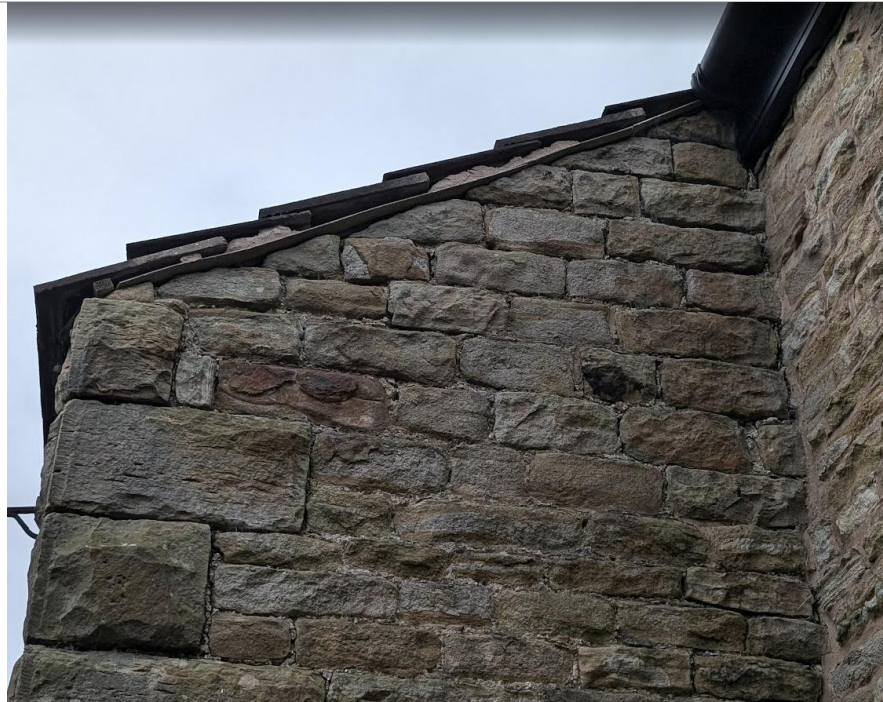
On the south-east aspect, potential bat roost features were limited to gaps under the roof tiles on the corner verge.

Photos 4a & 4b
South-east aspect
with gaps under
roof verge tiles.

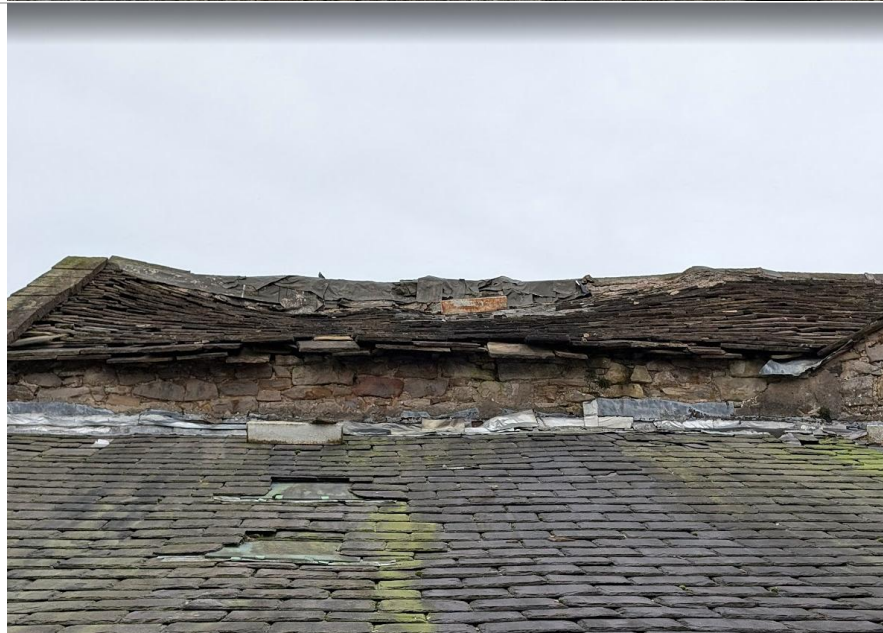
On the south-east aspect of the roof of the barn (facing Higher Commons Lane) were more modern concrete roof tiles. On the intersecting roof were traditional stone slates. The roof appeared to be in very poor condition and was sagging. Props had been placed on the inside to stabilise the roof from collapsing. The mono-pitched roof over the attached stable block and utility rooms comprised slate

Photo 5.
Collapsing barn
roof

- The licensed ecologist will supervise the soft destruction of the bat roost via the careful hand stripping of the roof slates. If the bat is present during the supervision, it will be captured by the ecologist who will assess the condition of the bat before transferring to the bat box.

The barn roof removal, piggery demolition and other initial ancillary work affecting the buildings should be undertaken outside of the nesting bird season (March to August inclusive). If it is necessary to conduct work within this period, it should be preceded by a nesting bird check conducted by a suitably qualified ecologist. Active nests found at any time must remain unaffected until the nest is no longer in use (i.e., all chicks have fledged).

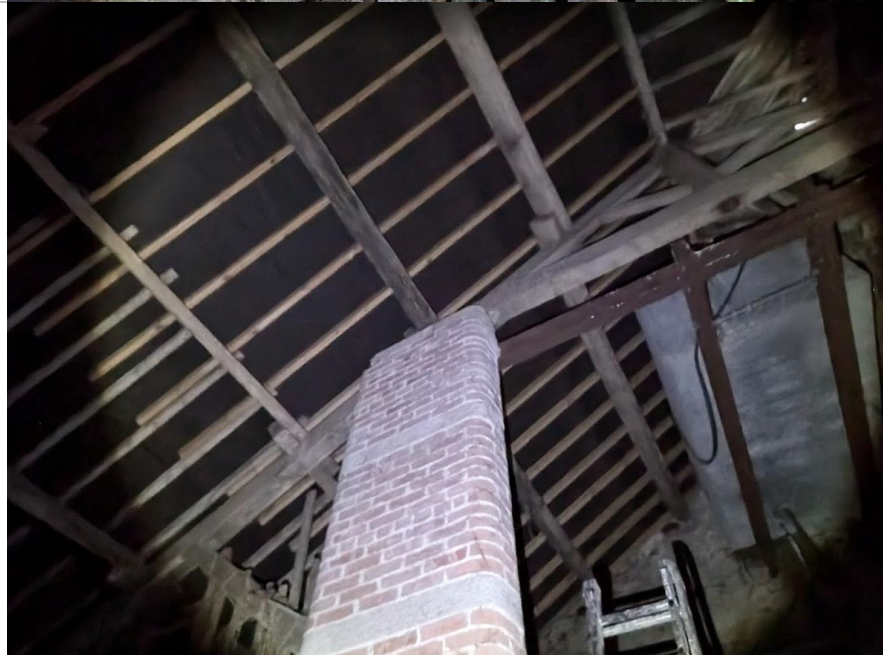
Photo 6.
Centre column of
barn.

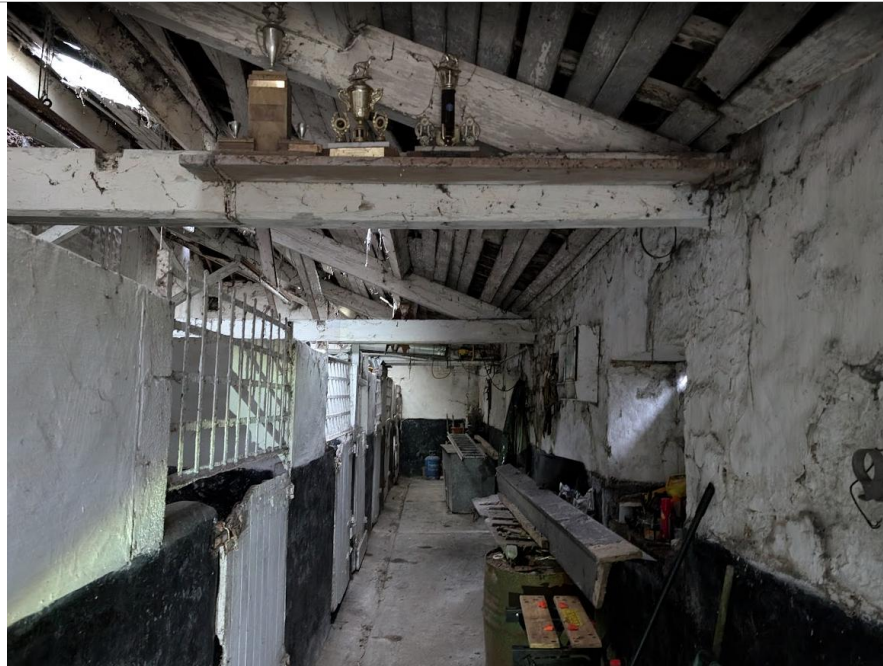
Photo 7.
Inside of stable.

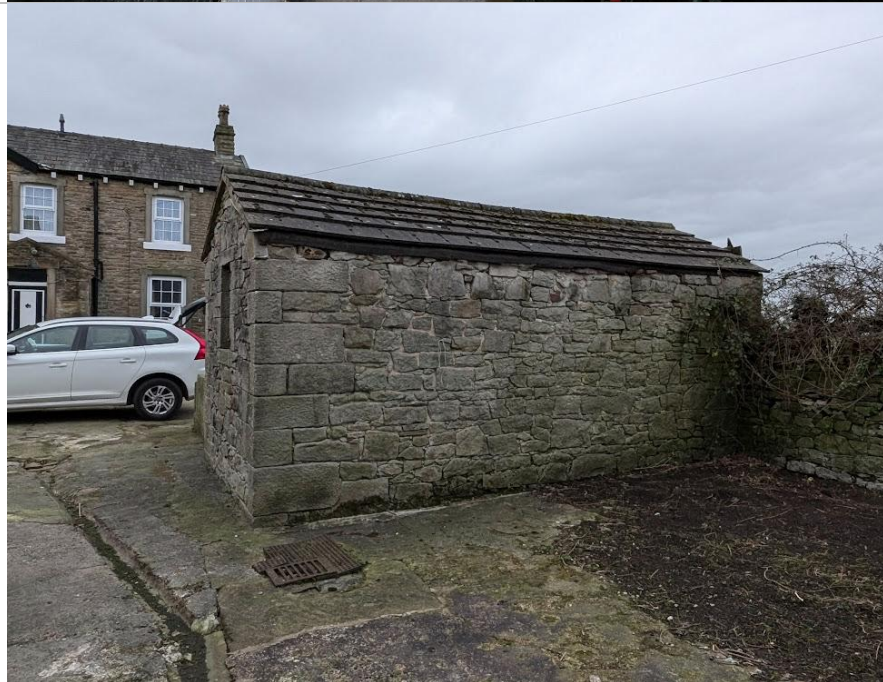
The piggery was a small, single storey, stone-built structure located to the north-west of the barn. It had a shallow pitched, concrete tiled roof and a bitumen-based underlining. The stonework appeared to be in good repair both inside and out. Whilst, the pointing mortar was degraded, no sufficiently recessed cavities for bats were observed. There were gaps under the roof verge; however, no suitable cavities were observed.

Photo 8.
Piggery.

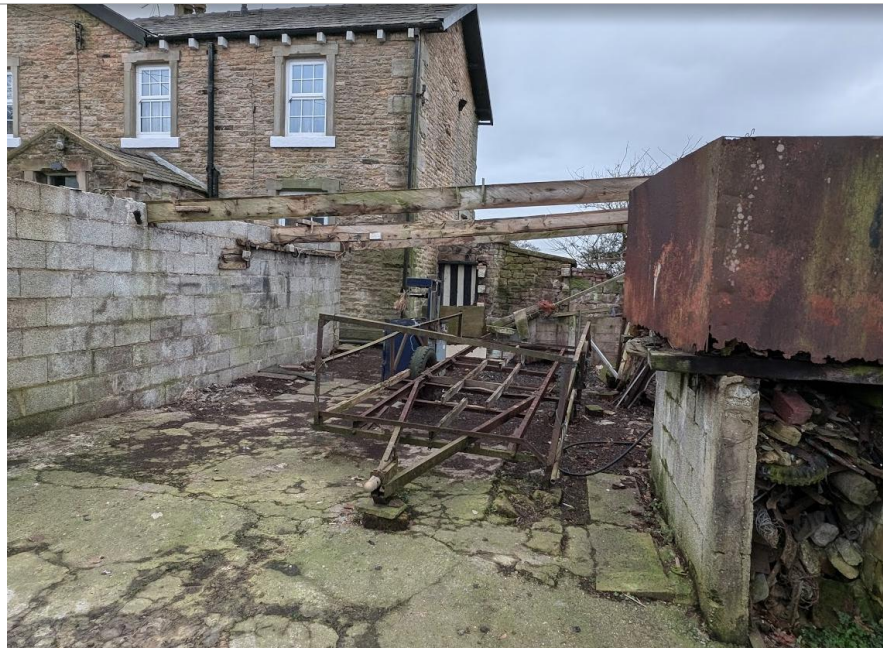
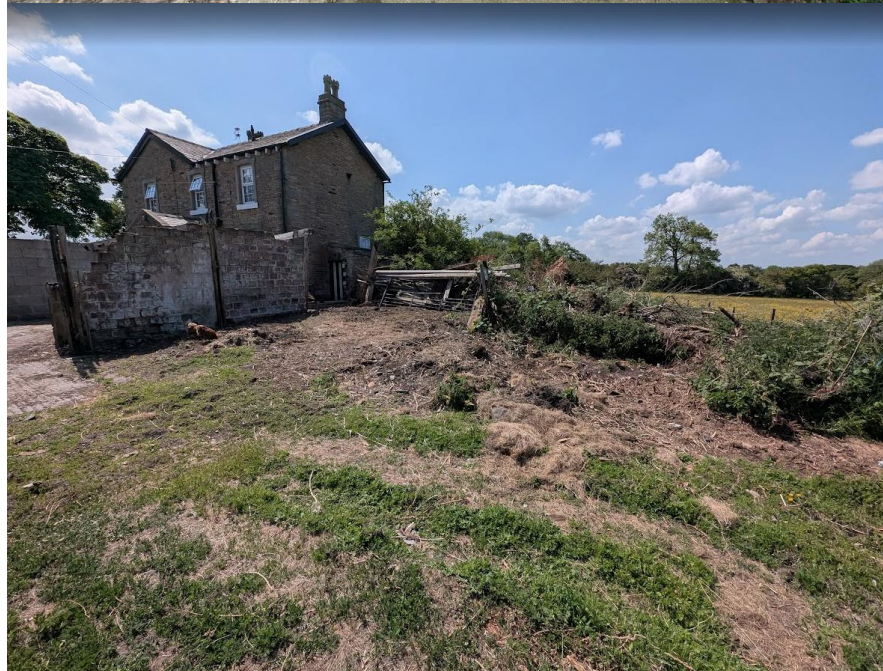
There is a small, stone-built lean-to on the north-west aspect of the farmhouse which is proposed to be cleared. No potential roost features were observed on this structure. All other built structures within the site had collapsed and were in the process of being cleared at the time of the assessment.

Photos 9a & 9b
Areas of former
outbuildings (stone
lean-to in
background).

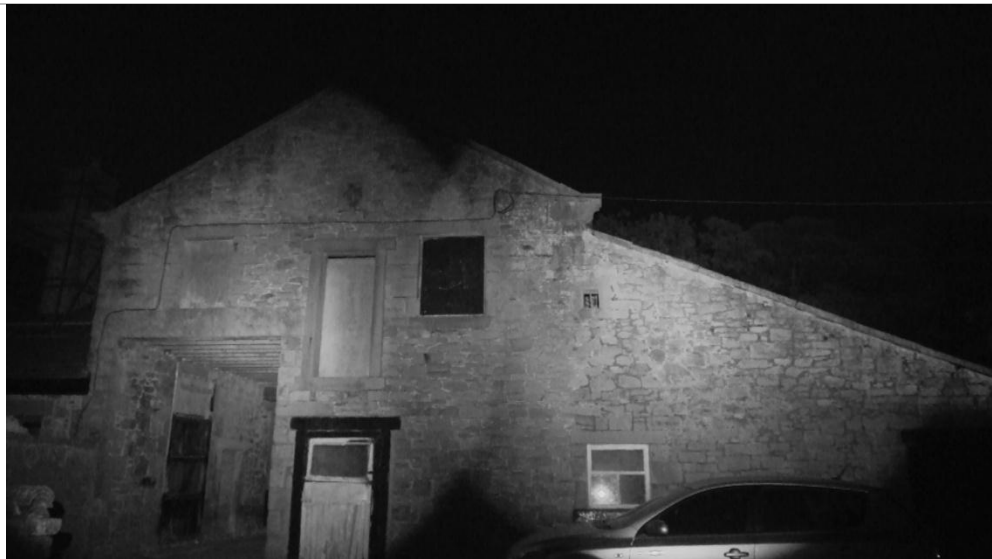
**Screenshot
1.**
North-west
elevation.

The survey position on the north-west side recorded common pipistrelle frequently entering and exiting the barn through the main entrance between 21:45 to 22:15. No clear indication of a roost site within the barn was observed although due to the frequency of activity, such evidence was difficult to obtain.
