Heritage statement
to support planning application for barn conversion at
Holmes Farm, Balderstone

May 2025

STEPHEN HAIGH

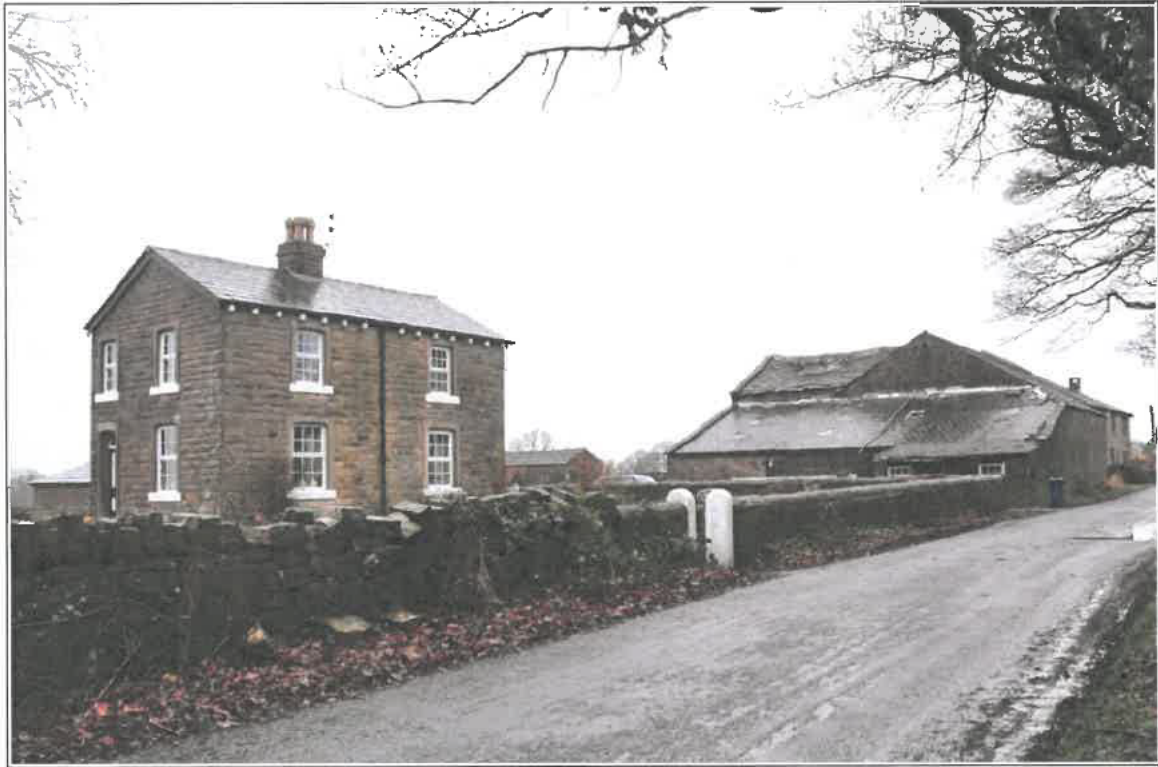
Photo 1: Farmhouse and barn, seen from the south, along Higher Commons Lane

- 3.1 Holmes Farm stands on the north-west side of Higher Commons Lane in Balderstone civil parish (NGR: SD 64166 31642). Buildings at the property include a detached farmhouse, a detached pigsty (shown as "store" on site plan), and a barn which adjoins Holmes Cottage (previously known as Holmes Farm Cottage) to the north-east. The barn was formerly a longer structure, part of which was converted to additional domestic accommodation for the cottage, circa 1997, under planning approval 3/1997/0700. The barn runs alongside Higher Commons Lane and there is a gateway at its south-west end, which leads into a concrete farmyard (see photo 1, below).

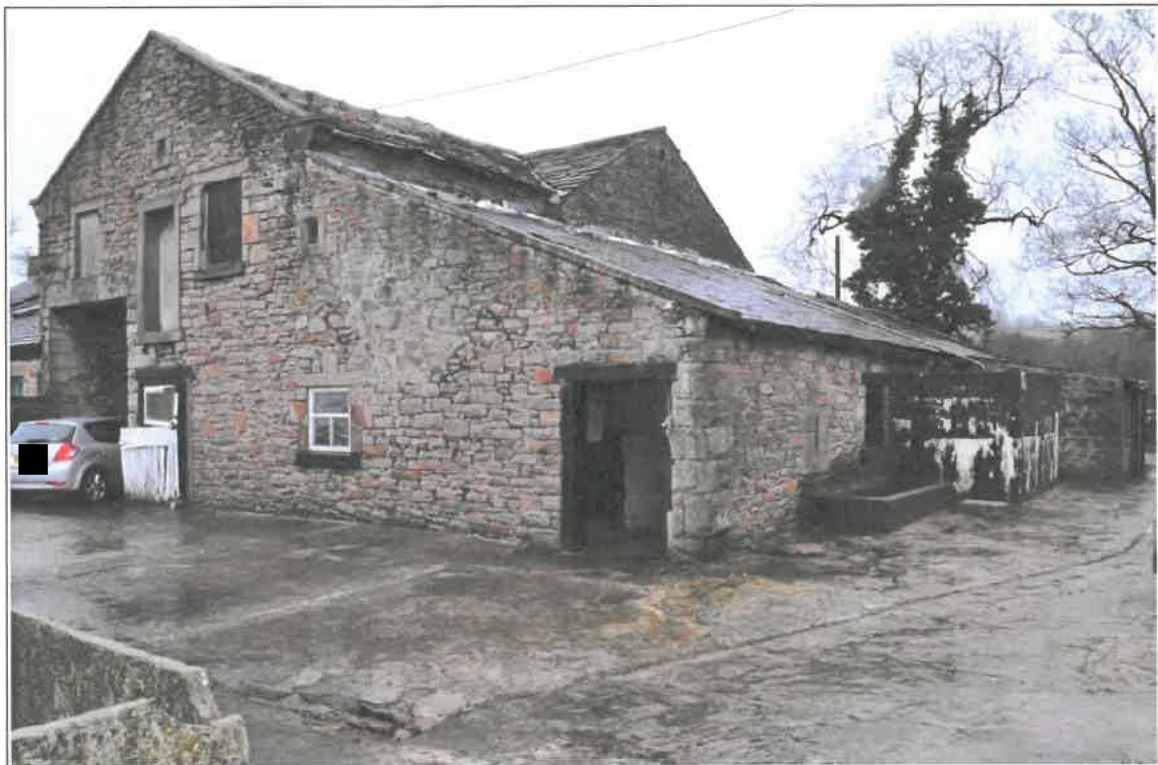
Photo 2: Barn, from the west

- 3.6 The barn faces north-west onto the yard (photo 2), where its cart entrance is set within a two-storey, gabled wing (roofed with stone slate), which also contains the entrances to a stable and hayloft over (photo 3). There are shaped kneelers to the gable, and to the right, a substantial lean-to shippon adjoins, the stonework of which appears to continue seamlessly with that of the stable, implying it is an original part of the building.

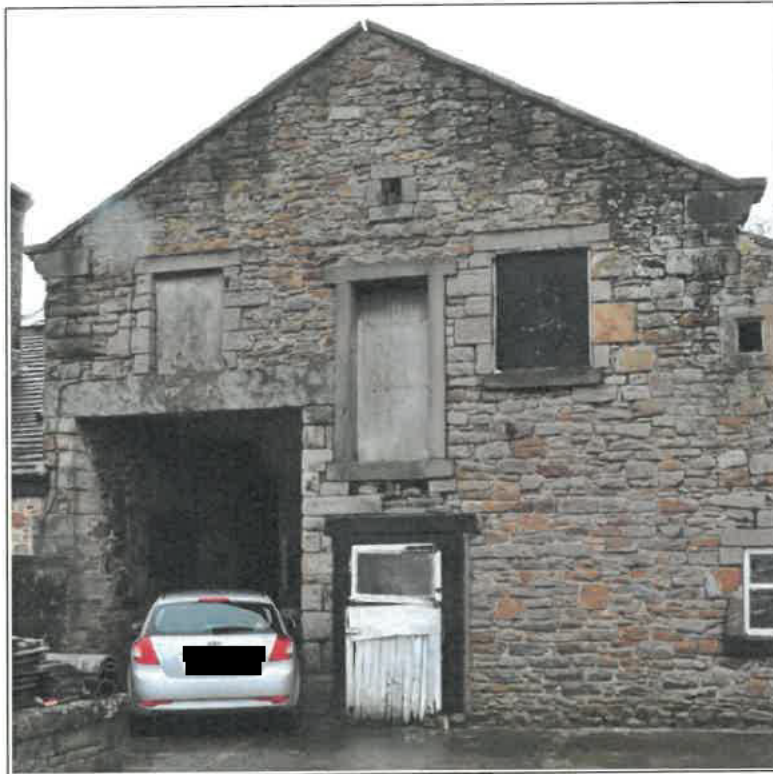
Photo 3: Gabled wing in north-west elevation of barn, containing cart entrance and doorways to stable and hayloft

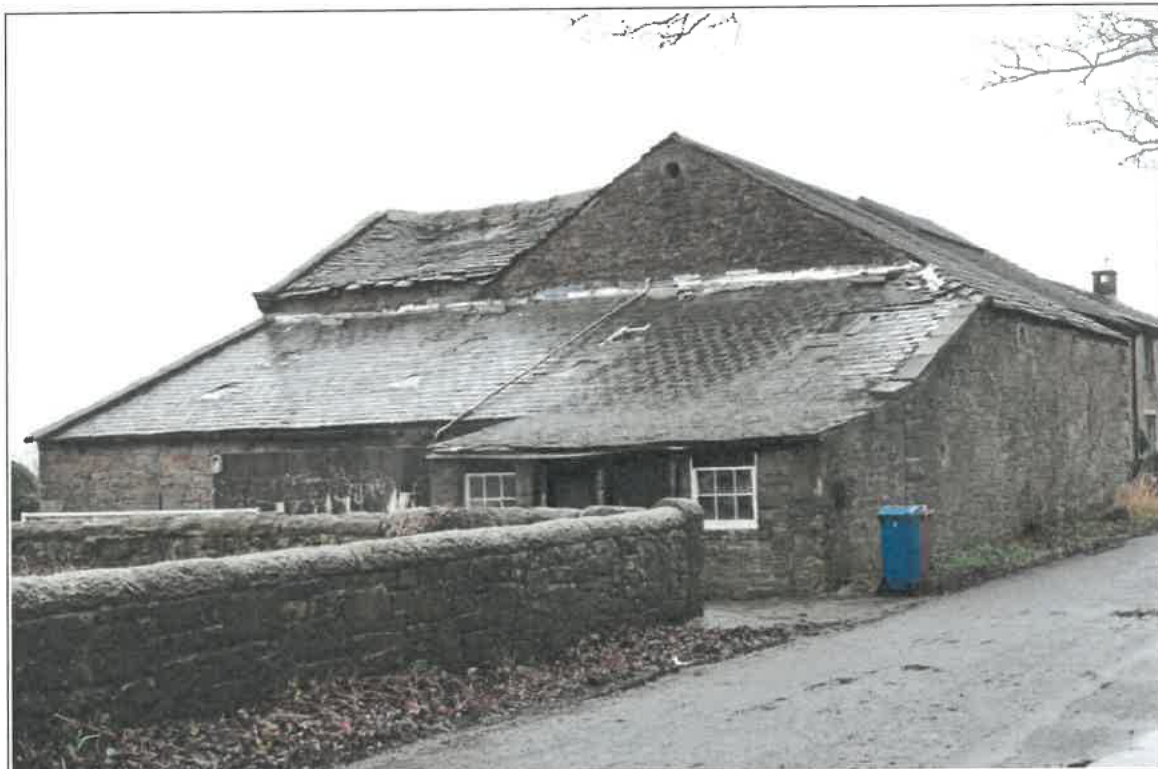
Photo 4: Barn, from the south. Lean-to shippon with later dairy on south-west end. Garden boundary wall in foreground.

- 3.7 The single-storey lean-to shippon was extended in the mid 20th century by a concrete water tank and another small lean-to, which contains two small rooms for use as a dairy. Both lean-tos have blue slate roofs (photo 4).

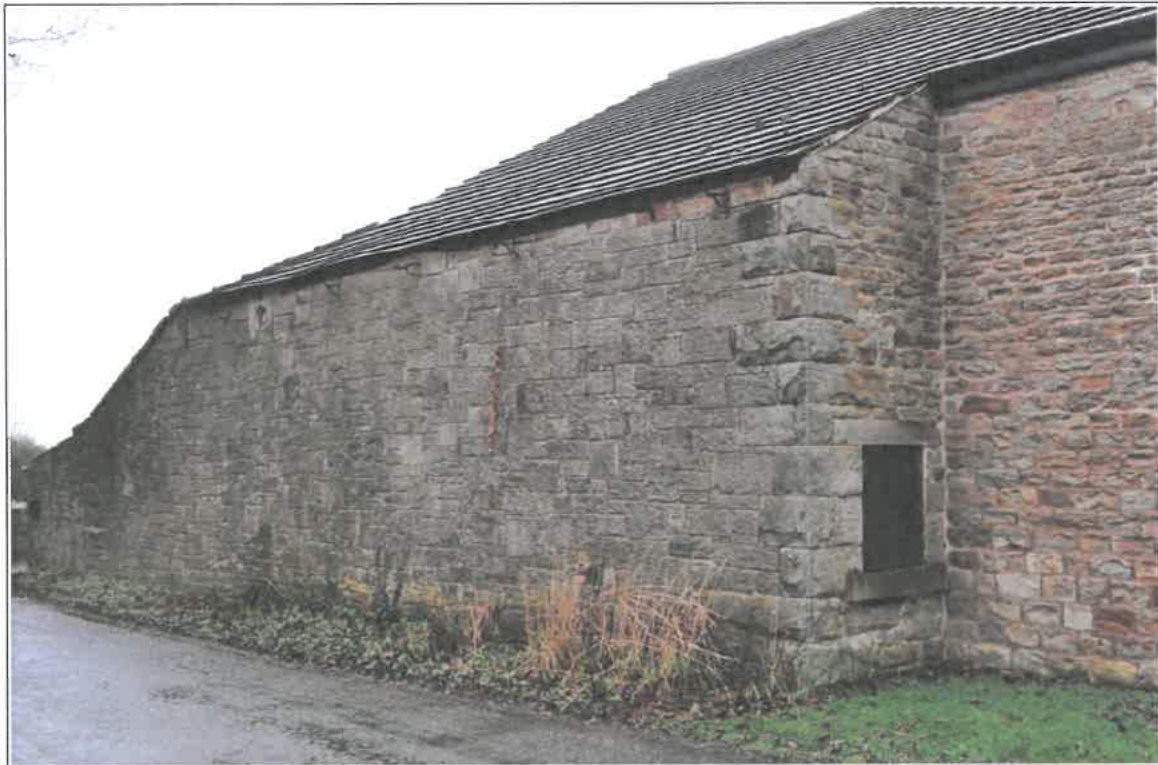
Photo 5: Roadside elevation of barn, in distinctly modern style of stonework

- 3.8 Along the roadside, the building's south-east elevation projects about 1.6m from that of the adjoining property, and the obvious contrast between the two types of stonework suggests this could be the result of extension or rebuilding. Modern concrete tiles cover the roof over this side of the barn (photos 5 & 6).

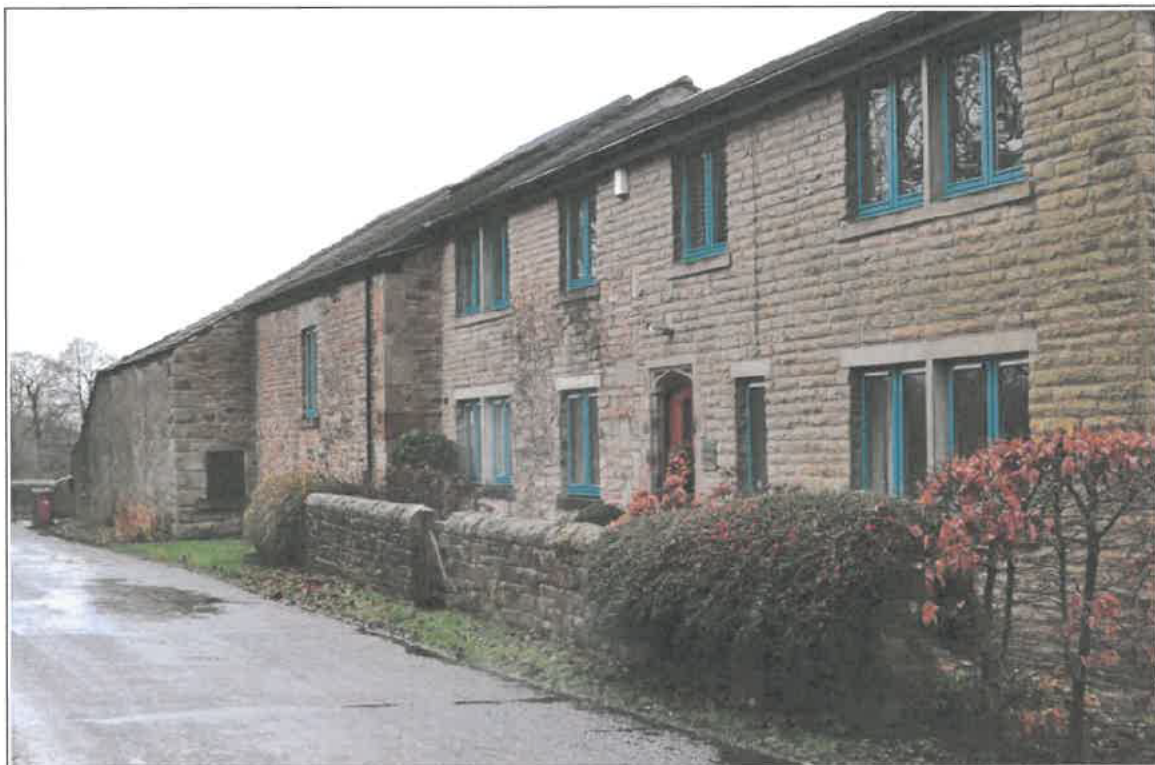
Photo 6: Holmes Cottage, incorporating previously converted part of barn

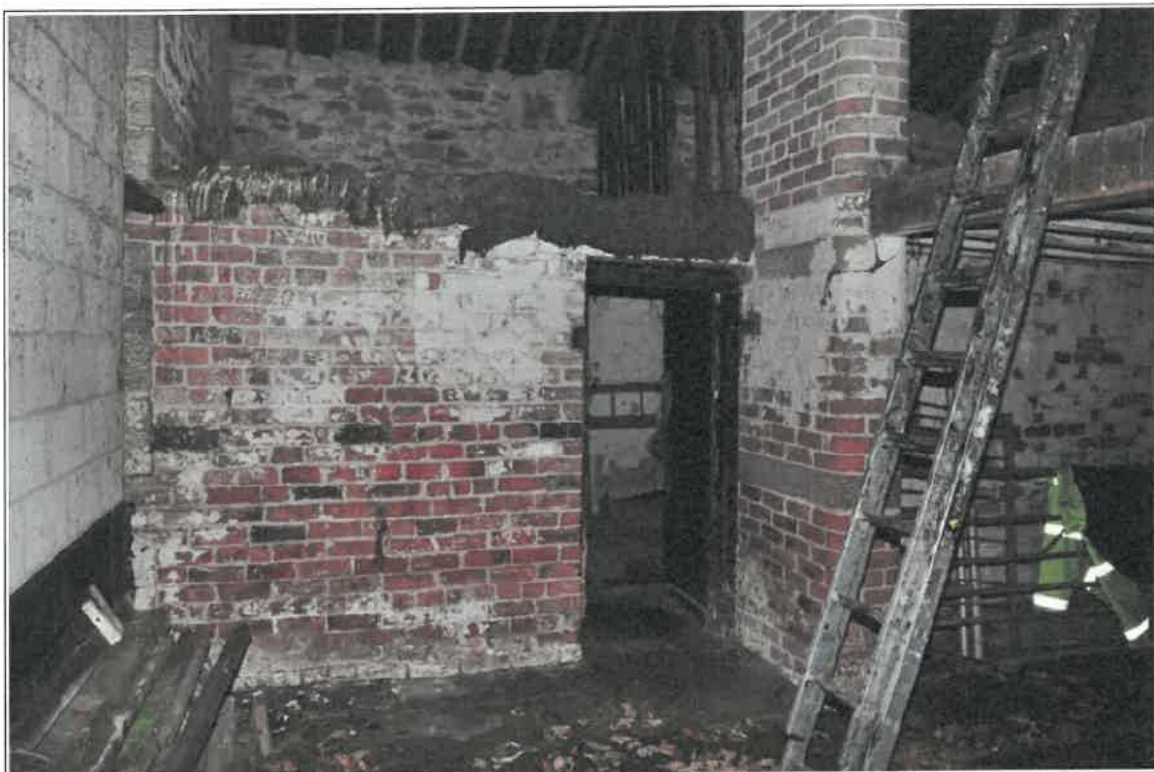
Photo 7: Barn interior, looking south-east from cart entrance

- 3.10 Notable features within the present barn include the manner in which the pair of doors within the cart entrance are accommodated within recesses when in the open position, and the use of brickwork for both internal walls and the pier which supports one part of the roof truss (photo 7). The hayloft within one bay of the two-storey structure (photo 8) and lack of a rear winnowing doorway both suggest that the barn was intended primarily to support dairy farming rather than a more mixed regime, although the two-stall stable (photo 9) would have housed workhorses. The long lean-to shippon along the south-east side (with modern stable divisions inserted in recent years) seems to have provided the only livestock housing, though more was probably accommodated within the previously converted north-east part of the building.

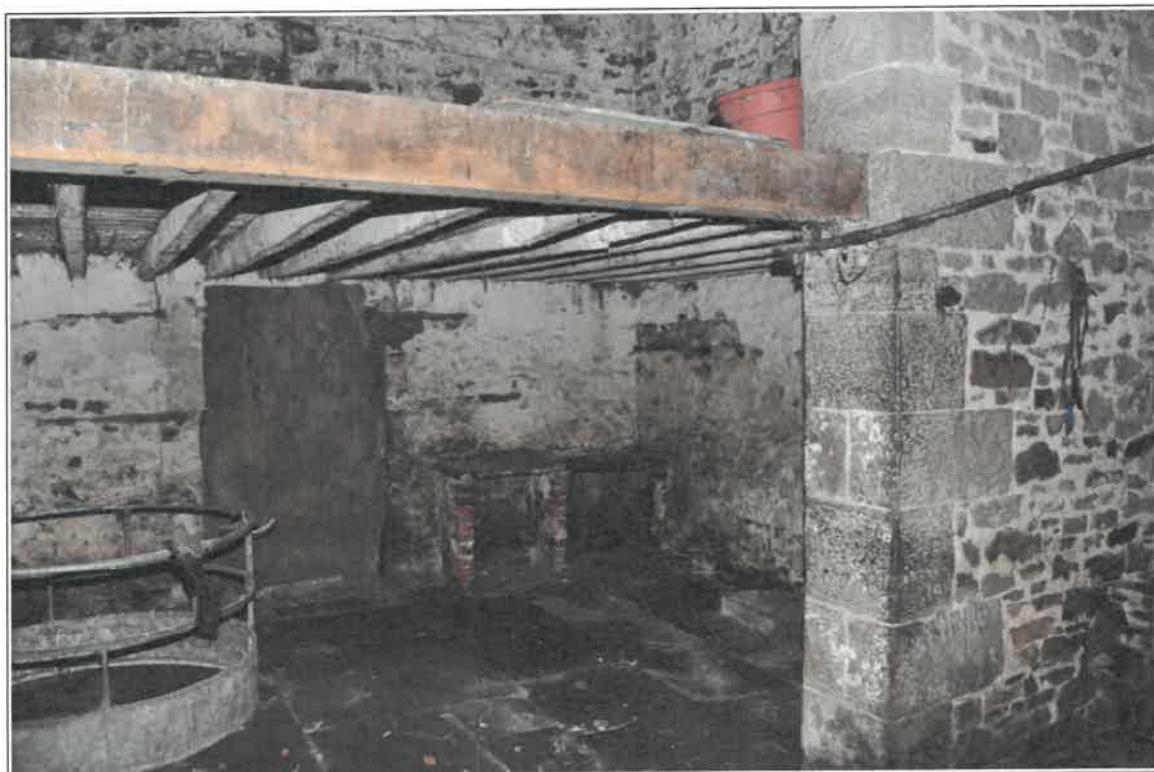
Photo 8: Barn interior: hayloft next to cart entrance

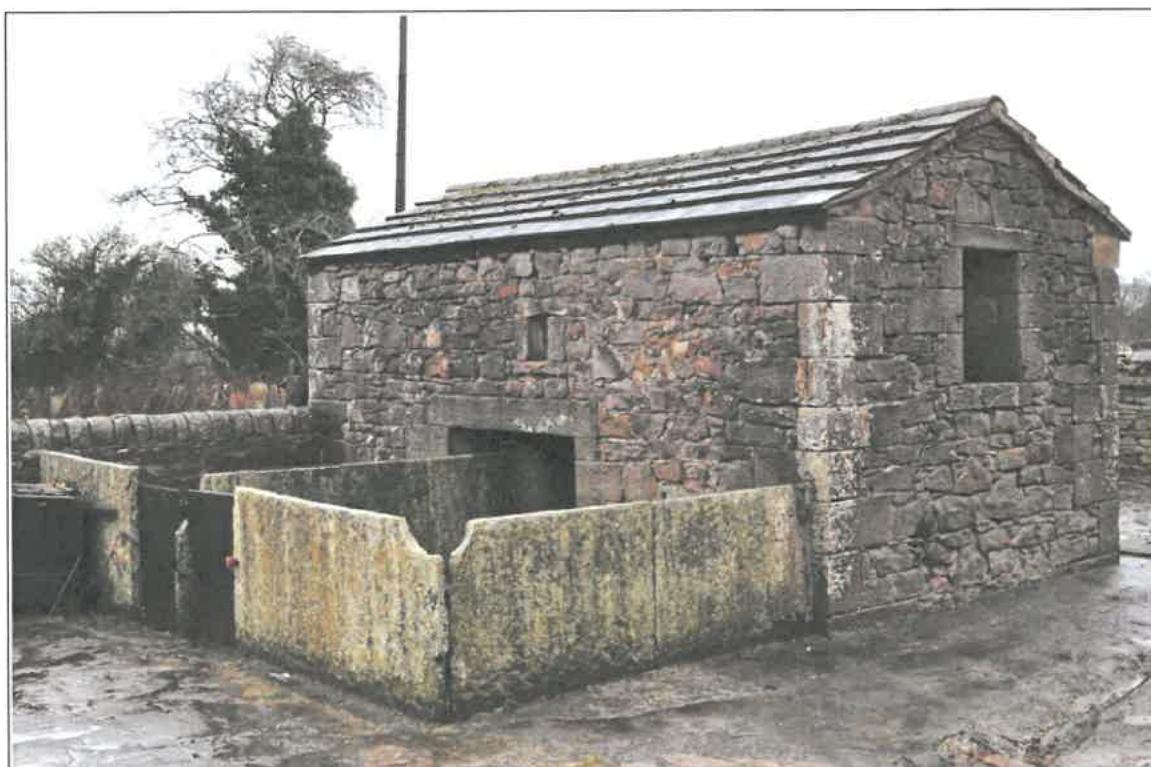
Photo 10: Pigsty, looking north

- 3.12 The double pigsty situated on the north-west side of the farmyard remains largely intact externally, albeit the roof has been replaced with concrete tiles (photo 10). It has a pair of pens on the south-west side enclosed by upright flagstones, and its low ground floor openings are characteristic for the building type, while a loft within the building very likely housed poultry. It is a good example of a mid to late 19th century pigsty, a building type closely associated with the dairy farming then thought to have been practised at Holmes Farm.
