Research and conservation of historic decorative schemes in the built environment

**Almshouse
Stydd, Ribchester
Render, mortar & paint analysis**

Client: Halsall Lloyd Partnership

Date: March 2023
LC Reference: 2023/13

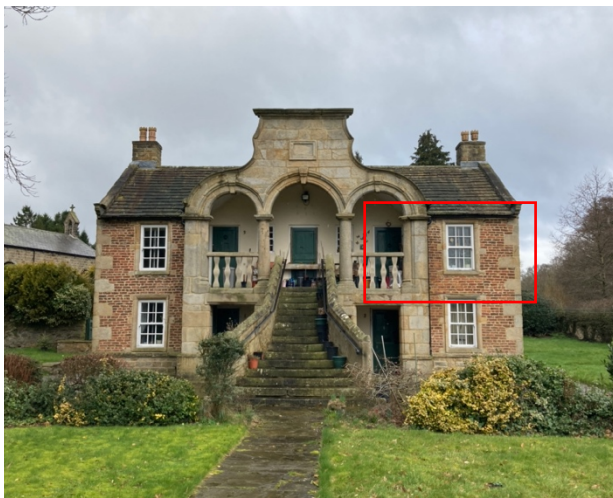
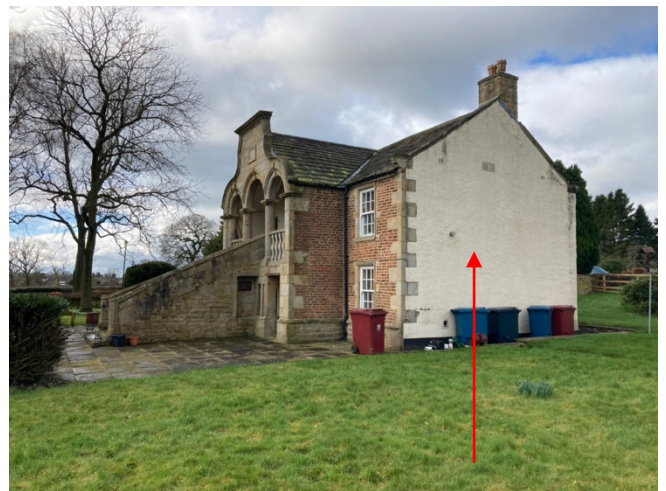
Figure 1: Images of the Almshouse

Flat 4 bounded in red

North east gable
