**BAT SURVEY, AT -
21 Woodside Road
Simonstone
Burnley**

DATE AND TIME OF VISIT
2nd April 2025 11.00am

REFERENCE NO. **7239**

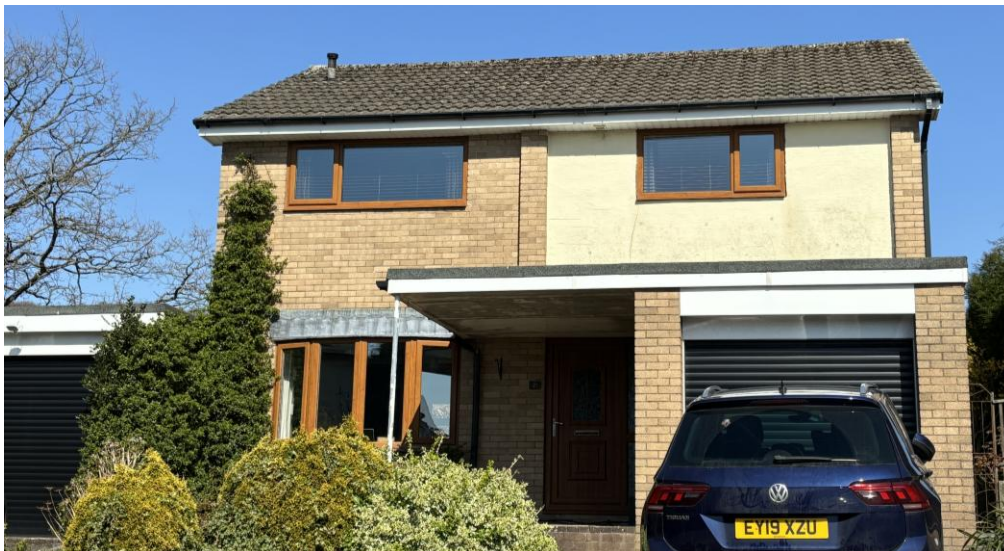
Front Elevation

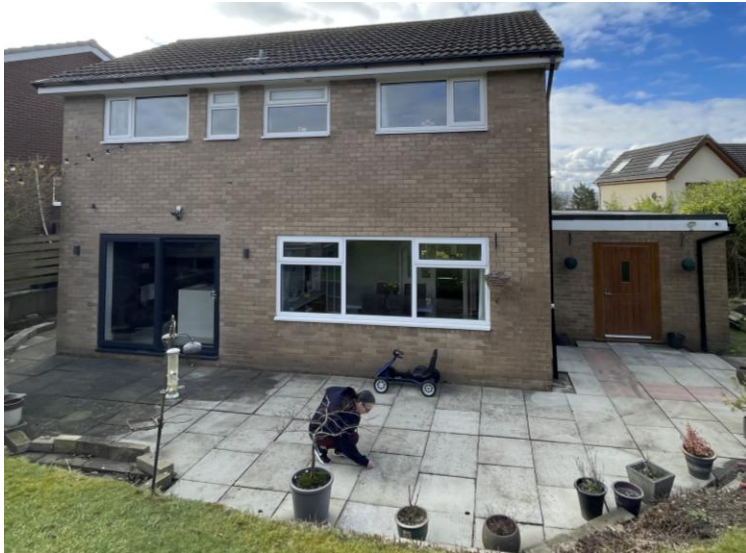
Rear Northeast Elevation of House and Garage

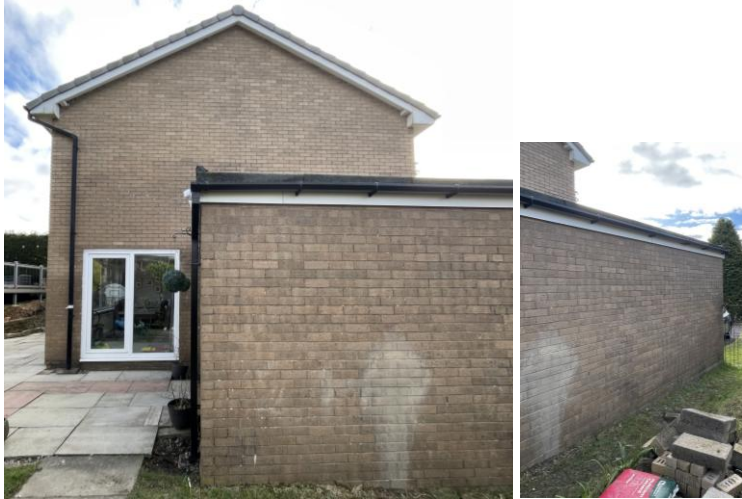
Side Northwest Elevation of house and garage

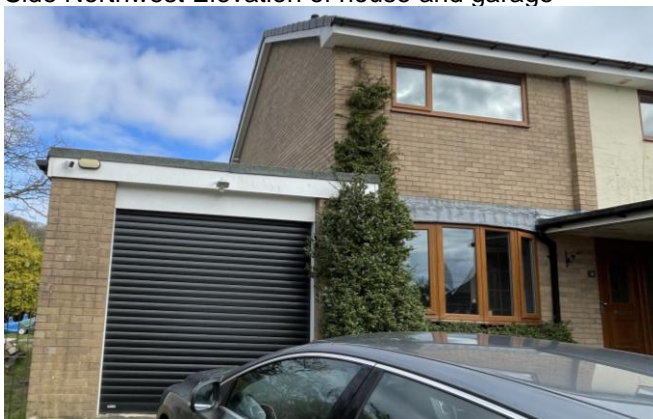
Front elevation of Garage and part house

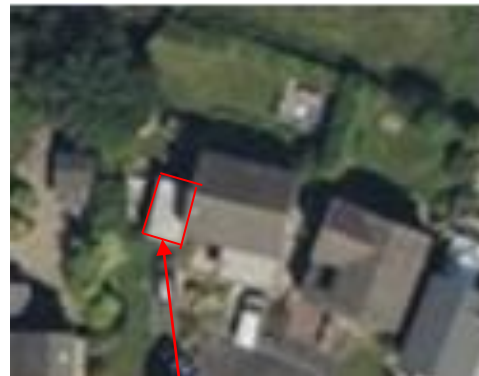
Garage to be removed

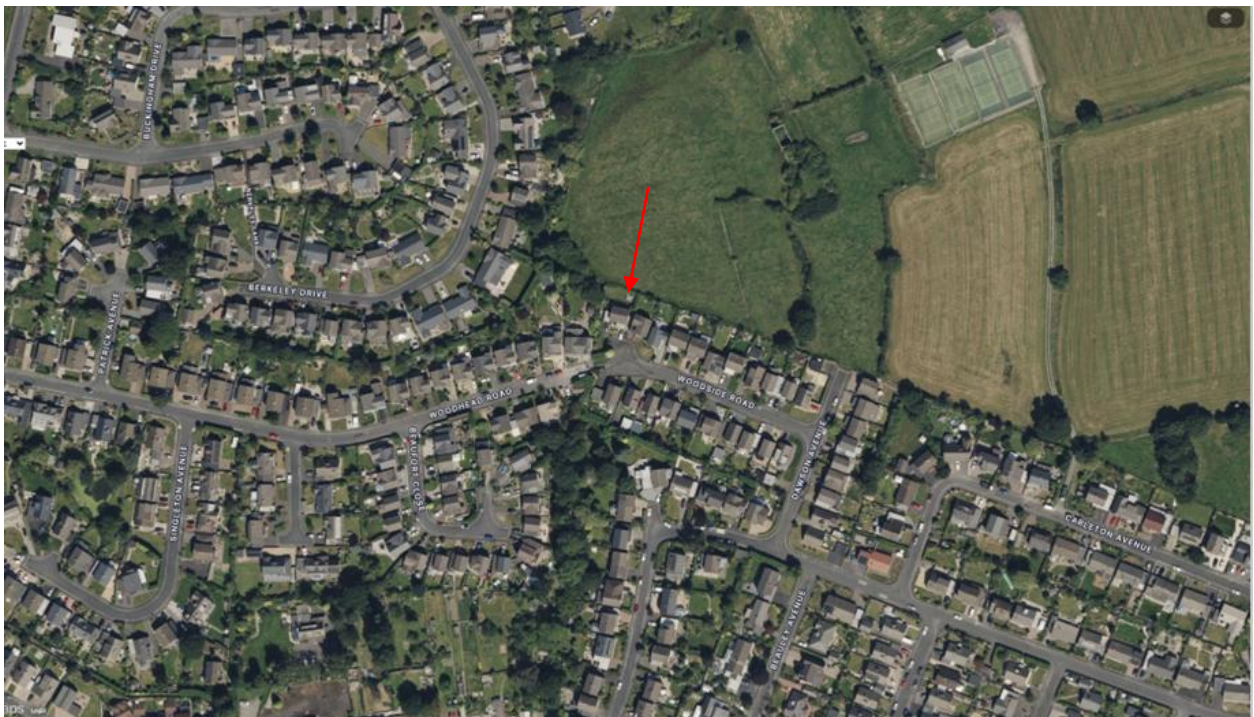
LOCATION **SD 771347** **130 m elevation**

The property is in an elevated position between Whalley Road 255m to the south and Trapp Lane 259m to the north, on the outskirts of the settlement area of Simonstone. It is located on the edge of an extensive residential area. The North boundary is adjacent to pastureland. All other boundaries are adjacent to further properties of a similar date and type.

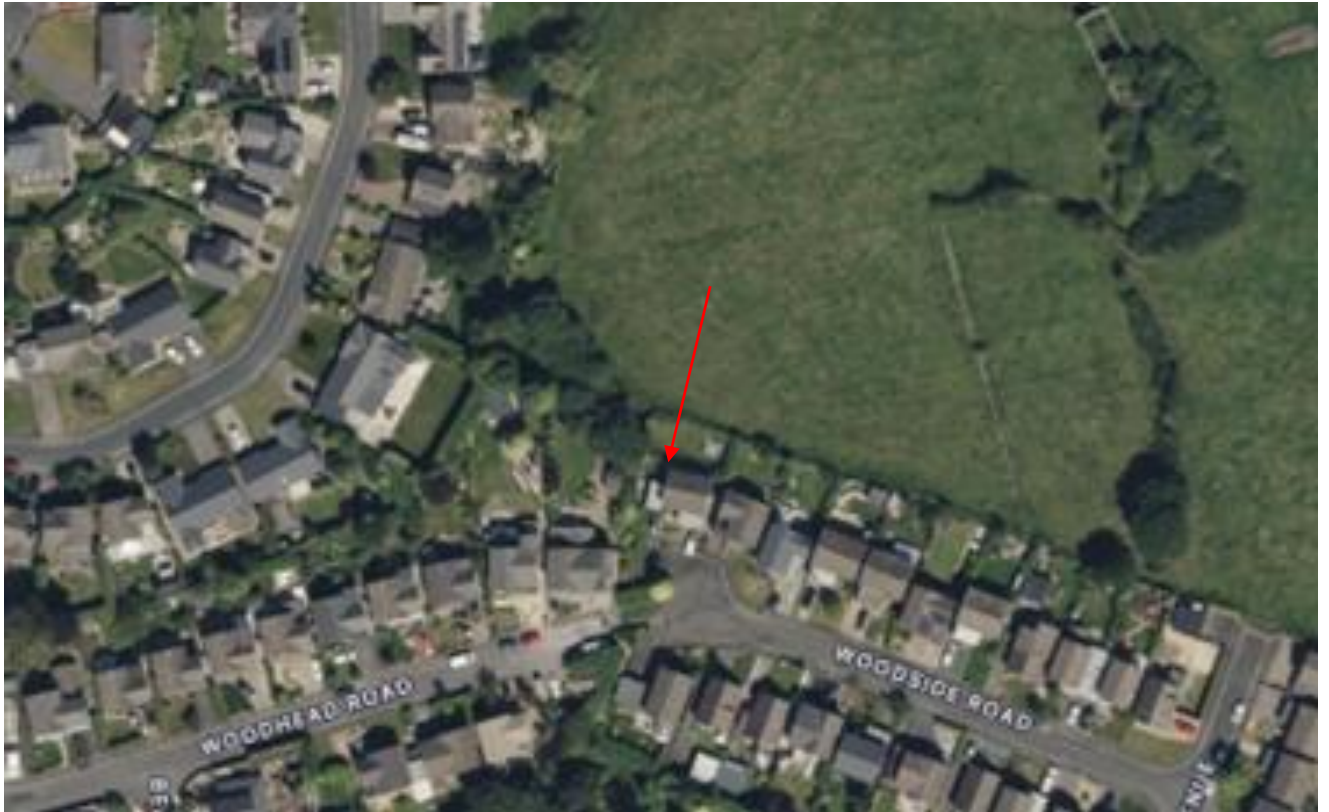
FORAGING POTENTIAL IN THE LOCATION

The house is in a garden laid to lawns to the front, rear and side. There is some domestic shrubbery along the west boundary the front (east) garden between the path/ drive, it provides low value foraging habitat. There are a couple of mature trees to the northwest on the boundary of the adjacent field. The nearest extensive mature woodland located approx 543m to the east of the house running from north to south lining Trapp Lane. The immediate locality generally does not provide high value foraging habitat.

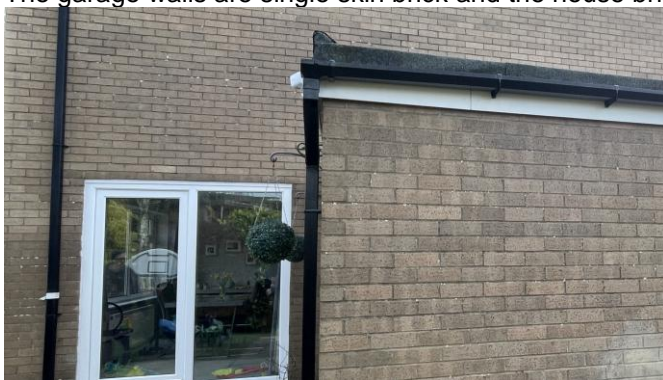
The garage walls are single skin brick and the house brick cavity construction.

All the walls are excellent condition no possible bat access points, cracks or crevices suitable for bat ingress.

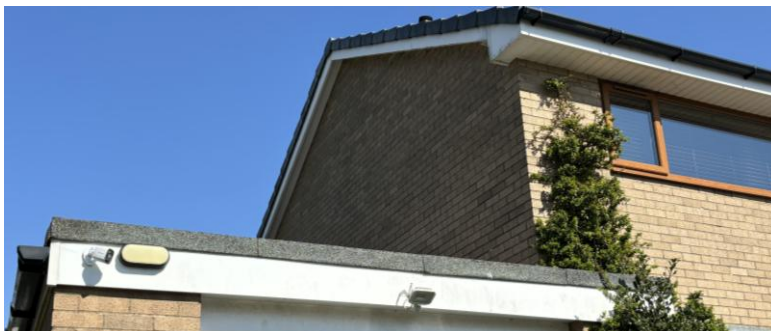
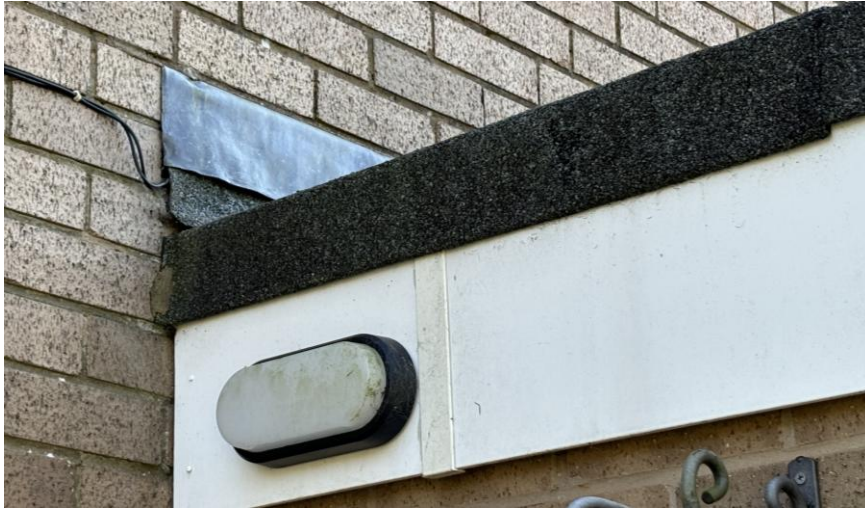
The garage roof is flat with a felt finish. Timber fascia's are flush fixed to the perimeter walls. Although the garage is detached (there is a 50mm gap between the buildings) the roof is flashed into the house wall.

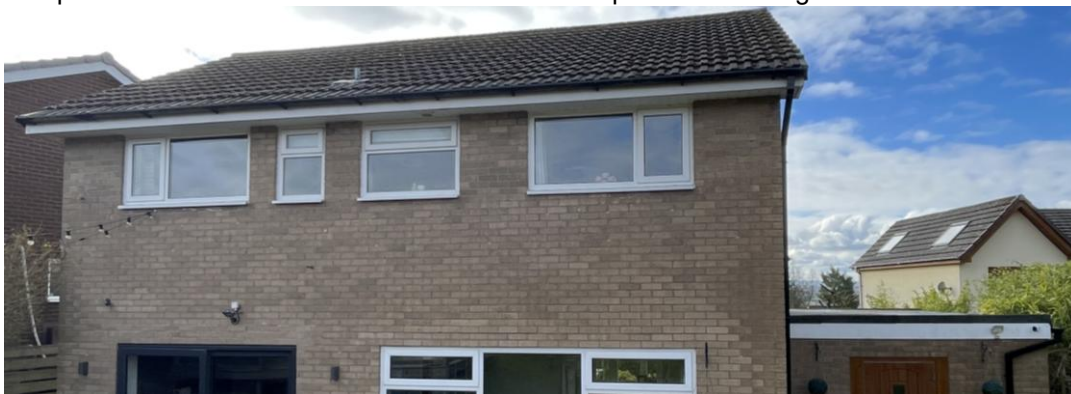
The pitched roof of the house has a tile finish with upvc fascia's barge boards and soffits.

The tiled roof is in perfect condition with no slipped or loose tiles. The soffits are very good condition and tight fitting as illustrated.

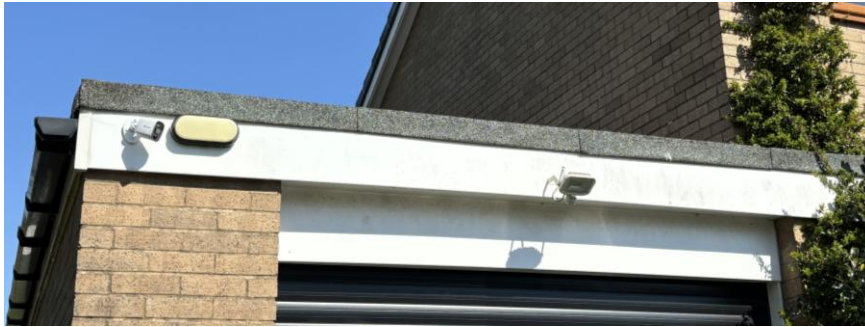
The detached Garage roof is in good condition with no tears or lifted joints in the felt covering. the fascia's are flush to the walls with no gaps. No access points or crevices suitable for bat ingress are present in the garage. The underside of the flashing over the gap between the garage and house was examined with the aid of a torch. The space was found not to provide any high value roost potential for bats.

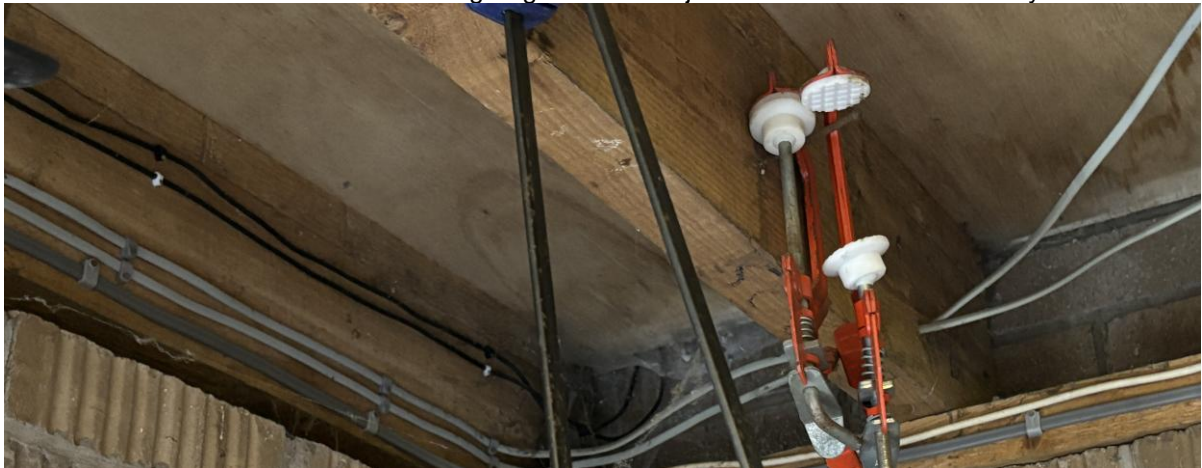
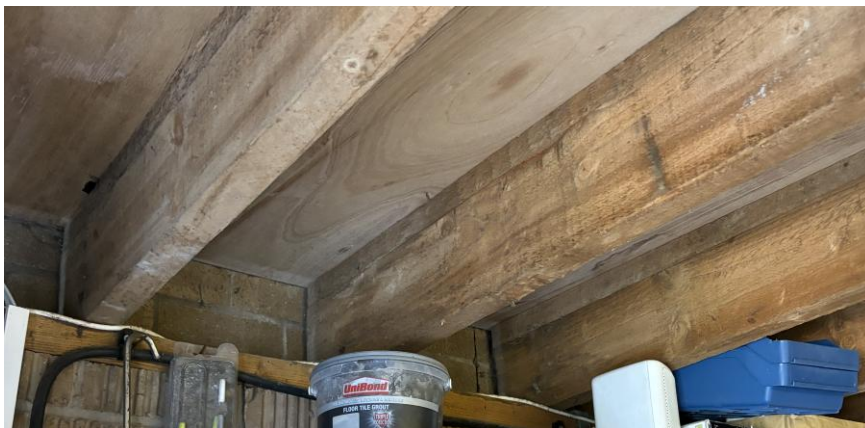
There was no enclosed roof void in the garage the timber joists and deck over were fully visible

All timbers were in good condition with no cracks or crevices.

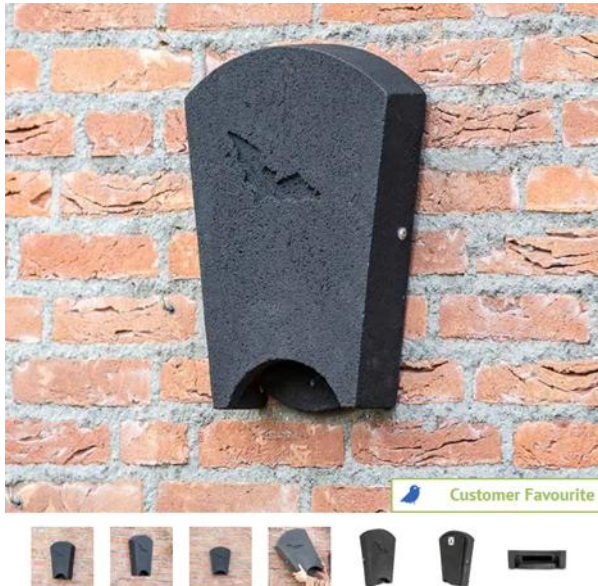
BEAUMARIS BAT BOX

However, the construction of the extension provides an opportunity to enhance the roost potential in the locality. It is therefore suggested that a Beaumaris bat box (or similar) illustrated below is fixed in a position that is at least 3m (10 feet) from the ground, sheltered from strong winds and exposed to the sun for part of the day. Position your box so it faces between southwest and southeast if possible. Make sure there is a clear flight line in.
