WRITTEN STONE FARM, WRITTEN STONE LANE, LONGRIDGE, PRESTON, LANCASHIRE

Archaeological Building Recording

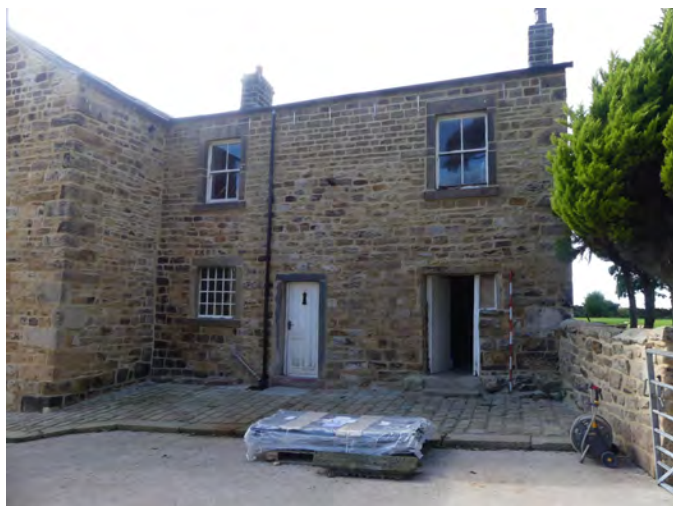
Plate 6 (left): North-east external elevation of the farmhouse, viewed from the north

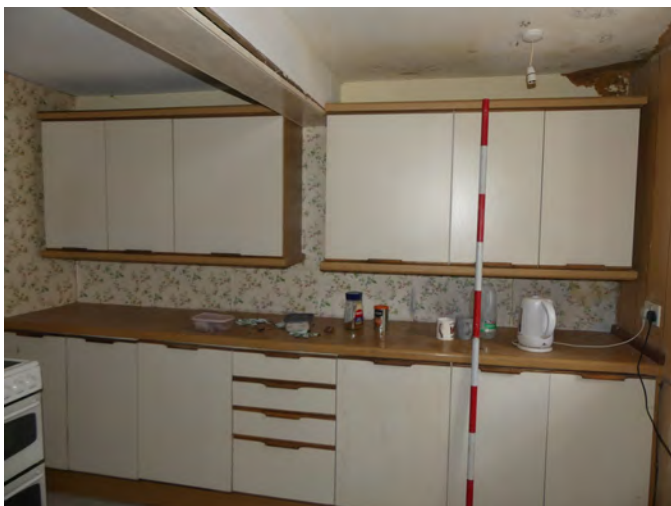
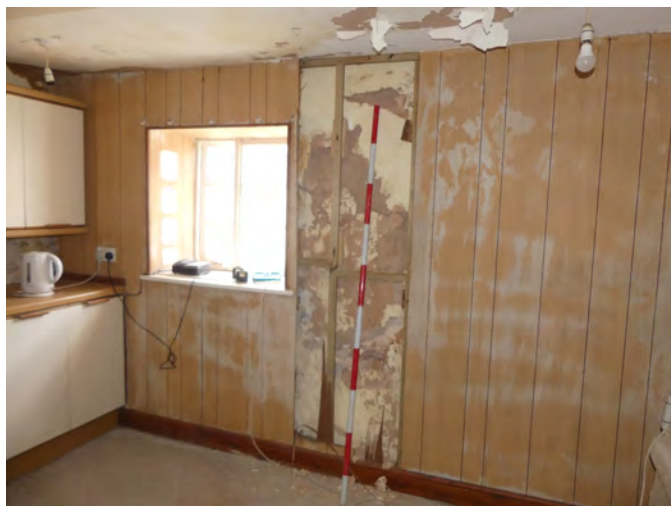
Plate 33 (left): South-east elevation of G3 (farmhouse), viewed from the north-west

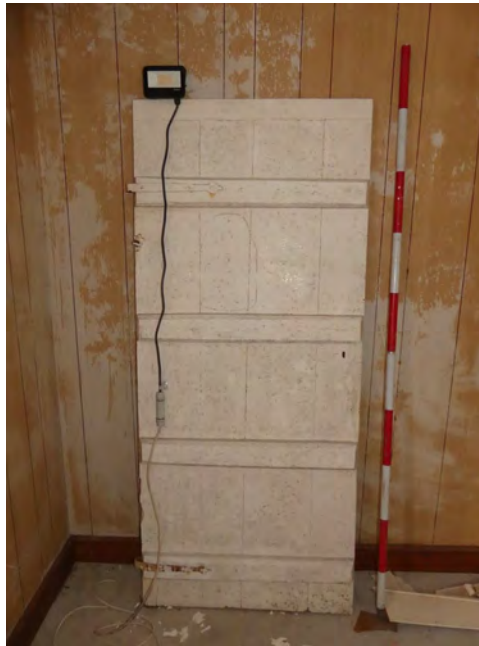
Plate 37: Loose door in G3 (farmhouse)

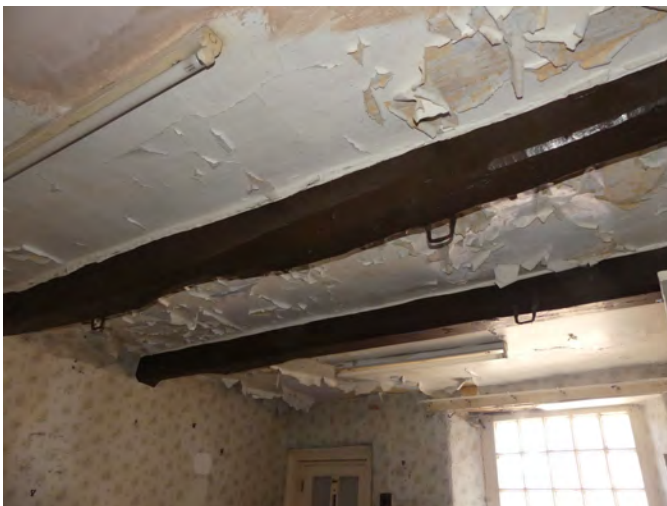
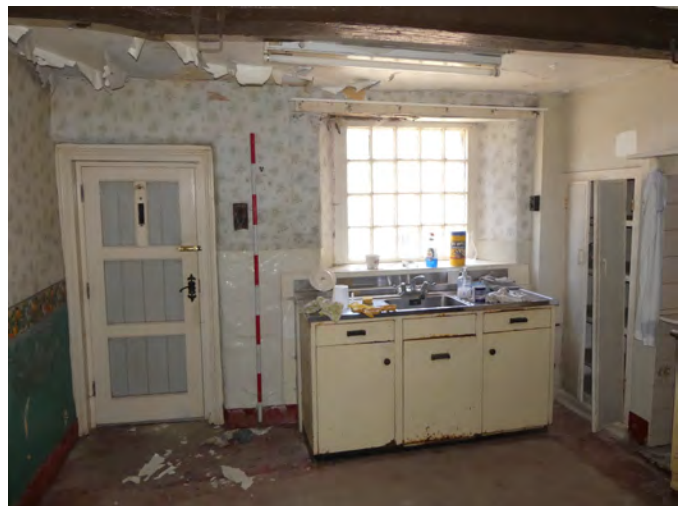
Plate 38 (left): Beams in G4 (farmhouse), viewed from the west

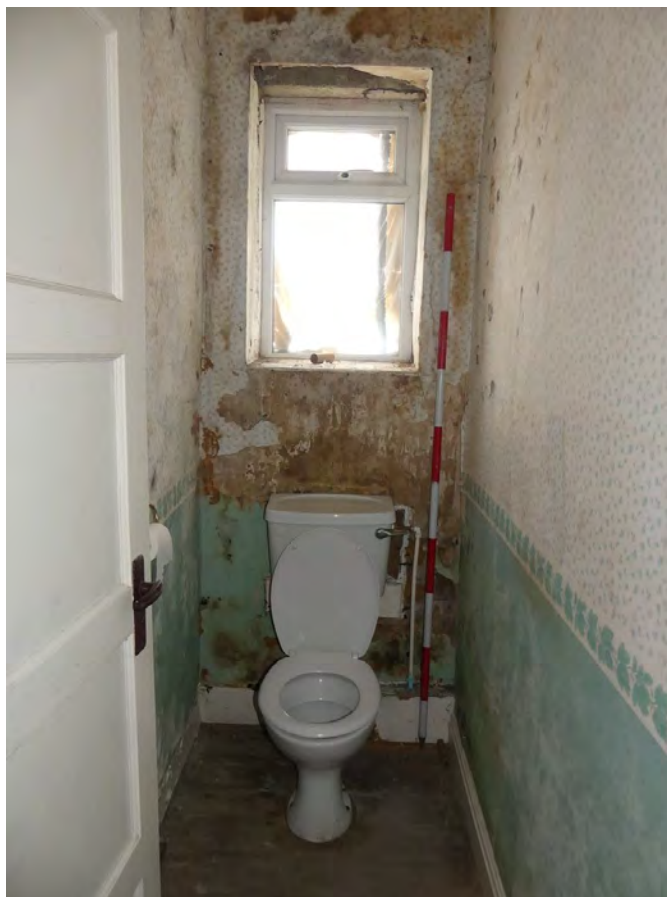
Plate 91: Window to the south-east in F5 (farmhouse), viewed from the north-east

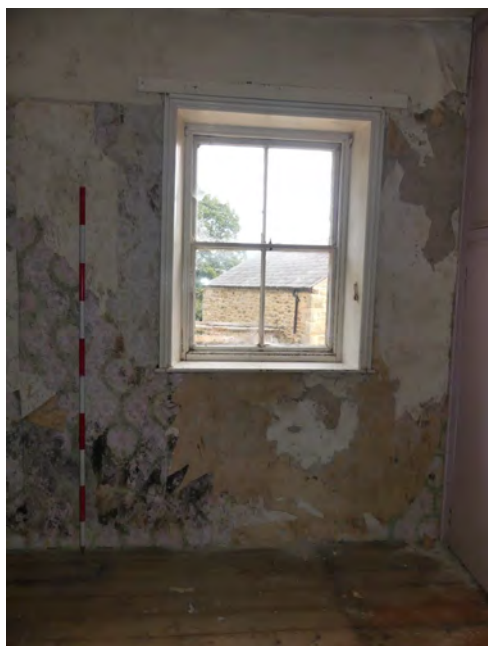
Plate 92 (left): Window to the north-east in F6 (farmhouse), viewed from the south-east

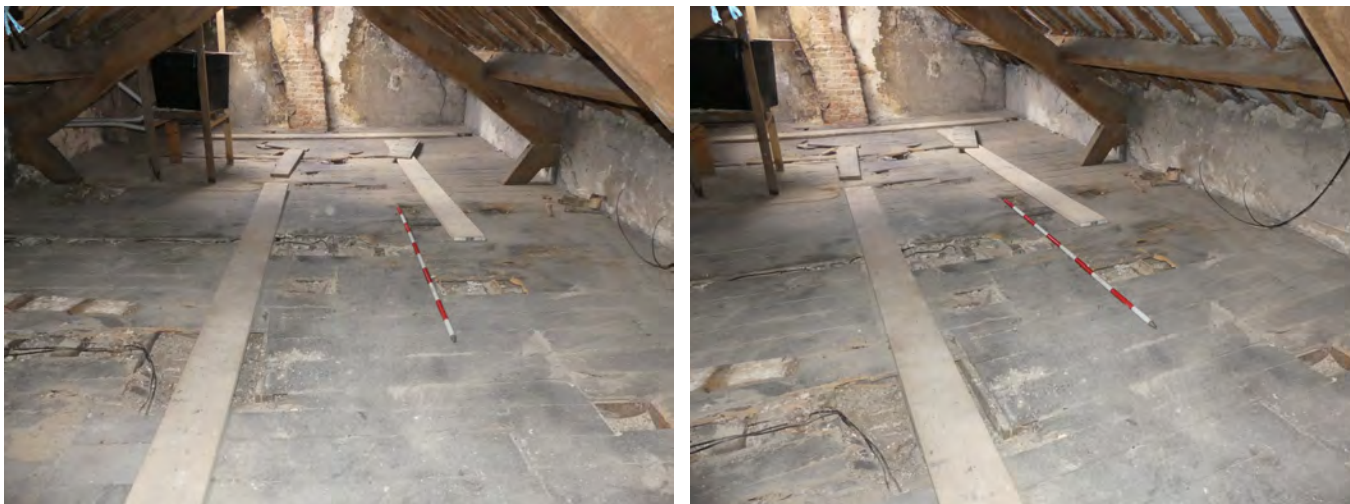
Plate 130 (left): Floor in A3 (farmhouse), viewed from the south-west
