## **Cranewood Farm**

# **Preliminary Bat Roost and Barn Owl Assessment Report**

<b>Document:</b>	<b>BOW17_1806 Cranewood Farm_Preliminary Roost Assessment Report</b>			
Version	Date	Prepared by	Technical Reviewer	Approved by
<i>DRAFT</i>	26/06/2025	Lauren Fairfax, <i>Graduate Ecologist</i>	Lucy Pocock, <i>Senior Ecologist</i>	Lucy Pocock, <i>Senior Ecologist</i>
<i>FINAL</i>	03/07/2025	Lauren Fairfax, <i>Graduate Ecologist</i>	Lucy Pocock, <i>Senior Ecologist</i>	Lucy Pocock, <i>Senior Ecologist</i>

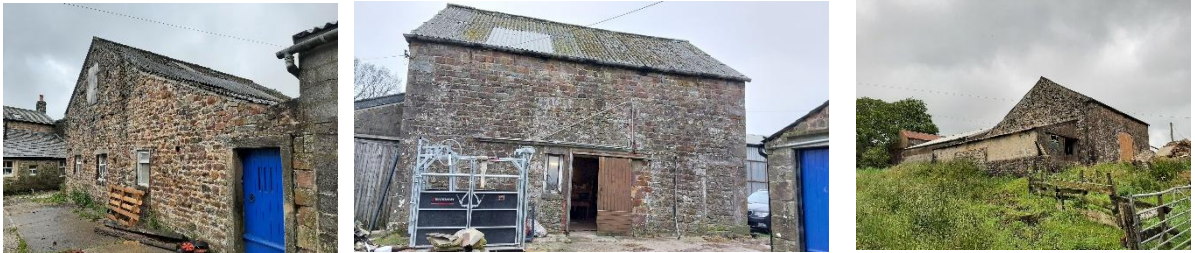
**Figures 2 – 4:** From left to right, Eastern, Southern, and Western elevations.

- 3.6 The barn planned to have roof works is situated to the north of the listed farmhouse and is stone built with a brick-built extension to the northwestern elevation and an attached lean-

to on the northern aspect (Fig 2-4). It has a pitched roof with an additional lean-to at the northeast end. The main building and extension are roofed with asbestos sheeting with the lean-to having a slate roof in moderate condition. The ridges and verges of the roof are also lined with asbestos sheeting. Three small cottage-style windows are present on the eastern aspect of the building along with a large barn door, all of which have small gaps above in the frames and fittings. The same cottage-style windows are also present to the western elevation between the main barn and the extension. There is a PVC gutter present on the southern aspect in good condition and a lead flashing valley gutter to the north also in good condition. No external security lights were identified during the site visit, however light spillage from the nearby farmhouse likely occurs.

- 3.7 Generally, the stonework was in moderate condition with numerous small gaps on the eastern and southern elevations which may provide a crevice type PRF, or access into an internal void or cavity wall (PRF 1). Across the asbestos roof are small gaps between the sheets that may provide roosting space, with a gap in the apex sheet on the eastern elevation (PRF 2). Slipped, raised, and missing slate tiles are visible on the lean-to roof area (PRF 3). Numerous ventilation holes are present on the eastern elevation which allow full access into the internal space (PRF 1).
- 3.8 All PRF's identified may provide access into a crevice that could support commonly occurring, opportunistic bats such as common pipistrelle. They may also provide access to a cavity wall or internal roof void which may be more suitable to brown long-eared or myotis bats.

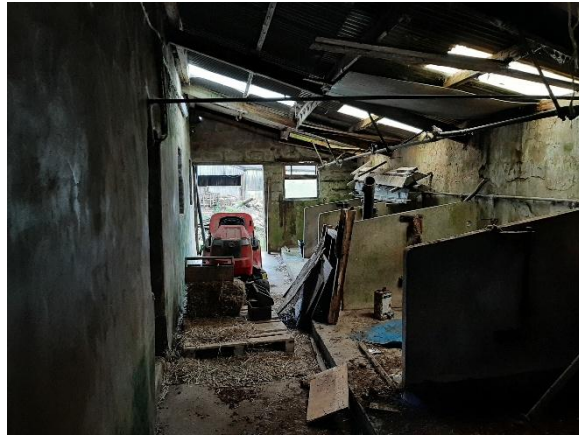
**Figure 5:** Internal view of extension area

- 3.9 The building is currently used as storage but is planned to be converted to stables. The internal space is interconnected with brick walls coated with white render in moderate condition. There are numerous exposed wooden beams and skylights present across the internal space. Access into the internal space was possible through open doors however, minimal suitable PRF's were identified. The whole internal space was damp and draughty, thus reducing roosting suitability. Furthermore, the skylights allow a lot of light into the internal space, thus making it less suitable to void dwelling species such as brown long-eared. There is no loft space present in any of the areas of the building.

- 3.10 There were no suitable PRF's identified in the internal space of the extension area (Fig 5).
- 3.11 Evidence of bats was noted during the survey in the form of bat droppings found on the eastern internal wall of the lean-to area (Appendix B). The space above the dropping comprises a wooden beam attached to the wall with a crevice type feature approximately 1cm wide along the length of the beam. The space was heavily cobwebbed indicating recent use is highly unlikely (PRF 4). No further evidence was found in any other internal or external space of the barn. The types of PRF's present on this site (crevice features between roof tiles and coverings), are highly unlikely to provide evidence of bats, as it would be concealed.

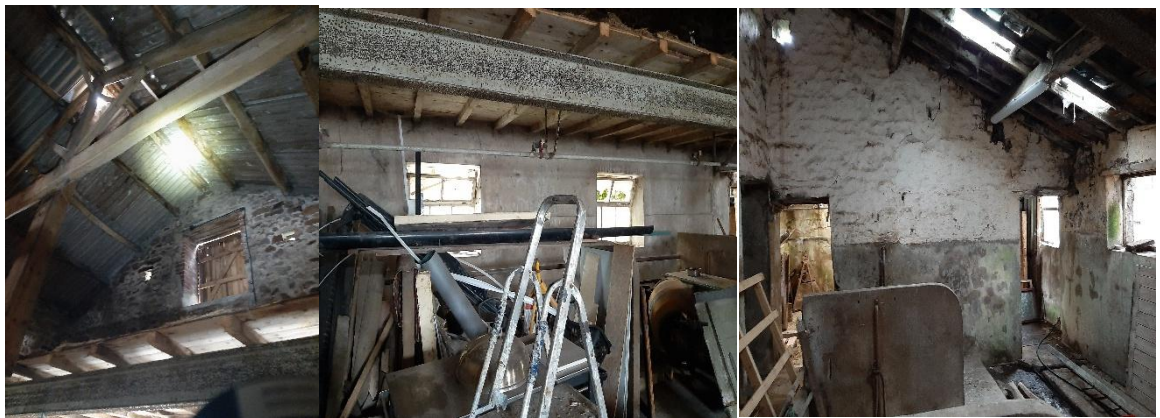
**Figures 6-8:** From left to right, upper space in main barn area, lower space in main barn area, and internal space in lean-to area.

- 3.12 The internal space of both the lean-to and main barn areas were damp and draughty with minimal PRF's identified (Fig 6-8). A single crevice-type PRF above the bat droppings was identified (PRF 4) to the eastern wall of the lean-to area. No other suitable PRF's were identified within the internal space.

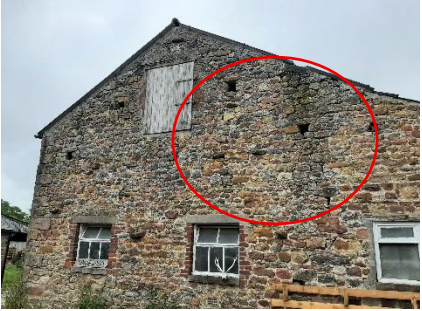
Feature	Description	Photograph
PRF 1- Gaps in mortar within stonework and ventilation holes	Gaps across the stonework to southern and eastern elevations. Gaps are of various sizes. Some made lead to a crevice or cavity wall, while other ventilation holes allow full access into the internal barn space.

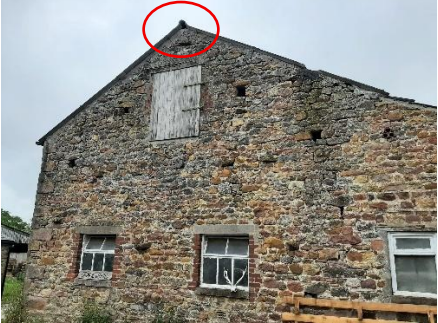
PRF 2- Gap in final asbestos sheet	Gap below asbestos sheeting on roof ridge. The gap may lead into an internal space.

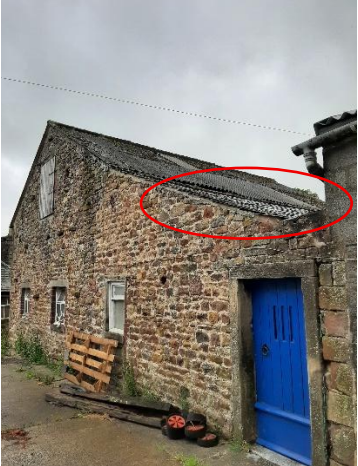
PRF 3- Lifted and slipped slate	Lifted and slipped slates on the northern elevation of the roof of the lean-to. This creates crevices under slates suitable for bats to roost.

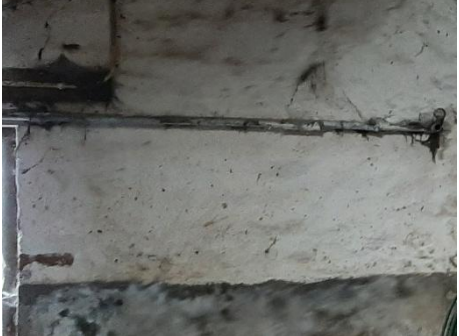
PRF 4- Cobwebbed wooden beam above bat droppings	A cobwebbed wooden beam was present above the identified bat droppings. There is a gap between the beam and stonework of 1cm wide along the length of the beam.

- 4.3 Considering together the identified PRFs and bat evidence found within the building, two dusk bat emergence surveys are recommended as per best practice guidance (Collins, 2024). The surveys should be conducted May-September inclusive, with at least one survey carried out May-August inclusive. It is also recommended that emergence surveys are separated by at least a 3-week period. The surveys will be used to indicate how bats are accessing the building, and how (if at all) bats may be using the identified PRF's. A licenced Ecologist will also be required to inspect the crevice beneath the beam where a bat dropping was found.

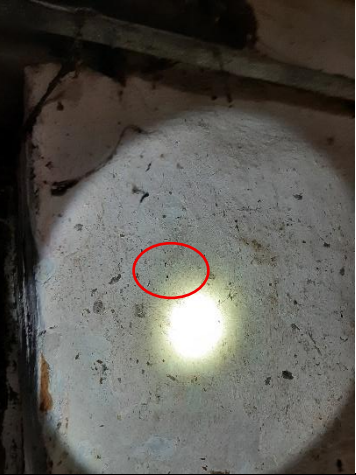
<p>Bat dropping</p>	<p>Bat dropping identified on eastern elevation internal wall of the lean-to.</p>

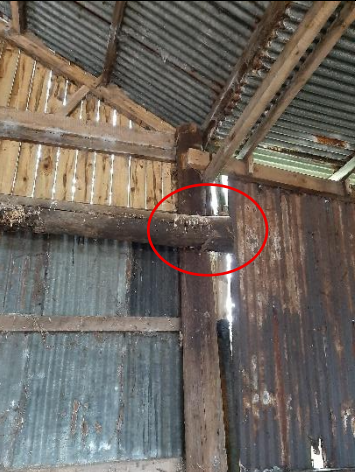
<p>Bird evidence</p>	<p>Bird droppings were identified on the western elevation wooden beam of the barn at the north of the site (Appendix C). Feathers were also seen within this barn.</p>

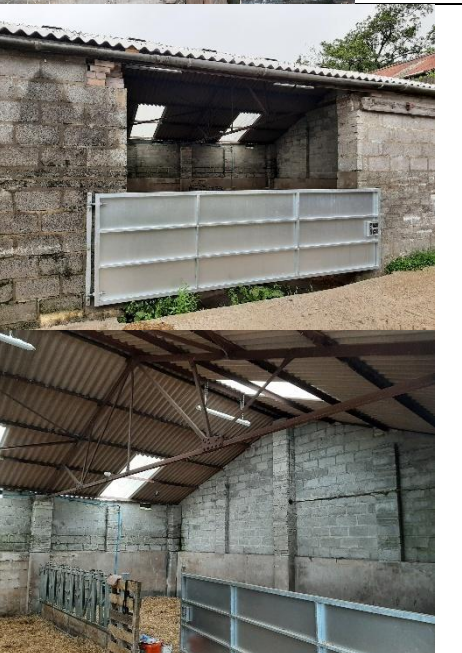
<p>Adjacent barn with Barn Owl suitability</p>	<p>Barn next to that which requires roof work identified to be suitable for nesting Barn Owl</p>

- 4.15 As barn owls can nest year-round if site conditions are suitable, a pre-works nesting bird check will be required by an experienced ecologist.
- 4.16 In addition to avoiding nesting bird season, to encourage nesting barn owls, it is recommended that at least one barn owl box is erected<sup>4</sup>. The box should be put in place prior to works starting and should be placed at least 3m in height off the ground. If feasible, placing an additional box may be beneficial as it is common for males to roost separately to females and young. The site visit identified the barns noted in Appendix C as suitable for barn owl boxes. Box 1 should be placed on the southern wall of the barn adjacent to that which requires works and a second box could be placed on the eastern wall of the opposite as high as possible (Appendix C).

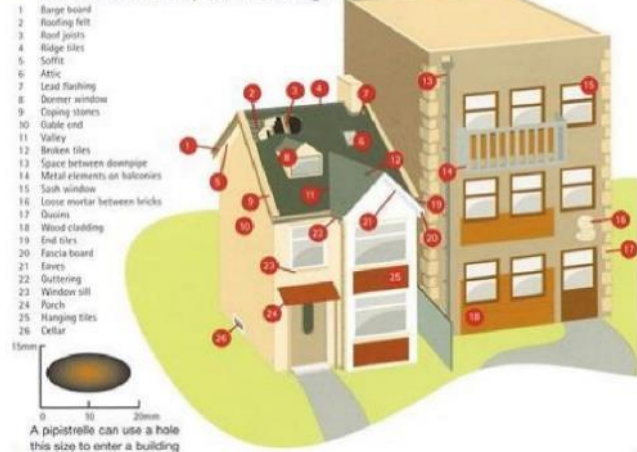
### Places that bats may use in buildings

Schematic from www.bats.org.uk
