Alder House, Holden Lane, Bolton-by-Bowland

Preliminary Roost Assessment

Report Ref. ER-8794-01

Lowood Estates

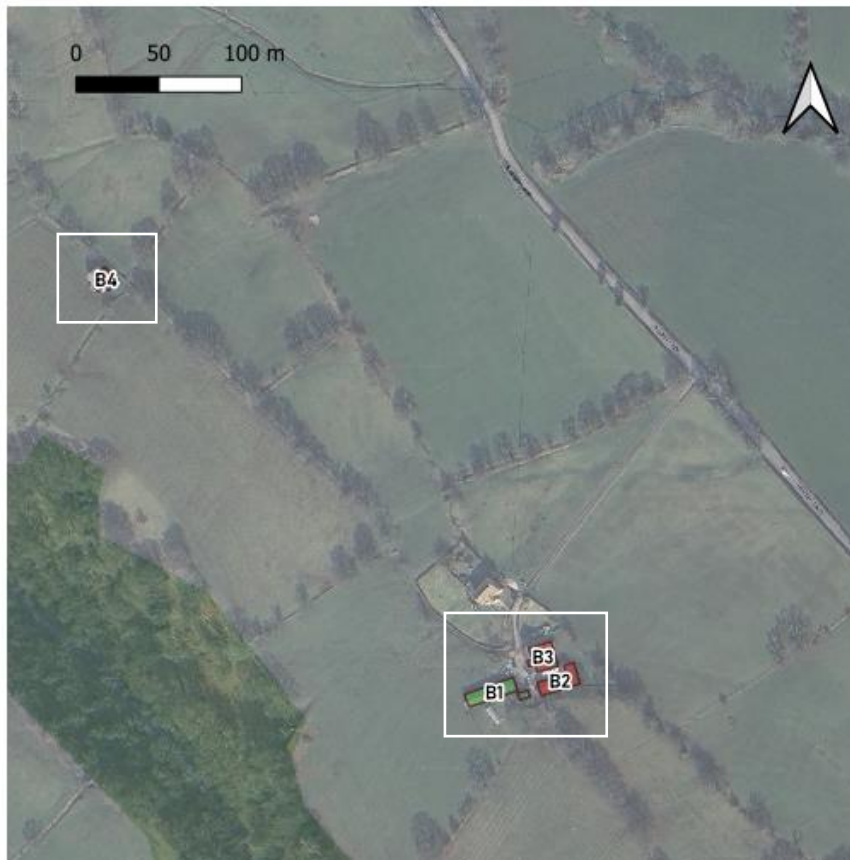
Figure 1 Buildings surveyed

1. Brooks Ecological was commissioned by Lowood Estates to carry out a Preliminary Roost Assessment (PRA) of farm buildings at Alder House near Bolton-by-Bowland.
2. The application site, 'the Site', comprises three stone built and one steel and asbestos sheet disused barns; see Figure 1 below. Proposals are to convert these to residential use.

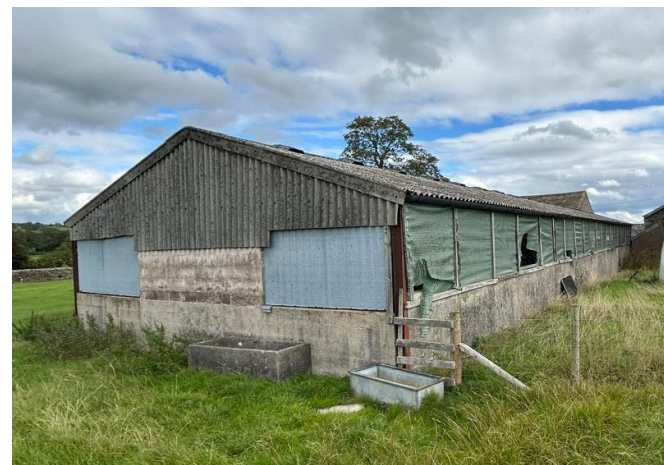
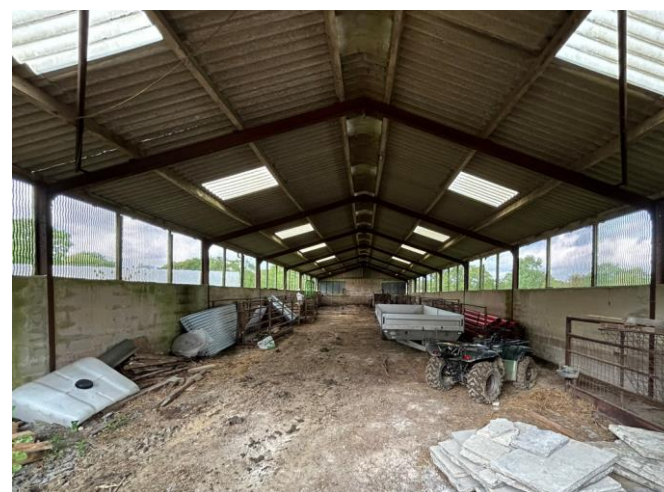
Figure 4 A&B Construction of B1

12. This is a simple steel frame barn with blockwork dwarf curtain walls, open sides and sheet asbestos/cement roof. The nature of its construction makes it light drafty and thermally instable and unsuited to bat roosting.

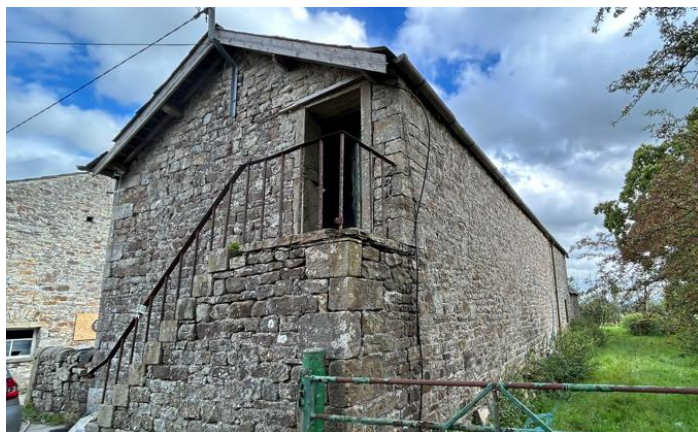
Figure 5 Gable of B2, PRF;s in the wall and at the eaves

- 13. This is a traditional stone built bars probably dating from the 1800s. It has solid walls with a stone double pitched roof

- 14. The building has solid walls with lime cement and frequently failed pointing. It has a hayloft which is currently accessible through an open door and poorly fitted timber shutters. There are plenty of cracks and crevices in the stonework making numerous potential roost features. The wall plate is accessible behind the gutters and at the gable eaves.

24. At this stage it is considered likely that some roosting will be found of more common species like pipistrelle but equally some of the more rural species like myotis and brown long eared can be anticipated. Roosting could be anticipated in the spring to autumn season in Building 2 but there is potential for hibernation in B3 and B4.

25. In line with best practice guidelines (Bat Conservation Trust, 2023), further survey should be carried out to establish if potential roost features are being used by bats. This should take the form of three surveys of B3 and B4 and two for B2. Surveys should be undertaken during the active bat survey season, which runs from May to August inclusive, with September providing sub-optimal conditions.

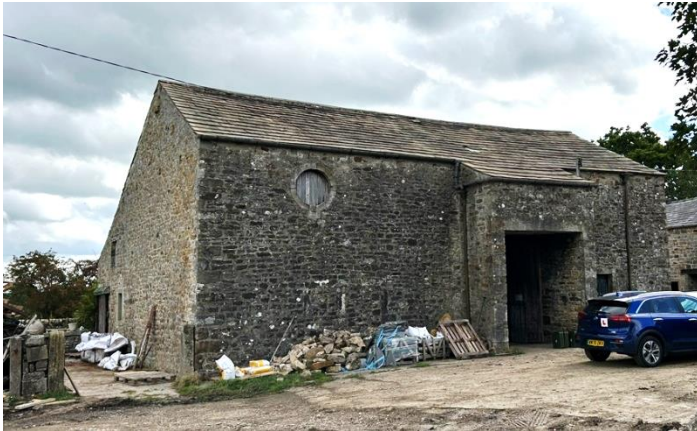
Figure 9 Gable of B2, PRF;s in the wall and at the eaves

- 15. A large old stone built farmyard barn probably dating from the 1700s with a double pitched local sandstone slate roof.

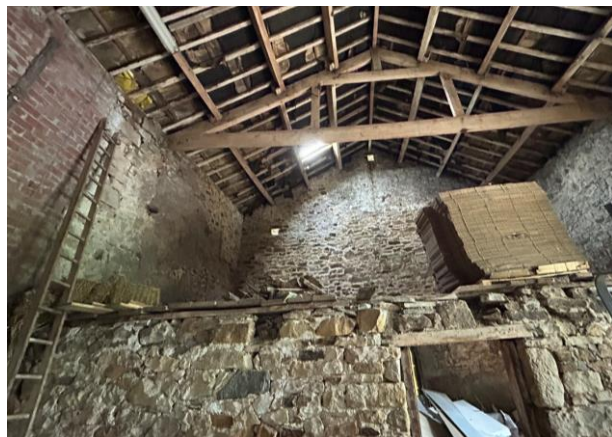
Figure 10 Interior of B3 supporting numerous PRF's

- 16. The barn has one large open ground to ceiling void with exposed timber and remnant but heavily damaged bitumen felt lining. PRFs here abound in the form of cracks in masonry, exposed wall plate, gaps behind roof slates and lining membrane and joint holes in exposed beams.

26. Additionally, hibernation monitoring is recommended on B3 and B4. This to be in the form of static bat detectors left to run from November to March.

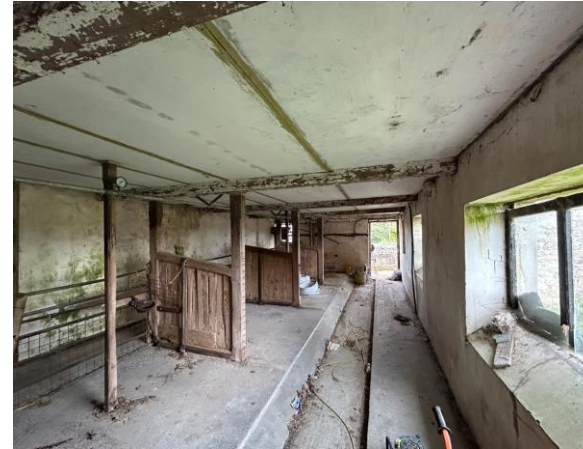
Figure 11 Milking parlour attached to B3

- 17. There is a lean-to extension which looks to have been used as a milking parlour. This is accessible through open doors and windows, a feature taken advantage of by the resident swallow populations which nest internally.

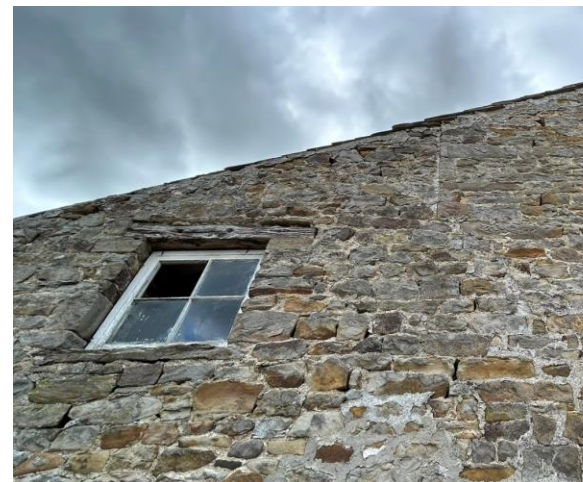
Figure 12 PRFs in B3, broken windows and missing mortar

- 18. Externally missing pointing and crumbled mortar and damaged window and roof frames make numerous potential access cavities into the walls

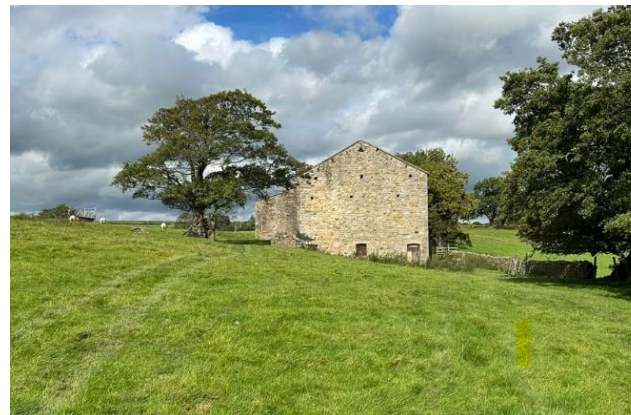
Figure 14 Barn in its setting

19. A large old stone built field barn probably dating from at least the 1700s with a double pitched local stone roof.

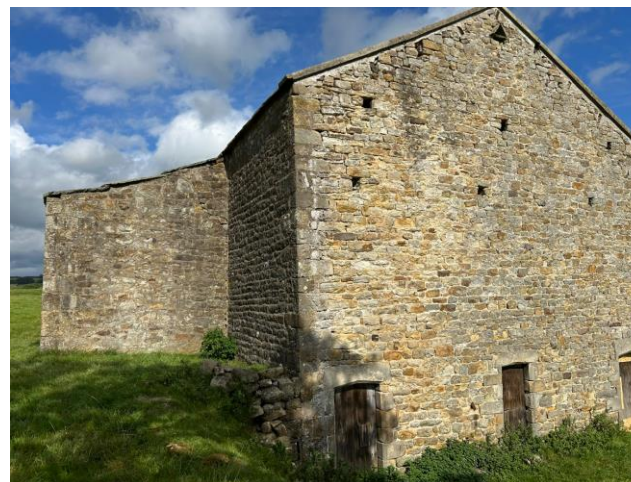
Figure 15 showing ventilation holes on southern gable.

20. The walls support numerous cracks and areas of lost mortar which create good PRF's in voids in rubble filled walls. Open wall vents are found on the gables which lead directly to the barn's interior.

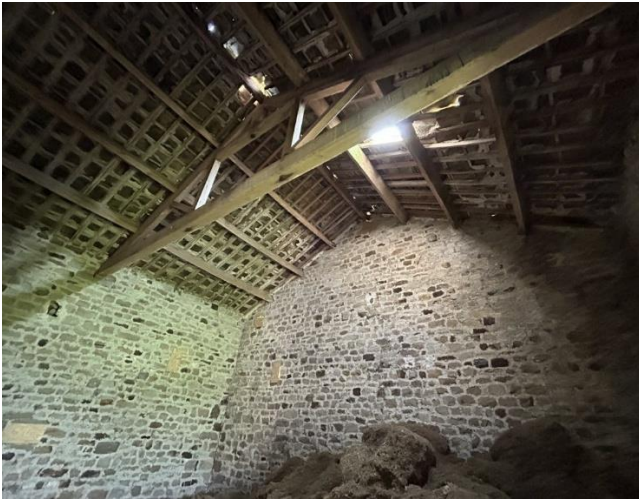
Figure 16 Unlined roof and exposed timbers

21. Internally the barn has an unlined roof with exposed beams and timbers. There are not too many wall crevices however due to some relatively recent lime pointing work. But an undercroft is accessible through collapses floor sections and a stairwell. This undercroft has potential to attract hibernating bats in particular.

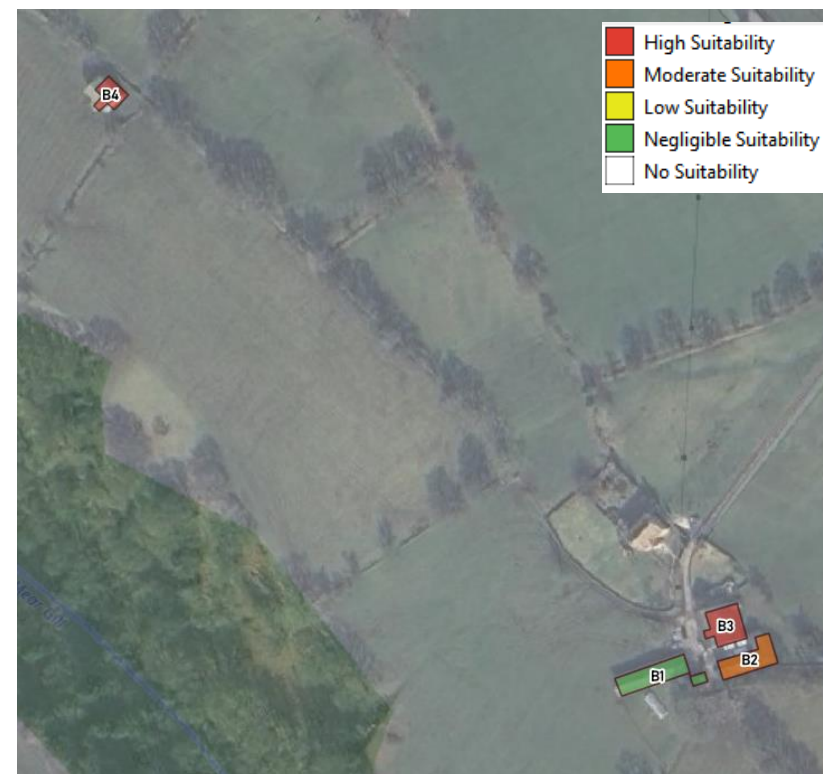
Figure 18 Showing bat roost suitability of on-Site buildings.

22. Based on the features present, the three buildings are assessed as having negligible and high suitability for supporting roosts.

Building	Key Features	Bat Roost Suitability
B1	None	Negligible
B2	Holes leading to wall cavities, Eaves and fly in roost potential.	Moderate
B3	Holes leading to wall cavities, Eaves and fly in roost potential. Internal wall cavities suitable for hibernation.	High
B4	Holes leading to wall cavities, Eaves and fly in roost potential. Under croft suitable for hibernation	High
