**HISTORIC BUILDING SURVEY REPORT:**  
**CUCKOO HALL, HIGHER ROAD, LONGRIDGE, LANCASHIRE**

Planning Reference: 3/2024/0121  
NGR: SD 63896 39018  
AAL Site Code: LOHR 25  
OASIS Reference Number: allenarc1-536093

By  
Allen Archaeology Ltd  
Report Number AAL 2025117

September 2025

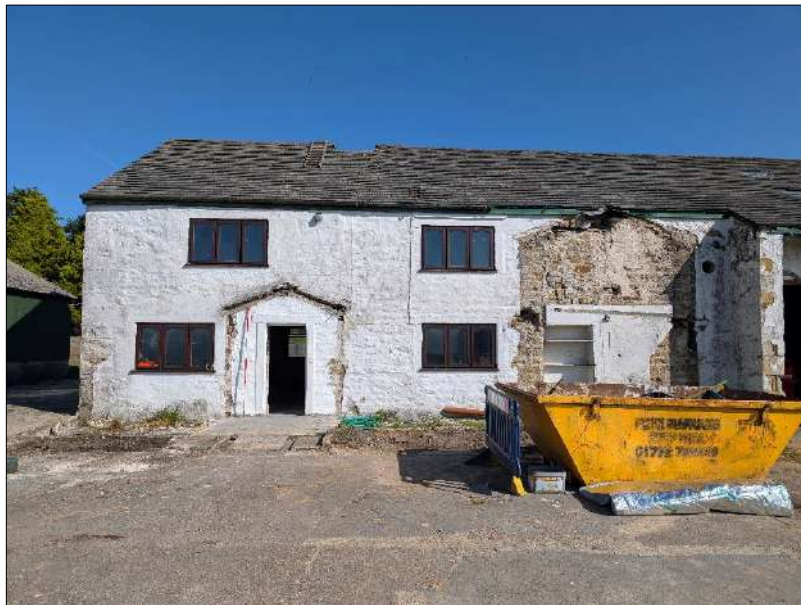
- 6.3 The south east facing façade of the farmhouse (Plate 1; Shot 166) comprised a two storey, two bay elevation with an entrance in the southwestern bay at ground floor level. The misalignment of the ground and first storey windows of the southwestern bay suggests that the ground floor window and entrance represent an alteration to the original fabric of the building. The limewash finish of the façade made details of alterations to the fabric difficult to establish from the exterior of the building. Where visible the masonry comprised roughly squared, random coursed quarry-faced sandstone blocks.

*Plate 1 (shot 166): Southeast-facing elevation of farmhouse, looking northwest, 2m scale*

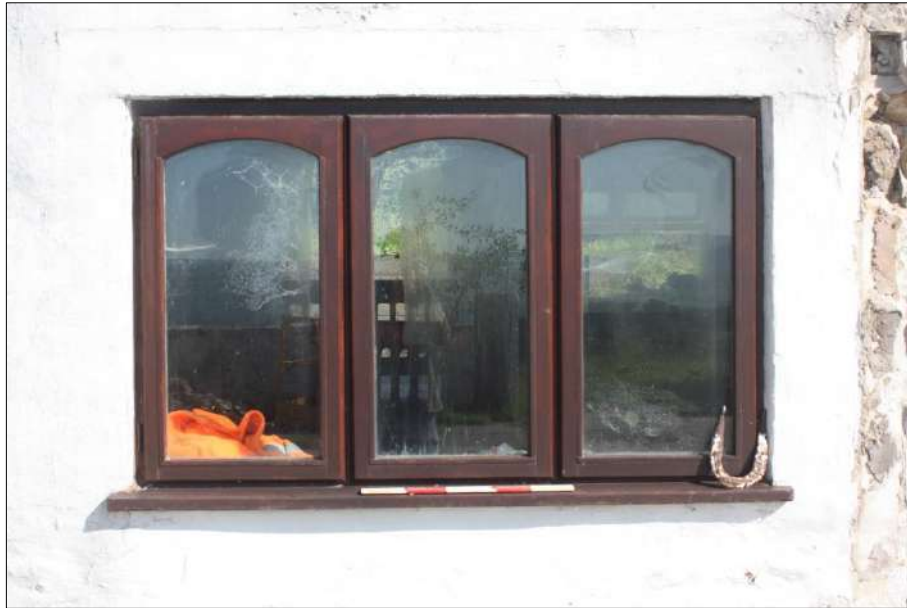
- 6.4 The windows in the southeastern elevation of the farmhouse were rectangular with three rectangular lights with segmental arches at the top (Plate 2: Shot 160). The timber framing and the glazing of the windows is of relatively recent origin.

*Plate 2 (shot 160): Detail of window, southeast elevation of farmhouse, looking northwest, 0.5m scale*

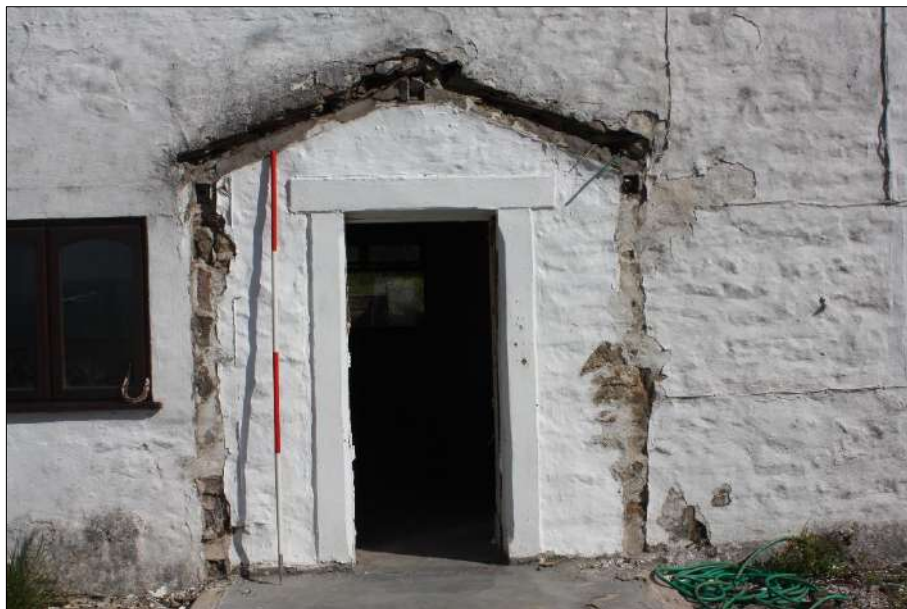
- 6.5 The entrance (Plate 3; Shot 159) comprised masonry jambs and lintel, with the jambs chamfered on the inner corners. Surrounding the entrance there was clear evidence of a porch, likely to have been of brick construction, that has been recently demolished.

*Plate 3 (shot 159): Entrance in southeast elevation of farmhouse, looking northwest, 2m scale*

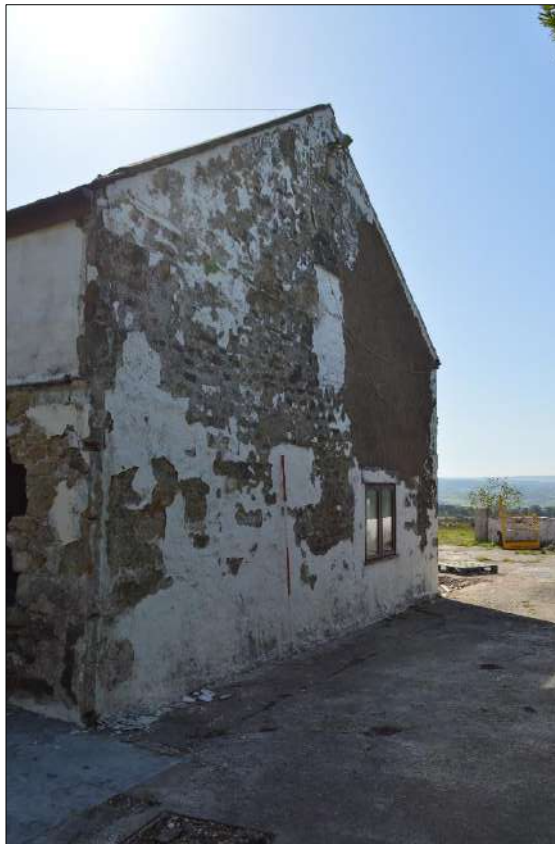
- 6.6 The southwest facing elevation of the farmhouse (Plate 4; Shot 36) as largely solid masonry, with a single square window (Plate 5; Shot 39) at ground floor level at the southeastern side of the elevation. The timber frame and glazing of the window were recent insertions in the same style as the windows in the southwestern elevation, although the window had a substantial stone lintel, suggesting that the opening itself may be part of the original fabric. There was also

*Plate 4 (shot 36): Southwest-facing elevation of farmhouse, looking southeast, 2m scale*

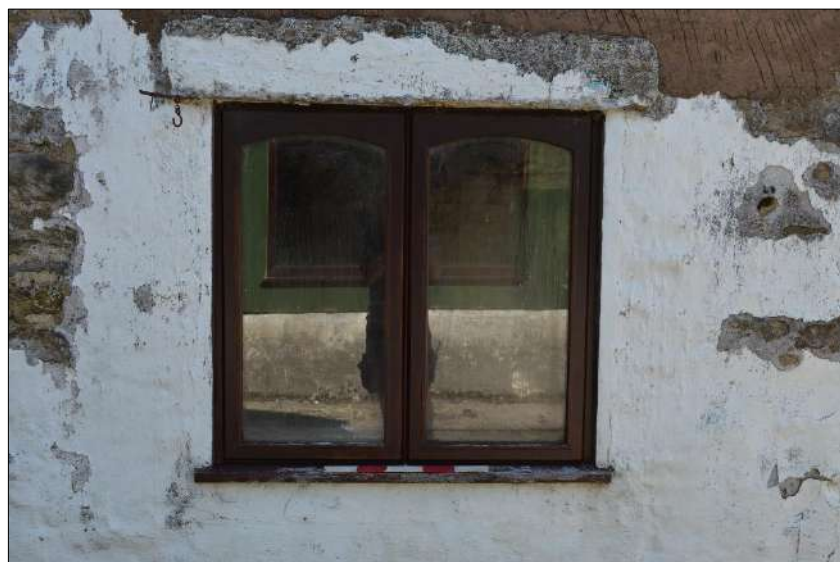
*Plate 5 (shot 39): Detail of ground floor window in southwest facing elevation of farmhouse, looking northeast, 0.5m scale*

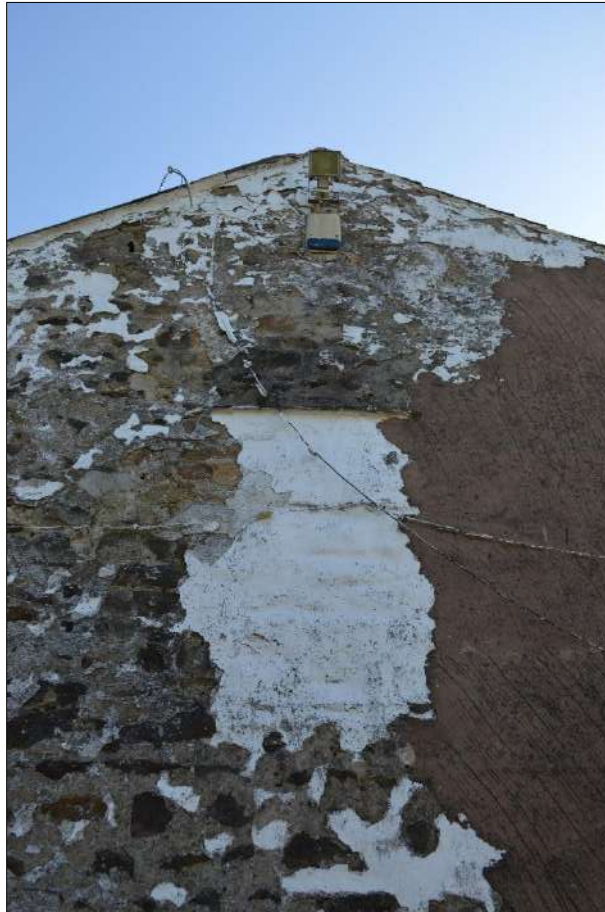
a blocked window (Plate 6; Shot 38) at first floor level, which was clearer internally (see below). To the southeast of the blocked window and above the ground floor window the gable end wall was finished with cement render which appeared to be of relatively modern date.

*Plate 6 (shot 38): Blocked first floor window in southwest-facing elevation of farmhouse, looking northeast, no scale*

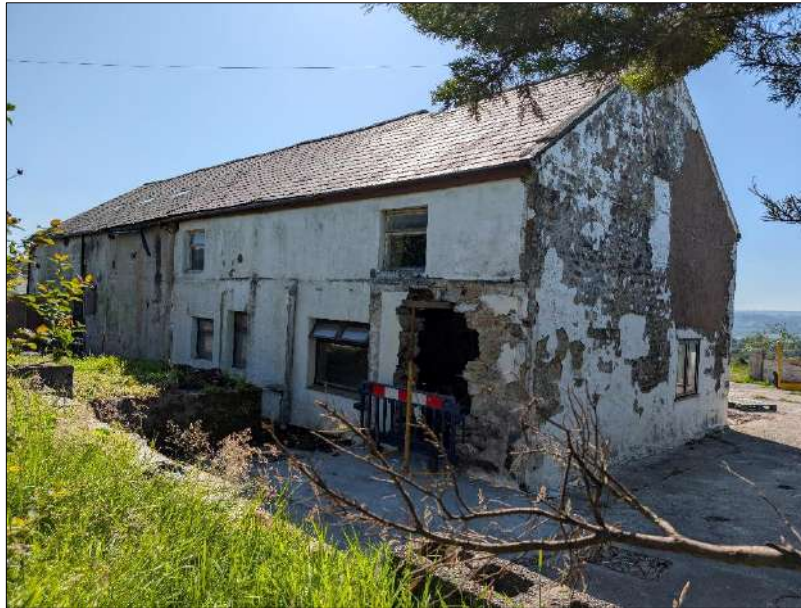
*Plate 7 (shot 172): Northwest-facing elevation of farmhouse, looking southeast, 2m scale*

- 6.7 The northwest facing elevation of the farmhouse (Plate 7; Shot 172) was once again finished with limewash. There were two windows at first floor level, and three at ground floor level, along with an opening (Plate 8; Shot 33) which had provided egress between the farmhouse and a modern extension on the western corner of the main range. The extension had been recently demolished, and presumably the damage to the entranceway occurred during the demolition work. The damage revealed the structure of the masonry of the wall, largely comprising roughly squared back-to-back facing stones with no core material, with occasional throughstones tying the faces together (Plate 9; Shot 35). The damaged area also clearly showed the layer of limewashed render on the exterior of the wall.

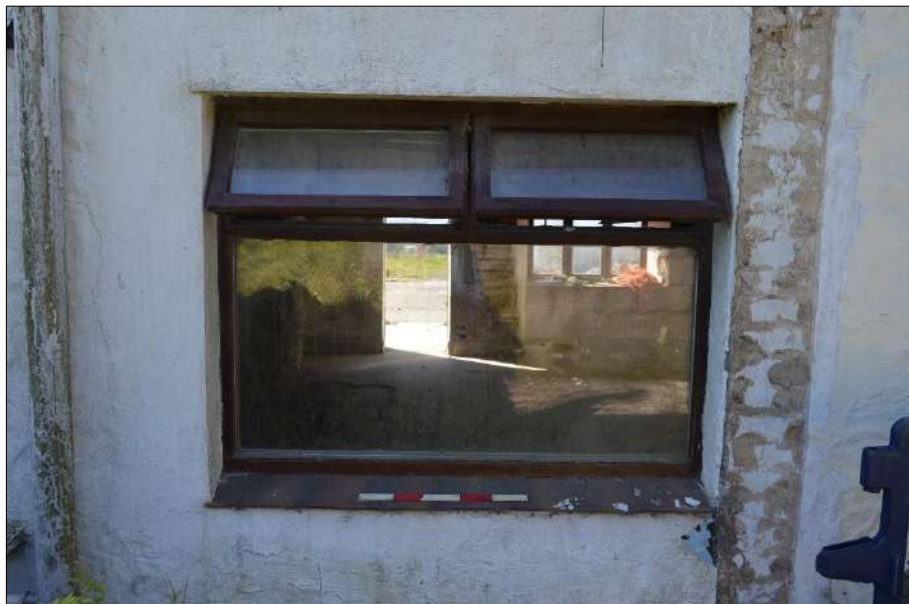
*Plate 10 (shot 31): Detail of ground floor window, northwest elevation of farmhouse, 0.5m scale*

- 6.8 To the northeast of the entranceway a rectangular window (Plate 10; Shot 31) had a large rectangular lower light with two top hung casements above. The window was timber framed and of recent origin. The photograph also shows the wall scar of the demolished extension to the right of the window.
- 6.9 In the northeastern bay of the farmhouse there were two windows (Plates 11 and 12; Shots 30 and 28) with frames and glazing in a similar style, both of which were rectangular with awning hung casements over fixed lights. All three of the ground floor windows were set fairly deeply into the wall, with wide flat reveals.

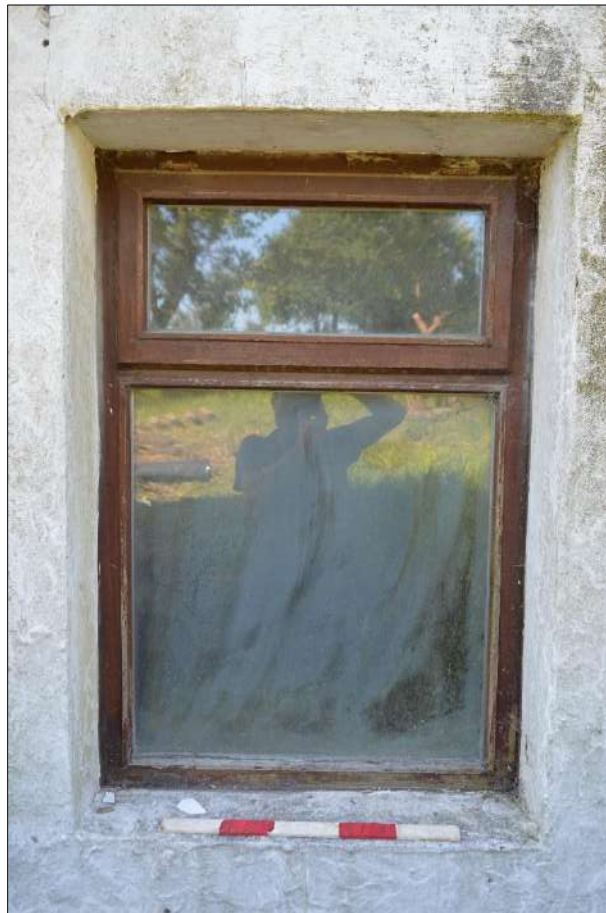
*Plate 11 (shot 30): Detail of ground floor window, northwest elevation of farmhouse, 0.5m scale*

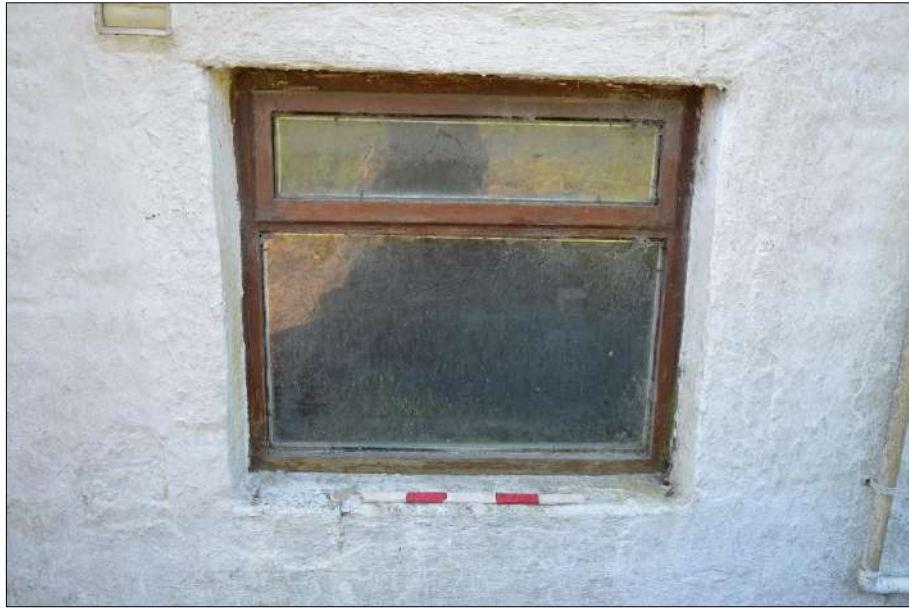
*Plate 12 (shot 28): Detail of ground floor window, northwest elevation of farmhouse, 0.5m scale*

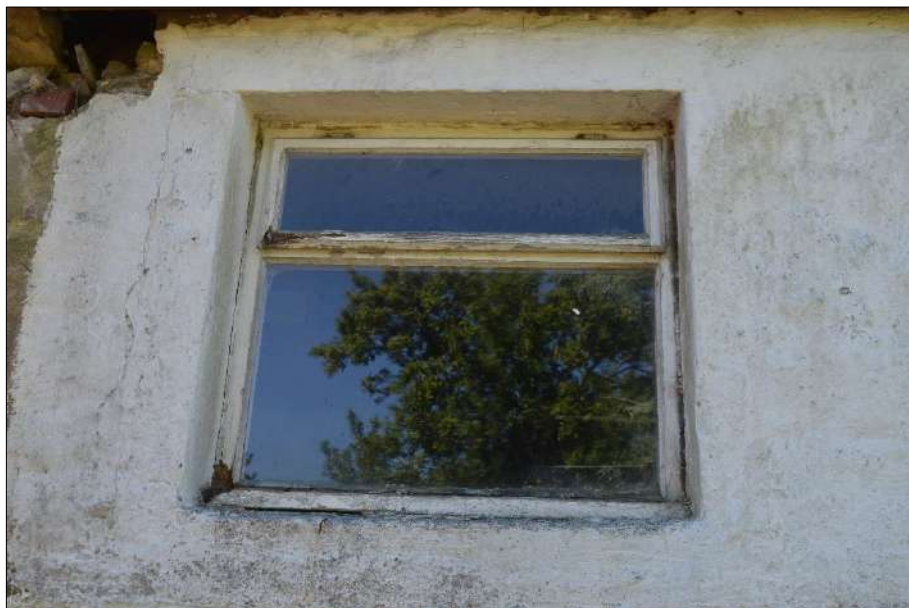
*Plate 13 (shot 29): Detail of first floor window, northwest elevation of farmhouse, no scale*

- 6.10 At first floor level there was a single window (Plate 13; Shot 29) in a similar style in each of the two bays, although the wooden frames of the windows were painted white rather than stained.

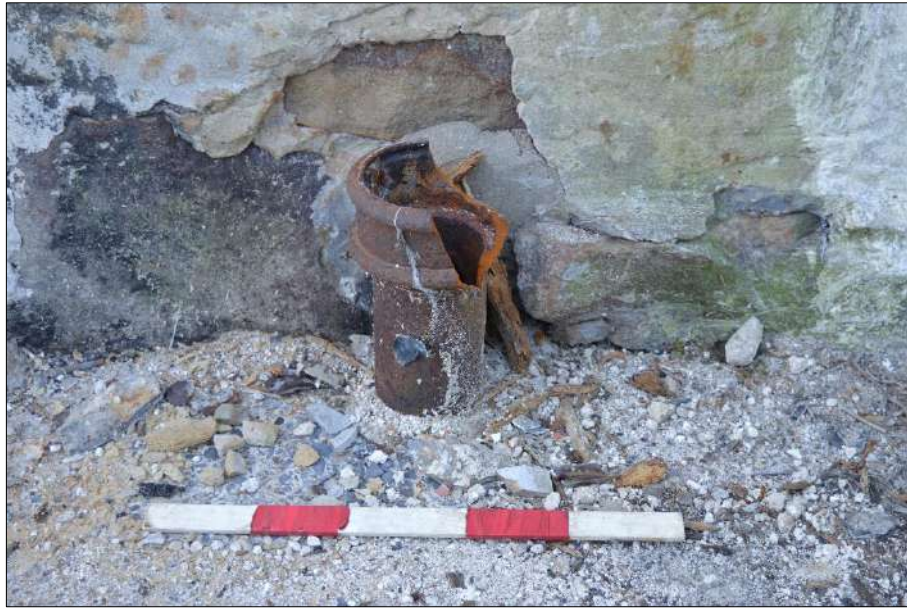
- 6.11 The remnant of a cast iron downpipe (Plate 14; Shot 27) was recorded adjacent to the base of the wall on the northwestern side of the farmhouse.

*Plate 14 (shot 27): Cast iron pipe on northwestern side of farmhouse, 0.5m scale*

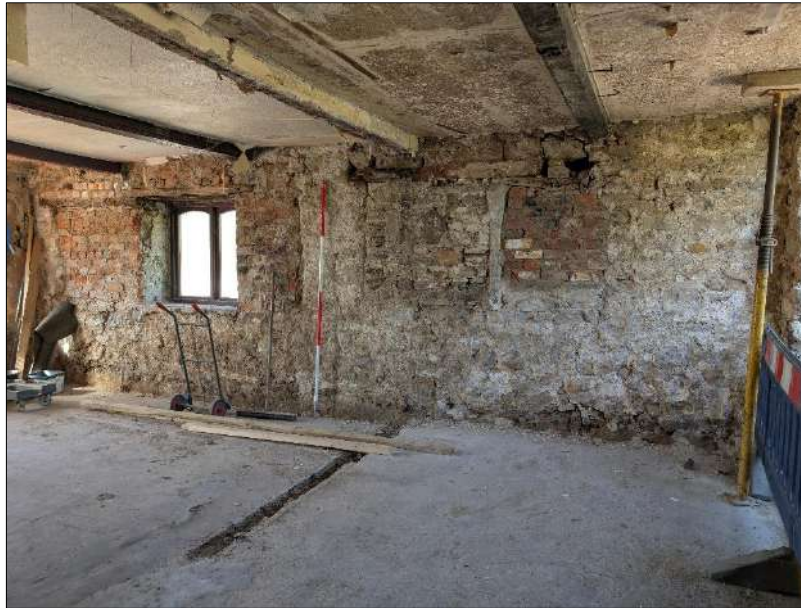
- 6.13 The modern fittings had been stripped out of the interior of the farmhouse buildings, exposing the structural masonry of the walls, which largely comprised random coursed lime mortar bonded sandstone blocks. A removed partition wall was clearly visible toward the northwestern end of the room (Plate 15; Shot 173).

*Plate 15 (shot 173): Interior of Room 1, looking southwest, 2m scale*

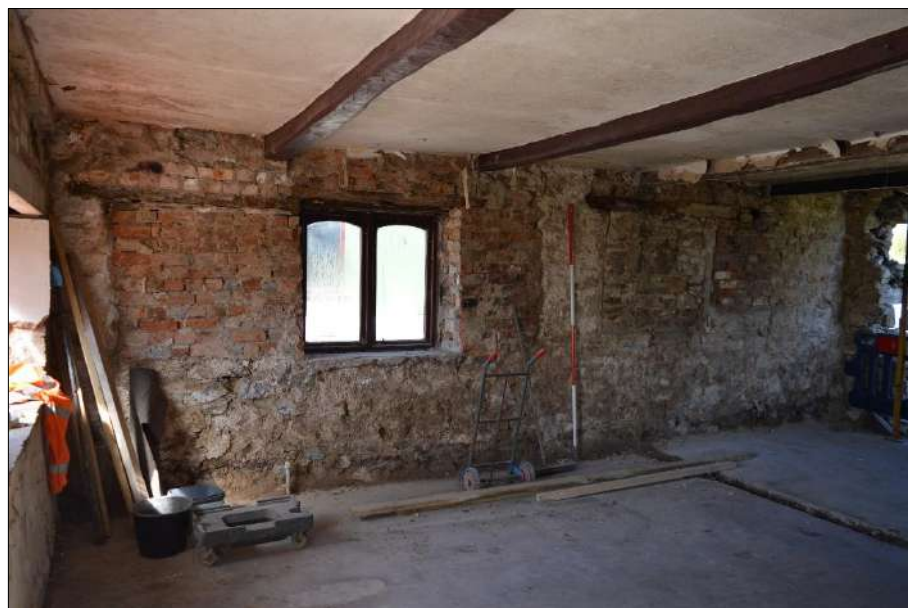
*Plate 16 (shot 43): Interior of Room 1, looking northwest, 2m scale*

- 6.14 On the southwestern wall of Room 1 the window (Plates 16 and 17; Shots 43 and 46) had a double timber lintel above the frame. The masonry to either side of the window and above it comprised hand pressed brick laid in a hybrid English bond with alternately one or two stretcher courses per header course (Plate 18; Shot 40). This suggests that the position of the window is the result of an extensive alteration to the southwestern wall, probably in the first half of the 19<sup>th</sup> century.

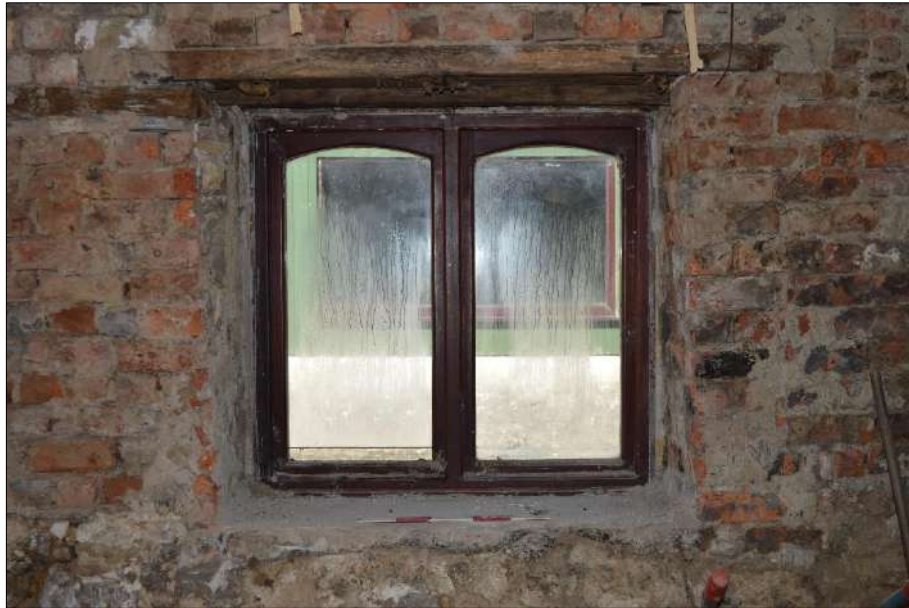
*Plate 17 (shot 46): Detail of window, southwestern wall, Room 1, 0.5m scale*

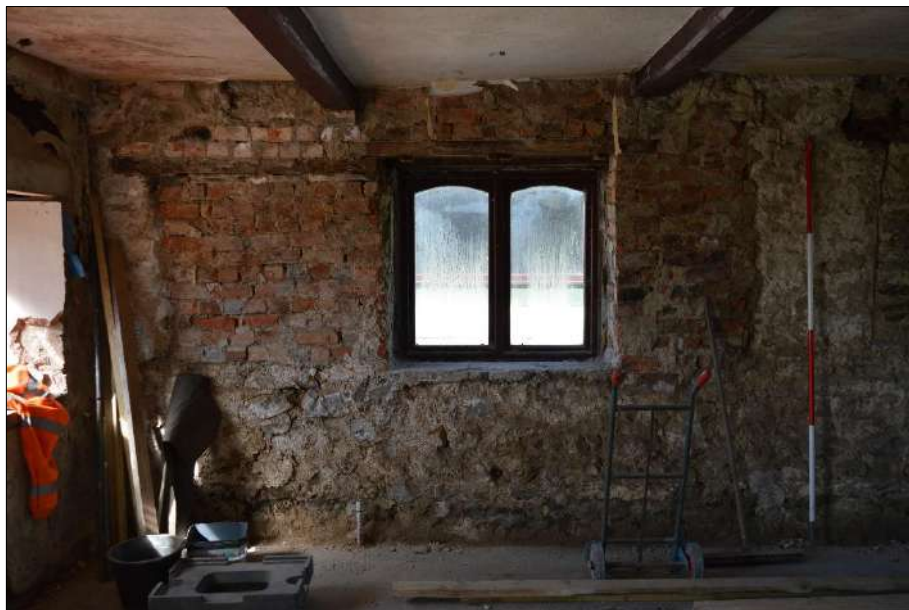
*Plate 18 (shot 40): Southeastern part of southwestern wall, Room 1, 2m scale*

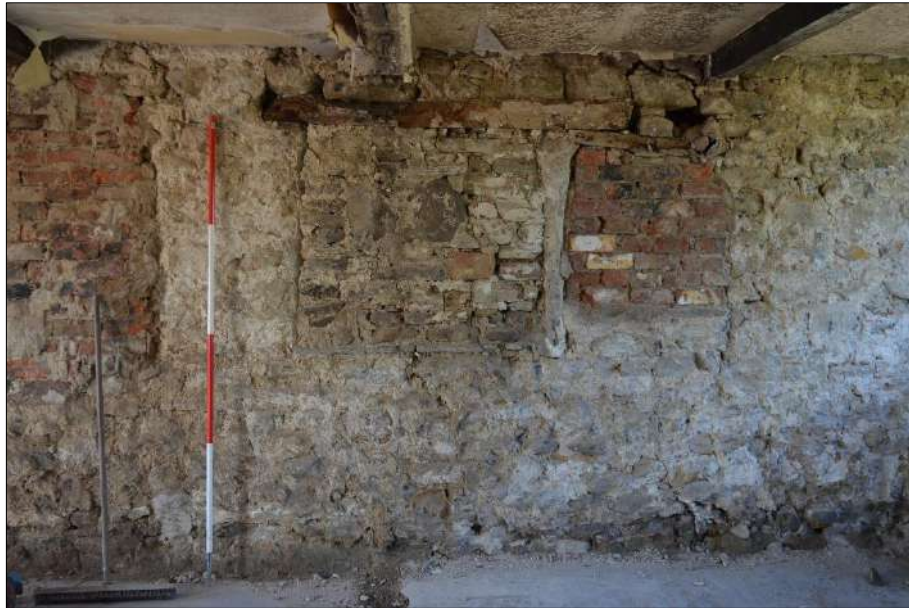
- 6.15 The northwestern part of the southeastern wall (Plate 19; Shot 44) had evidence of two adjacent blocked windows, a larger square opening to the southeast, with a smaller one immediately to the northwest, separated by a vertical timber member. The larger window was largely blocked with sandstone rubble although there was occasional hand pressed brick. The smaller window was blocked with handmade brick, possibly at the same time as the alteration to the southeastern part of the wall described above.

*Plate 19 (shot 44): Detail of blocked windows in southwestern wall, Room 1, 2m scale*

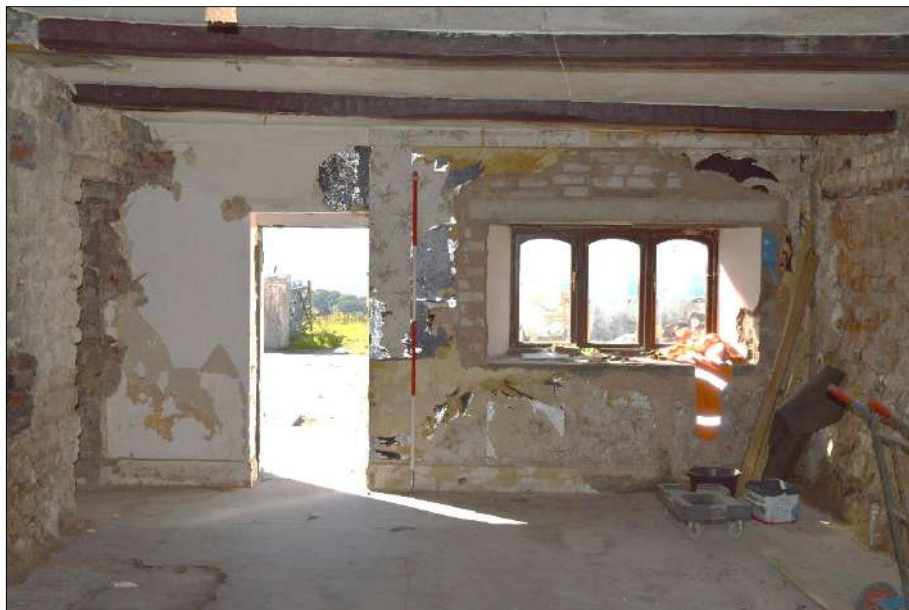
*Plate 20 (shot 47): Southeastern wall, Room 1, 2m scale*

- 6.16 The southeastern wall of Room 1 (Plate 20; Shot 47) largely had the internal render and some wallpaper remaining, so the nature of the fabric was unclear. The rectangular window (Plate 21; Shot 175) had very deep splayed reveals and was surmounted by a concrete lintel with blockwork above, suggesting that the position of the window as well as the glazing represents a relatively late alteration to the fabric of the farmhouse.

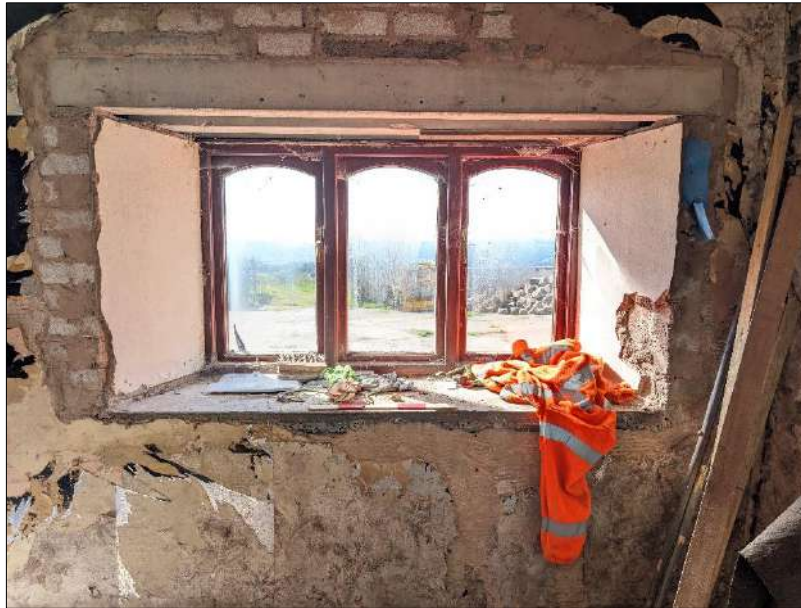
*Plate 21 (shot 175): Detail of window, southeastern wall, Room 1, 0.5m scale*

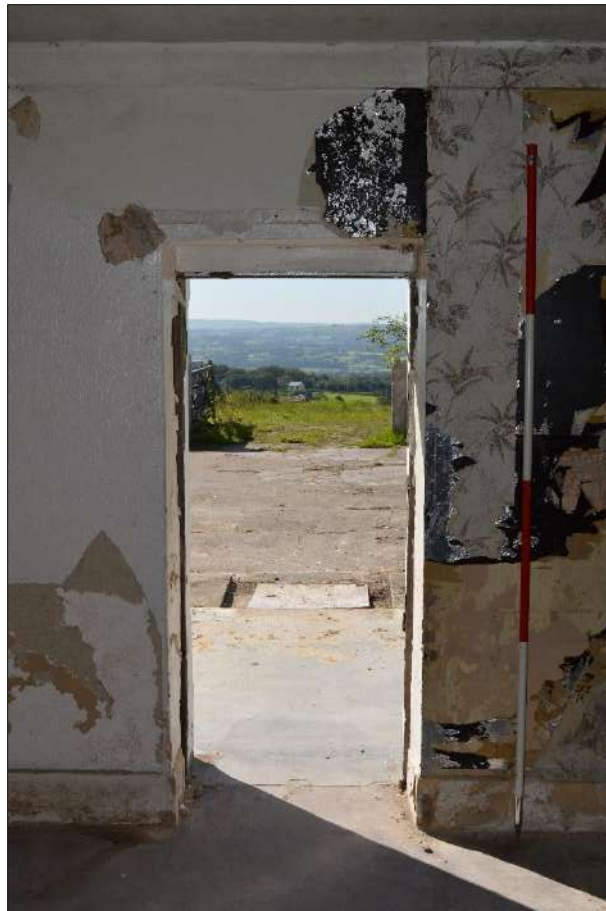
- 6.17 The entranceway in the southeastern wall of Room 1 (Plate 22; Shot 48) was a plain rectangular opening with timber lintel and jambs. The door had been removed.

*Plate 22 (shot 48): Detail of doorway in southeastern wall, Room 1, 2m scale*

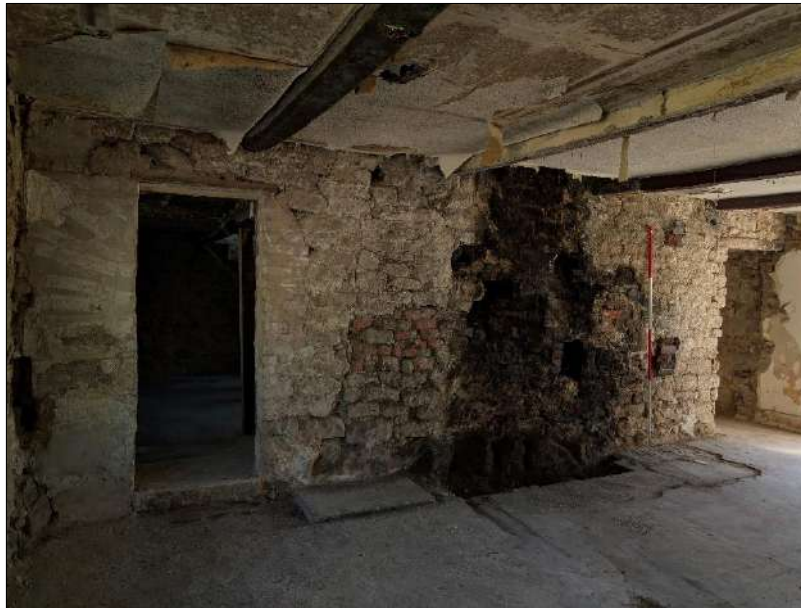
- 6.18 The northeastern wall of Room 1 (Plate 23; Shot 177) was of random coursed sandstone rubble construction, but with a number of later alterations.

*Plate 23 (shot 177): Northeastern wall, Room 1, 2m scale*

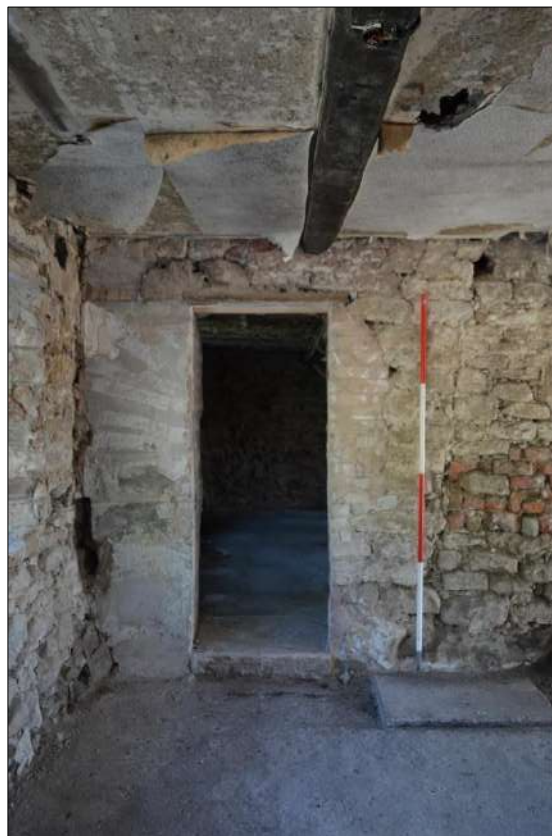
- 6.19 A doorway between Room 1 and Room 3 at the northwestern end of the wall (Plate 24; Shot 52) had a simple timber frame with brickwork to either side, demonstrating that it represents a later alteration to the original fabric of the building.

*Plate 24 (shot 52): Detail of doorway in northeastern wall of Room 1, 2m scale*

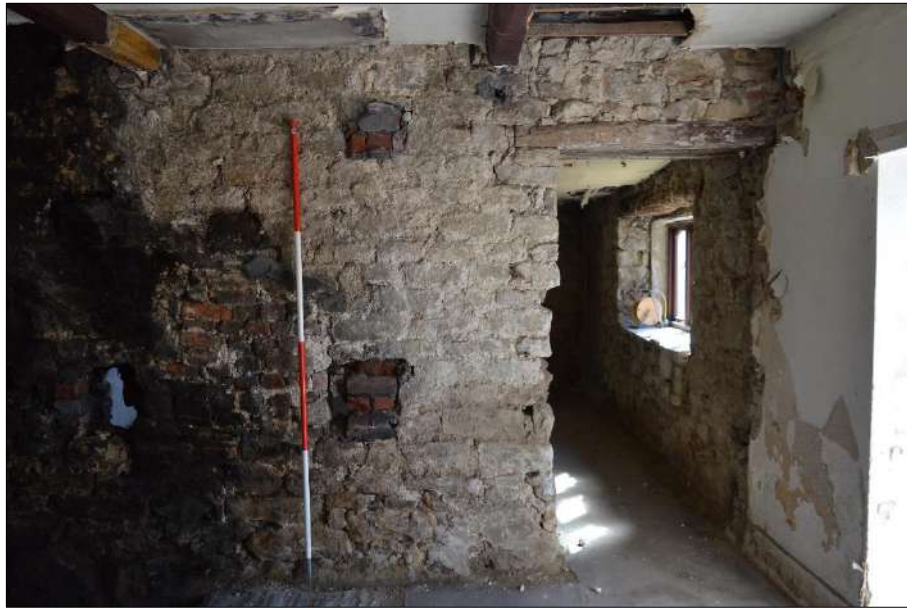
- 6.20 At the southeastern end of the wall a doorway between Room 1 and Room 2 (Plate 25; Shot 51) comprised a rectangular opening with a timber lintel that appeared to represent an original feature of the farmhouse.

*Plate 25 (shot 51): Detail of doorway in northeastern wall of Room 1, 2m scale*

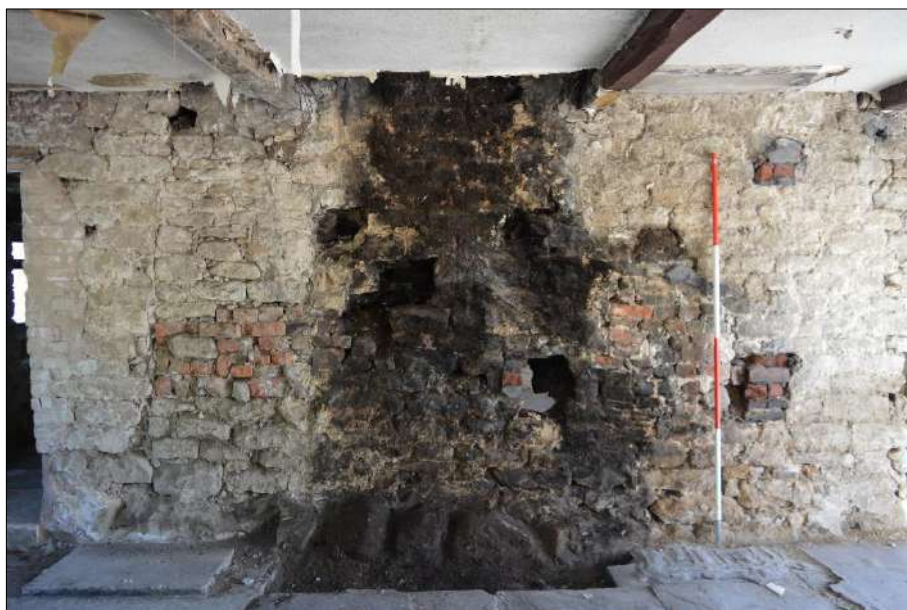
- 6.21 Between the two doorways a fireplace or range in the centre of the northeastern wall had been substantially removed (Plate 26; Shot 50), with evidence of its original extent visible on the floor (Plate 27; Shot 178) and ceiling (Plate 28; Shot 28) of the room, as well as on existing plans of the farmhouse provided by the client. Surrounding the fireplace a number of brick blocked openings in the masonry of the wall are likely to relate to the former presence of a cooking range.

*Plate 26 (shot 50): Detail of demolished fireplace on northeastern wall, Room 1, 2m scale*

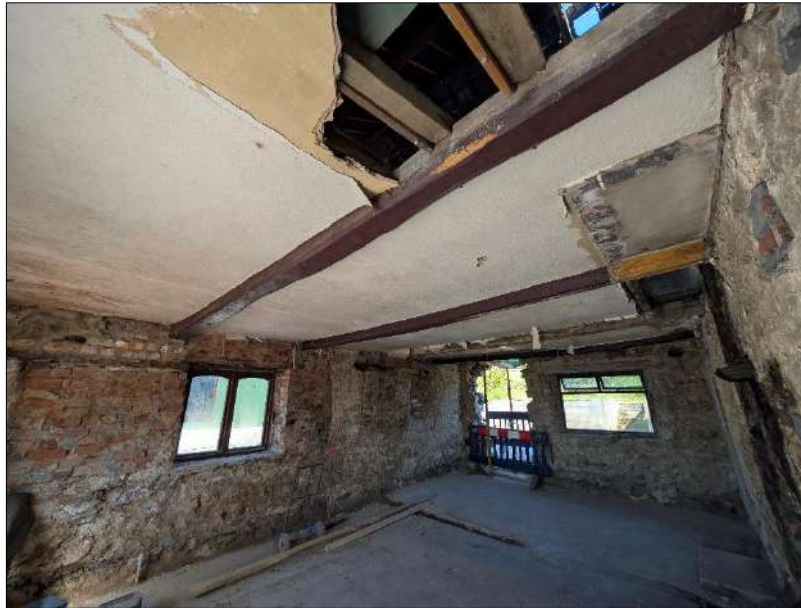
*Plate 27 (shot 178): Interior of Room 1, looking northwest, showing extent of demolished fireplace on ceiling, no scale*

- 6.23 The ceiling (Plate 31; Shot 54) of Room 1 comprised exposed hanging beams parallel with the roof line, with perpendicular joists above. The plasterboard ceiling was hung from battens attached to the sides of the joists (Plate 27; Shot 178).

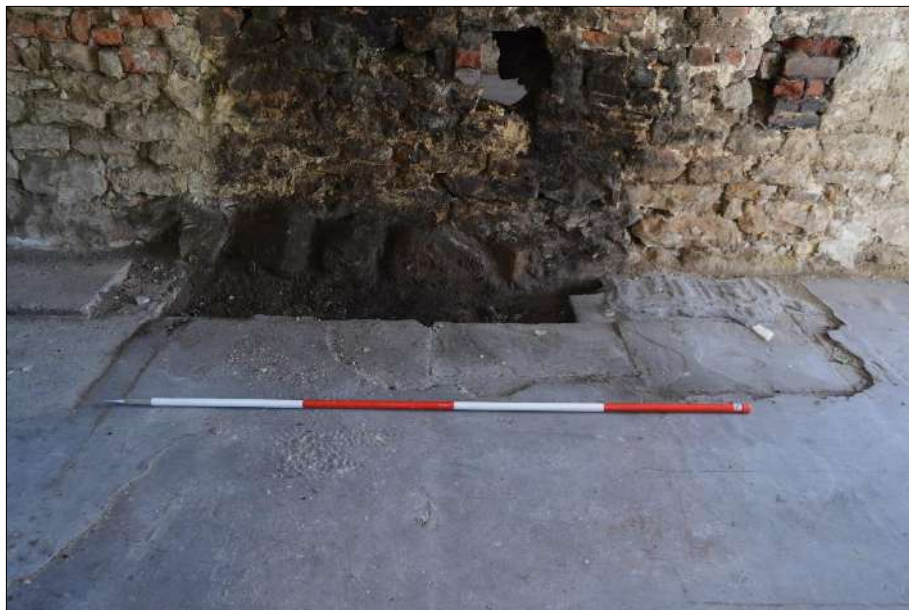
*Plate 28 (shot 53): Base of demolished fireplace, 2m scale*

- 6.24 The floor of Room 1 was of poured concrete, with rectangular limestone flags below, at least in the area of the hearth of the demolished fireplace (Plate 28; Shot 53).

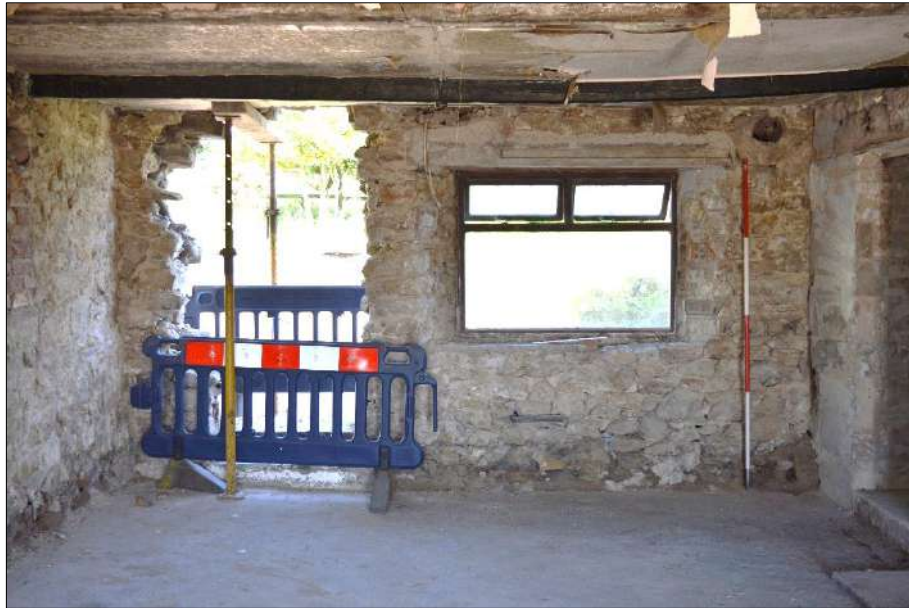
*Plate 29 (shot 41): Northwestern wall, Room 1, 2m scale*

- 6.22 The northwestern wall of Room 1 (Plate 29; Shot 41) was of random coursed sandstone rubble construction, with two openings. That to the southwest was a doorway leading to a demolished modern extension, the doorway had been heavily damaged presumably during the demolition work. To the northeast of the doorway, a rectangular window (Plate 30; Shot 42) with splayed reveals appeared to be in its original position, though some infill above the window suggested that it had been altered later.

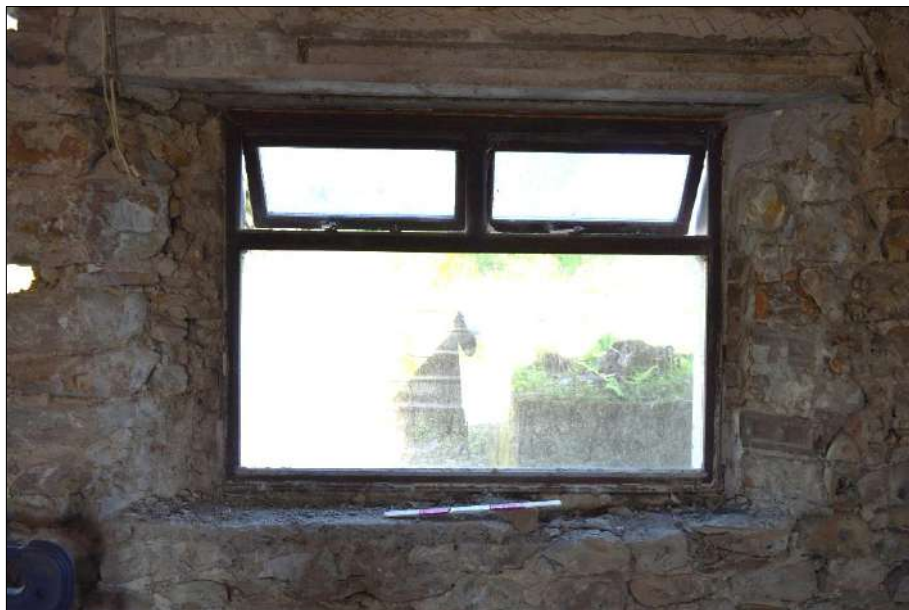
*Plate 30 (shot 42): Detail of window, northwestern wall, Room 1, 0.5m scale*

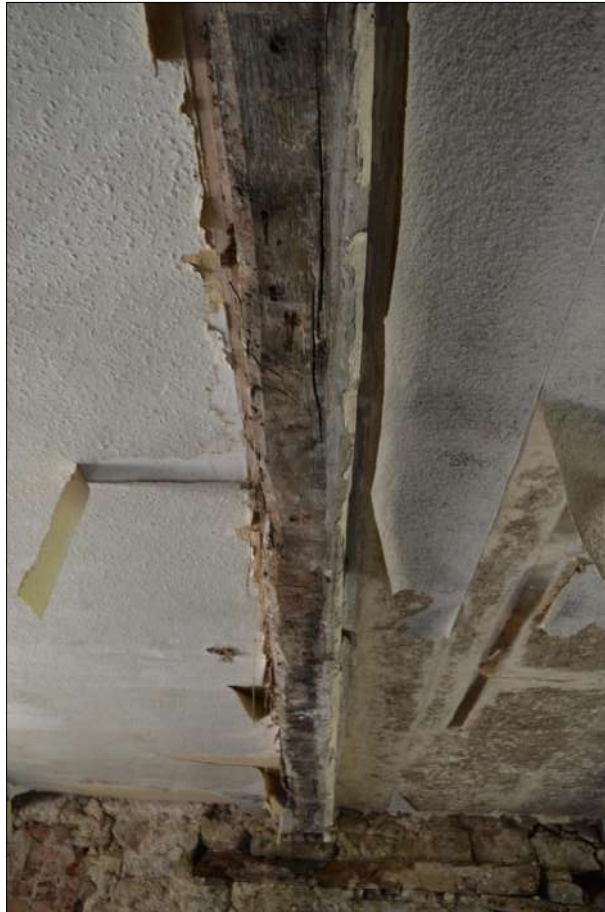
*Plate 31 (shot 54): Detail of ceiling beam, Room 1, no scale*

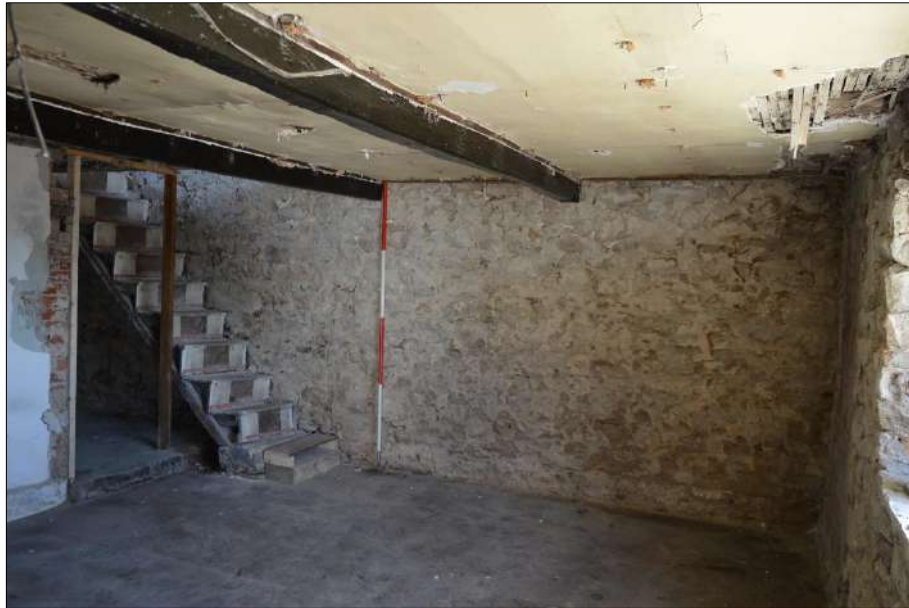
*Plate 32 (shot 55): Interior of Room 2, looking northeast, 2m scale*

- 6.25 Room 2 (Plate 32) was located to the northeast of Room 1 on the southeastern side of the farmhouse. The ceiling had exposed beams continuing from Room 1, but with a lath and plaster ceiling rather than a plasterboard one, and a concrete floor.

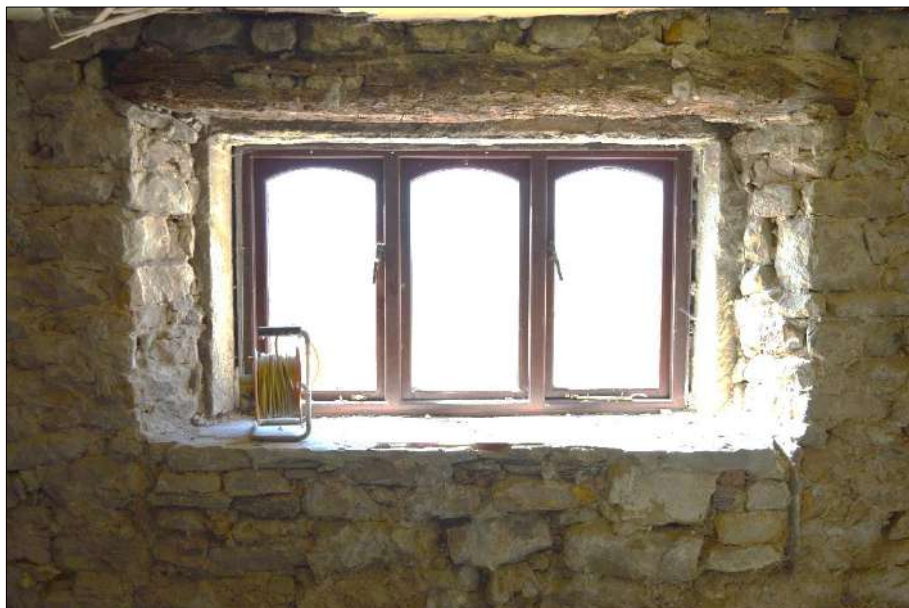
*Plate 33 (shot 57): Detail of window, southeastern wall, Room 2, 0.5m scale*

- 6.26 The rectangular window (Plate 33; Shot 57) in the southeastern wall of Room 2 had a timber lintel and a stone surround and appeared to be part of the original fabric of the farmhouse, although the frame and glazing were later replacements.

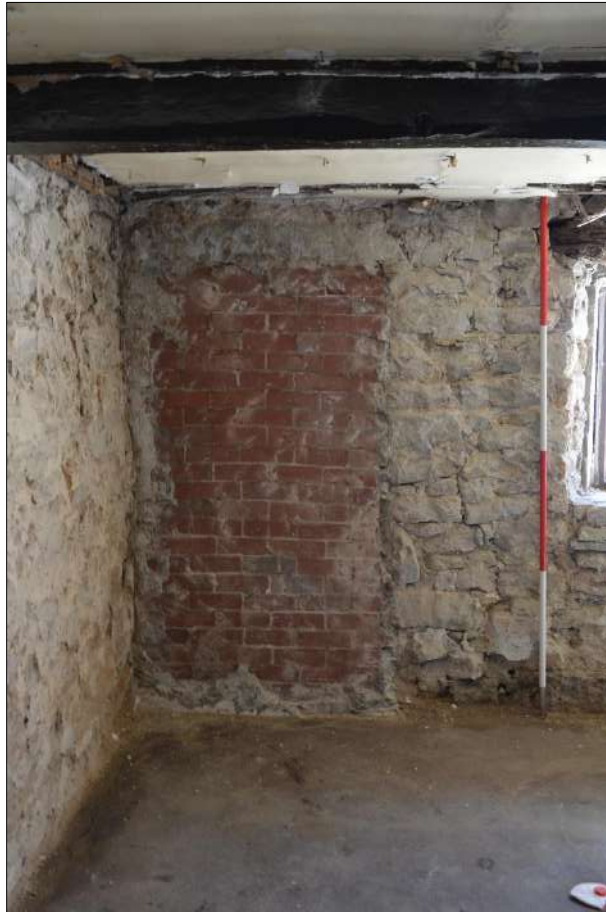
*Plate 34 (shot 60): Detail of blocked doorway in southeastern wall of Room 2, 2m scale*

- 6.27 To the northeast of the window a former doorway (Plate 34; Shot 60) was visible, blocked with machine pressed brick laid in stretcher bond. The blocking may have been inserted following the demolition of a southeast projecting extension or outshut depicted as part of the farmhouse on historic mapping from 1844 onwards, and demolished recently due to its unstable condition.

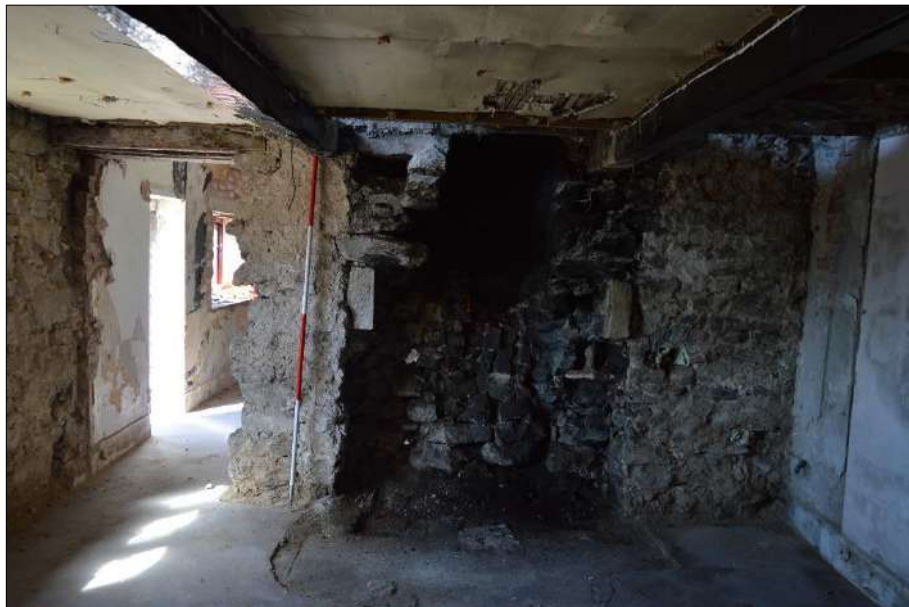
- 6.28 The southwestern wall of Room 2 (Plate 35; Shot 61) had a doorway leading to Room 1 at the southeastern end, and centrally placed demolished fireplace (Plate 36; Shot 62), utilising the same flue as the fireplace in Room 1.

*Plate 35 (shot 61): Southwestern wall of Room 2, 2m scale*

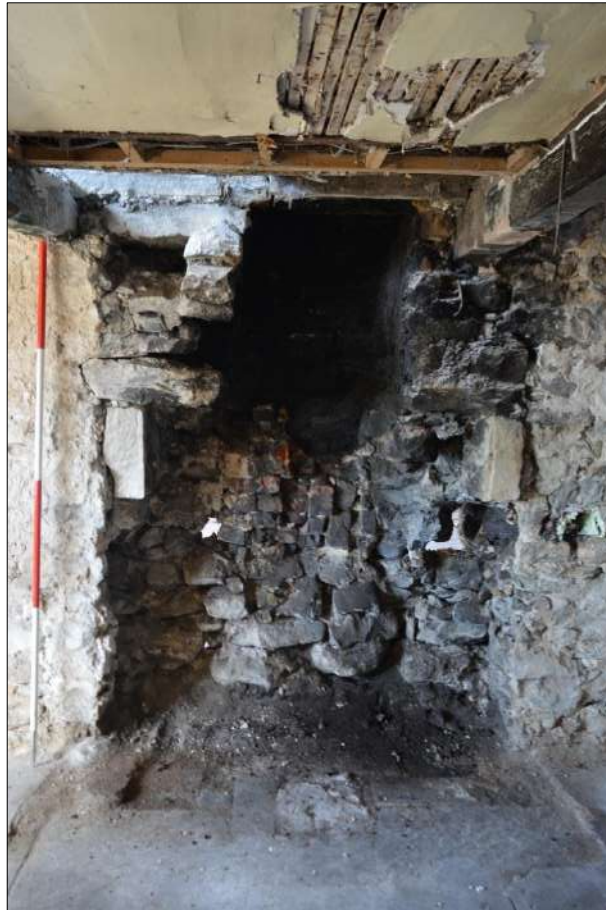
*Plate 36 (shot 62): Detail of demolished fireplace, southwestern wall of Room 2, 2m scale*

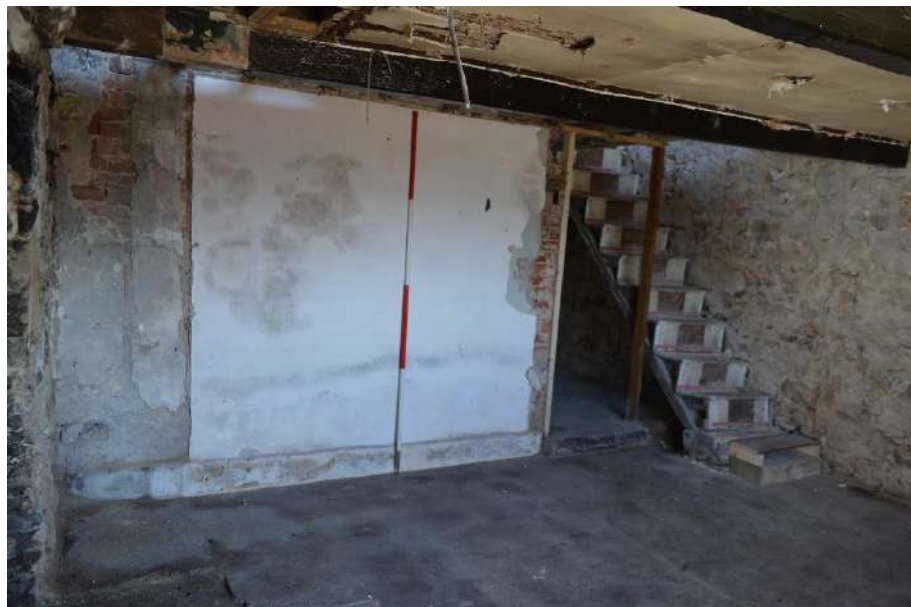
*Plate 37 (shot 65): Northwestern wall of Room 2, 2m scale*

- 6.29 The northwestern wall of Room 2 (Plate 37; Shot 65) comprised a rendered brick partition that did not extend across the full width of the bay, with access to Room 3 and a staircase leading to the first floor to the northeast. The position of the partition was to the northwest of the ridge line of the roof, as represents a later alteration to the original fabric of the farmhouse. It is likely that the removed partition in Room 1, which is on the same line, would have been very similar in character and construction.

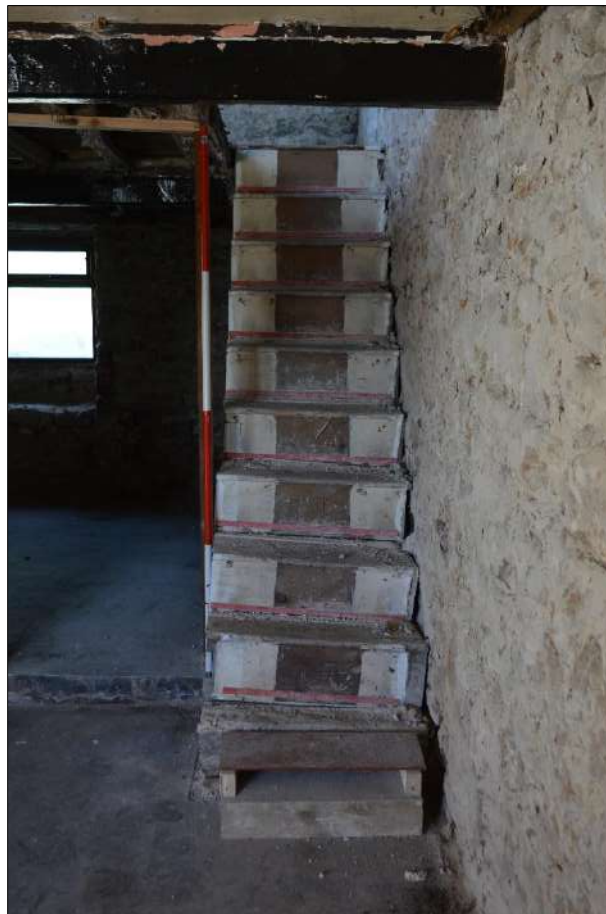
*Plate 38 (shot 67): Detail of staircase, Room 2, 2m scale*

- 6.30 The straight staircase (Plates 38 and 39; Shots 67 and 70) leading from Room 2 to the first floor was of fairly crude construction. The northeastern side of the staircase abutted the northeastern wall of Room 2 and both sides of the staircase rested on diagonal string beams between the ceiling beam and the floor (Plate 40; Shot 69). There was no newel post or handrail. The treads were of timber construction and the painting of the outside edges of the risers indicated that the stairs were carpeted with a runner, although later gripper strips across the full width of the stairs suggest the runner was replaced with a full width carpet.
