**HISTORIC BUILDING SURVEY REPORT:**  
**CUCKOO HALL, HIGHER ROAD, LONGRIDGE, LANCASHIRE**

Planning Reference: 3/2024/0121  
NGR: SD 63896 39018  
AAL Site Code: LOHR 25  
OASIS Reference Number: allenarc1-536093

By  
Allen Archaeology Ltd  
Report Number AAL 2025117

September 2025

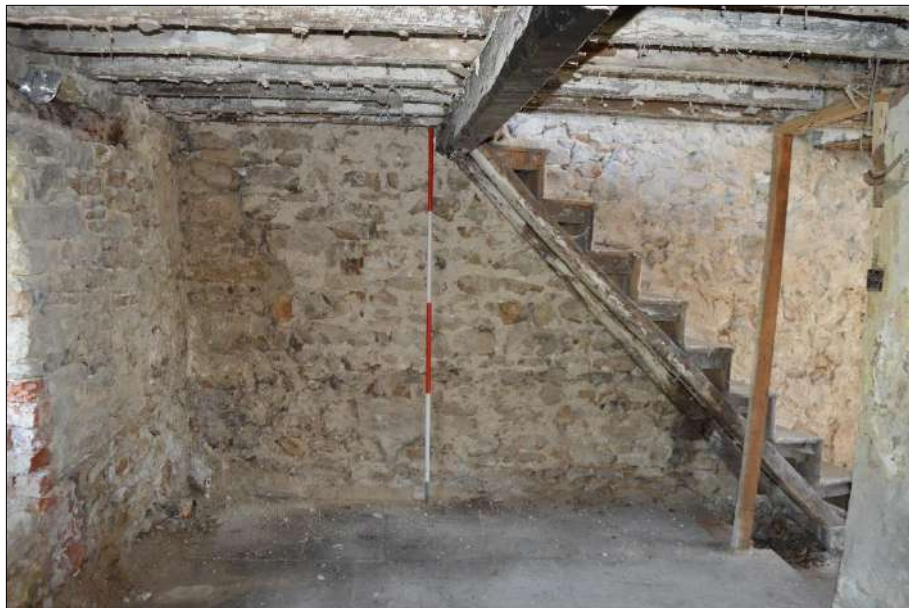
- 6.31 The northeastern wall of Room 2 was of random coursed sandstone rubble construction. There was little evidence of alteration. The wall was abutted by the staircase leading to the first floor.

*Plate 40 (shot 69): Northeastern wall of Room 2, 2m scale*

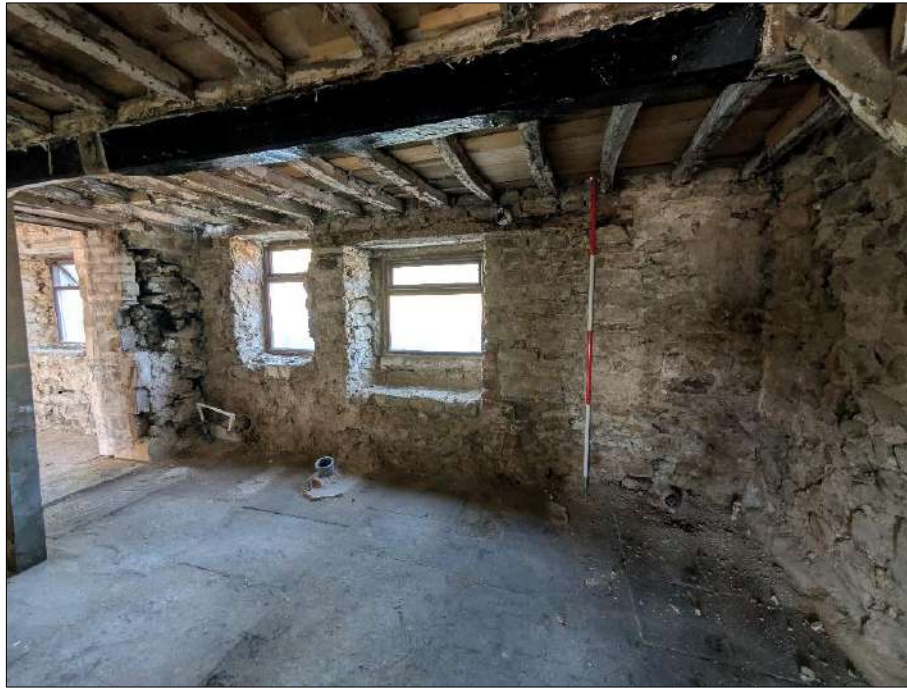
*Plate 41 (shot 182): Interior of Room 3, looking northwest, 2m scale*

- 6.32 The floor level of Room 3 was at a higher level to that of Room 2. The floor comprised large rectangular sandstone flags (Plate 41; Shot 182). There was no ceiling in Room 3, the underside of the floorboards of the first floor being visible resting on the joists carried by the exposed beam (Plate 42; Shot 75).

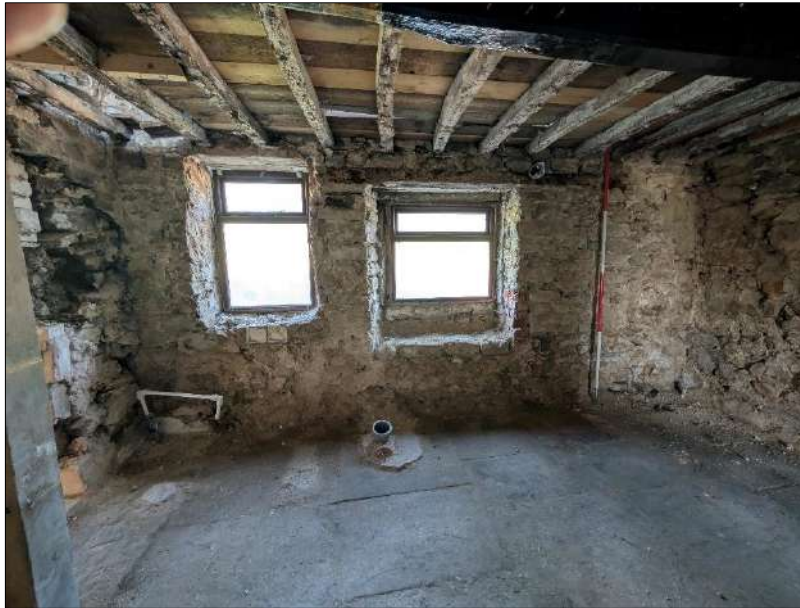
- 6.33 The northwestern wall of Room 3 was of random coursed sandstone rubble construction and was pierced by two windows (Plate 43; Shot 181).

Plate 43 (shot 181): Northwestern wall of Room 3, 2m scale

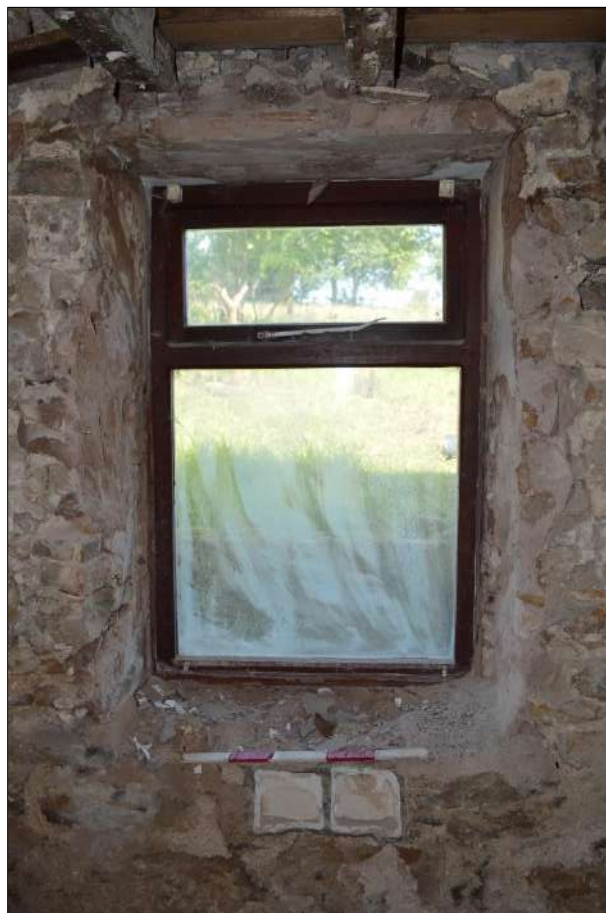
Plate 44 (shot 73): Detail of window, northwestern wall, Room 3, 0.5m scale

- 6.34 The southwestern window in the northwestern wall of Room 3 (Plate 44; Shot 73) was a rectangular opening with deep reveals and little evidence of alteration, although the wooden frame and glazing were recent. The window to the northeast (Plate 45; Shot 71) had a patch of brickwork on the northeastern side which suggested that the window opening may have been enlarged, but then subsequently partially blocked when the modern frame was inserted. A timber lintel above, much wider than the window itself, suggests that there may have originally been a substantial entranceway in this part of the farmhouse building.

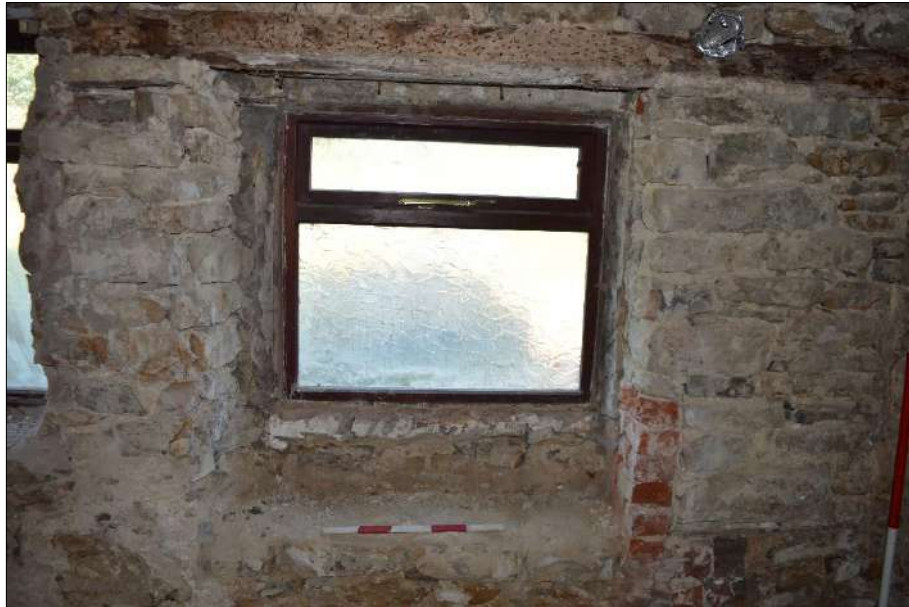
*Plate 45 (shot 71): Detail of window, northwestern wall, Room 3, 0.5m scale*

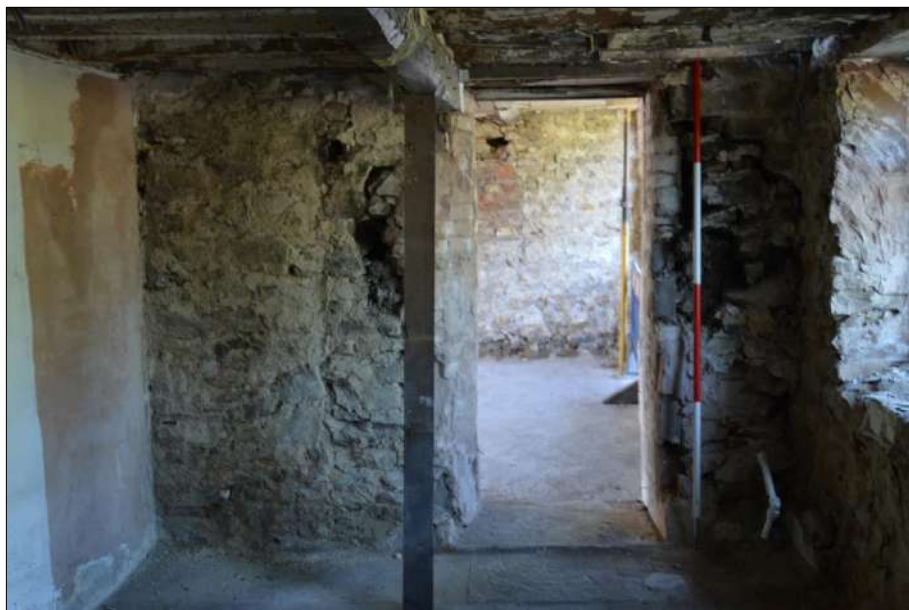
*Plate 46 (shot 68): Southwestern wall of Room 3, 2m scale*

- 6.35 The southwestern wall (Plate 46; Shot 68) of Room 3 was of random coursed sandstone rubble construction and pierced by a doorway leading to Room 1.

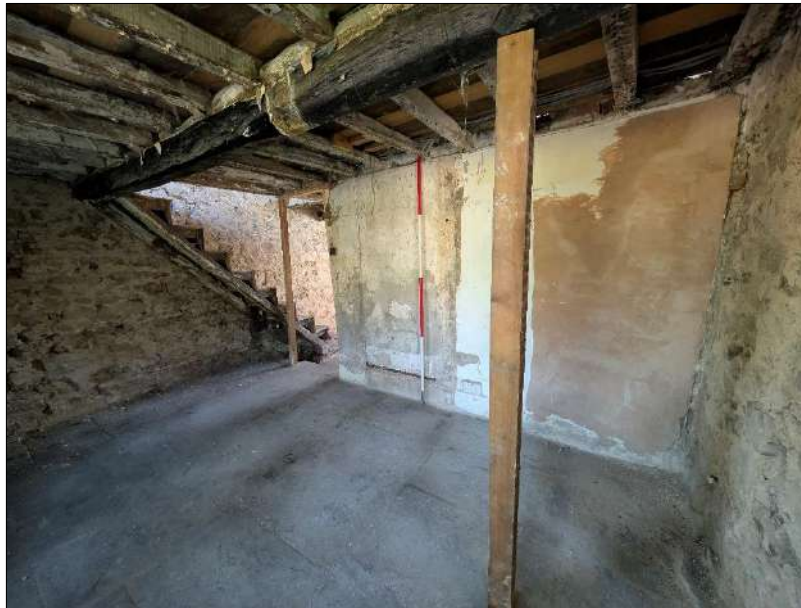
- 6.36 The southeastern wall of Room 3 (Plate 47; Shot 180), forming the partition between Room 3 and Room 2 was rendered but is known to be of brick construction.

*Plate 47 (shot 180): Southwestern wall of Room 3, 2m scale*

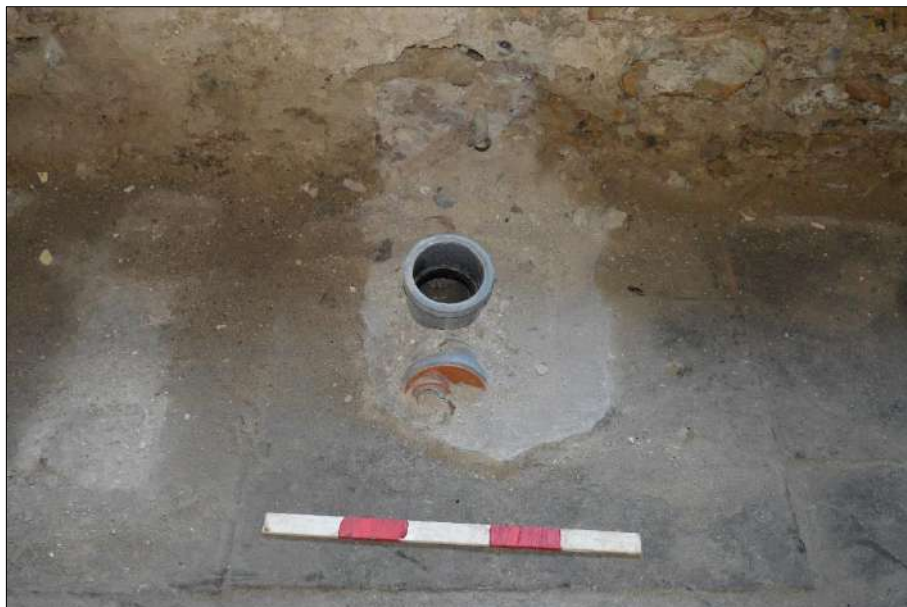
- 6.37 Set into the floor of Room 3 there was a waste pipe (Plate 48; Shot 74) from a removed toilet associated with the recent use of the room as a bathroom. Other elements of the plumbing system also survived in Room 3, all representing modern alterations to the farmhouse building.

*Plate 48 (shot 74): Detail of pipework associated with modern bathroom fittings, Room 3, 0.5m scale*

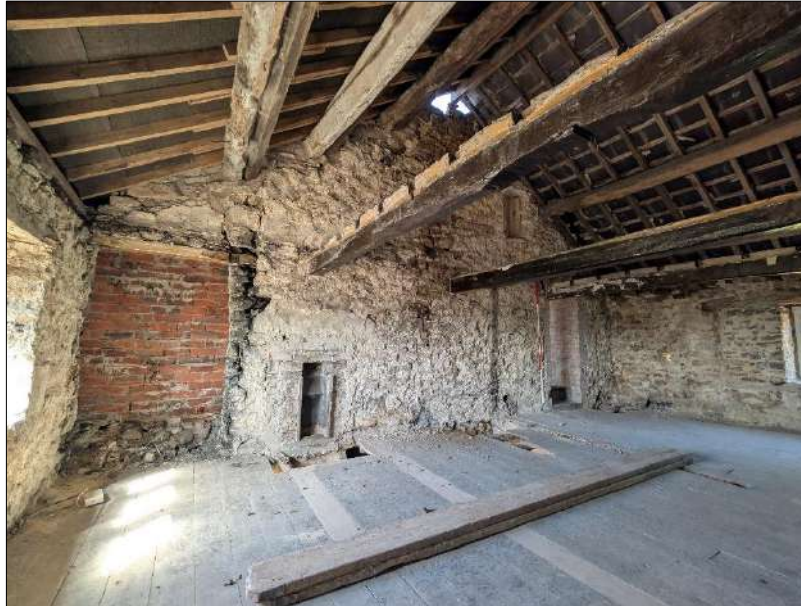
*Plate 49 (shot 183): Interior of Room 4, looking northwest, 2m scale*

- 6.38 The room designated as Room 4 comprised the northeastern room on the first floor of the farmhouse (Plate 49; Shot 183).

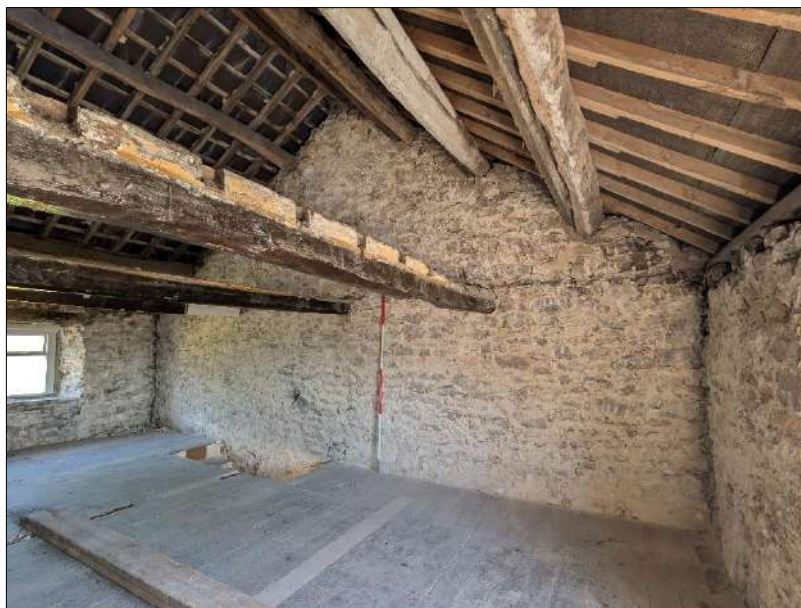
*Plate 50 (shot 185): Northeastern wall of Room 4, 2m scale*

- 6.39 The northeastern wall of Room 4 (Plate 50; Shot 185) was of random coursed sandstone rubble construction, with little sign of alteration. Three beams aligned with the ridge line of the farmhouse were present at the eaves level of the roof, demonstrating that the first-floor rooms had had a ceiling, with a separate loft space above, this floor level having subsequently been removed. Two of the beams were likely to be later replacements, but that to the southeast retained the mortises for the floor joists (Plate 51; Shot 87) and is likely to represent an original member of the building's fabric.

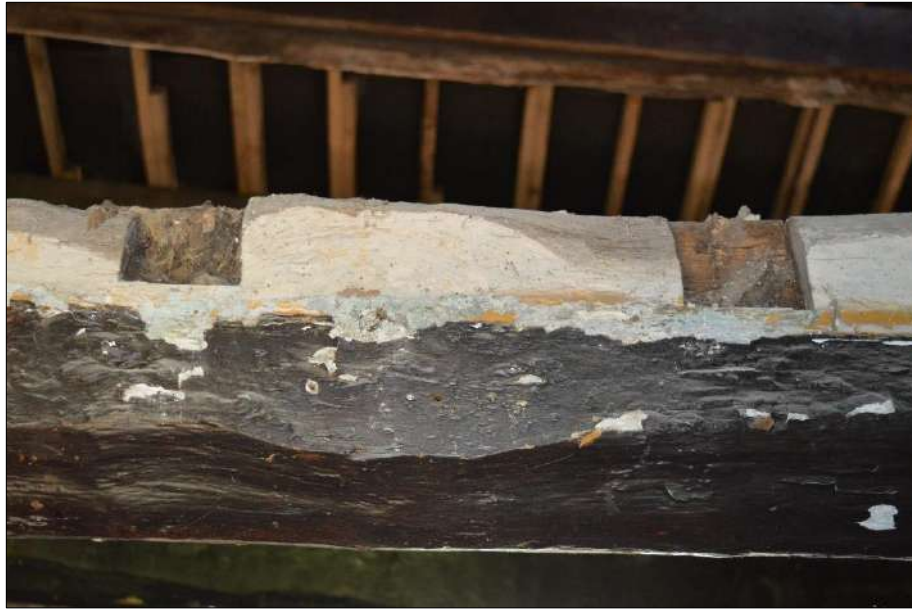
*Plate 51 (shot 87): Detail of mortise joints in ceiling beam, Room 4, no scale*

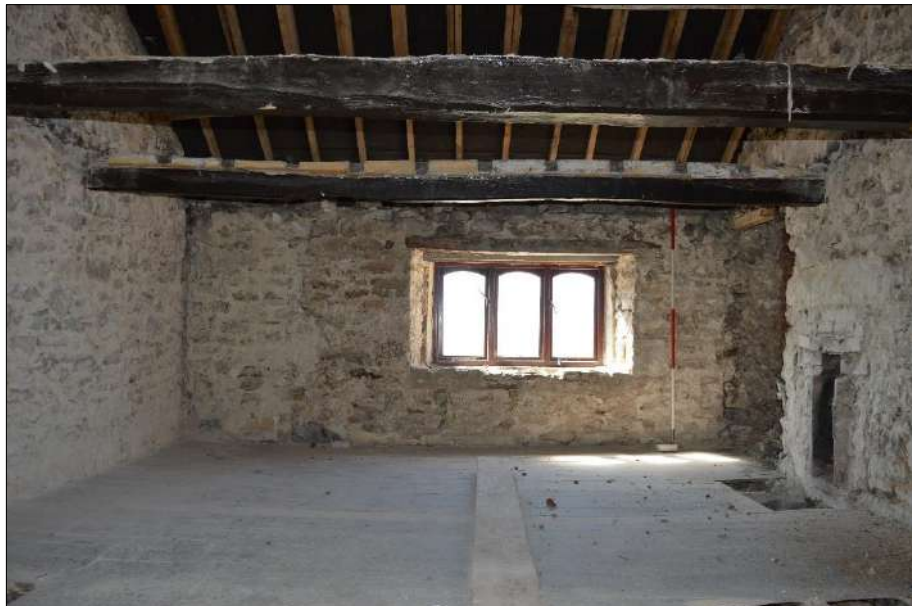
*Plate 52 (shot 83): Southeastern wall of Room 4, 2m scale*

- 6.40 The southeastern wall of Room 4 (Plate 52; Shot 83) was pierced by a landscape rectangular window (Plate 53; Shot 86) with splayed reveals and a timber lintel above. The position of the widow opening is likely to be original, although the wooden frame and glazing are later replacements. To the northeast of the window in the corner of the room there was thicker rendering on the wall, although it was not clear whether this was associated with a structural alteration.

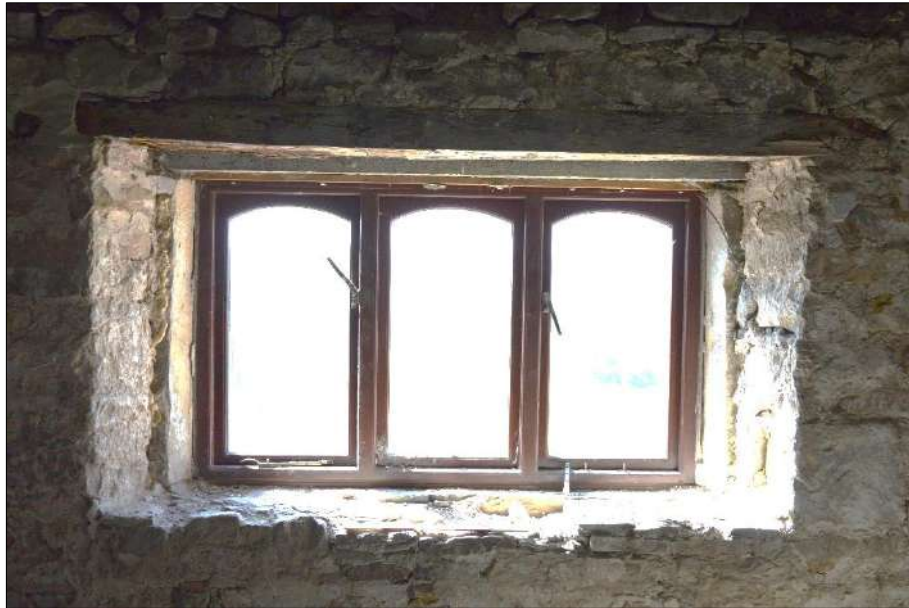
*Plate 53 (shot 86): Detail of window, southeastern wall of Room 4, 0.5m scale*

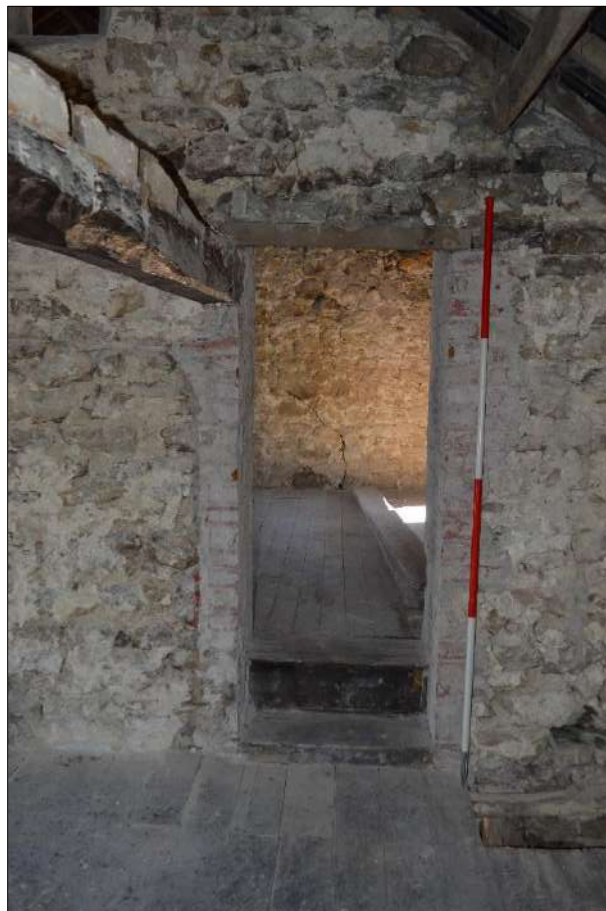
- 6.41 The southwestern wall of Room 4 had a doorway leading to Room 5 (Plate 54; Shot 79) at the northwestern end with a timber lintel and brick jambs, which is likely to represent an alteration to the original fabric of the building. At the southeastern end of the wall a blocked doorway (Plate 55; Shot 82) between Room 4 and Room 5 was blocked with machine made brick, which may have been inserted when the doorway at the northwestern end of the wall was added.

*Plate 54 (shot 79): Detail of doorway, southwestern wall of Room 4, 2m scale*

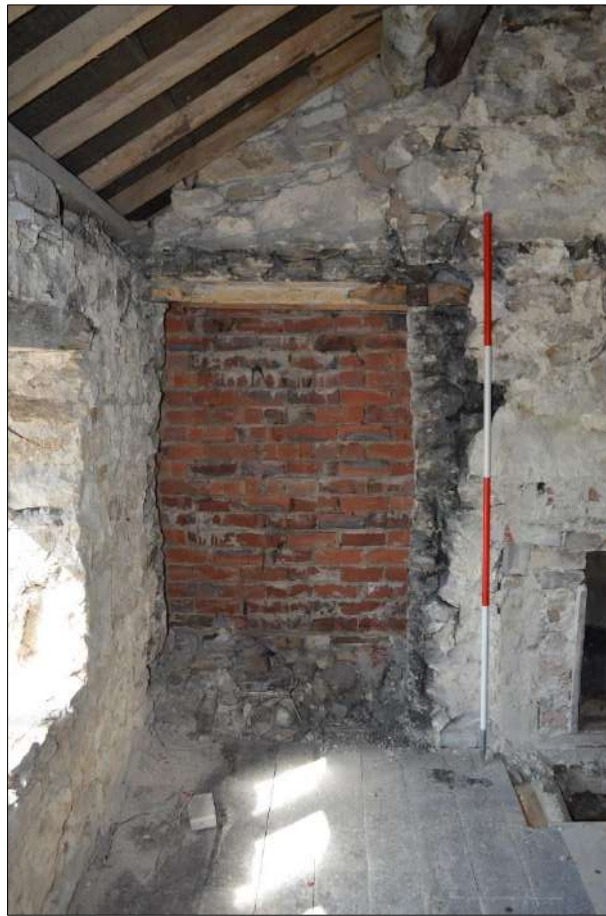
*Plate 55 (shot 82): Detail of blocked doorway, southwestern wall of Room 4, 2m scale*

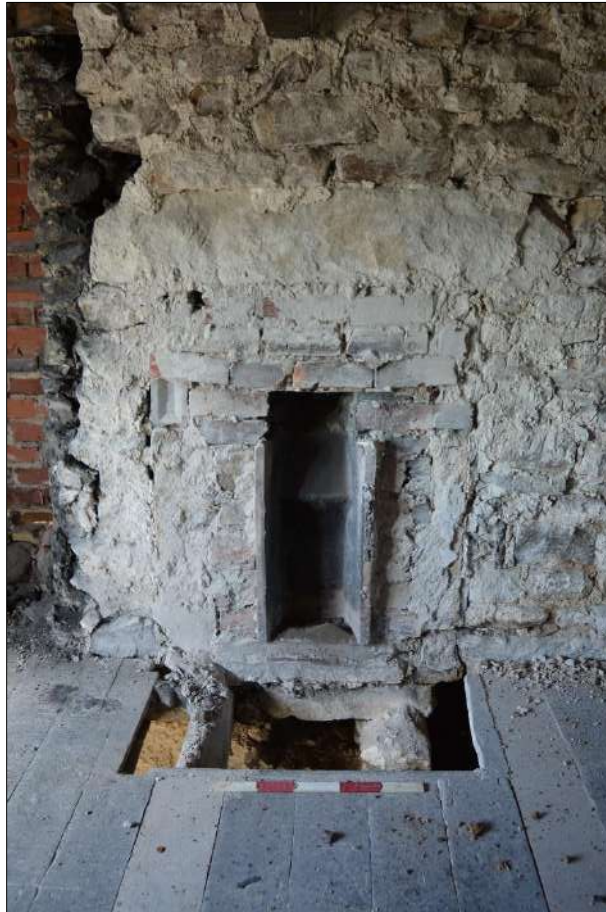
*Plate 56 (shot 81): Detail of fireplace, southwestern wall of Room 4, 0.5m scale*

- 6.42 Between the two doorways in the southwestern wall of Room 4 there was a fireplace (Plate 56; Shot 81), which probably shared the same flue as those noted in Rooms 1 and 2 on the ground floor. The original opening has a substantial sandstone lintel above and has largely been blocked with brick contemporary with the insertion of a fireclay fire back. The grate and all other fittings have been removed.

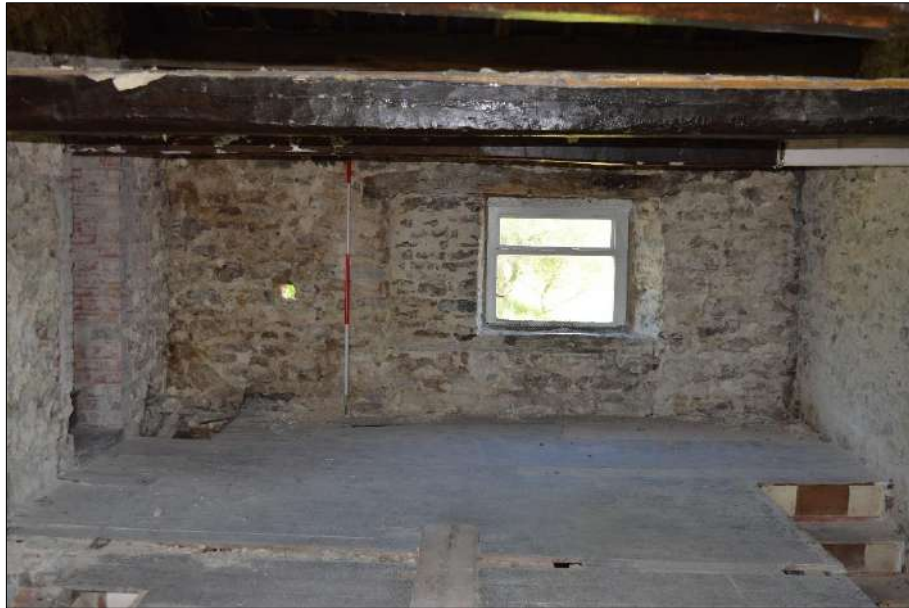
- 6.43 The northwestern wall of Room 4 (Plate 57; Shot 76) was pierced by a window (Plate 58; Shot 78), which represented the altered form of a larger window opening, with a timber lintel above; it had been largely blocked with sandstone rubble when the window was reduced in size. The extant window had a splayed reveal on the northeastern side and a flat reveal on the southwestern side where the blocking had been inserted. The large size of the original window opening and that in the southeastern wall of the room suggests the possibility that there may have been a loom located in the room, with textile manufacture used to supplement the income from farming.

*Plate 57 (shot 76): Northwestern wall of Room 4, 2m scale*

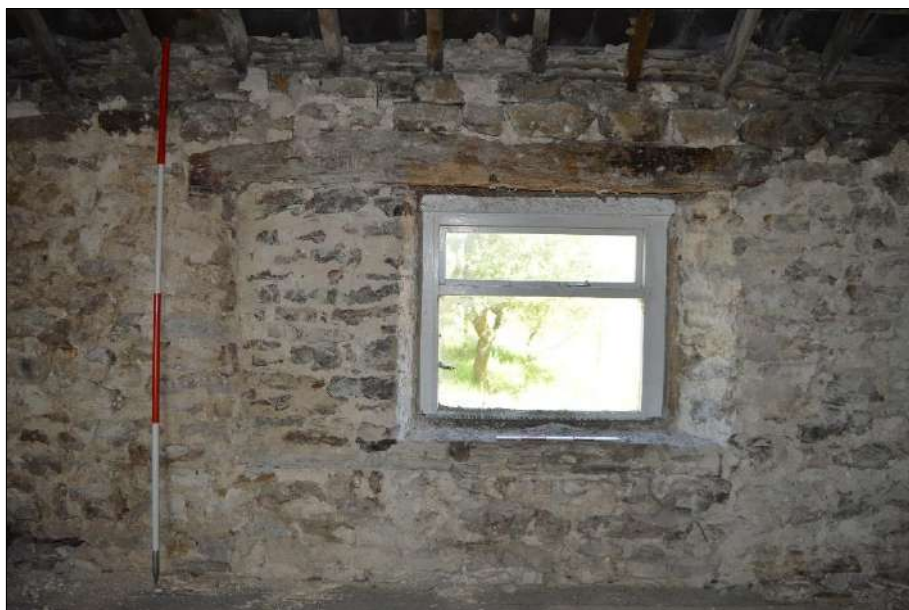
*Plate 58 (shot 78): Detail of window, northwestern wall of Room 4, 2m and 0.5m scales*

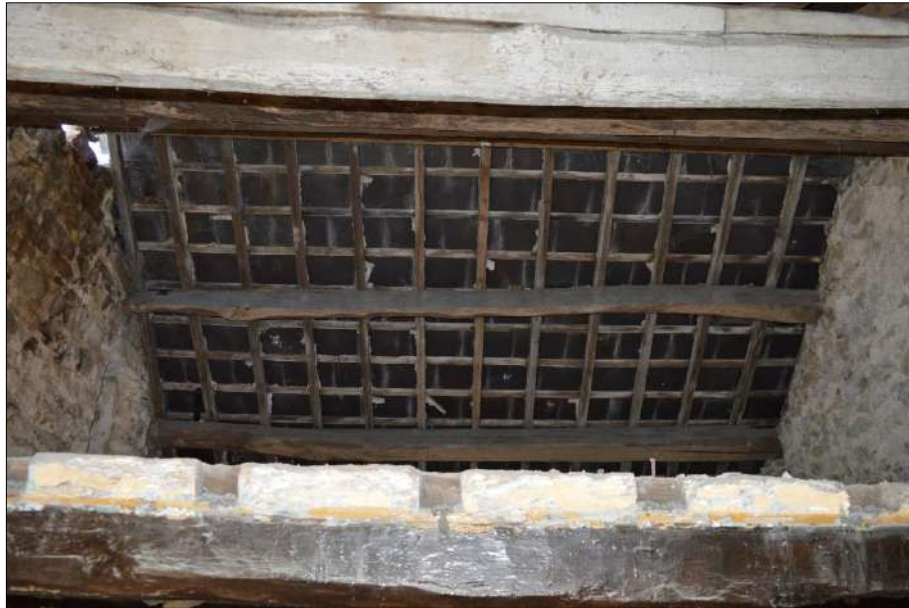
*Plate 59 (shot 77): Detail of roof structure, Room 4, no scale*

- 6.44 The floor of the room comprised timber floorboards laid parallel to the ridge line of the roof. The roof structure (Plate 59; Shot 77) was visible as the ceiling had been removed and comprised substantial beams resting directly on the slopes of the walls, carrying rafters and purlins on which the roof was laid. Some elements of the roof structure had been replaced but several of the beams were likely to be original.

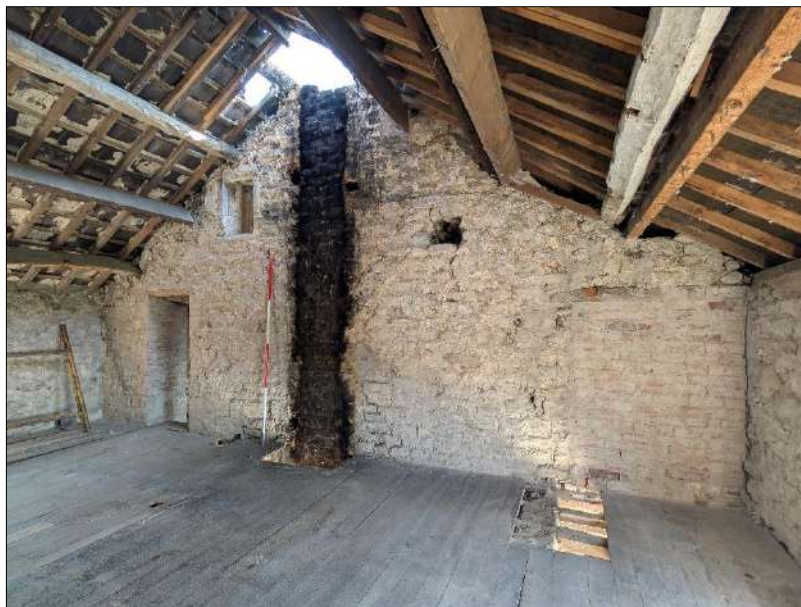
- 6.45 The room designated as Room 5 (Plate 60; Shot 189) was the southwestern room on the first floor of the farmhouse. The floor of Room 5 was at a slightly higher level than that of Room 4, with a single low step in the doorway between the two rooms. The floor was of timber board construction as in Room 4.

*Plate 60 (shot 189): Interior of Room 5, looking northeast, 2m scale*

- 6.46 The northeastern wall of the room (Plate 60; Shot 189) was of random coursed sandstone rubble masonry. The doorway between Room 5 and Room 4 (Plate 61; Shot 89) had a timber lintel and brick jambs, as on the opposite side. There was no door hung in the opening.

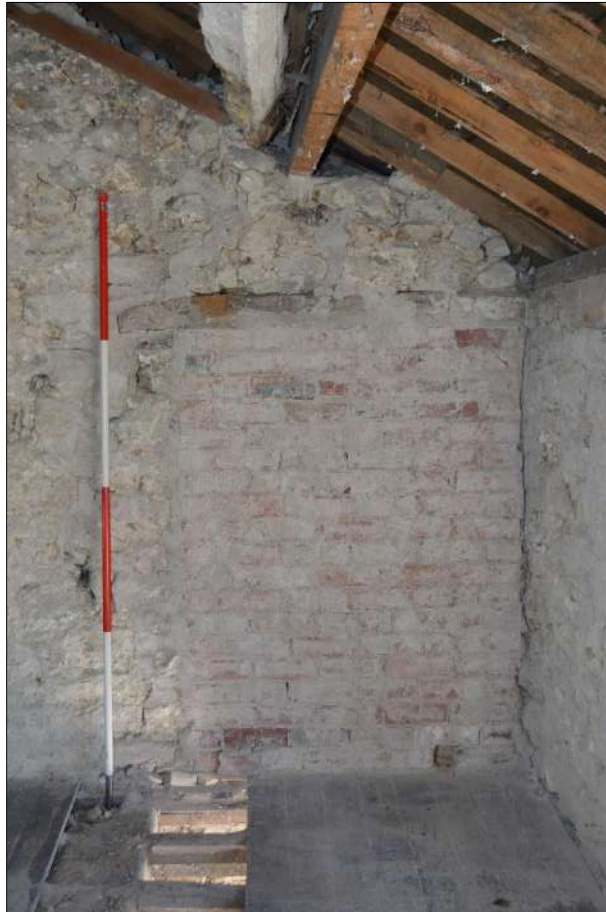
*Plate 62 (shot 92): Detail of blocked doorway, northeastern wall of Room 5, 2m scale*

- 6.47 At the southeastern end of the wall the blocked doorway between the first-floor rooms was visible, with brick blocking as before.
- 6.48 Between the two doorways the northeastern wall of Room 5 was stained with soot at the back of the flue of the fireplaces within the farmhouse (Plate 60; Shot 189). A rectangular gap in the floorboards in Room 5 suggests that a fireplace in this room had been removed. Between the flue and the blocked door, a gap in the masonry of the wall (Plate 63; Shot 91) is likely to represent a socket for a ceiling beam, although no beams were *in situ* in Room 5. Between the flue and the open doorway, a small rectangular opening at loft level with chamfered jambs (Plate 64; Shot 90) suggests that there had been a ceiling present in Room 5 with a separate loft above.

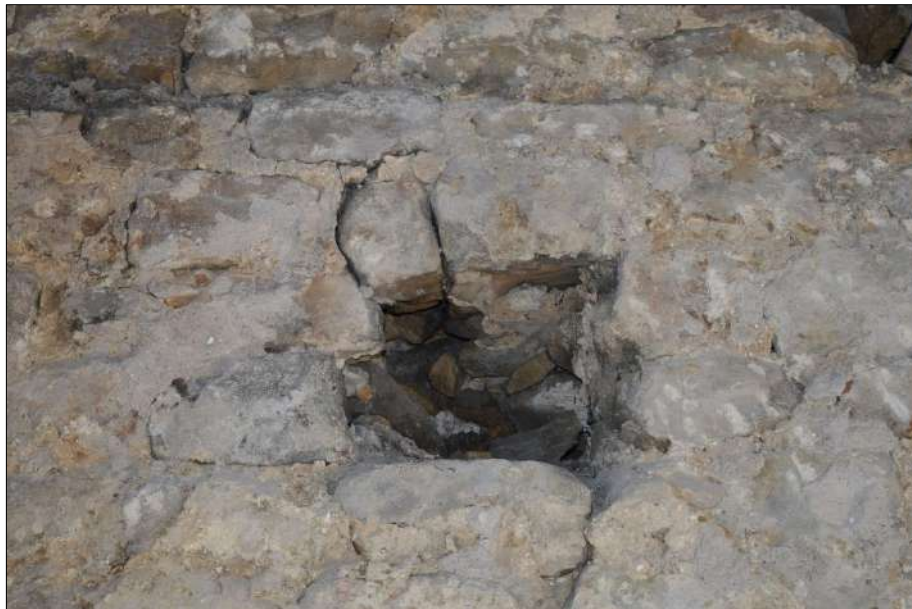
*Plate 63 (shot 91): Detail of possible socket for ceiling beam, northeastern wall of Room 5, no scale*

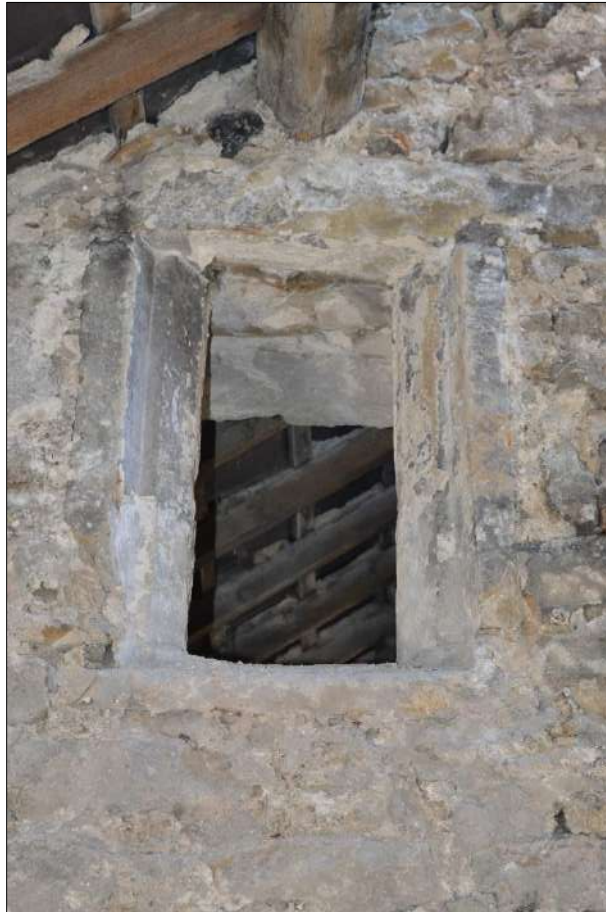
*Plate 64 (shot 90): Detail of loft level opening, northeastern wall of Room 5, no scale*

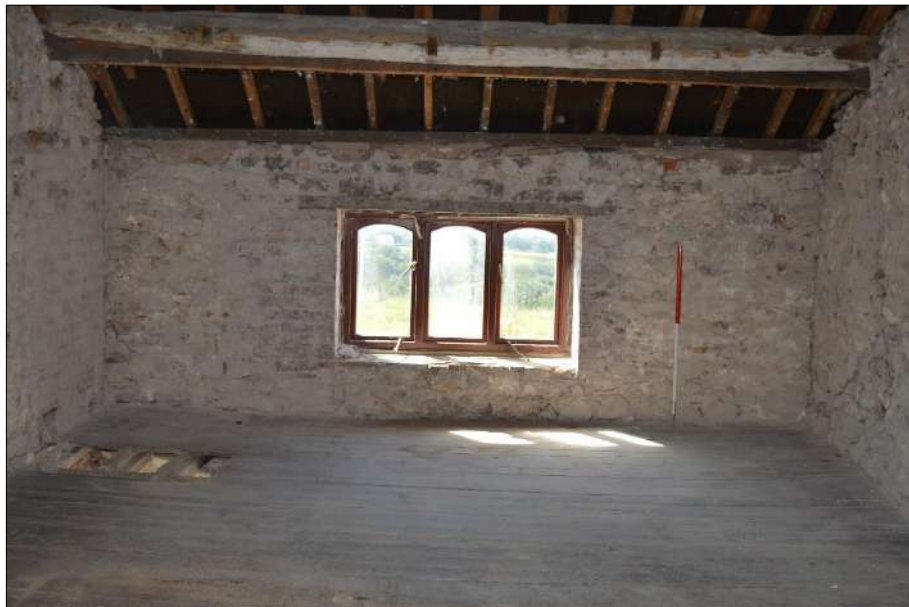
- 6.49 The southeastern wall of Room 5 (Plate 65; Shot 97) was pierced by a window (Plate 66; Shot 98) with a timber lintel above and brick infill to either side, more extensively to the northeast, indicating that the original window opening had been altered to reduce its size.

*Plate 65 (shot 97): Southeastern wall of Room 5, 2m scale*

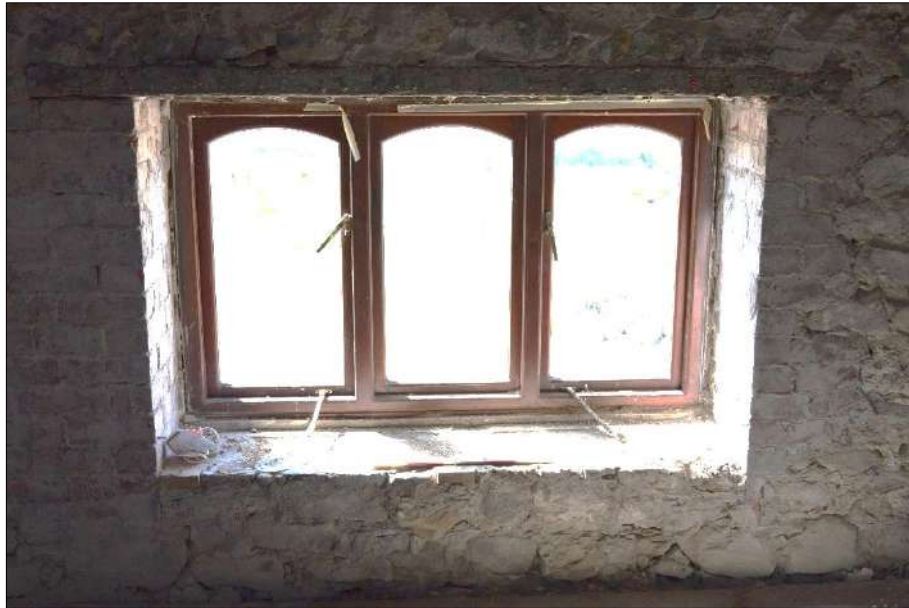
*Plate 66 (shot 98): Detail of window, southeastern wall of Room 5, 0.5m scale*

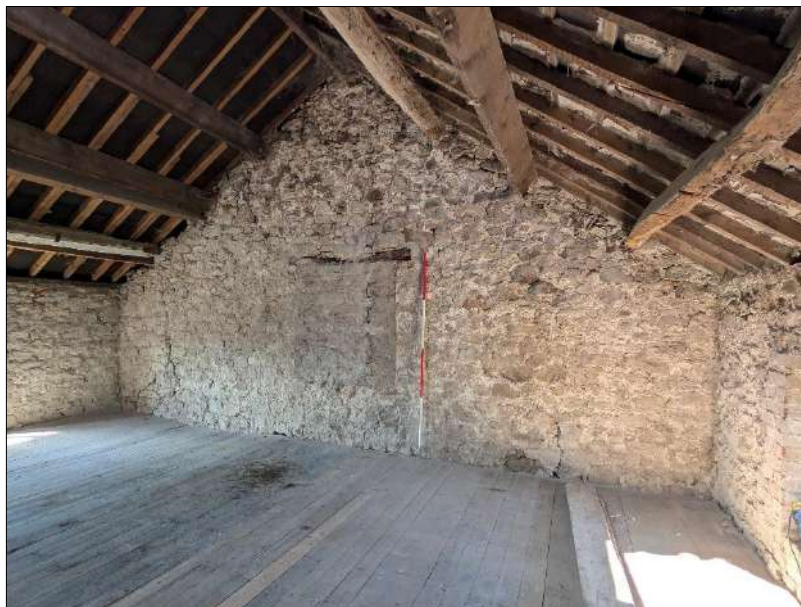
- 6.50 The southwestern wall of Room 5 (Plate 67; Shot 187) was of random coursed sandstone rubble construction, with a blocked opening (Plate 68; Shot 88) in the central part of the wall. The opening comprised a substantial square window that had been blocked with sandstone rubble. It was surmounted by a timber lintel likely to be roughly at the level of the removed ceiling in Room 5, although no sockets for ceiling beams were immediately visible in the southeastern wall.

*Plate 67 (shot 187): Southwestern wall of Room 5, 2m scale*

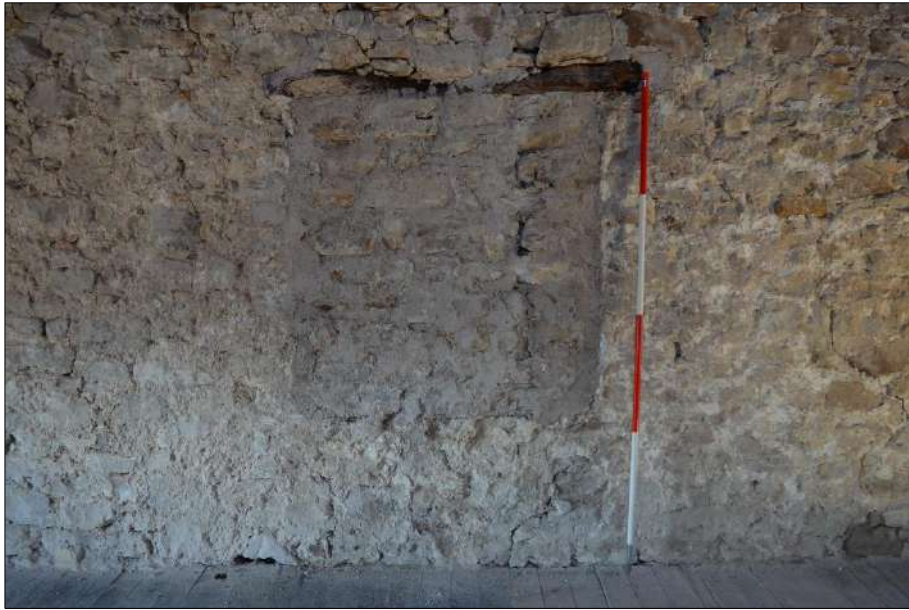
*Plate 68 (shot 88): Detail of blocked window, southwestern wall of Room 5, 2m scale*

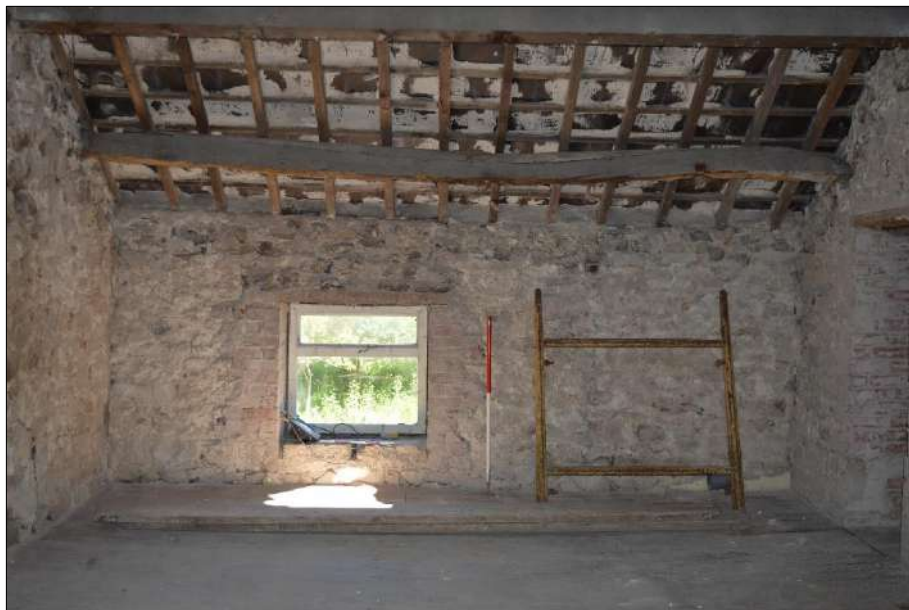
*Plate 69 (shot 94): Northwestern wall of Room 5, 1m and 0.5m scales*

- 6.51 The northwestern wall of Room 5 (Plate 69; Shot 94) was of sandstone rubble construction with a single window (Plate 70; Shot 95). The window was square with a timber lintel and flat reveals formed from brick infill to either side of the window, indicating that the window opening was an alteration to the original fabric of the farmhouse, and that it may have been preceded by a larger window, as noted on other parts of the first floor.

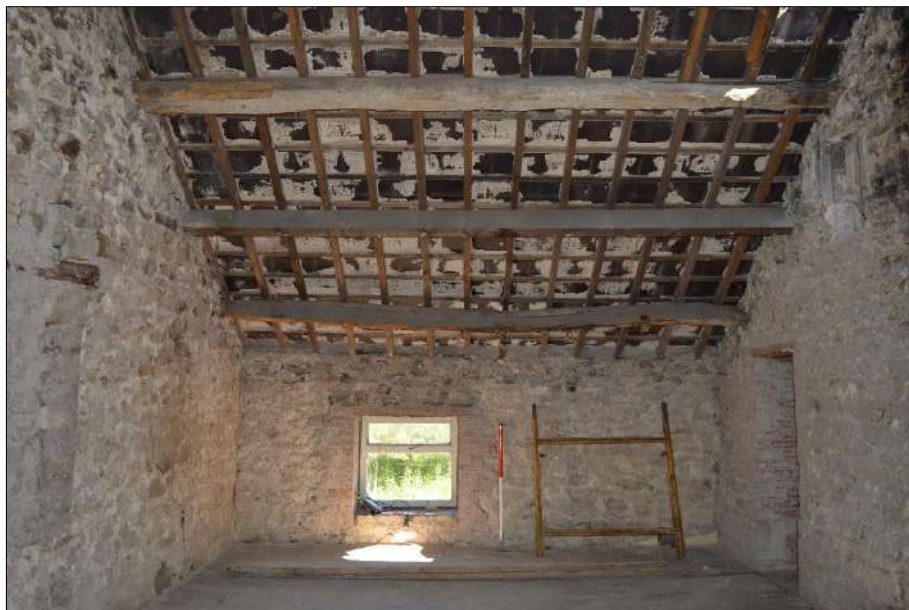
*Plate 71 (shot 93): Northwest side of Room 5 showing roof construction, 1m and 0.5m scales*

- 6.52 The roof construction was the same as that noted in Room 4, with no trusses and a square grid of rafters and purlins supporting the roof on the northwestern slope (Plate 71; Shot 93), while on the southeastern slope the purlins were not present and the rafters were formed of pairs of overlapping planks (Plate 72; Shot 96). The roof structure showed much alteration, although some of the main beams are probably original.

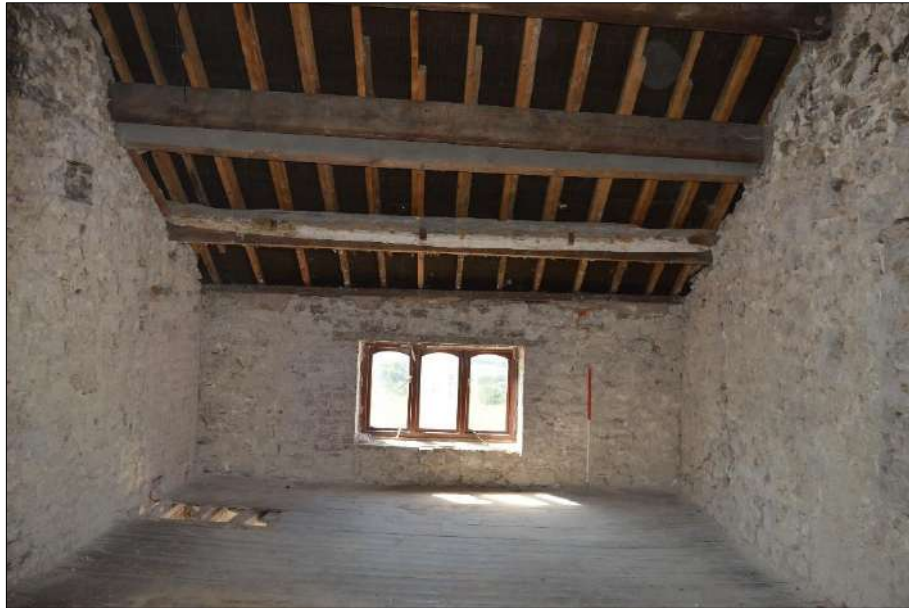
*Plate 72 (shot 96): Southeast side of Room 5 showing roof construction, 1m and 0.5m scales*

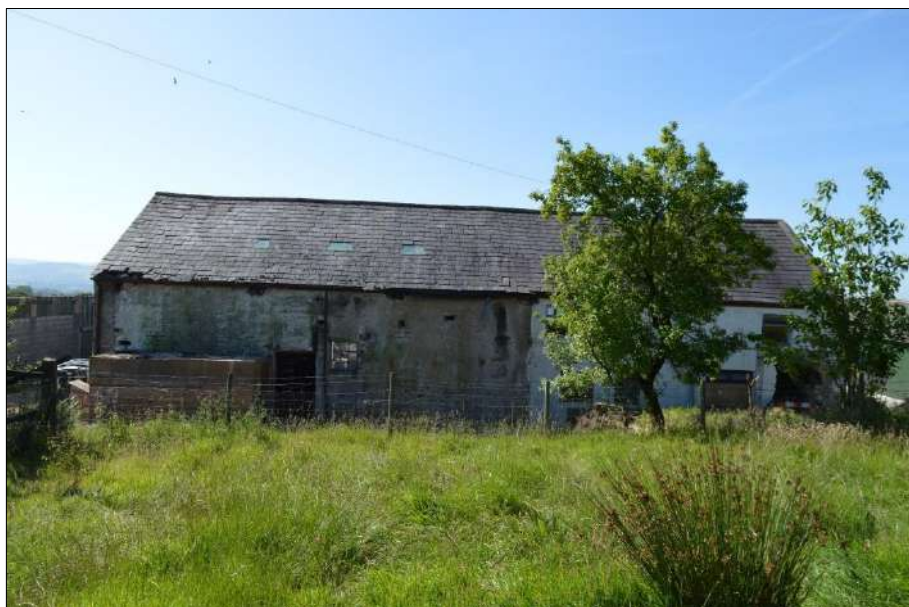
- 6.53 An agricultural building was attached to the farmhouse at the northeastern end. It is likely to be a later addition to the farmhouse, but pre-dates the 1<sup>st</sup> edition OS mapping of 1844.
- 6.54 The northwest-facing elevation of the barn (Plate 73; Shot 23) was of rendered sandstone rubble construction. There were two openings in the elevation, a window (Plate 74; Shot 76) positioned roughly centrally and a doorway immediately to the northeast. The window was square and divided into nine lights in a 3x3 grid by a wooden frame. Three of the panes of glass have fallen from the frame.

*Plate 73 (shot 23): Northwest-facing elevation of main range, barn to left, no scale*

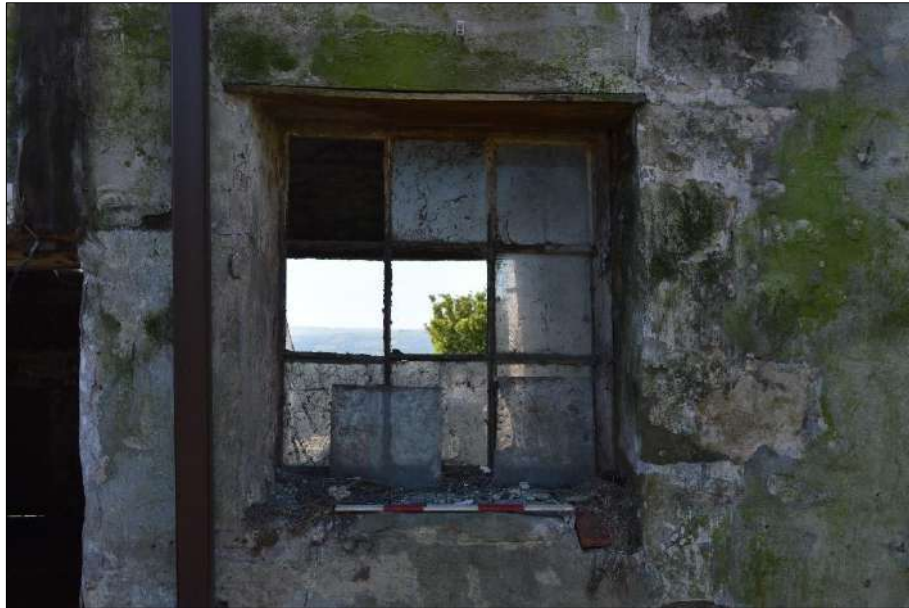
*Plate 74 (shot 26): Detail of window in northwest elevation of barn, 0.5m scale*

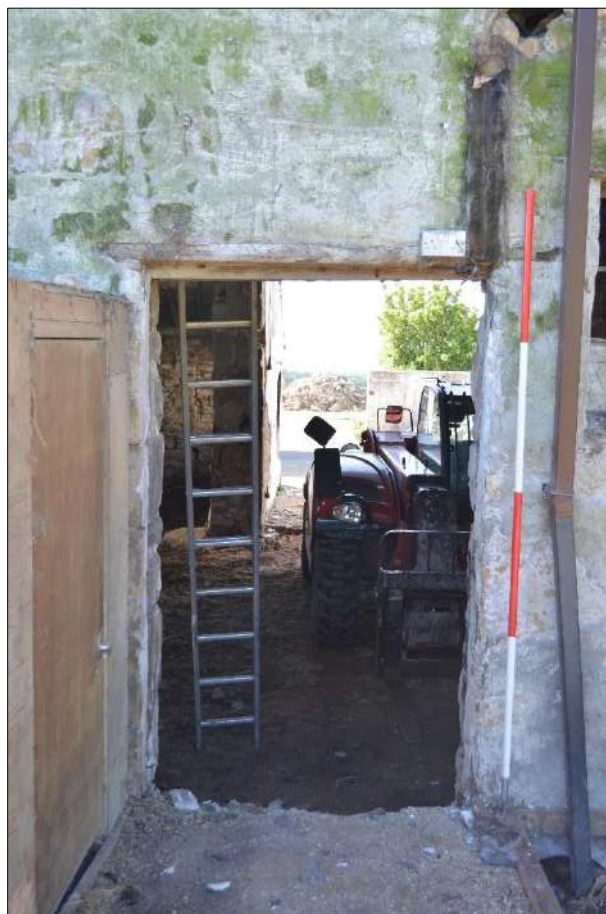
*Plate 75 (shot 25): Detail of doorway in northwest elevation of barn, 2m scale*

- 6.55 To the northeast of the window a doorway (Plate 75; Shot 25) was a plain rectangular opening in the side of the barn with a timber lintel and no door. Immediately to the northeast of the doorway a low shed or storage area of plywood construction was attached to the façade of the barn.

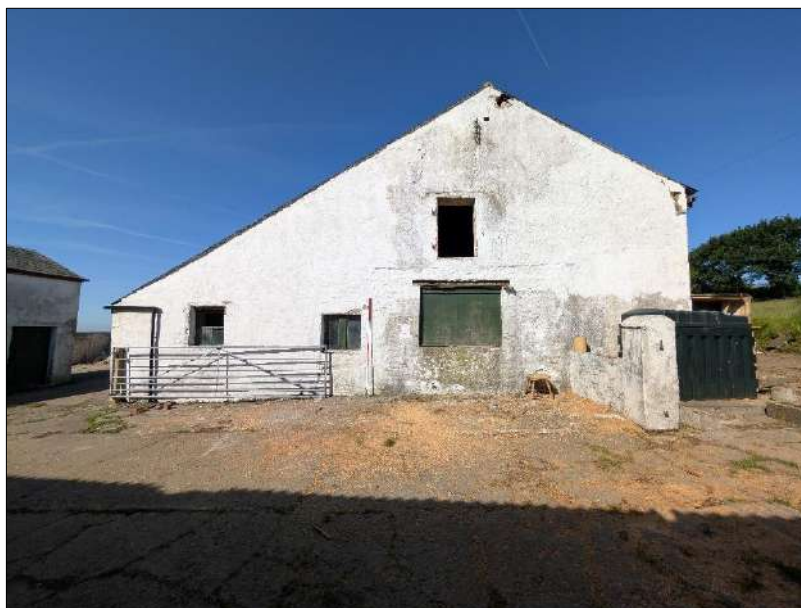
- 6.56 The northeastern elevation of the barn (Plate 76; Shot 171) had a skew pitched roof due to the projecting single storey outshut to the southeast. There were three windows at ground floor level, with a doorway above the northwesternmost of the windows.

*Plate 76 (shot 171): Northeast facing elevation of barn, 2m scale*

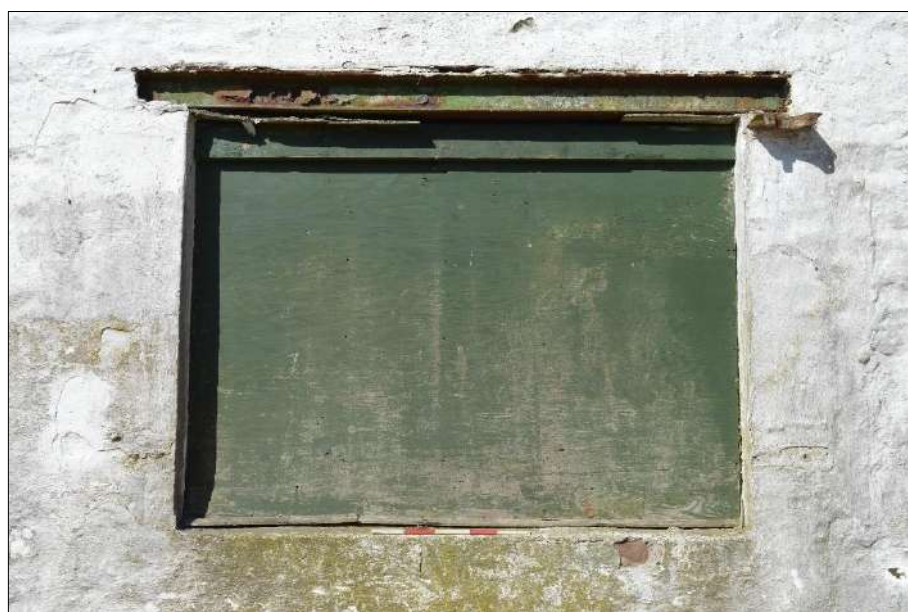
*Plate 77 (shot 19): Detail of window in northeast elevation of barn, 0.5m scale*

- 6.57 The northwesternmost window (Plate 77; Shot 19) was a landscape rectangular opening surmounted by a lintel comprising a length of steel H-beam. There was no frame or glazing in the opening, which was boarded up with plywood.
