**HISTORIC BUILDING SURVEY REPORT:**  
**CUCKOO HALL, HIGHER ROAD, LONGRIDGE, LANCASHIRE**

Planning Reference: 3/2024/0121  
NGR: SD 63896 39018  
AAL Site Code: LOHR 25  
OASIS Reference Number: allenarc1-536093

By  
Allen Archaeology Ltd  
Report Number AAL 2025117

September 2025

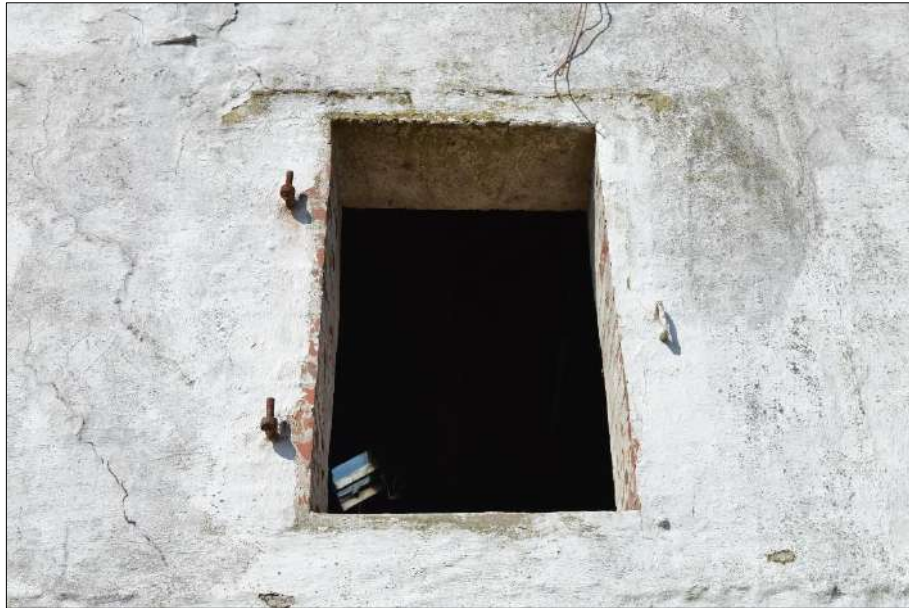
*Plate 78 (shot 20): Detail of doorway in northeast elevation of barn, no scale*

- 6.58 Above this window a doorway (Plate 78; Shot 20) with stone lintel and threshold and brick jambs had presumably given access to load a hayloft above the barn. On the southeast side of the door two cast iron pintles from flag hinges indicate that the door was hung on that side. An iron keep for a locking bar was attached to the wall on the other side of the door.

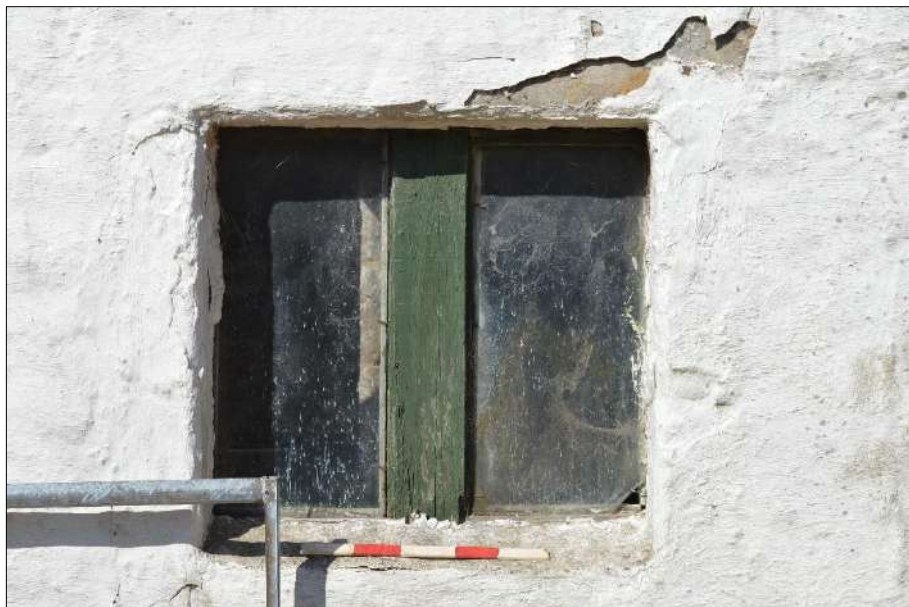
*Plate 79 (shot 18): Detail of window in northeast elevation of barn, 0.5m scale*

- 6.59 To the southeast of the window and doorway another window (Plate 79; Shot 18) was square in shape and divided into two lights with a wide strip of wood serving as a mullion. To the southeast of this window another (Plate 80; Shot 17) of very similar form was divided horizontally with two panes of glass below and presumably it had a missing awning hung casement above.

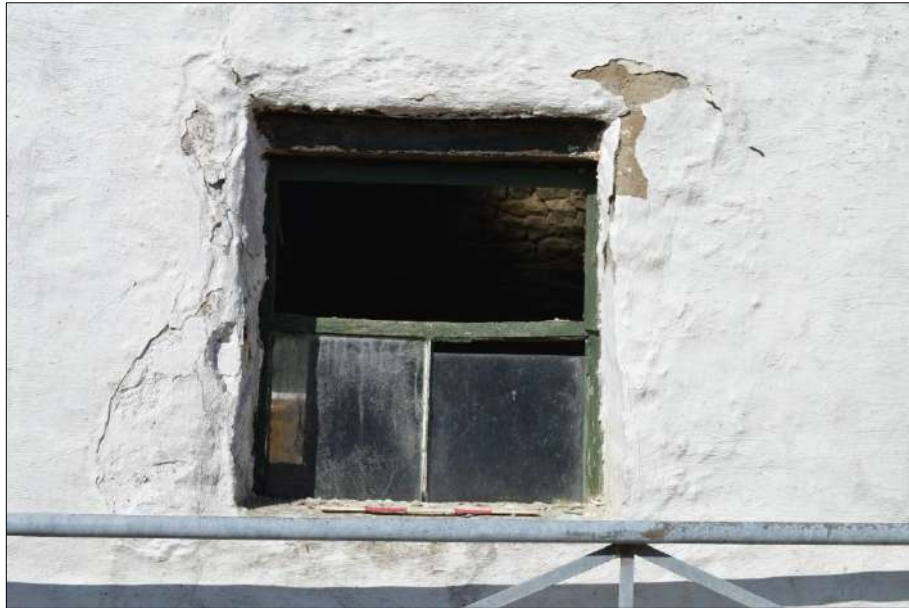
*Plate 80 (shot 17): Detail of window in northeast elevation of barn, 0.5m scale*

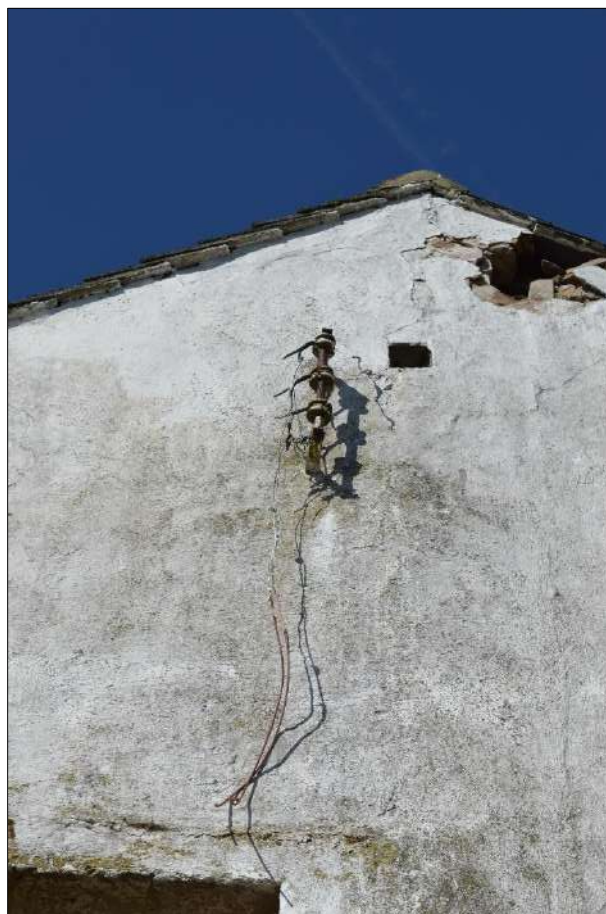
*Plate 81 (shot 21): Detail of bracket and vent in northeast elevation of barn, no scale*

- 6.60 Close to the apex of the gable on the northeastern elevation an iron telegraph wire bracket was attached to the wall (Plate 81; Shot 21). Adjacent to the top of this the wall was pierced by a small square vent.

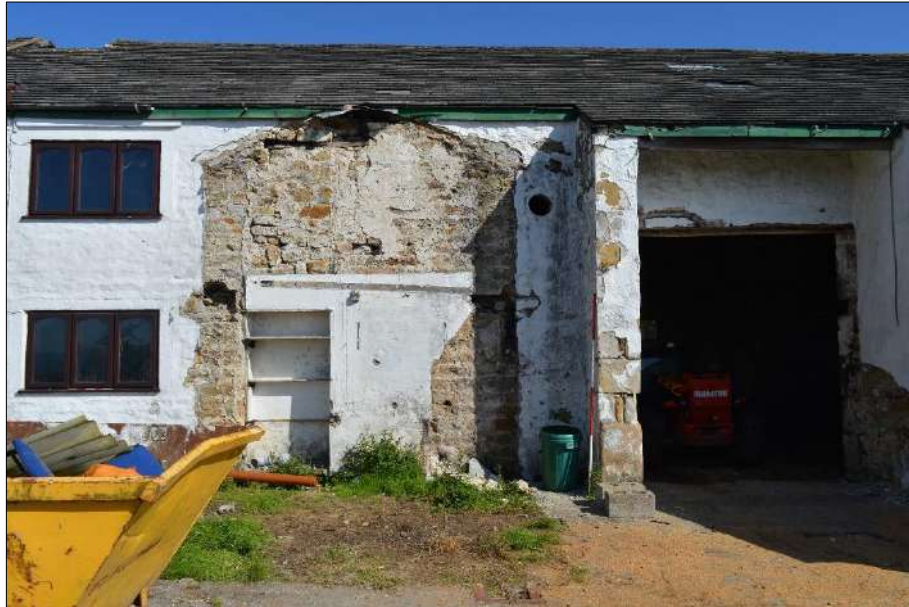
- 6.61 The southeastern elevation of the barn (Plates 82 and 83; Shots 1 and 2) was largely of rendered and limewashed sandstone rubble. At the southwestern end of the elevation the scar could clearly be seen where a southeast projecting extension between the farmhouse and the barn had been recently demolished. An alcove with shelving corresponded to a blocked door in Room 2 of the farmhouse. Above this in the southeast elevation there was evidence of a blocked door at first floor level, indicating that the extension was also a two-storey construction. Beyond the location of the demolished extension there was a projecting wall on one side of a wide rectangular entranceway, the other side of which was formed by the wall of the outshut at the northeastern end of the range. The entranceway had a substantial timber lintel (Plate 84; Shot 11) and lacked any doors.

*Plate 82 (shot 1): Southeast facing elevation of barn, southwest end, 2m scale*

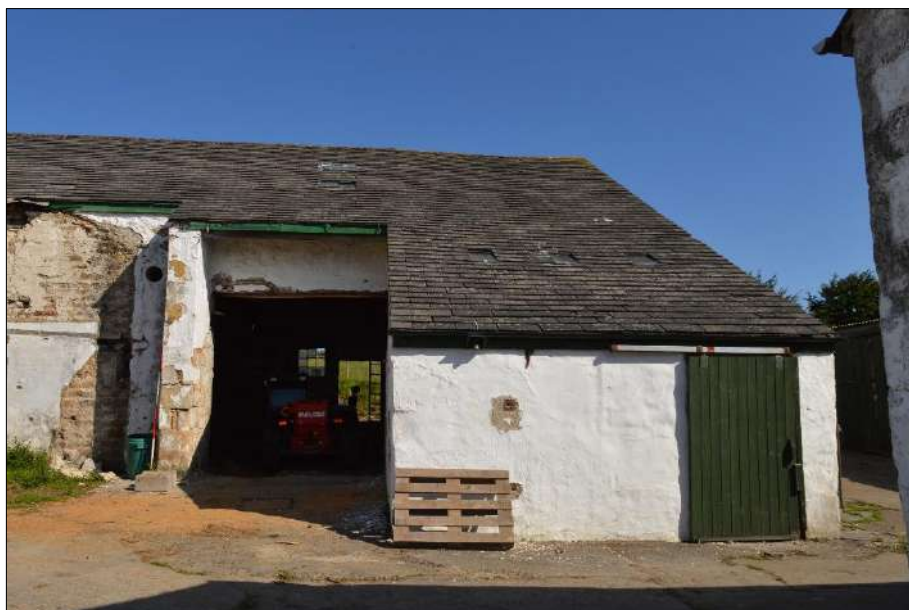
*Plate 83 (shot 2): Southeast facing elevation of barn, northeast end, 2m scale*

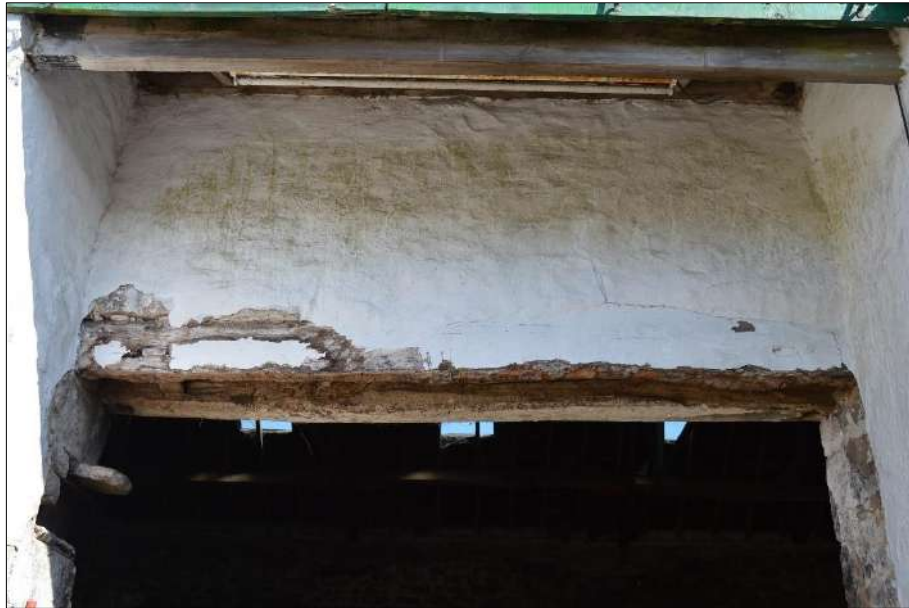
*Plate 84 (shot 11): Timber lintel over entranceway, southeast facing elevation of barn, no scale*

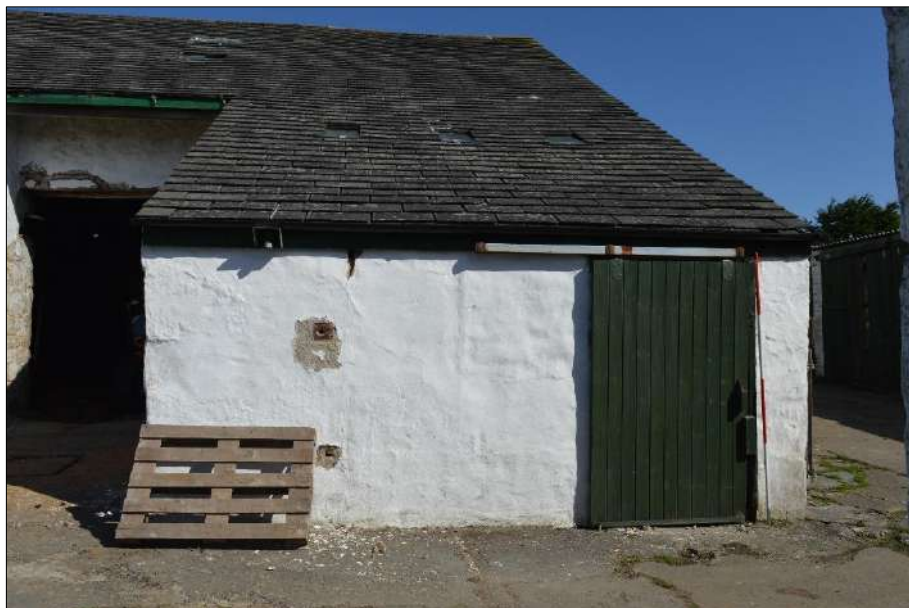
- 6.62 To the northeast of the entranceway the southeast elevation of the outshut (Plate 85; Shot 13) was rendered and limewashed. At the northeastern end there was a large solid sliding door of plank construction (Plate 86; Shot 14). At the top of the door the outline of a blocked window was visible despite the render.

*Plate 85 (shot 13): Southeast-facing elevation of outshut, northeast end of main range, 2m scale*

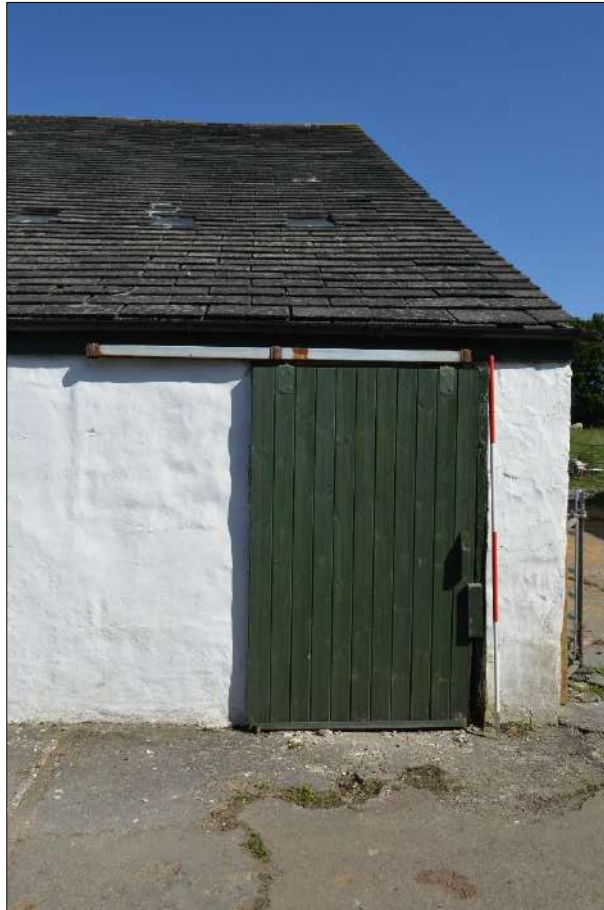
*Plate 86 (shot 14): Detail of door of outshut, northeast end of main range, 2m scale*

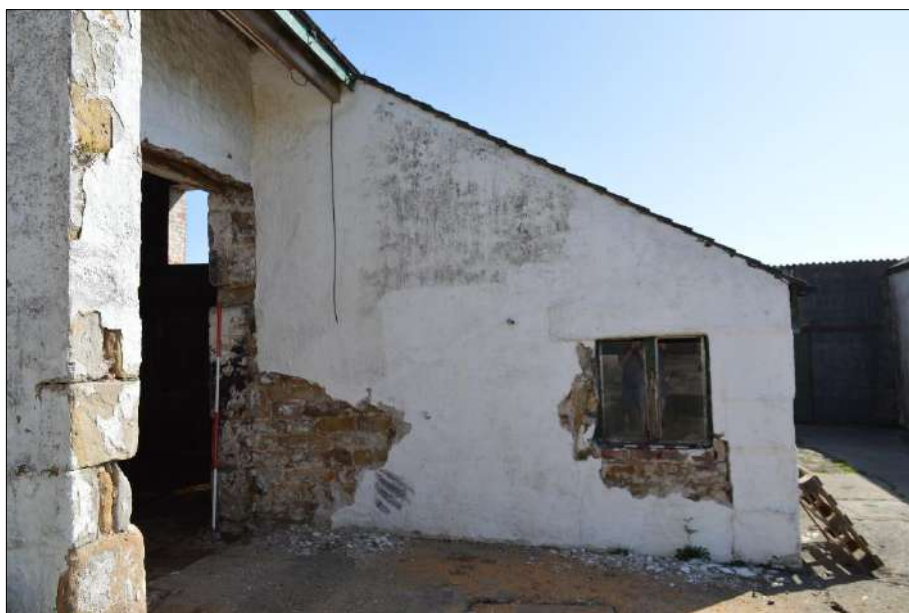
*Plate 87 (shot 12): Southwest elevation of outshut, northeast end of main range, 2m scale*

- 6.63 The southwest facing elevation of the outshut (Plate 87; Shot 12) was also rendered and limewashed. A small square timber framed window (Plate 88; Shot 5) with a substantial stone lintel was divided vertically into two lights. A single course of brick below the window frame indicates that it is probably a later alteration to the original fabric.

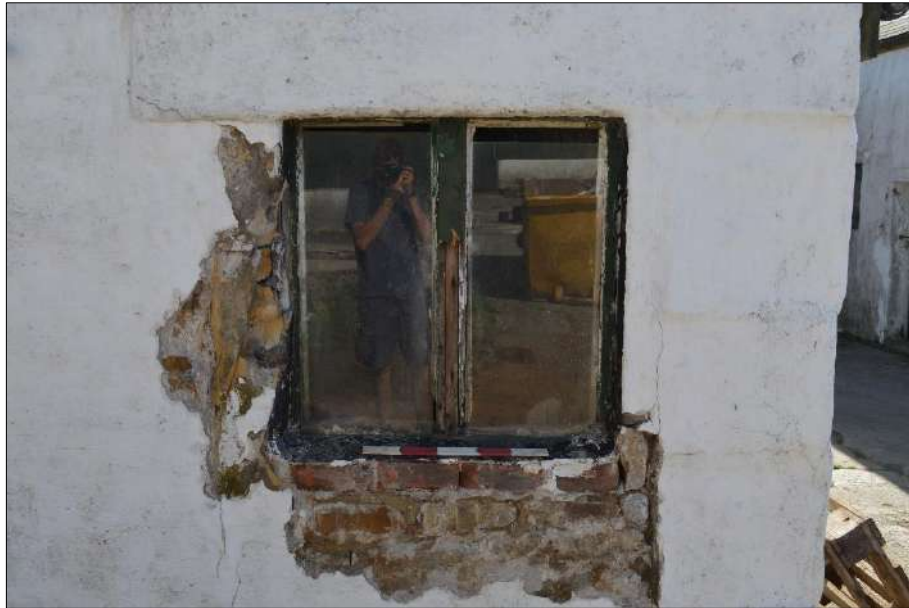
*Plate 88 (shot 5): Detail of window, southwest elevation of outshut, 0.5m scale*

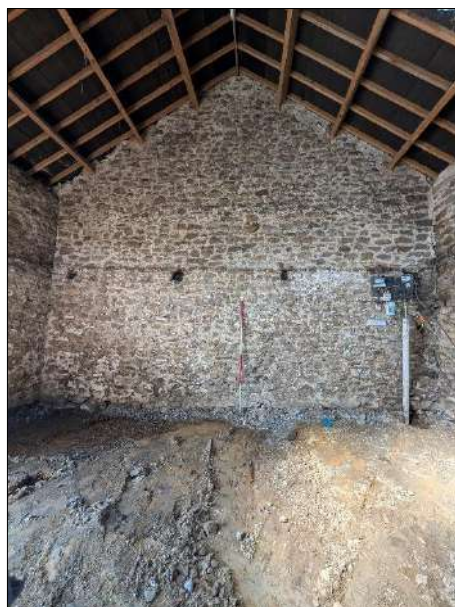
- 6.64 The interior of the attached barn was essentially one large room (Plate 89 and 90; Shots 193 and 194), designated as Room 6 for continuity. This space included the southeast projecting outshut, which was not separated from the main barn area by a partition. As with other parts of the main range, interior fittings had been removed from the barn, including any hard floor surface that may have existed. The roof structure comprised a pair of steel fink trusses supporting purlins and rafters of relatively recent origin.

*Plate 89 (shot 193): Interior of Room 6, southwest end, looking southwest, 2m scale*

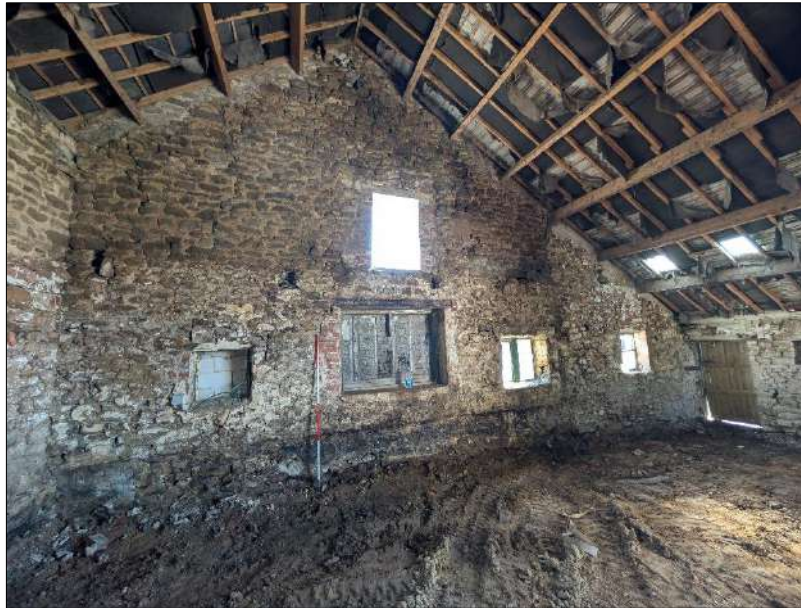
*Plate 90 (shot 194): Interior of Room 6, northeast end, looking southeast, 2m scale*

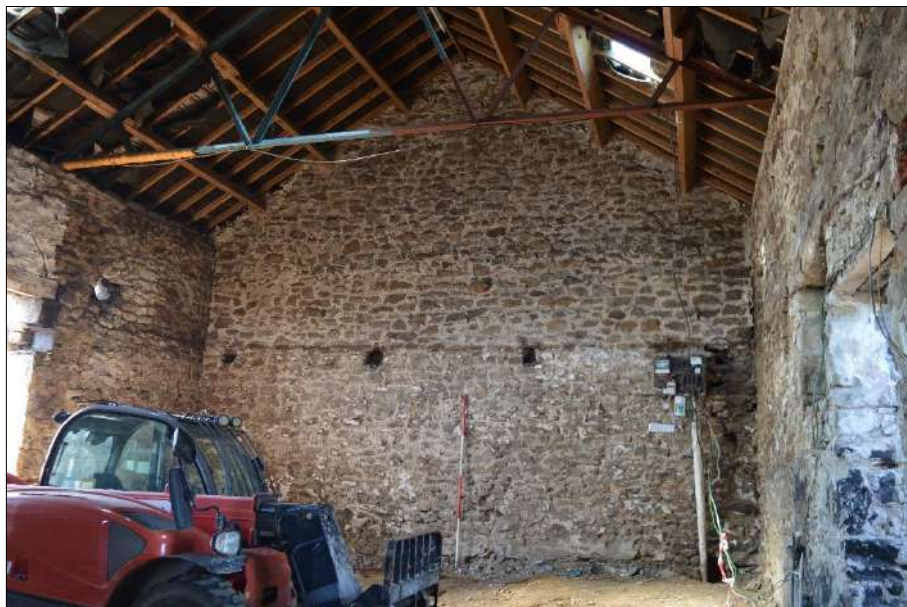
- 6.65 The southwestern wall of Room 6 (Plate 91; Shot 106) was of random coursed sandstone rubble construction. A row of four beam sockets in the wall indicated the former presence of a second storey in the main body of the barn, likely to have been a hayloft. There was no indication in the masonry of the wall that there had ever been direct access from the farmhouse to the barn. An electric distribution board with attached meters was attached to the wall just below the former floor level at the northwestern side.

*Plate 91 (shot 106): Southwestern wall of Room 6, 2m scale*

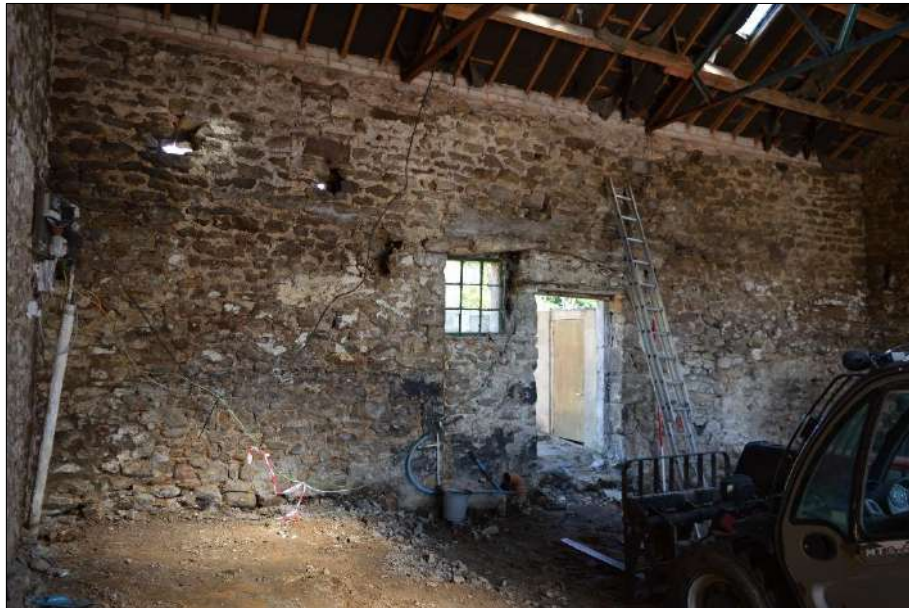
- 6.66 The northwestern wall of Room 6 (Plate 92; Shot 100) was also of sandstone rubble construction. A centrally positioned doorway and adjacent window (Plate 93; Shot 102) had a substantial timber lintel suggesting that the doorway and window had been inserted into an originally much larger opening, with mixed stone and brick infill adjacent to the doorway and

window, the larger original opening was opposite the large opening in the southeastern wall and may have been originally associated with a cross passage for threshing grain.

*Plate 92 (shot 100): Northwestern wall of Room 6, 2m scale*

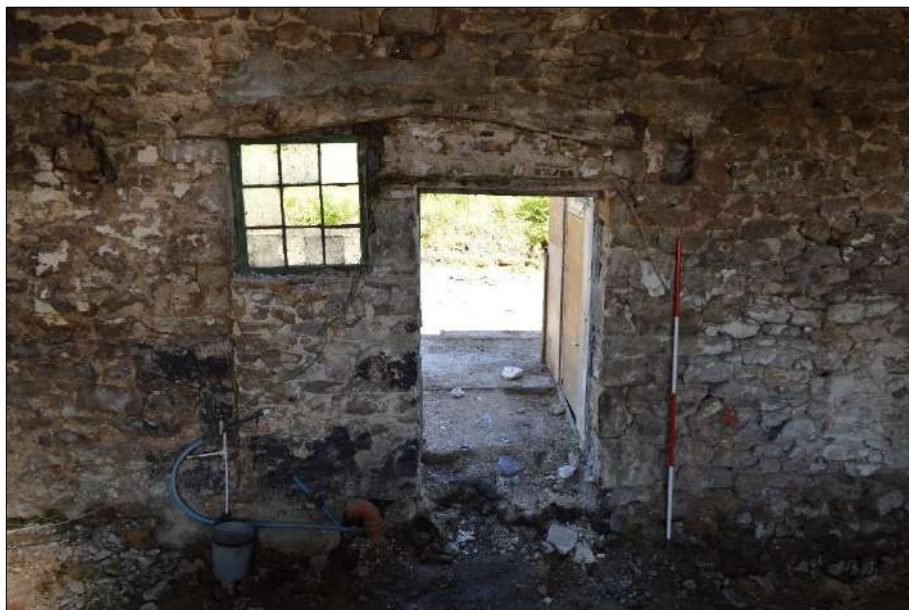
*Plate 93 (shot 102): Remodelled entranceway in northwestern wall of Room 6, 2m scale*

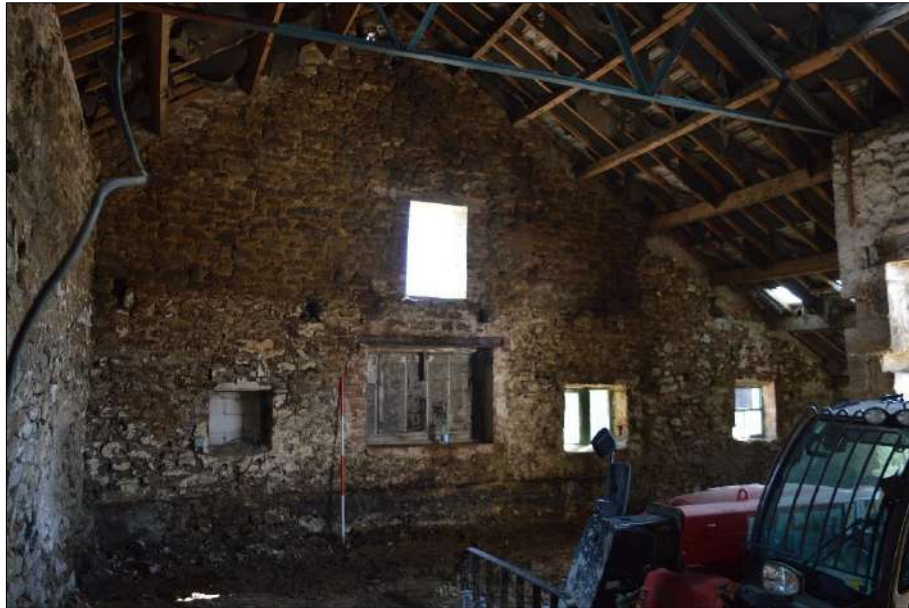
- 6.67 The northeastern wall of the room (Plate 94; Shot 107) was of sandstone rubble construction with four window, one blocked, at ground floor level and a doorway at the level of the upper storey.

*Plate 94 (shot 107): Northeastern wall of Room 6, 2m scale*

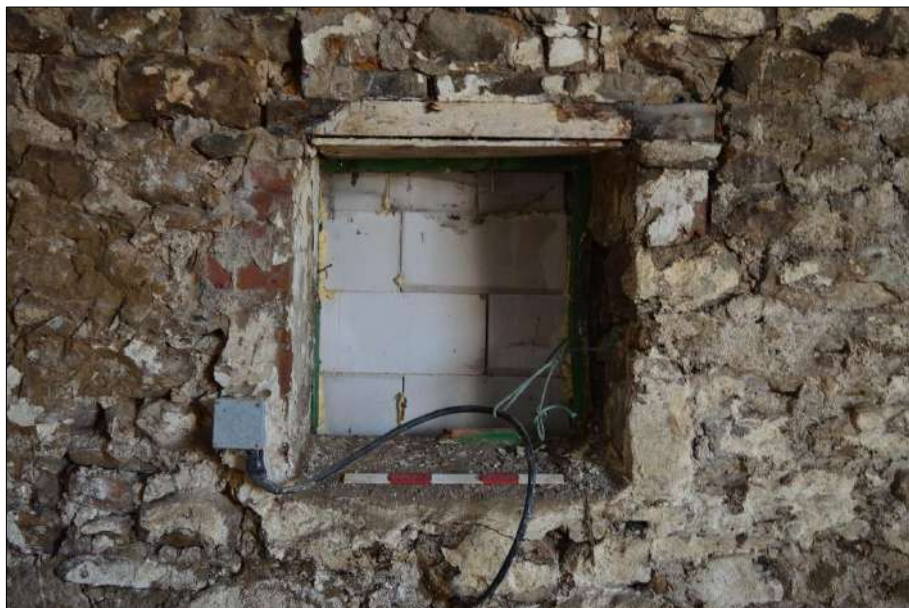
- 6.68 At the northwestern end of the wall a small square window (Plate 95; Shot 108) with a wooden lintel was blocked with cement blocks. Brick infill adjacent to the window suggests that it represents a later alteration to the original fabric of the barn.

*Plate 95 (shot 108): Detail of window, northeast wall of Room 6, 0.5m scale*

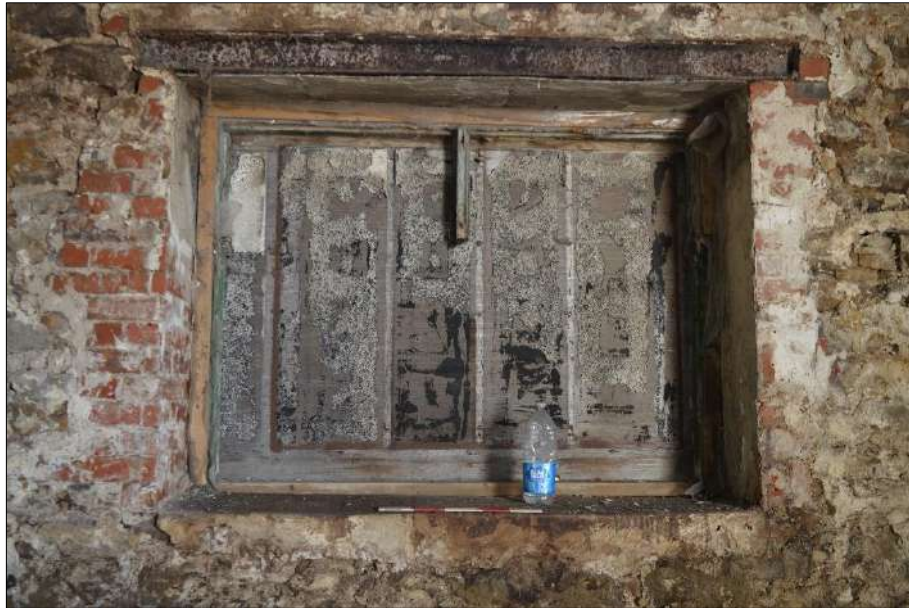
- 6.69 To the southeast a larger rectangular window (Plate 96; Shot 109) had a steel H-beam lintel and a wooden frame. Brick infill to either side of the window indicated that it was a later insertion into the original fabric of the barn.

*Plate 96 (shot 109): Detail of window, northeast wall of Room 6, 0.5m scale*

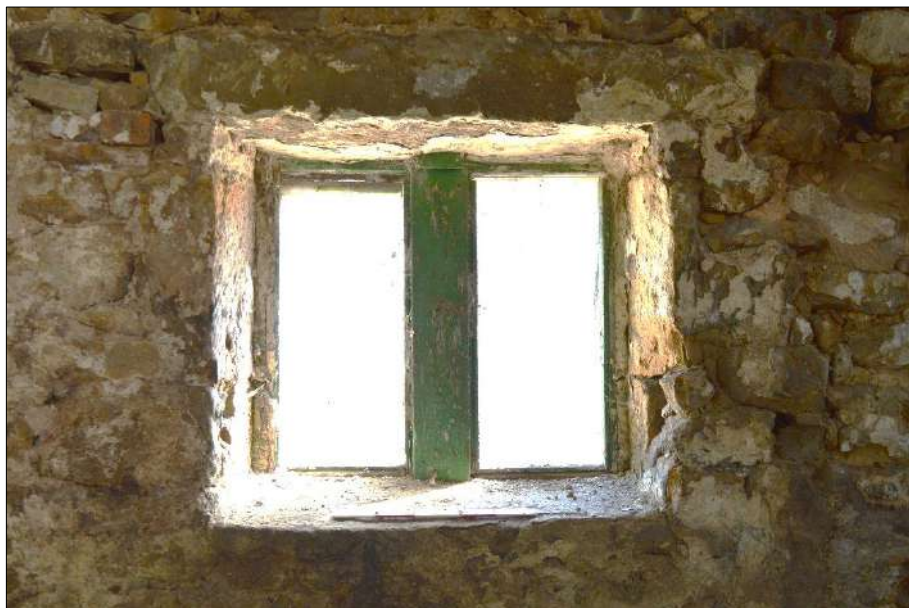
- 6.70 To the southeast of the larger window a further two small square windows (Plates 97 and 98; Shots 111 and 112) were recorded. Between the two windows there was a straight joint in the masonry where the outshut had been added to the southeastern wall of the main barn.

*Plate 97 (shot 111): Detail of window, northeast wall of Room 6, 0.5m scale*

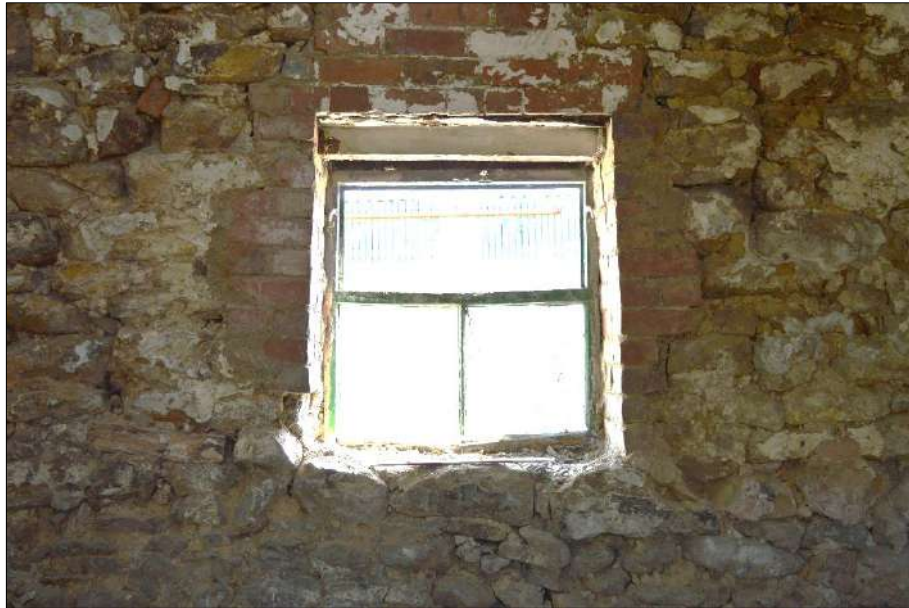
*Plate 98 (shot 112): Detail of window, northeast wall of Room 6, 0.5m scale*

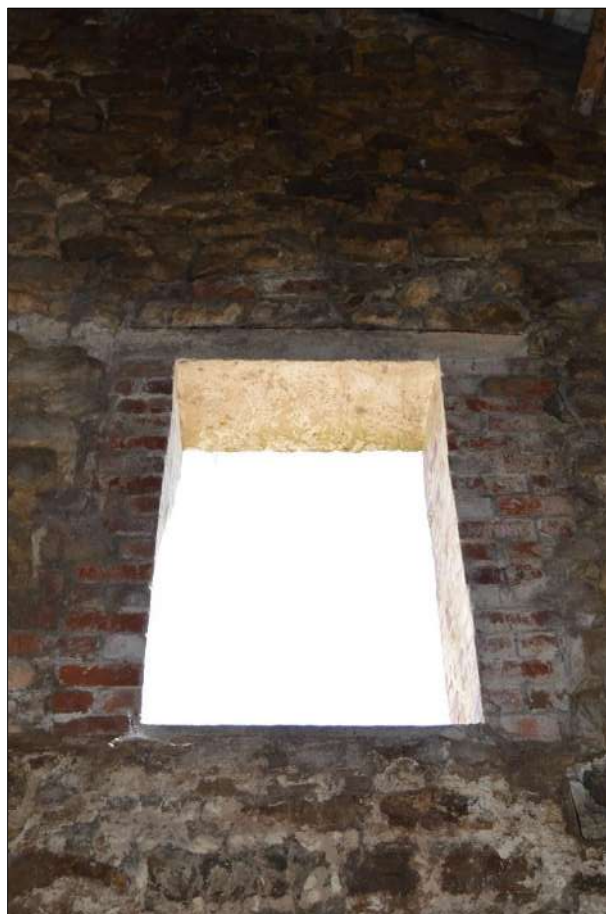
*Plate 99 (shot 110): Detail of doorway, northeast wall of Room 6, no scale*

- 6.71 A row of four beam sockets in the northeastern wall indicated the position of the former floor of the second storey. In the centre of the gable end of the two-storey barn, above the rectangular window, a doorway (Plate 99; Shot 110) with a timber lintel and brick jambs,

presumably a loading door for a grain store or hayloft, probably also represented a later alteration to the original fabric of the barn.

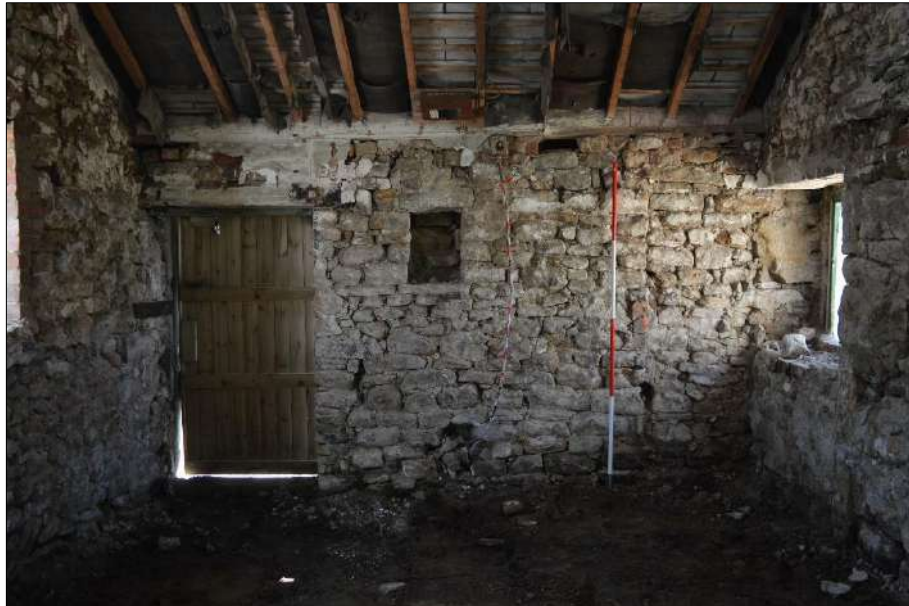
- 6.72 The southeast wall of the single storey outshut to the southeast of the barn (Plate 100; Shot 113) had a doorway with a timber lintel at the northeast end, with a solid door of plank construction (Plate 101). At the southwest end of the wall there was evidence of another blocked doorway (Plate 102; Shot 114)

*Plate 100 (shot 113): Southeastern wall of outshut, Room 6, 2m scale*

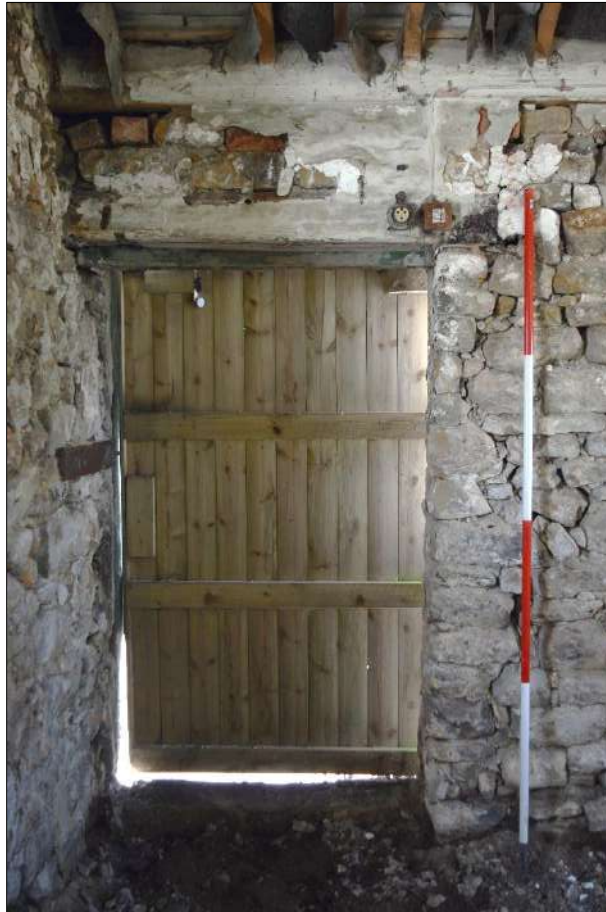
*Plate 102 (shot 114): Detail of blocked doorway in southeastern wall of outshut, Room 6, 2m scale*

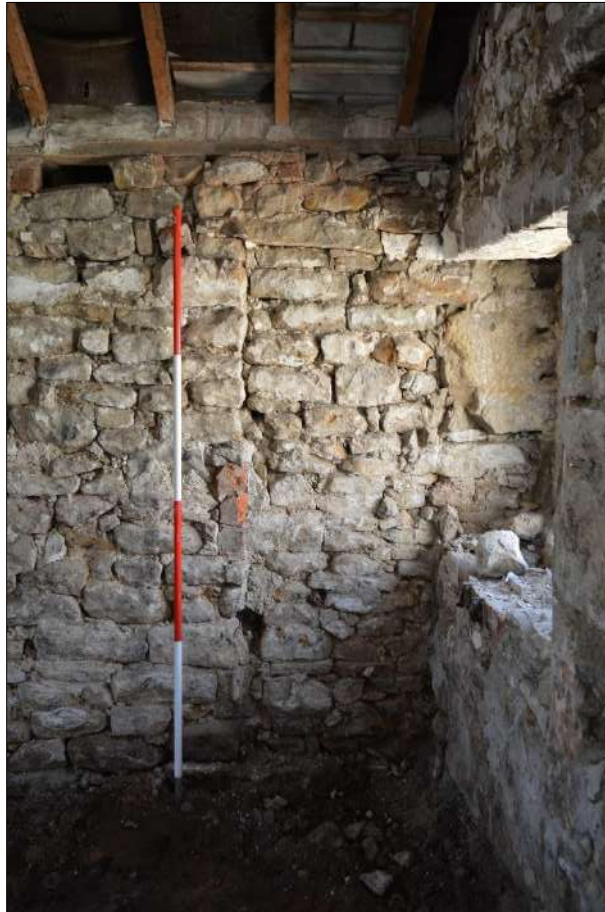
- 6.73 Between the existing doorway and the blocked doorway there was a blocked opening (Plate 103; Shot 115) adjacent to the existing doorway comprising a rectangular opening with blocking behind, possibly representing a former window or vent. There was no evidence of frame or glazing having been fitted

*Plate 103 (shot 115): Detail of blocked opening in southeastern wall of outshut, Room 6, no scale*

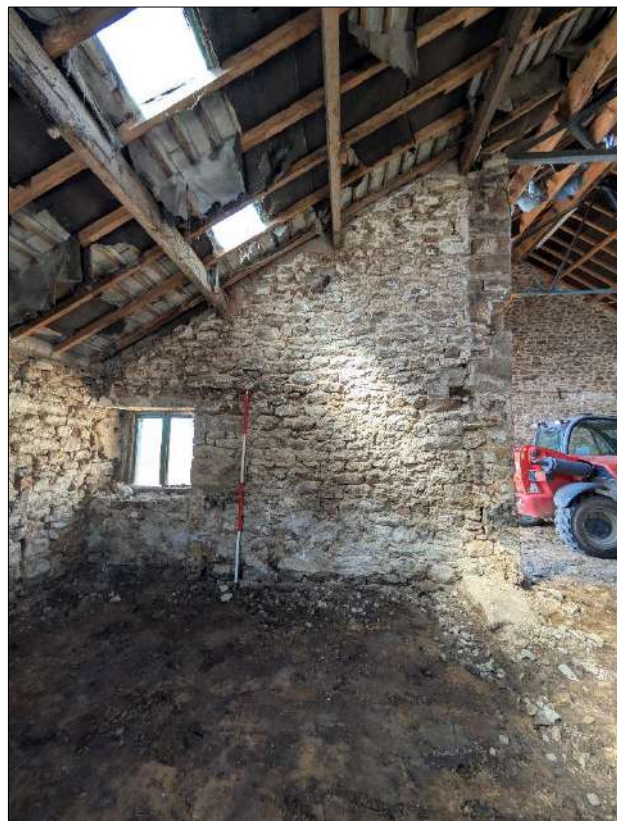
- 6.75 The southwestern wall of the outshut (Plate 105; Shot 195) had a square window at the southeastern end (Plate 106). The window had a stone lintel and rubble blocking below, suggesting that it may have been reduced in size from an original doorway.

*Plate 106 (shot 118): Detail of window in southwestern wall of outshut, Room 6, 2m scale*

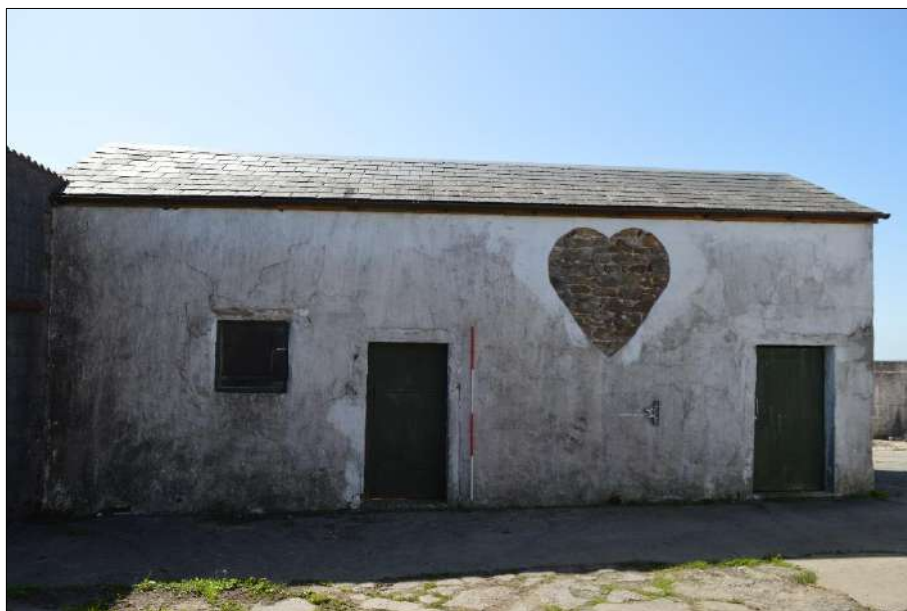
- 6.78 The northwestern elevation of the outbuilding (Plate 109) was rendered with the exception of a heart-shaped patch (Plate 110; Shot 136) at first floor level between the two ground floor doorways, where the render had been removed to expose the random coursed sandstone

rubble masonry below. Fresh render and limewash around the edges of the heart suggest that this is a relatively modern alteration.

*Plate 110 (shot 136): Heart shaped patch of exposed masonry in northwestern elevation of outbuilding, no scale*

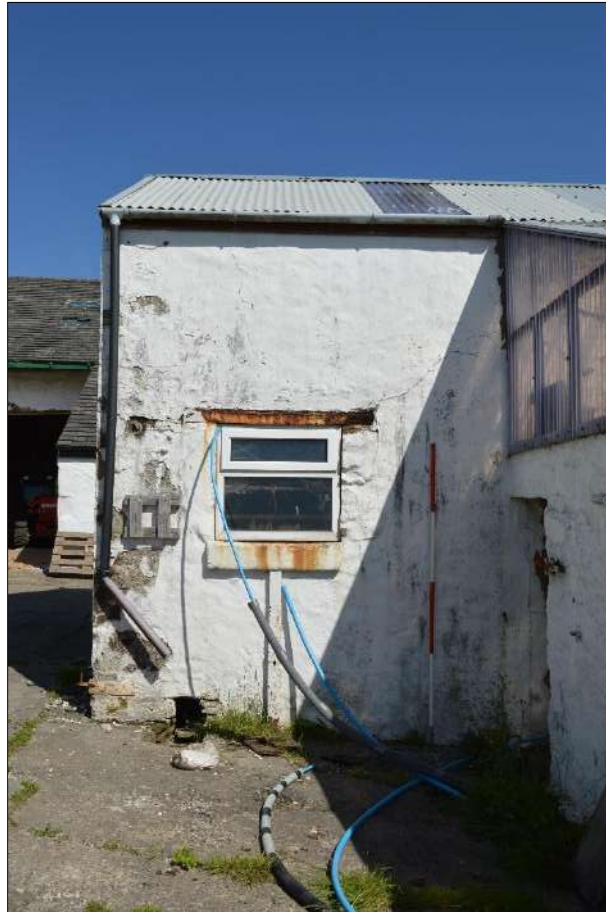
*Plate 114 (shot 127): Southeastern elevation of outbuilding, southwestern end, 2m scale*

- 6.81 The southeastern elevation of the outbuilding, at the southwestern end (Plate 114; Shot 127) was rendered and limewashed, with a single rectangular window (Plate 115) with a steel joist for a lintel and a concrete sill, representing a later alteration to the original fabric of the outbuilding. The window comprised a uPVC frame with patterned frosted glass in the awning hung casement and plain glass in the lower light.

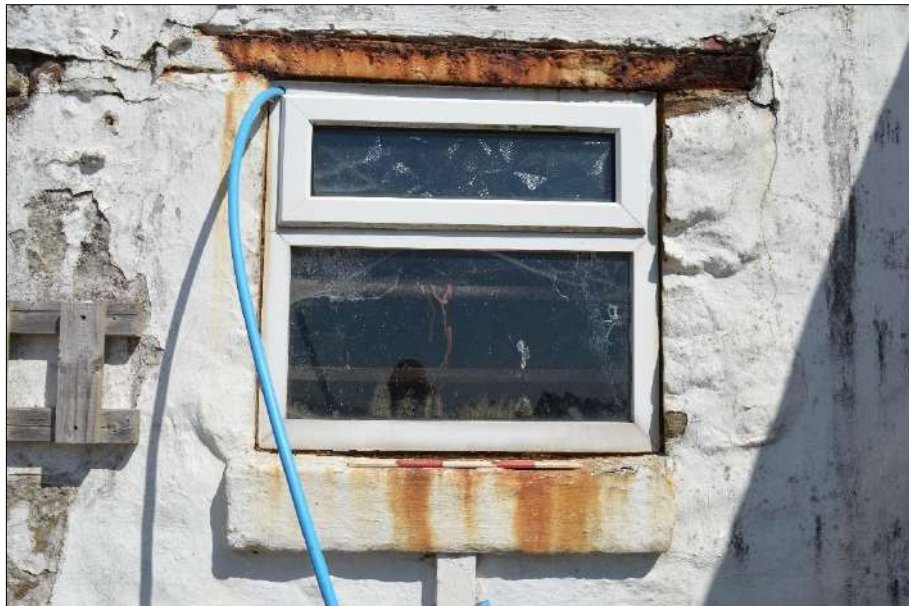
*Plate 115 (shot 128): Detail of window in southeastern elevation of outbuilding, 0.5m scale*

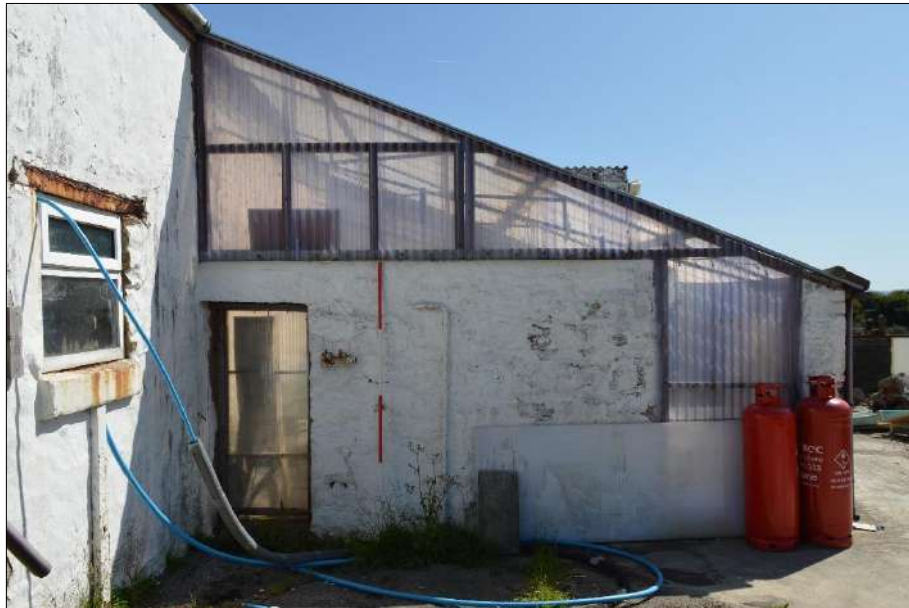
- 6.82 The southwestern elevation of the southeast projecting extension to the outbuilding (Plate 116; Shot 125). was of sandstone rubble construction, with areas of timber framing with corrugated plastic sheeting. The extension is depicted on historic mapping from 1910, although it has been extended to the southeast latterly. A single doorway (Plate 117; Shot 126) at the northwestern

*Plate 116 (shot 125): Southwestern elevation of extension to outbuilding, 2m scale*

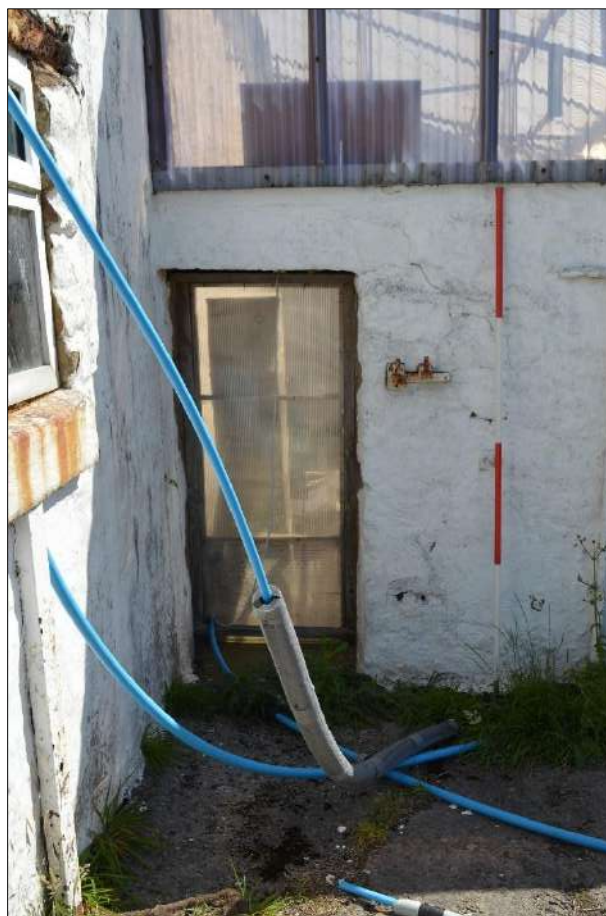
end of the elevation had a timber frame with a timber and plastic door. Cast iron pintles affixed to the wall to the southeast of the existing door may relate to an earlier access arrangement.

*Plate 117 (shot 126): Detail of door in southwestern elevation of extension to outbuilding, 2m scale*

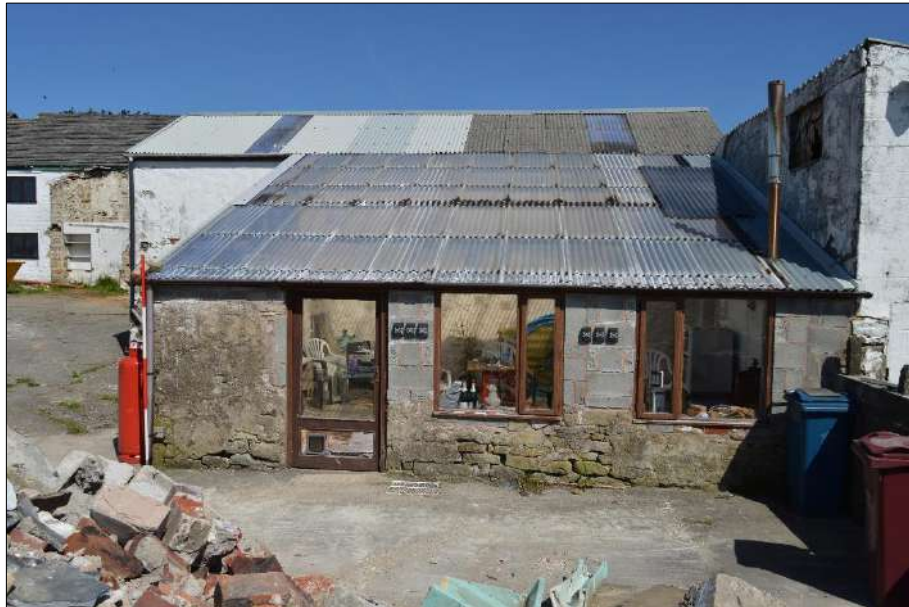
- 6.83 The southeastern elevation of the extension (Plate 118; Shot 131) was of mixed sandstone rubble and cement block construction, with a corrugated steel sheet roof. There were two timber framed windows (Plate 119; Shot 132) and a door in the elevation, all representing recent additions.

*Plate 118 (shot 131): Southeastern elevation of extension to outbuilding, 2m scale*

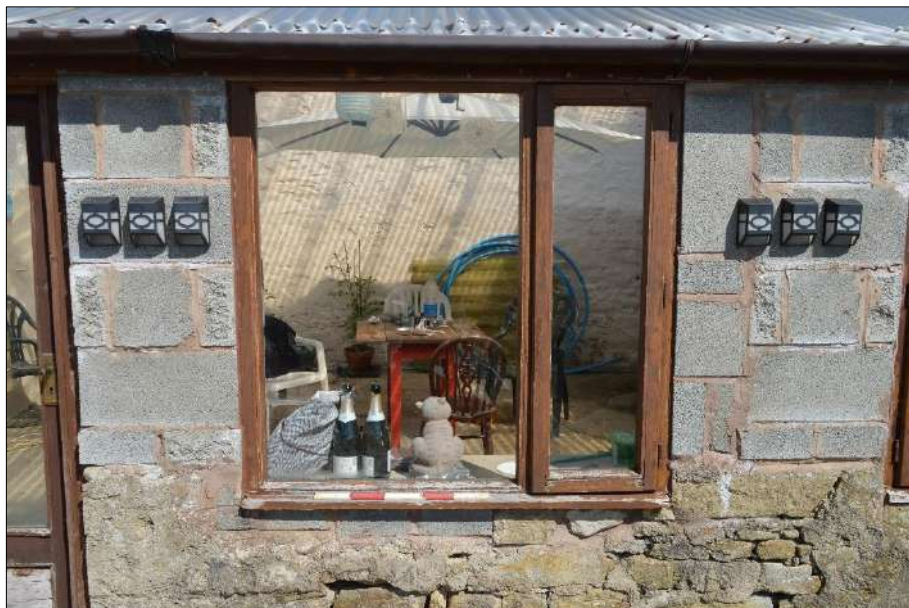
*Plate 119 (shot 132): Detail of window in southeastern elevation of extension to outbuilding, 0.5m scale*

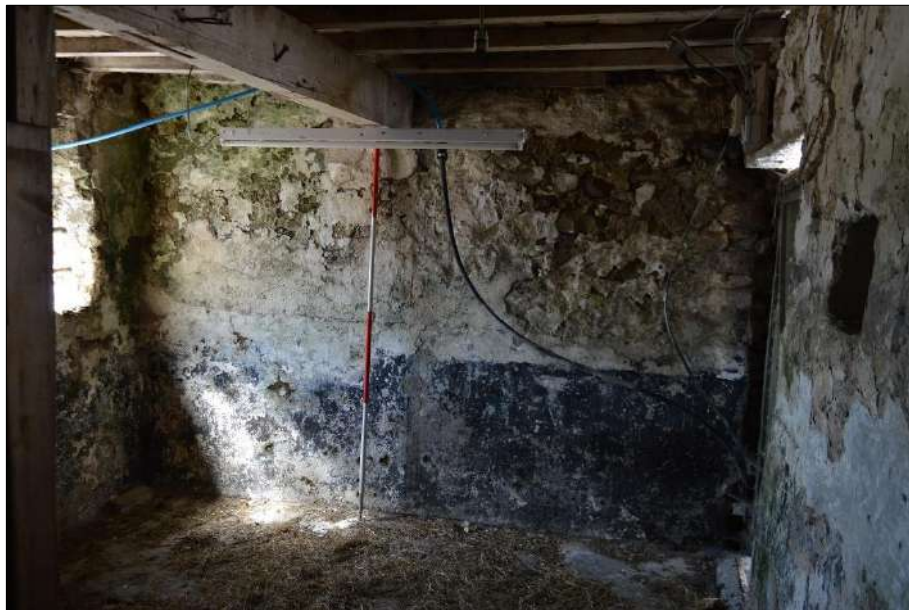
- 6.85 The southwest wall of Room 7 (Plate 120; Shot 144) was of sandstone rubble construction and was rendered and limewashed on the upper part and painted black on the lower, possibly with bitumen paint. There were no openings in the southwestern wall.

*Plate 120 (shot 144): Southwest wall of Room 7, 2m scale*

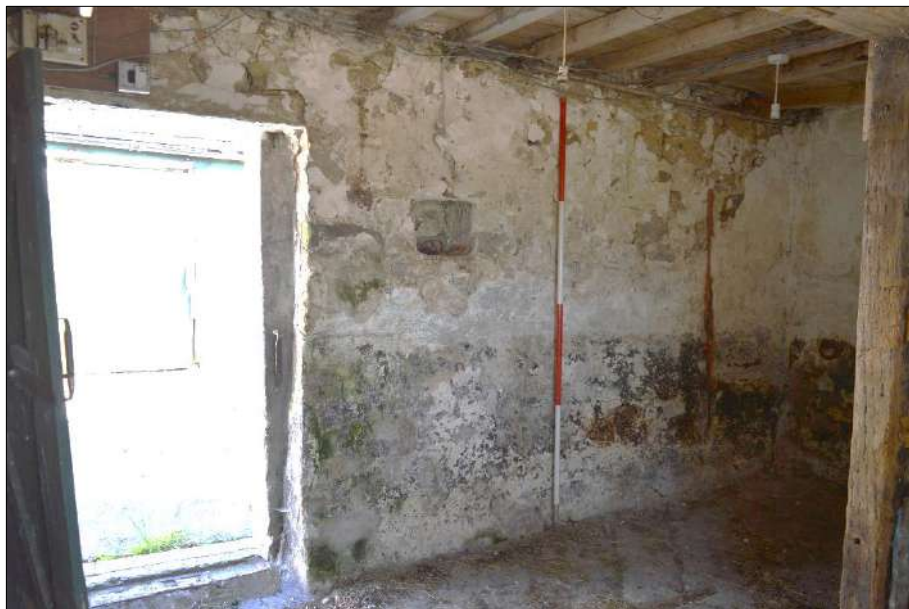
- 6.86 The northwestern wall of Room 7 (Plate 121; Shot 142) was of similar construction and finish to the southwestern wall. At the southwestern end there was a rectangular doorway with timber lintel and jambs. To the northeast of the door there was a recess in the masonry of the wall (Plate 122; Shot 143).

*Plate 121 (shot 142): Northwestern wall of Room 7, 2m scale*

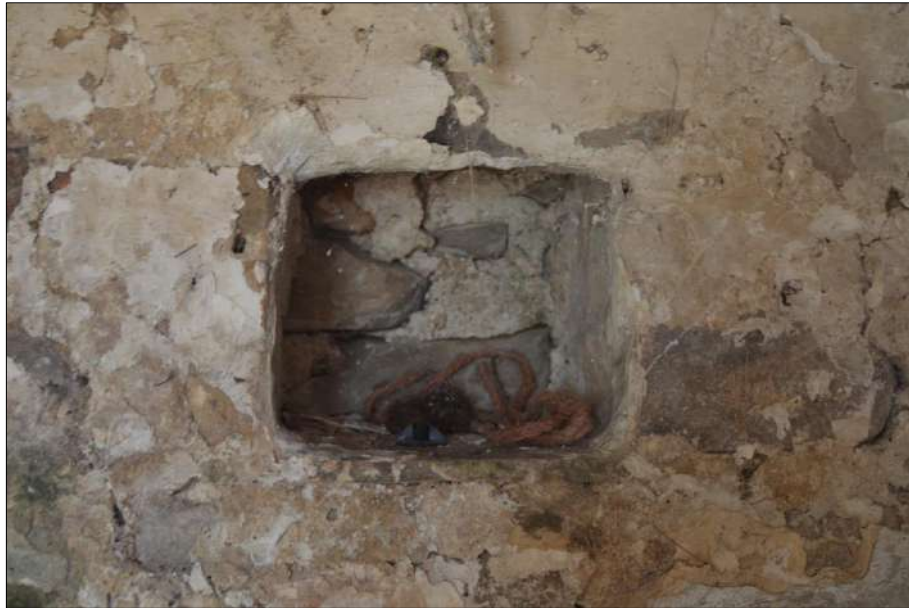
*Plate 122 (shot 143): Detail of recess in northwestern wall of Room 7, no scale*
