**HISTORIC BUILDING SURVEY REPORT:**  
**CUCKOO HALL, HIGHER ROAD, LONGRIDGE, LANCASHIRE**

Planning Reference: 3/2024/0121  
NGR: SD 63896 39018  
AAL Site Code: LOHR 25  
OASIS Reference Number: allenarc1-536093

By  
Allen Archaeology Ltd  
Report Number AAL 2025117

September 2025

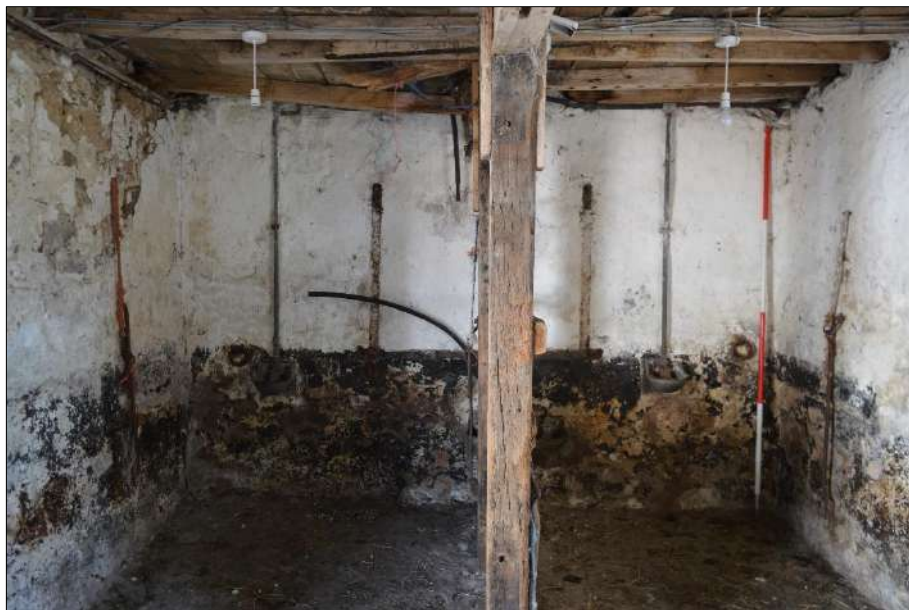
- 6.87 The northeastern wall of the room (Plate 123; Shot 140) was similar in construction and finish to the other walls within Room 7. The northeastern part of the room was divided into two stalls by a timber partition (Plate 124; Shot 197), and the concrete floor had drainage channels in the surface (Plate 125; Shot 145). Water pipes and troughs were attached to the northeastern wall in the centre of each of the two stalls (Plate 126; Shot 141).

*Plate 123 (shot 140): Northeastern wall of Room 7, 2m scale*

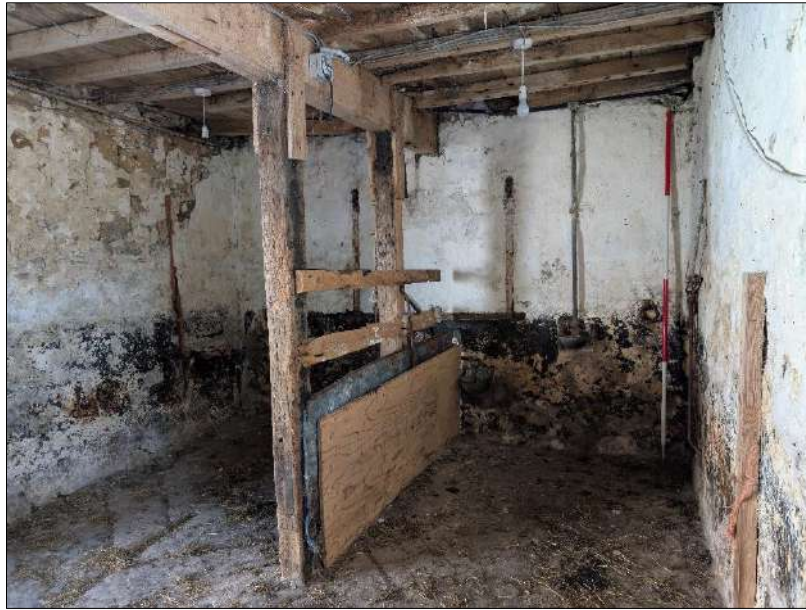
*Plate 124 (shot 197): Stalls at northeastern end of Room 7, 2m scale*

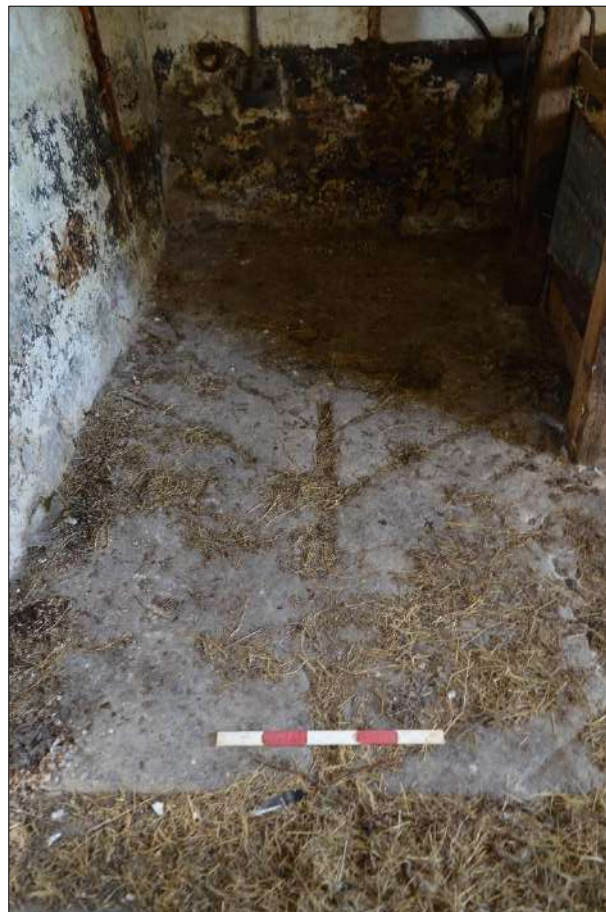
*Plate 125 (shot 145): Detail of floor, northwestern stall at northeastern end of Room 7, 0.5m scale*

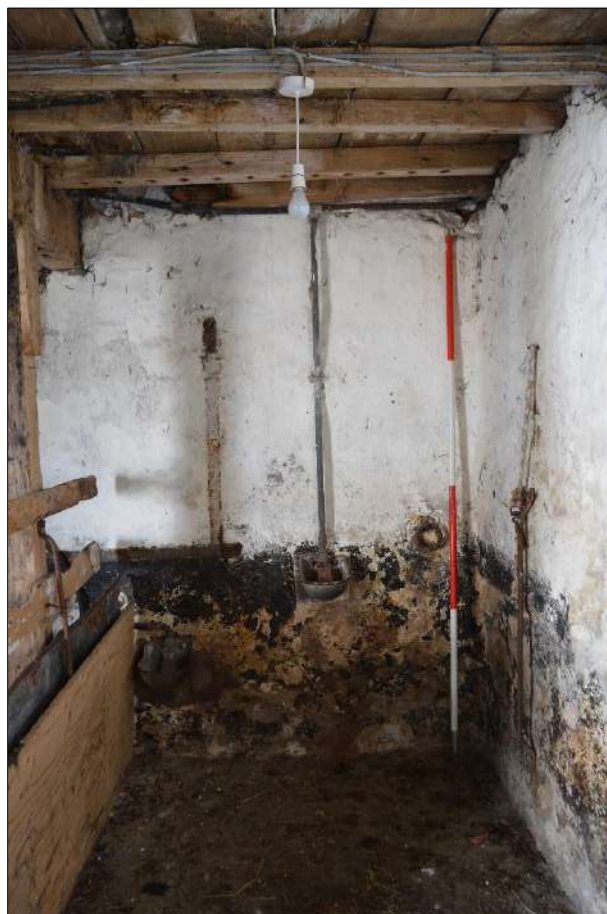
*Plate 126 (shot 141): Southeastern stall at northeastern end of Room 7, 2m scale*

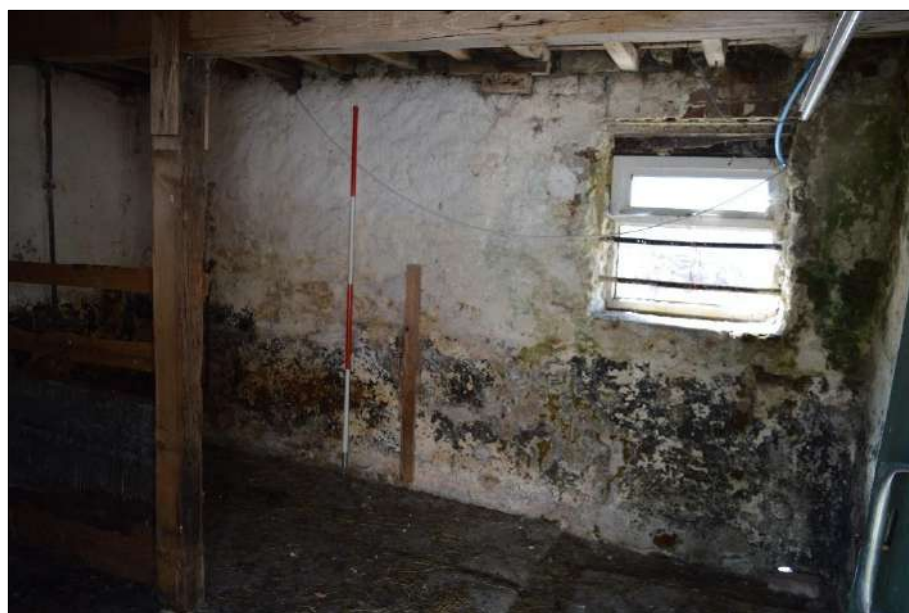
- 6.88 The southeastern wall of Room 7 (Plate 127; Shot 138) was of rendered and limewashed/black painted sandstone rubble as before. A single rectangular window (Plate 128) with an iron or steel lintel and two horizontal bars had been retrofitted with a uPVC frame and glazing. Blocking

*Plate 127 (shot 138): Southeastern wall of Room 7, 2m scale*

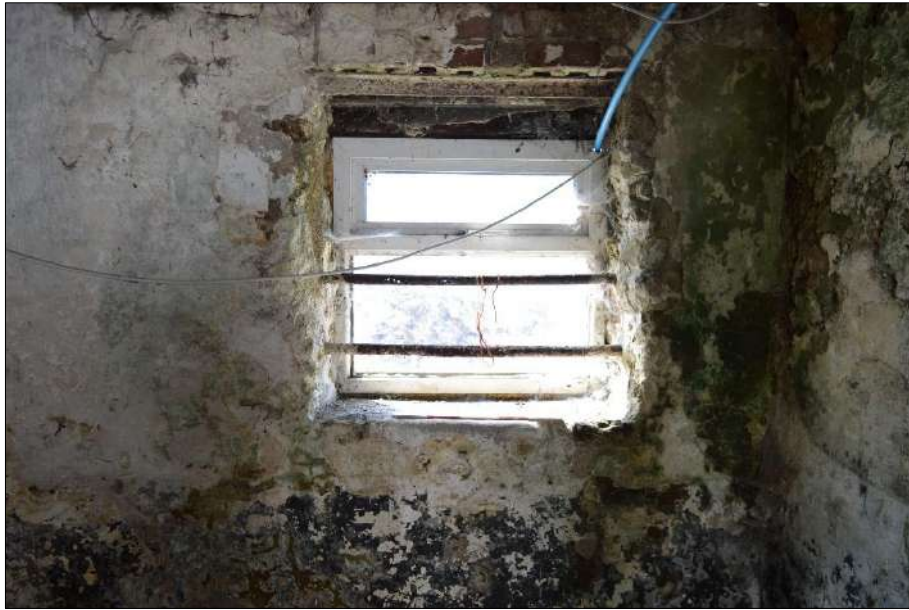
above the frame comprising machine pressed brick is likely to have been inserted at the time of this alteration.

*Plate 128 (shot 139): Detail of window in southeastern wall of Room 7, 0.5m scale*

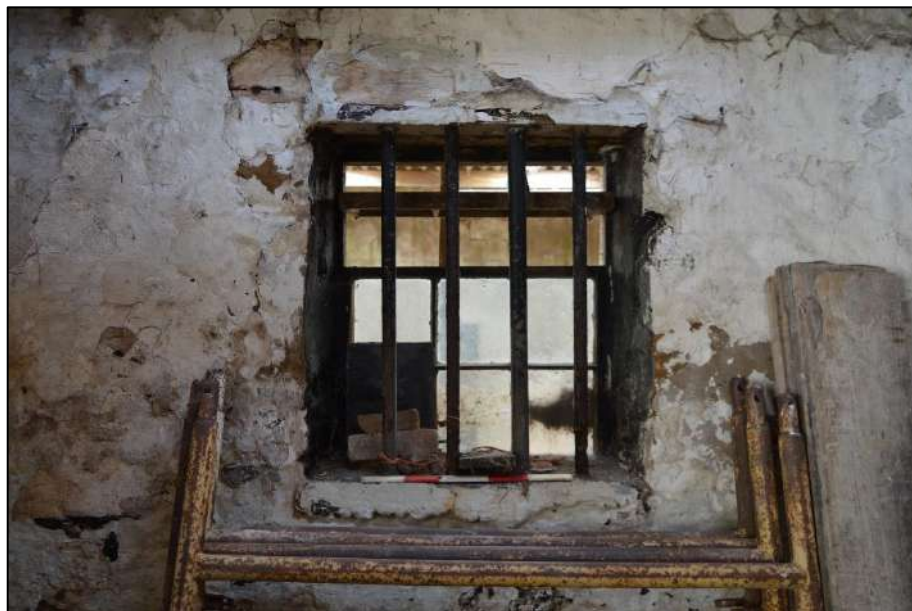
- 6.89 The ceiling within Room 7 comprised timber joists laid perpendicular to the ridge line of the roof, supporting plank floorboards.
- 6.90 Room 8 was in use as a storage area, and consequently internal details were difficult to determine, although it is likely that two stalls were originally located against the southwestern wall, back-to-back with those in Room 7. A timber framed sash window (Plate 129; Shot 147) in the northeastern wall of the room had a timber lintel and stone sill, with four vertical iron bars on the inside.

*Plate 129 (shot 147): Detail of window in northeastern wall of Room 8, 0.5m scale*

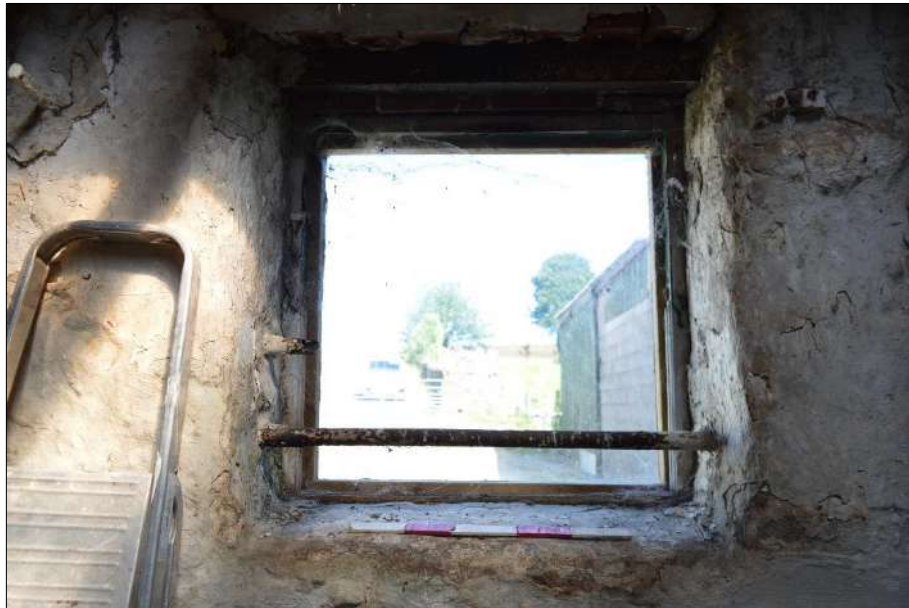
- 6.91 In the northwestern wall of the room a square window (Plate 130; Shot 150) had the remnants of two horizontal bars and thus resembled the window in the southeastern wall of Room 7,

lacking, however, the late insertion of a uPVC frame. Rather it retained a timber frame with a single pane of glass.

*Plate 130 (shot 150): Detail of window in northwestern wall of Room 8, 0.5m scale*

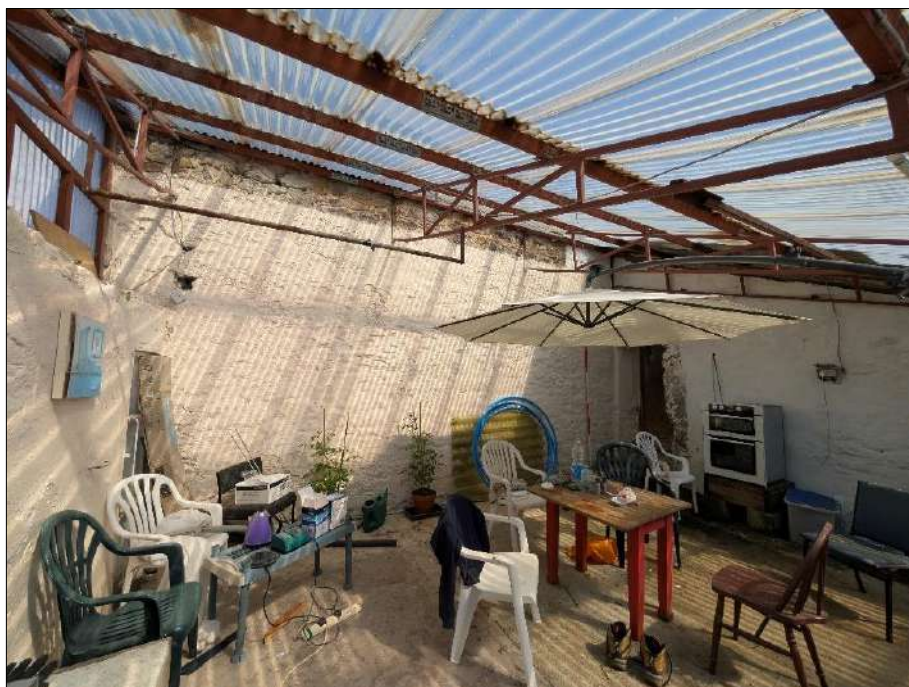
- 6.92 Room 11 (Plate 131; Shot 204) refers to the single storey southeast projecting extension at the northeastern end of the outbuilding. Historic mapping suggests that part of this extension originates in the early 20<sup>th</sup> century, as it does not appear on the 1898 OS mapping, but is depicted on that of 1910.

*Plate 131 (shot 204): Interior of Room 11, 2m scale*

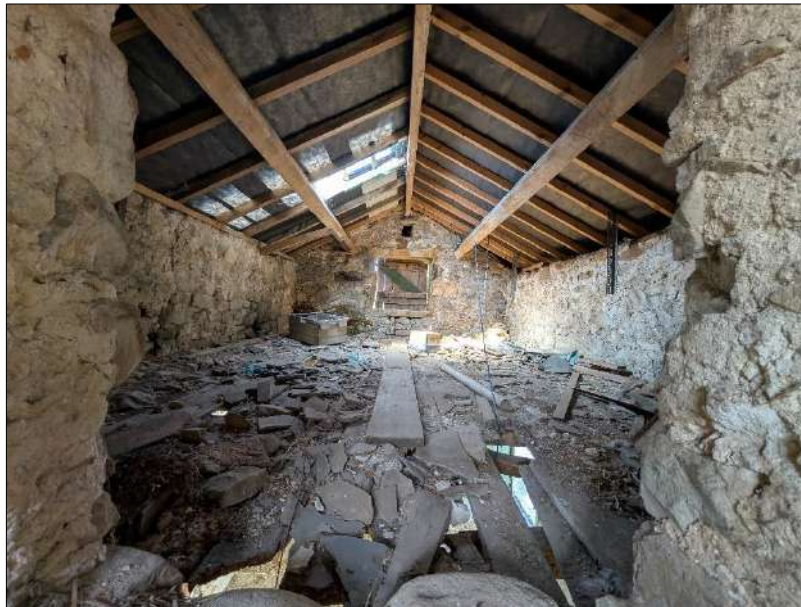
*Plate 132 (shot 201): Interior of Room 9, no scale*

- 6.95 Room 9 had low walls to the northwest and southeast of random coursed sandstone rubble construction (Plate 132; Shot 201). The gable end wall had a square loading door with substantial sandstone lintel and sill, with a plank-built timber door fitted. Above the door there was a partially blocked vent comprising a square gap in the masonry.
- 6.96 The roof structure of Room 9 consisted of timber wall plates, ridge beam and axial beams supporting rafters that carry the roof, which is likely to be a relatively recent replacement of the original.

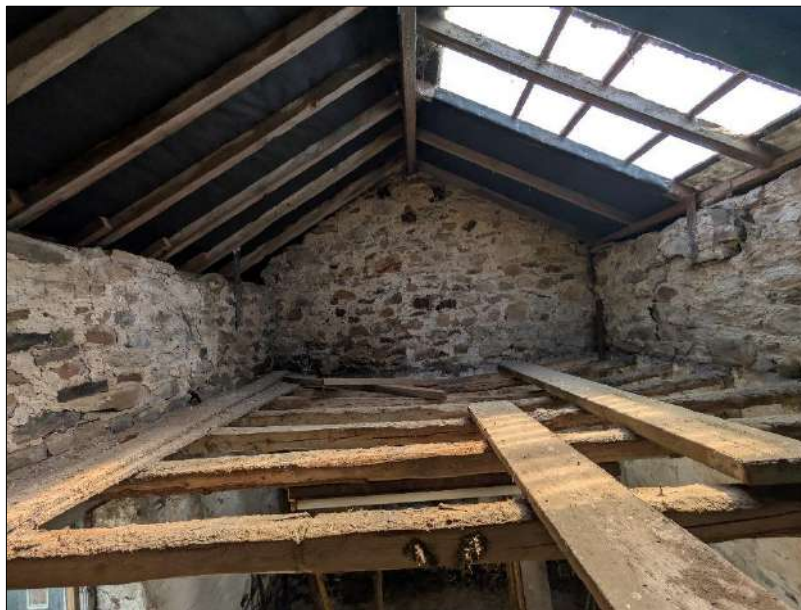
*Plate 133 (shot 202): Interior of Room 10, no scale*

- 6.97 In Room 10 the roof structure was the same, and again the roof is likely to represent a fairly modern replacement. The masonry (Plate 133; Shot 202) was of very similar character and form to that observed in Room 9. Near the apex of the gable at the northeastern end of the room there was a metal fixing, the function of which could not be ascertained, as the exterior of the gable at this end could not be observed.
- 6.98 In the gable of the partition wall between Room 9 and Room 10 there was a rectangular doorway with a lintel formed by two large pieces of timber (Plate 134; Shot 199). There was no door fitted to the opening, nor any evidence that there ever had been.

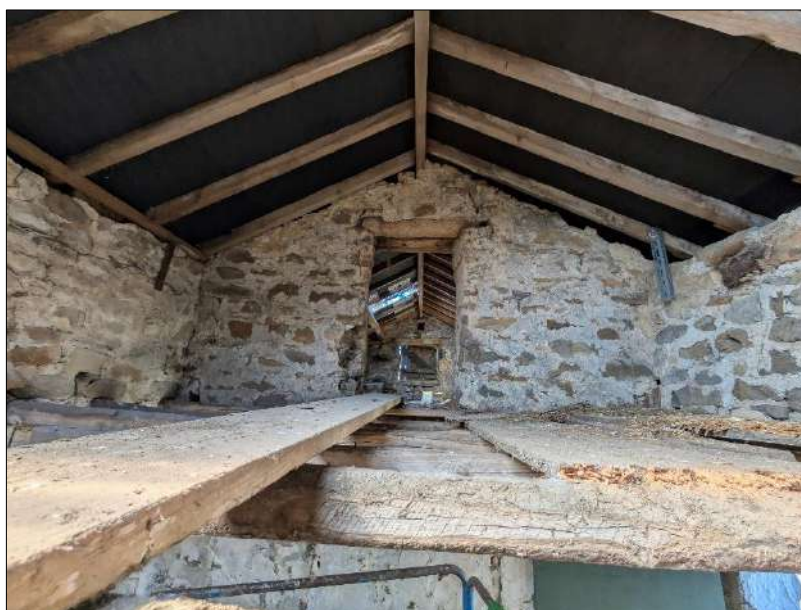
*Plate 134 (shot 199): Southwestern wall of Room 10, no scale*

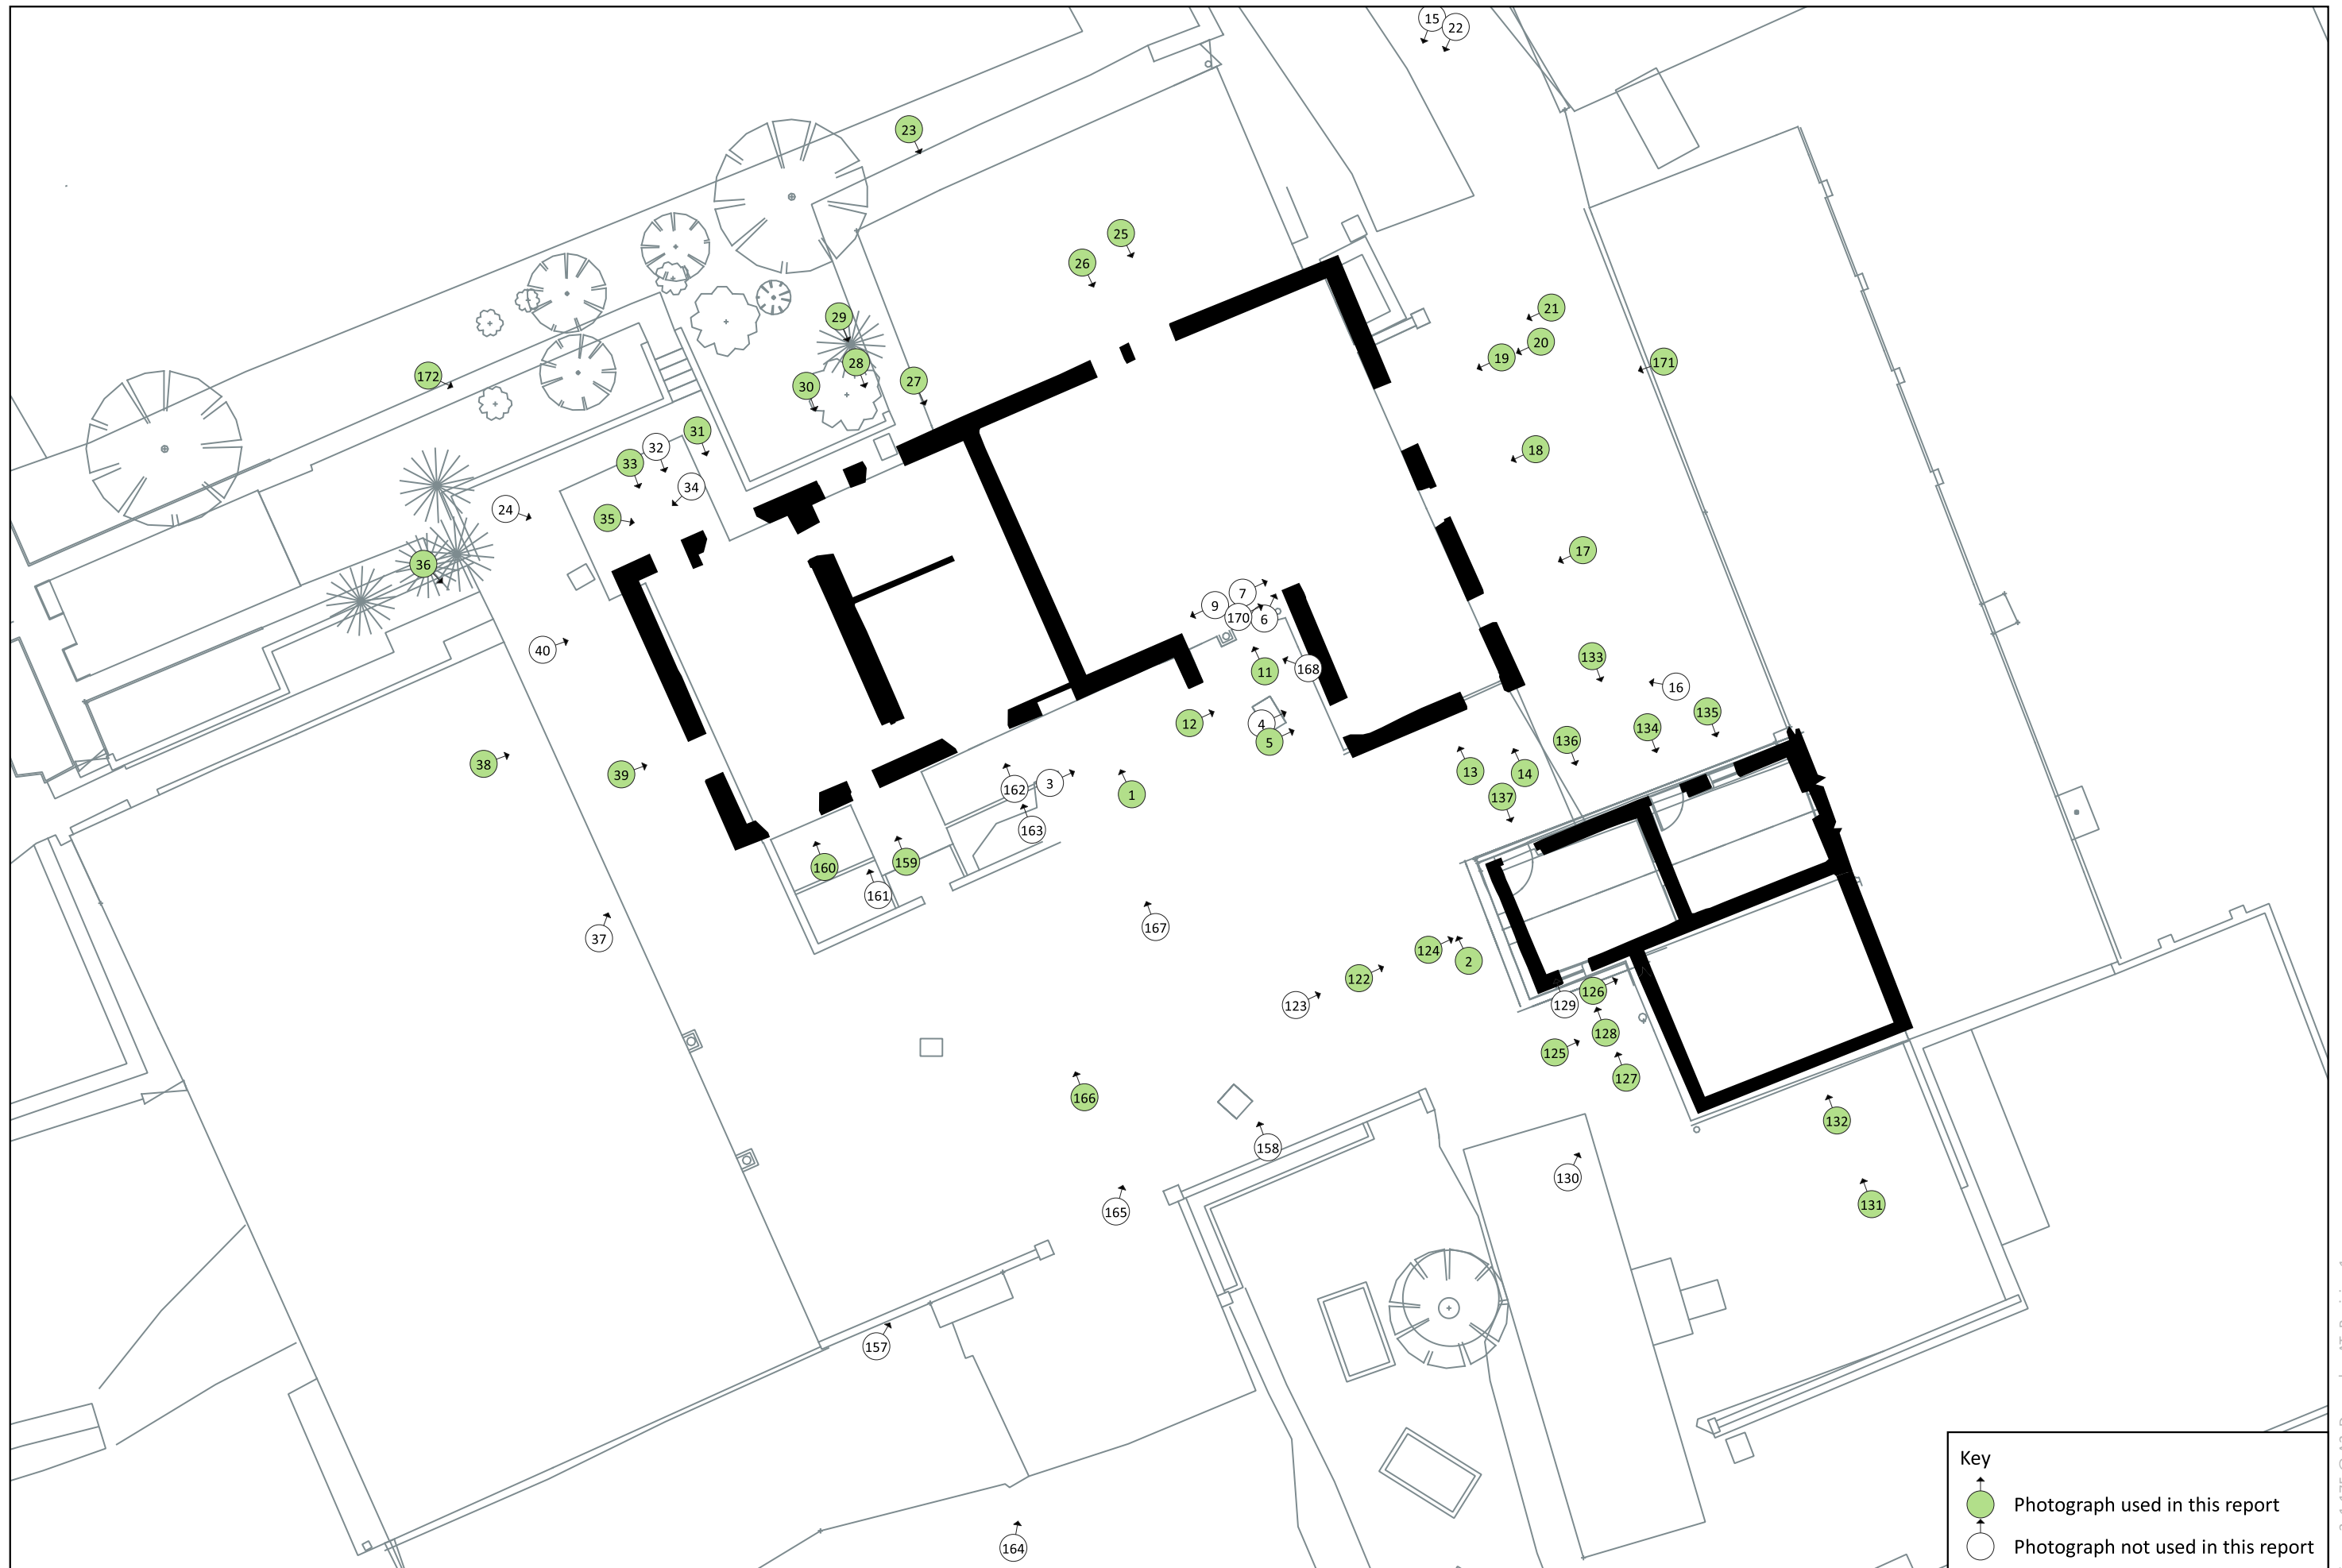
Figure 3: Location and direction of exterior photographs (highlighted photographs reproduced in report)
