Re: Application No. 3/2022/0834 proposed conversion of existing buildings to ancillary accommodation

In order to assess the likelihood of bats being present at Crow Trees Barn, a daytime inspection of the buildings and their surroundings and a single bat emergence survey were carried out on 31st August 2025.

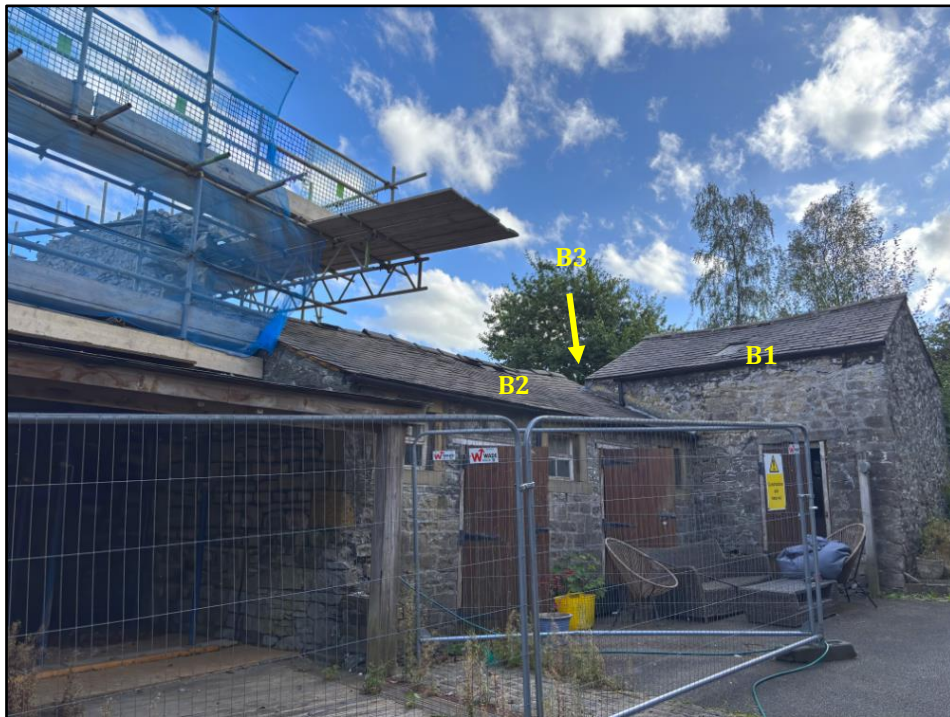
Image showing View of front (north and east) elevations of survey building. B3 is lean-to, lower section to the rear. Note presence of scaffold and Heras fencing from the adjacent development.

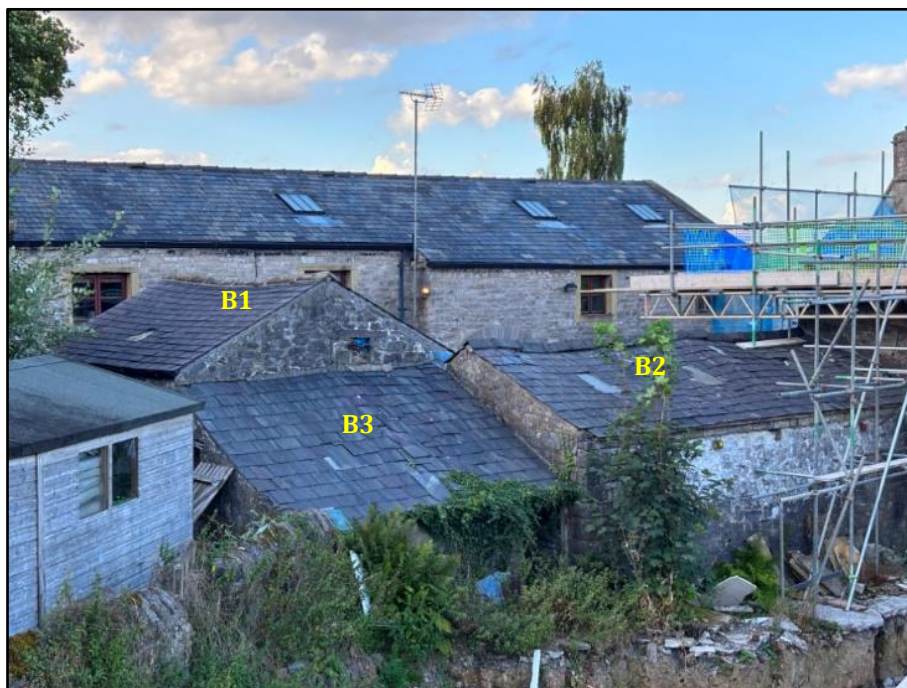
Image showing rear (south) elevation of survey buildings.

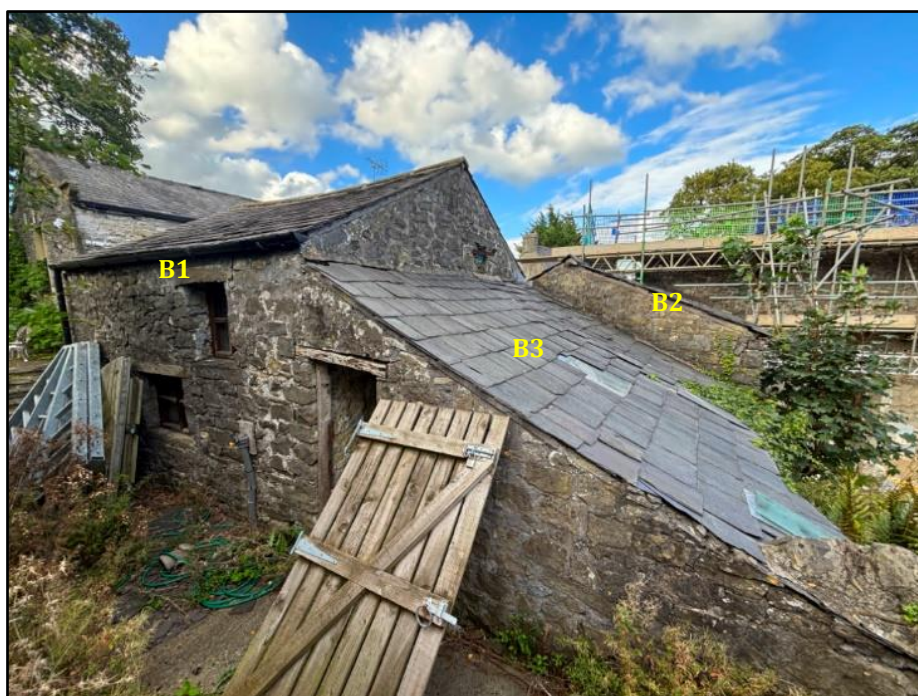
Image showing side (west elevation) of survey buildings.

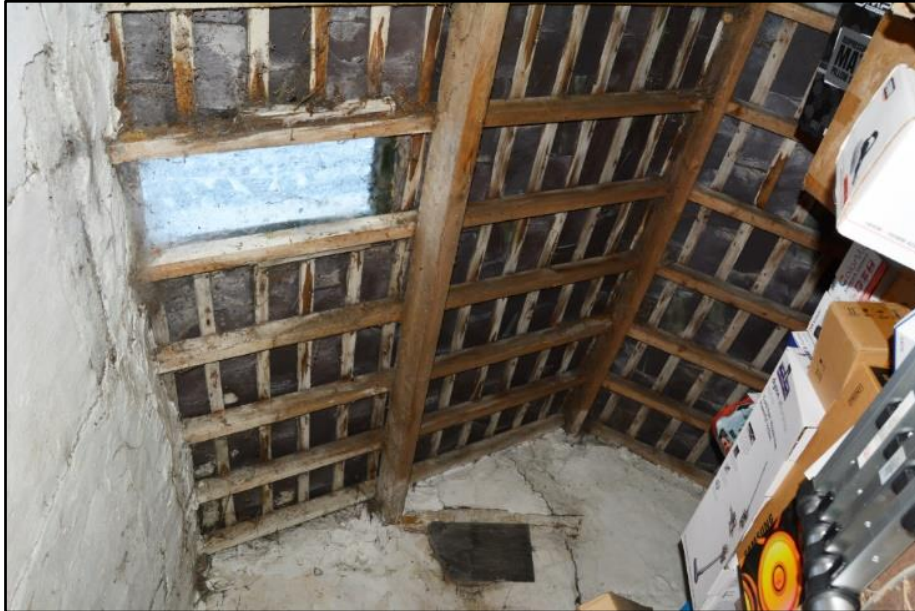
Example of intact roof underside with roof lights. This example is typical of roof underside in all of the buildings. Lack of roof liner in this type of building reduces the likelihood of use by day roosting and hibernating bats.

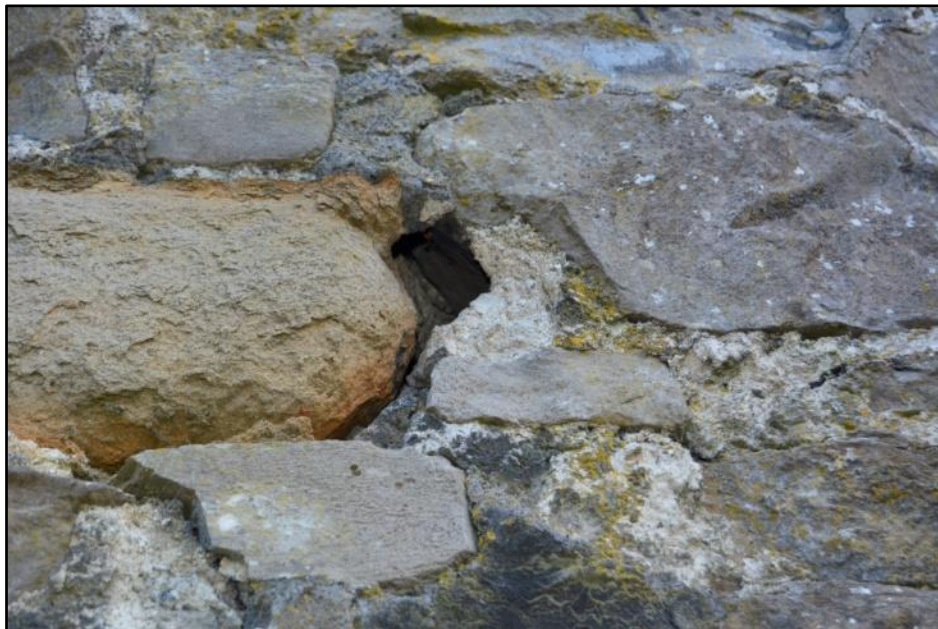
Example of external wall cavity.

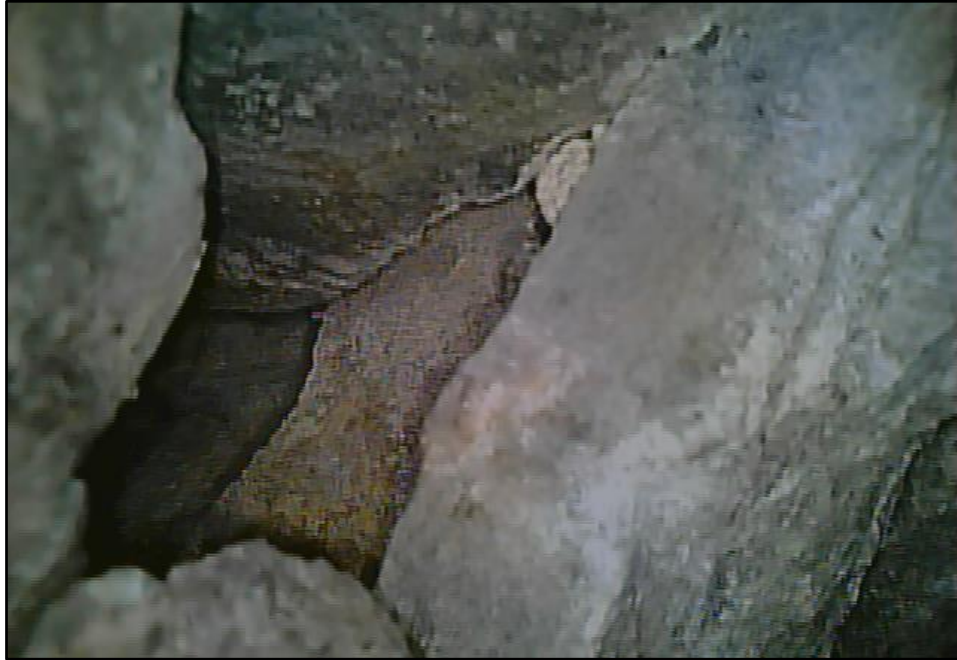
There are three discrete units (B1, B2, B3) forming a collection of adjoining outbuildings set within an L shaped footprint. All the buildings are constructed of stone walls with unlined, slate roof coverings. There are a small number internal and external deep wall cavities present in all of the buildings. These cavities were inspected with an endoscope during the survey and no bats or signs of use by bats was found.

Image of deep wall cavity taken using endoscope- no evidence of use by bats.

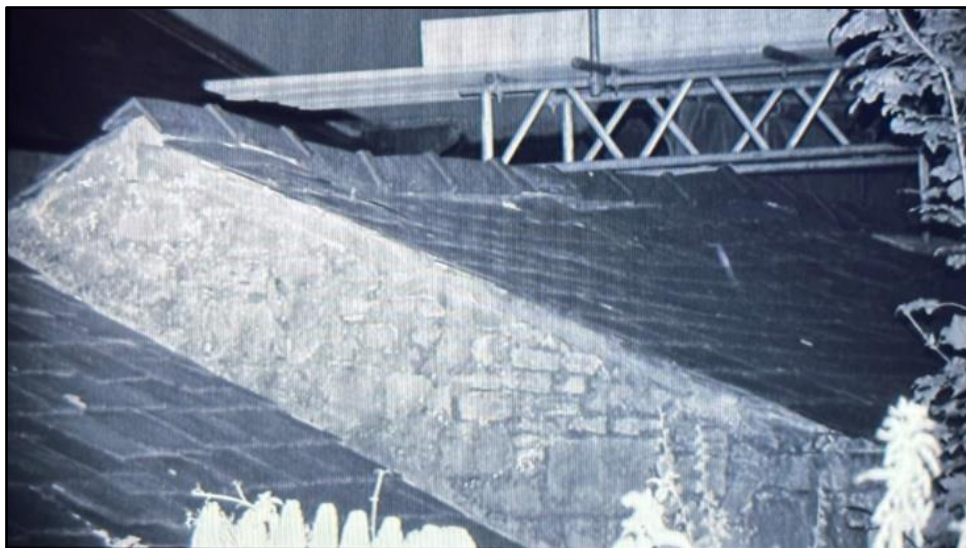
Roof coverings associated with Buildings 2 and 3 are in a poor state of repair, with large gaps present due to missing, slipped and broken slates. The roof coverings on Building 1 are however more intact and a small number of suitable gaps are present associated with roof and along the roof verges. There are no roof voids in any of the buildings and all the buildings are unheated, light and draughty, with Building 3 (the smallest unit, south corner) being the most exposed due to missing doors.

Infrared image taken on camera during emergence survey showing roof verge and roof covering of Building 2.
