## Preliminary Roost Assessment

41 St Mary's Drive, Langho, Blackburn, BB6 8DL

**Project:**

This report is prepared to inform a planning application with the Ribble Valley Borough Council. The proposal is described as:  
“Dorma roof extension/addition and side extension over garage”

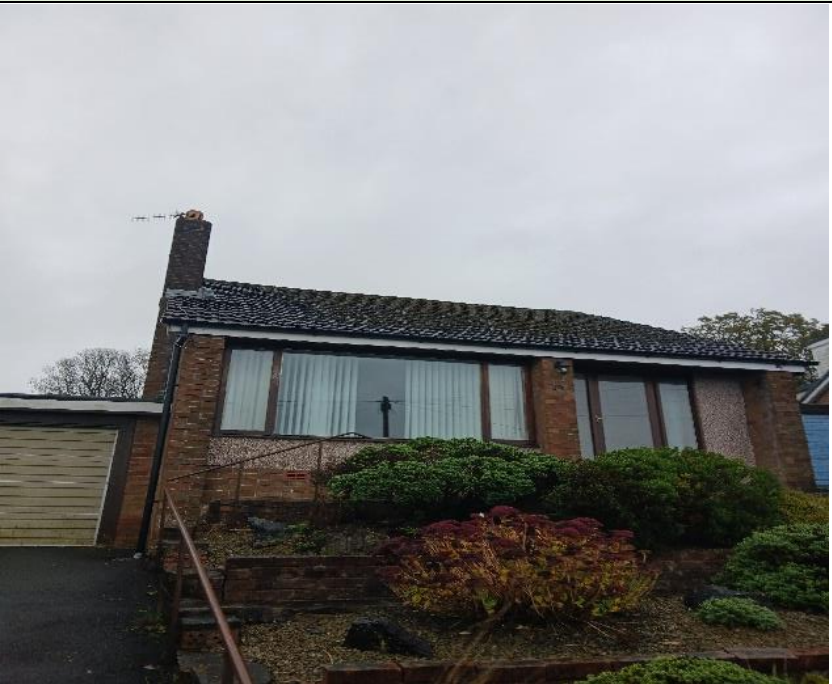
| <b>Field Survey Results</b> | | | |
|---|---|---|---|
| <p><i>Summary</i></p> <p>B1 is a single-storey detached brick-built residential dwelling with a pitched side-gabled roof comprised of concrete interlocking tiles. A brick chimney stack is present on the north gable end. The dwelling has upvc bargeboard and fascia's. The windows are timber-framed. The loft space is comprised of timber rafters with bitumen roofing felt, clad with loft insulation. The internal walls comprise concrete blocks, with a partial area clad with plasterboard.</p> <p>Attached to the dwelling is a single-storey brick-built garage with a flat roof comprised of corrugated fibre-cement sheets externally. The window is timber-framed.</p> <p>Attached to the east of the dwelling is a glass conservatory.</p> <p>The building has <b>low roosting value</b>.</p> | | | |

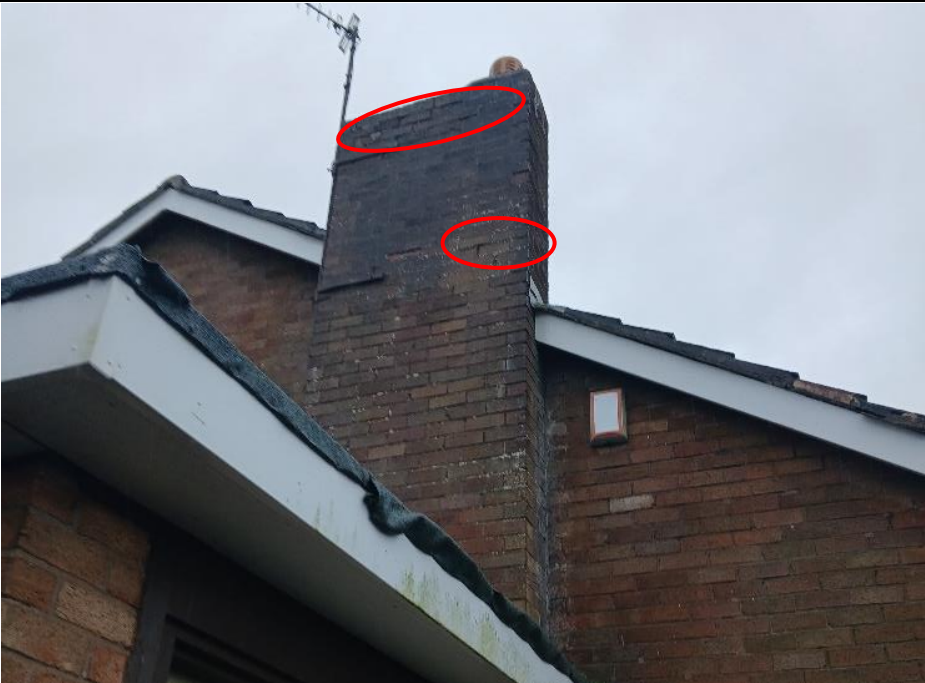
| <b>Field Survey Results</b> | | | |
|---|---|---|---|
| Walls | Red brick construction | <p><b>Condition/description</b><br/>Tightly sealed. Missing mortar on north facing chimney stack.</p> <p><b>Suitability/access/evidence of bats</b><br/>Missing mortar provides ideal roosting habitat for crevice dwelling bats and could support a low number of crevice dwelling bats. Roosting features are small and as such are not suitable to support maternity roosts. No evidence</p> | |

| | | <p>found but recent and current rain would wash this away externally.</p> | <p>Missing mortar on north facing chimney</p> |

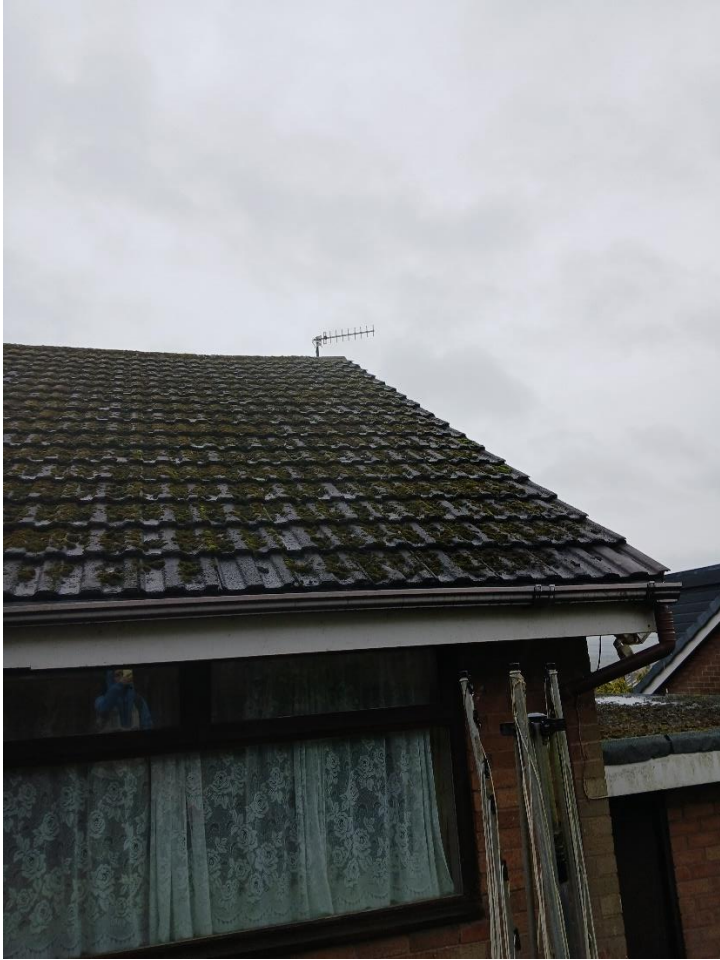
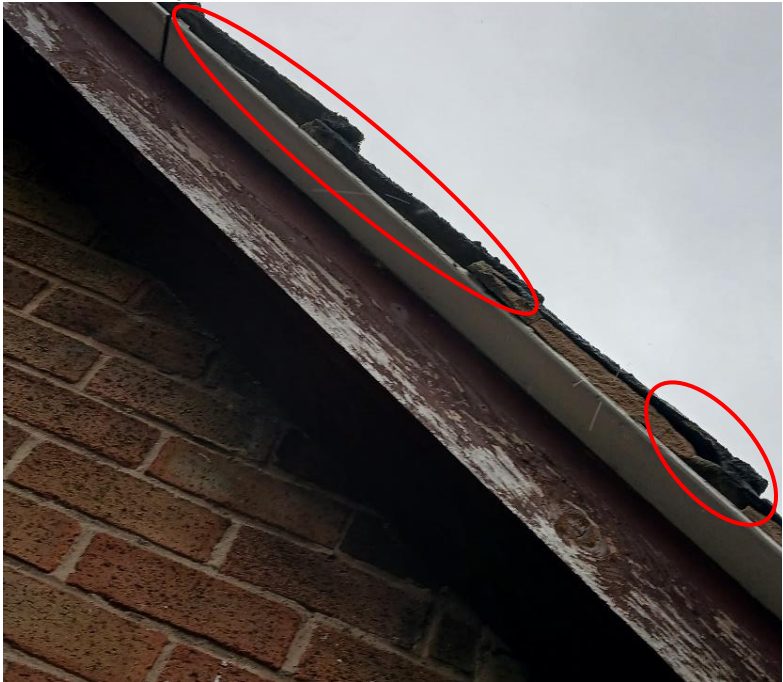
| Roof | Concrete | <p><b>Condition/description</b></p> <p>Side-gabled roof. Tiles are tightly sealed but missing mortar under verge tiles on the north and south elevations.</p> <p><b>Suitability/access/evidence of bats</b></p> <p>Space under tiles where mortar is missing could accommodate crevice dwelling bats. This could provide access into the wider roof structure and as such support a higher numbers of bats. These features may also offer suitable hibernation habitat. No evidence found but recent and current rain would wash this away externally</p> | |

| | | | <p>Tightly sealed tiles on eastern elevation.</p> <p>Missing mortar under verge tiles on the southern elevation.</p> |

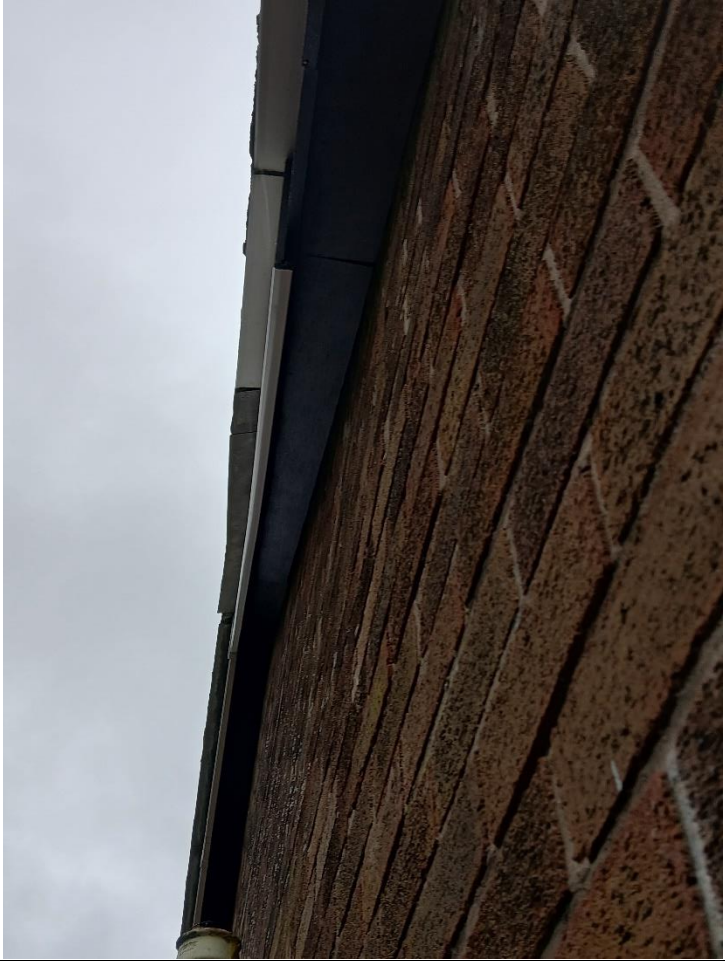
| Eaves | Closed | <b>Condition/description</b><br>No gaps under eaves.<br><b>Suitability/access/evidence of bats</b><br>No roosting features evident. Not suitable due to lack of access. No evidence found but recent and current rain would wash this away externally. | |

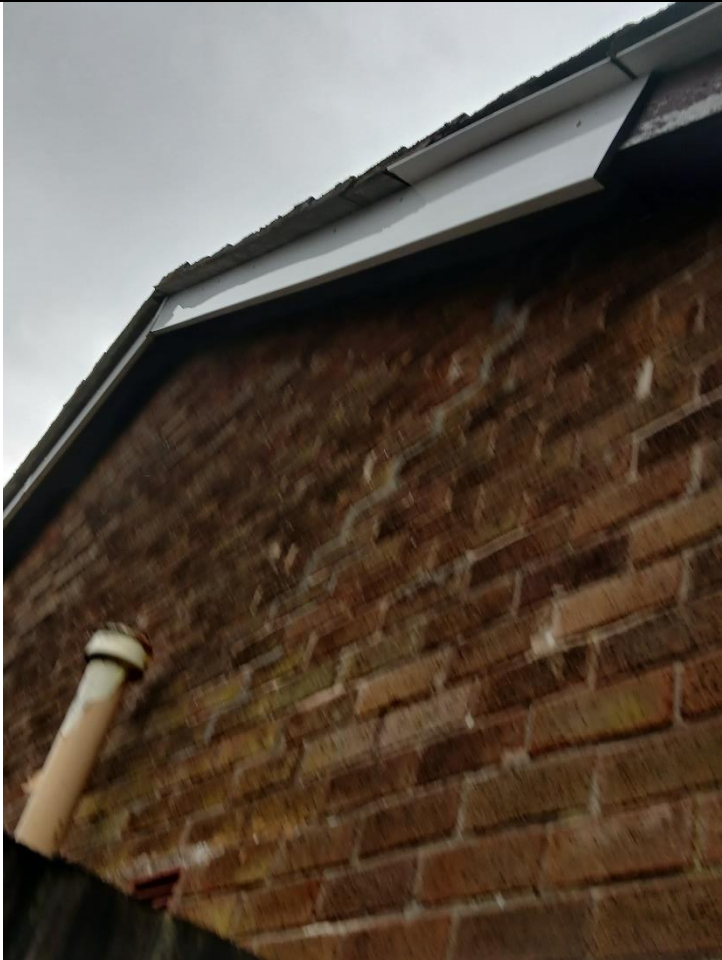
| Barge boards/fascia boards | UPVC/ timber | <b>Condition/description</b><br>Tight fitting, missing upvc replacements partially to the east on the south facing gable end, however no gaps evident. | <p>Fascia/barge boards on the southern elevation.</p> |

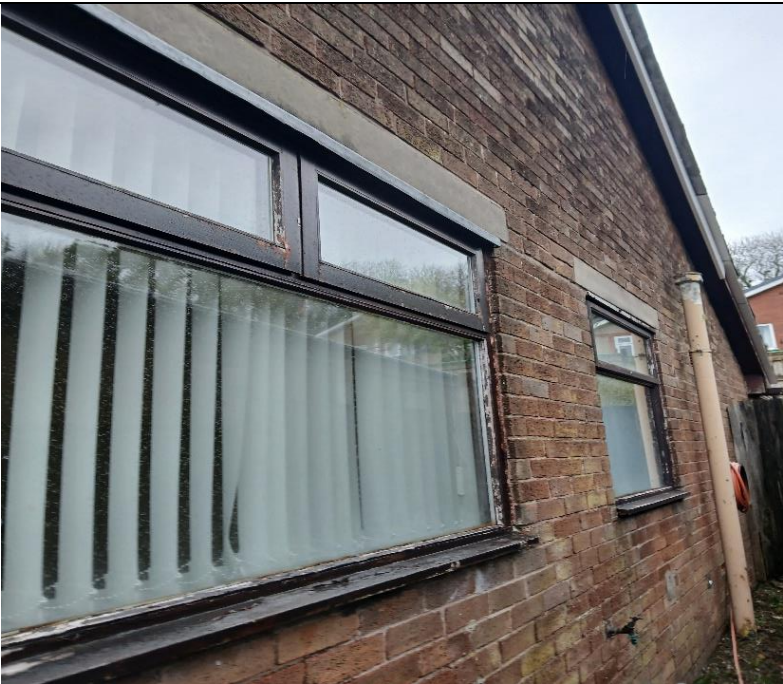
| Window/doors frames and lintels | Timber | <b>Condition/description</b><br>Tight fitting | <p>Timber windows on the southern elevation</p> |

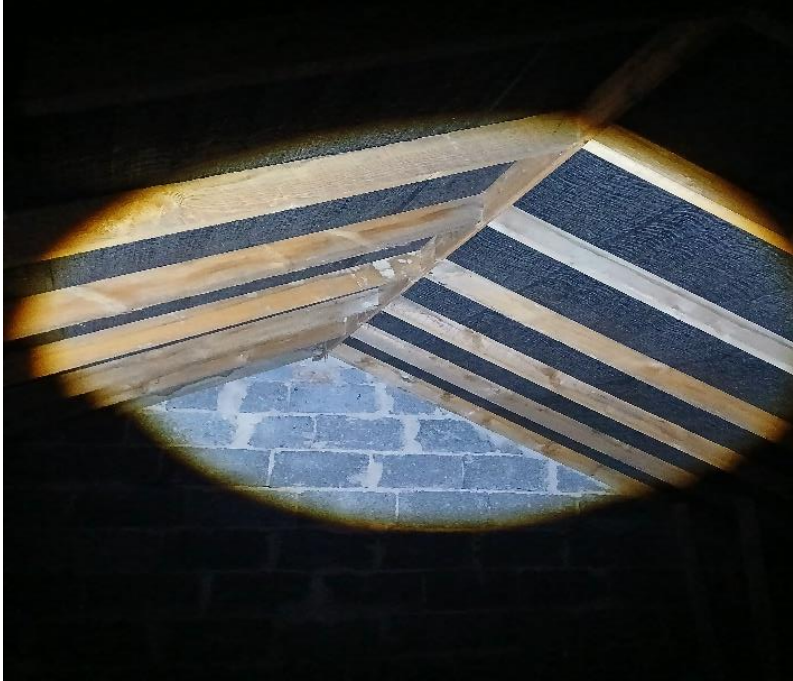
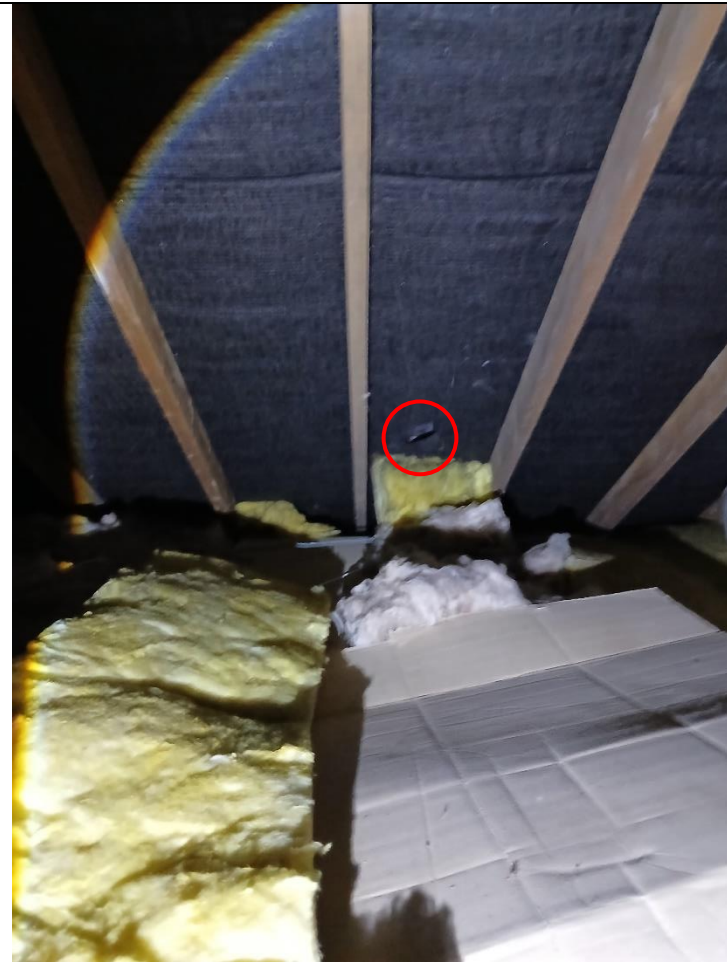
| <p>Internal void of main dwelling</p> | <p>Timber rafters, bitumen roofing felt clad with loft insulation. Internal walls comprise concrete blocks with partial area clad with plasterboard.</p> | <p><b>Condition/description</b></p> <p>Internal space measures approx. 10m long, 7m wide, floor to ridge height approx. 2.6m.</p> <p>The internal timbers appear to be relatively new and in good condition with no signs of surface wear or cracks within.</p> <p>Roof membrane relatively sealed, albeit a slight tear in the membrane to the east.</p> <p>The building is currently disused which reduces levels of disturbance that could prevent bats from roosting. No light ingress noted.</p> <p><b>Suitability/access/evidence of bats</b></p> <p>Tear in roof membrane could provide access for both crevice and void dwellings bats via the gaps under verge tiles. No evidence of bats found within.</p> | |

Slight tear in membrane to the east.

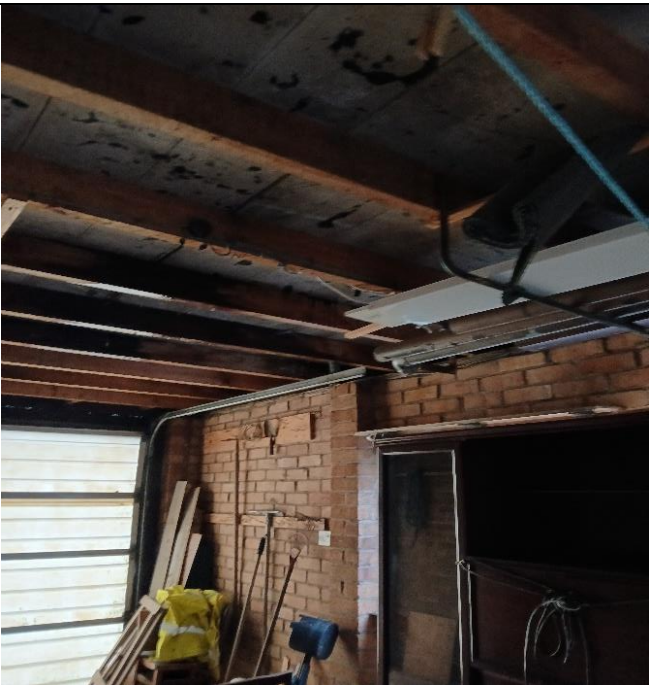
| Internal void of garage | Timber beams, red brick construction. | <b>Condition/description</b><br>Internal space measures approx. 7.5m long, 3m wide, floor to ridge height approx. 2.3m.<br>Open structure. Gap in the north facing window leading into the void.<br><br><b>Suitability/access/evidence of bats</b><br>There is a lack of stable temperatures and crevices within. Further there is extensive light ingress. As such the garage is deemed not suitable for crevice and void dwelling bats. | |
