# **Heritage statement to support listed building consent/planning application for reinstatement of original stair window and construction of new glasshouse to rear of Duke of York Inn, Grindleton**

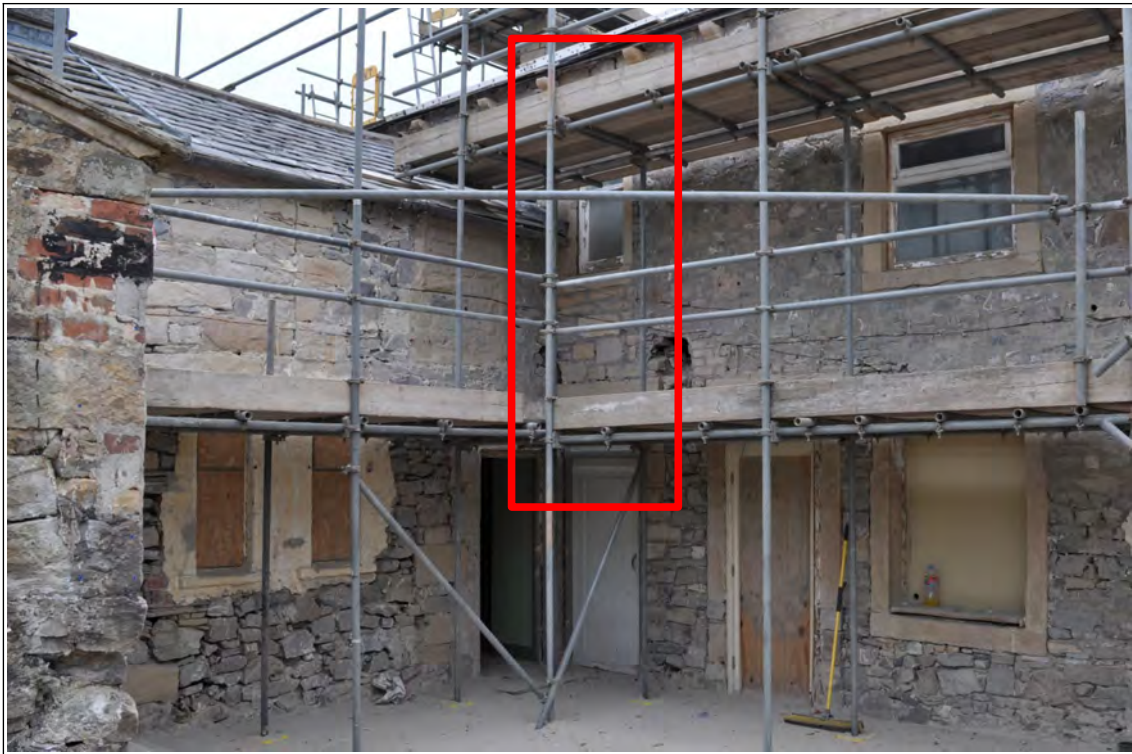
Photo 1: Rear elevation, showing stair window

- 5.2 Removal of render and plaster from the back wall during the present conversion has revealed clear evidence for the original stair window opening, which extends below and above the existing first floor window (photos 1 to 3, below). The tall form of the original window is entirely in keeping with those seen in other buildings of this period, character, type and size.

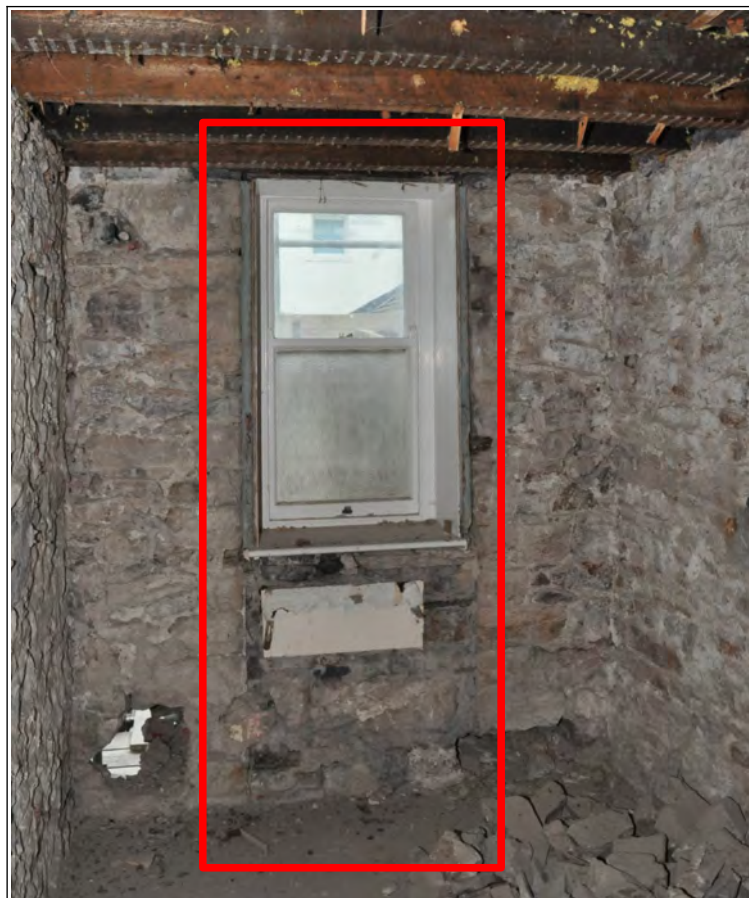
Photo 2: Existing window at first floor level; note infill below

- 5.1 The original stair window in the rear elevation has been reduced in size previously through partial blocking up, a change which took place in the early 20th century (between 1905 and 1926, according to previous heritage statements for the site), when the original staircase between ground and first floor was replaced, and that up to the second floor was taken out altogether and replaced by one in the east end of the building.

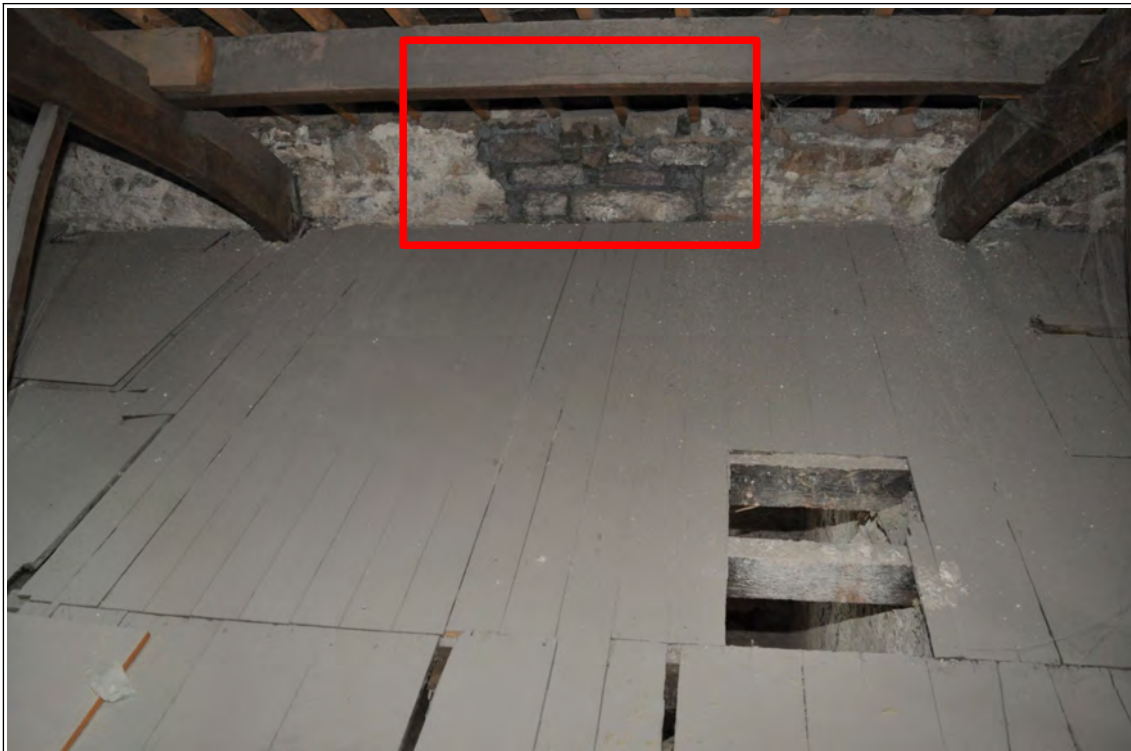
Photo 3: Window infill and position of former stair (to be reinstated) on second floor

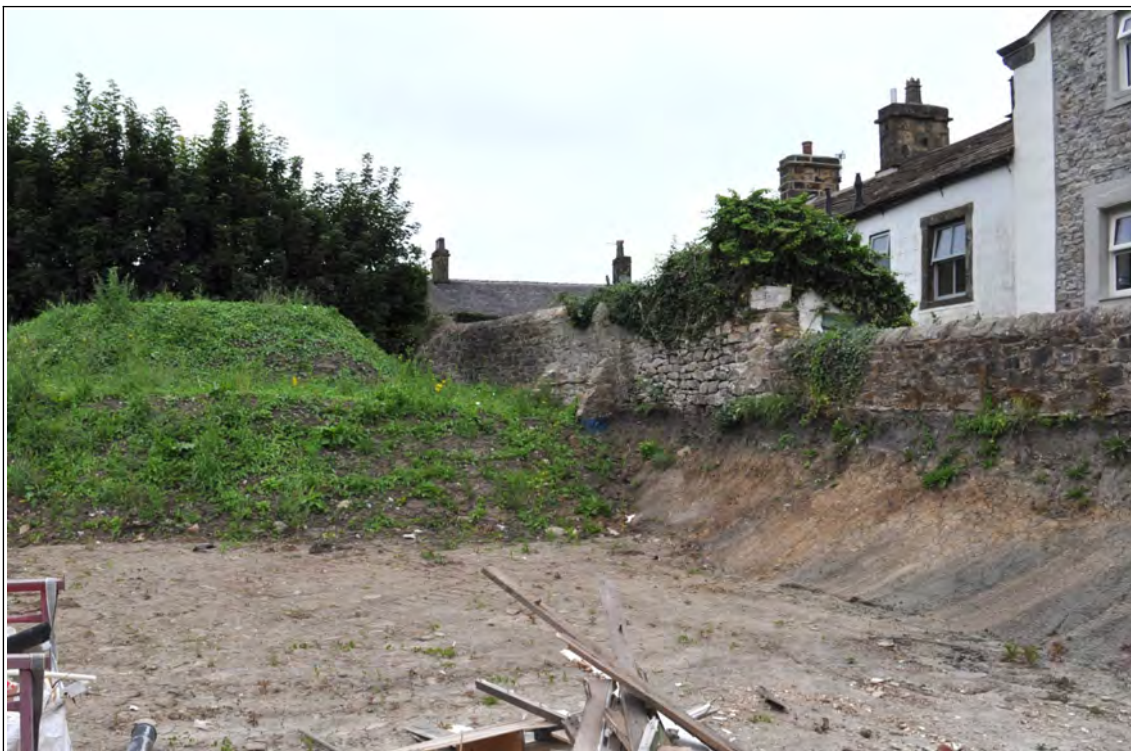
Photo 4: Site of proposed glasshouse

- 5.5 It is also proposed to erect a greenhouse with stone dwarf walls, measuring 10m x 3m, in the plot to the rear of of the former public house, against the eastern boundary wall, about 8m from the nearest part of the historic building (photo 4).
