Proposed solar installation at Stonyhurst College, Clitheroe, Lancashire BB7 9PZ

Thank you for your request for a bat and bird survey relating to proposed solar installation at the above site.

3.0 Results of the Survey

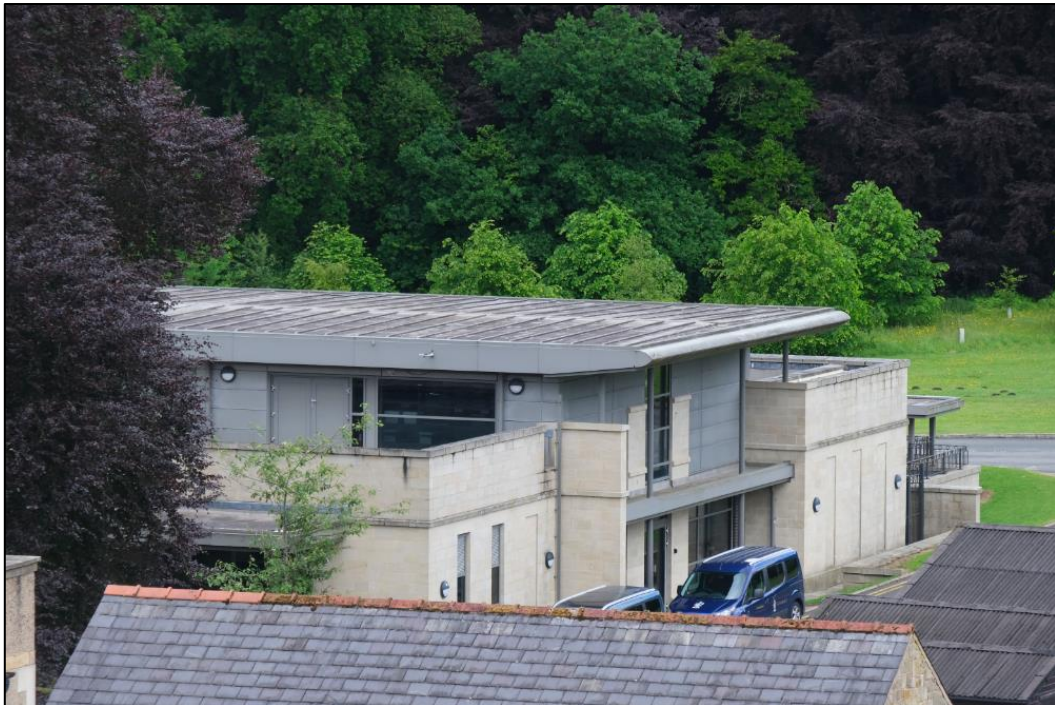
Building 1 –New Refectory comprises a flat metal sheet roof on steel roof supports, with lower-level flat roof sections on the north and south elevations covered with a sealed membrane. There are no roof voids and no suitable features for use by roosting bats.

Image showing (external) roof covering of Building 1

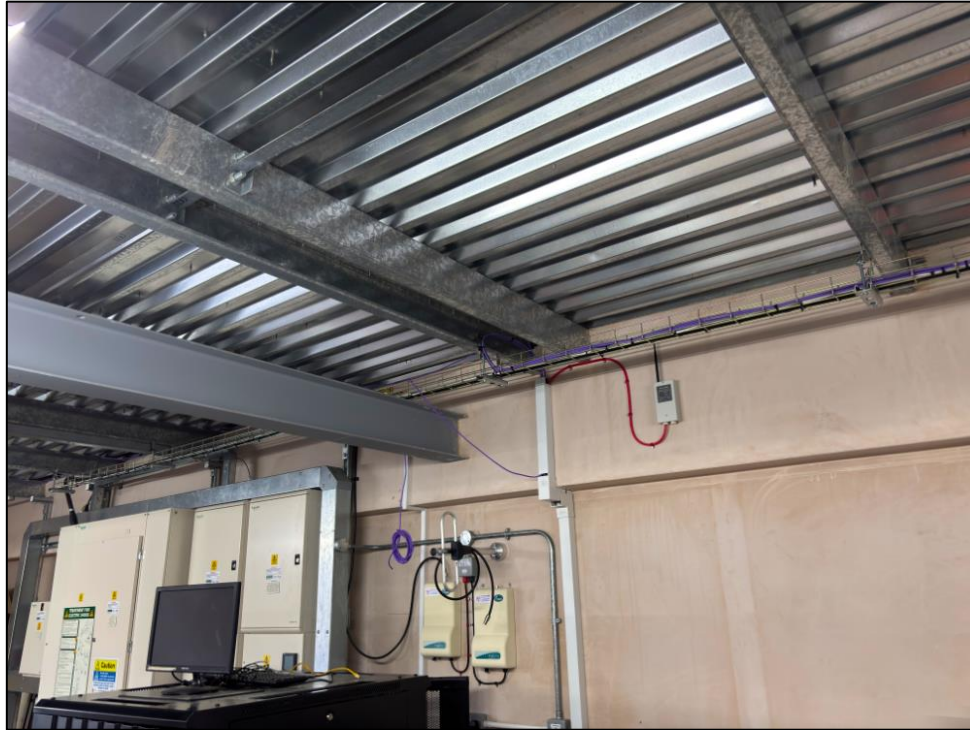
Image showing (internal) roof underside of Building 1

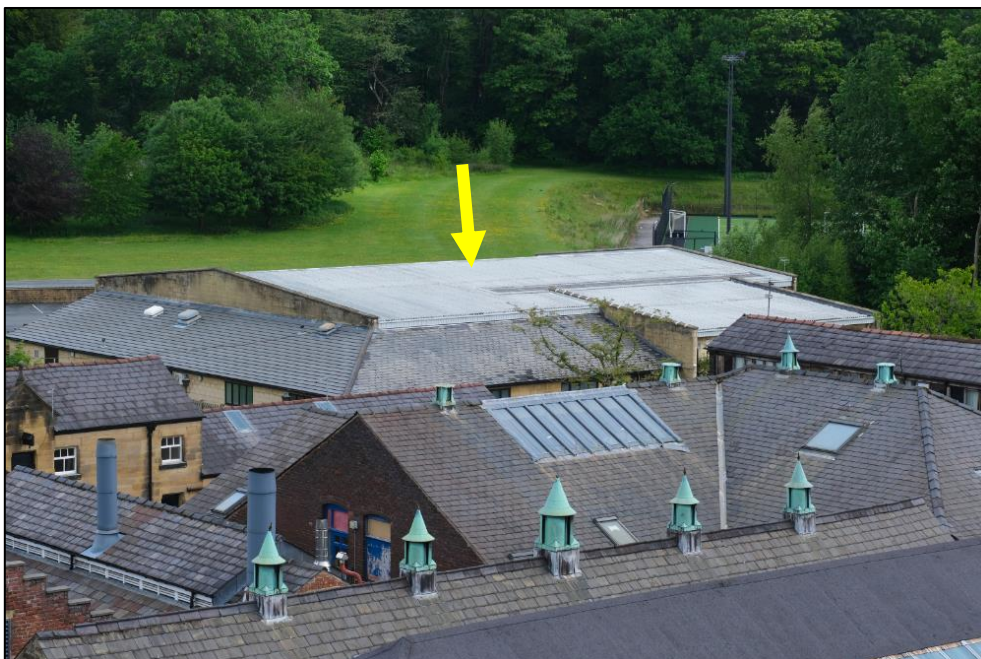
Building 2 –Main Sports Centre comprises a shallow pitched metal sheet roof with stone parapet gables and steel roof supports. There are no roof voids and no suitable features for use by roosting bats.

There is high potential for nesting birds to be present within mature trees, shrubs and woodland habitat in close proximity to Buildings 1, 2 and 3 during the nesting season (February to September).

Image showing (external) roof covering of Building 2 (yellow arrow) and its context, with other buildings and vegetation in close proximity

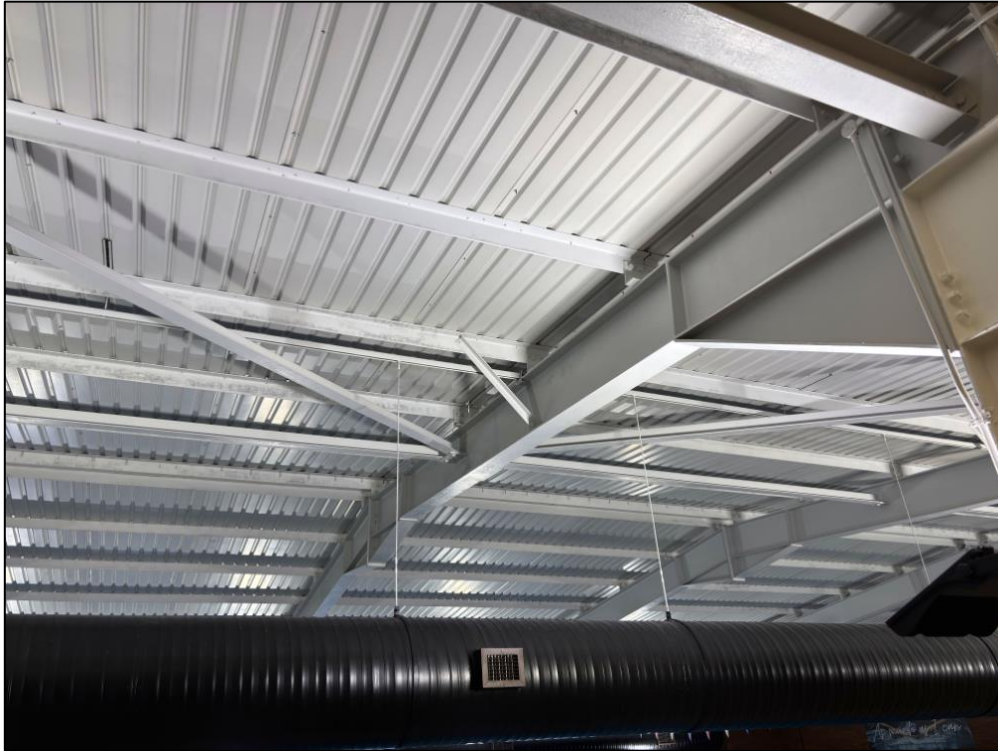
Image showing (internal) roof underside of Building 2

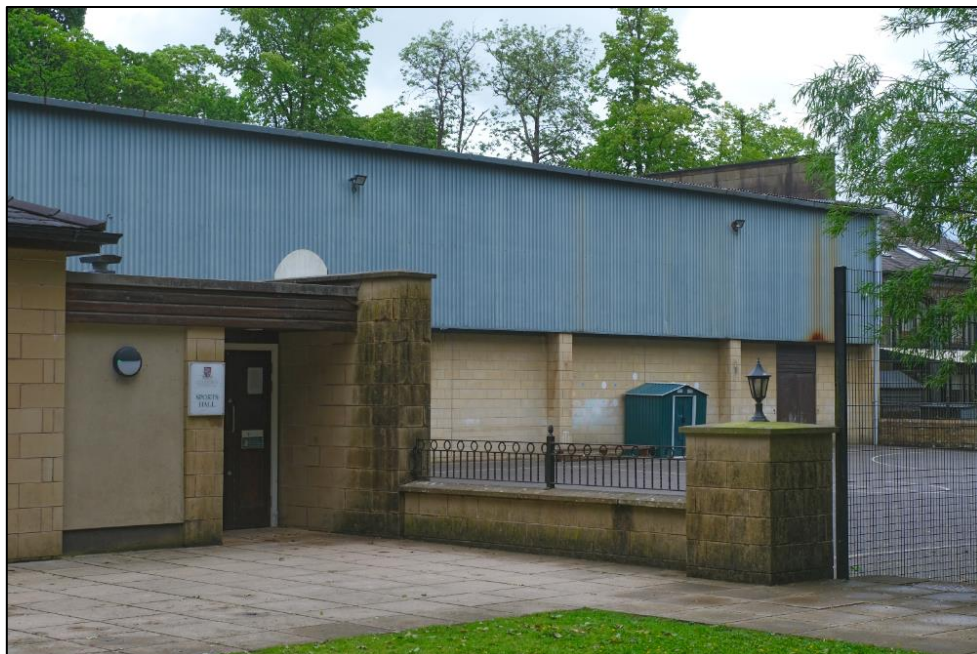
Building 3 - St Marys Hall Sports Hall comprises a shallow pitched metal sheet roof on steel roof supports and roof lights. There are no roof voids and no suitable features for use by roosting bats.

Image showing external view of Building 3 (red arrow) with mature trees and vegetation behind and in close proximity

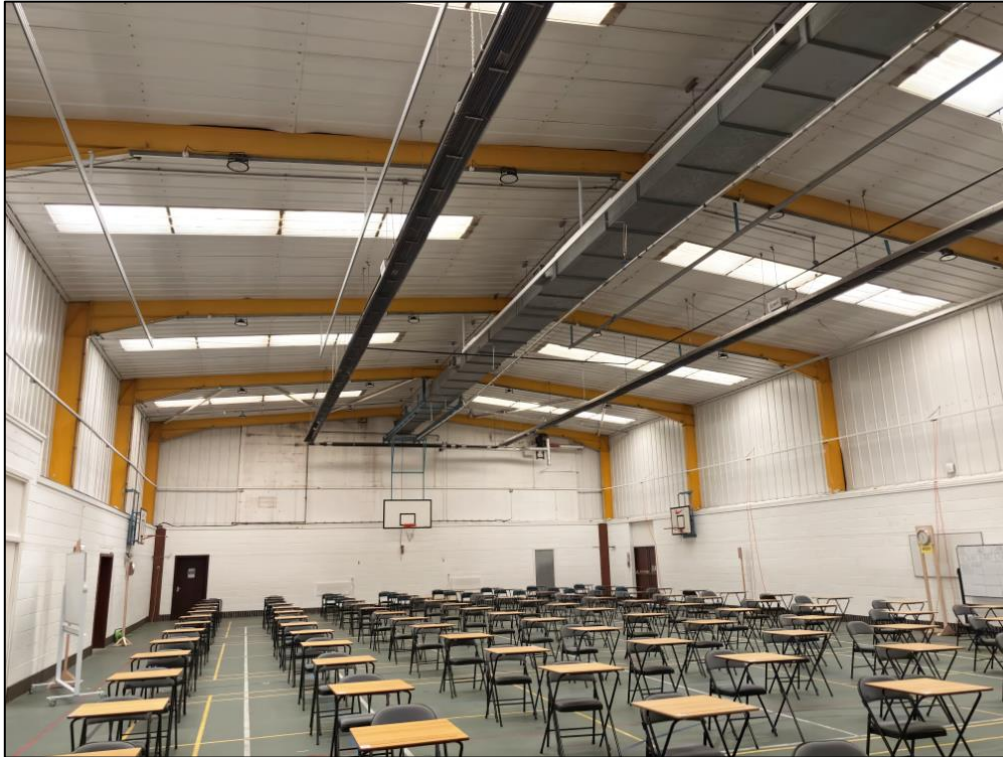
Image showing (internal) roof underside of Building 3

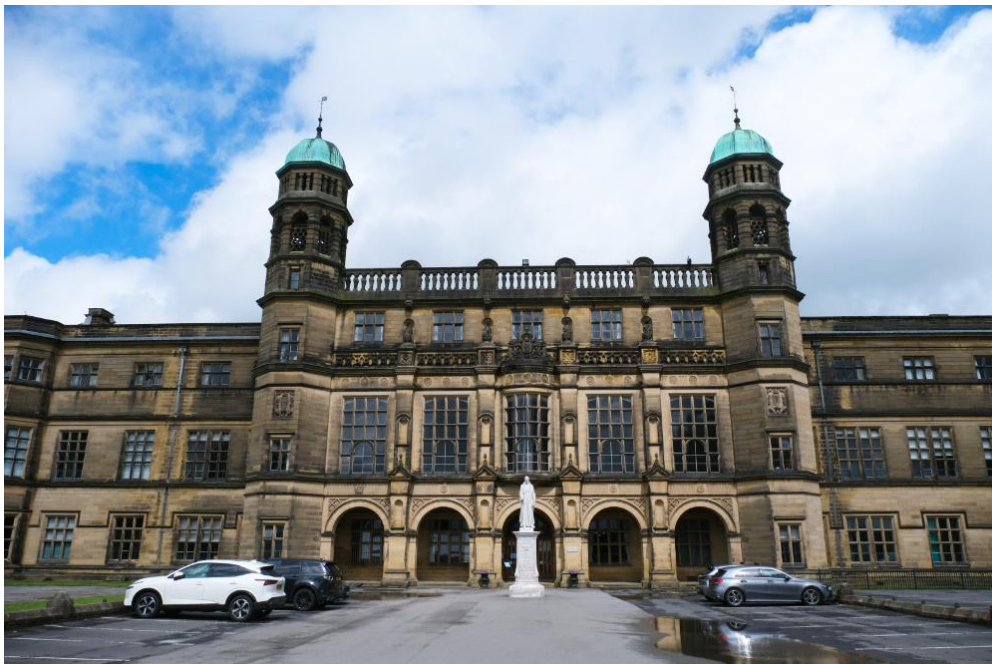
A well-known, established kestrel nest site is present within one of the towers on South Fronts (Building 4). Although no kestrel activity or recent signs of nesting was found during the survey, the tower structures have high potential for use by bird species including Kestrels throughout the year.

Ground level image of Building 4 showing Towers, known nest site for kestrels

Species	Impacts, Issues & Rationale	Action
Nesting birds	<p>There are <u>predicted</u> impacts (disturbance, damage and destruction) to nesting birds, nests and eggs as a result of the development.</p> <p>There is high potential for a range of nesting bird species to be present and/or nesting during the bird nesting season (February to September).</p> <p>Under the Wildlife and Countryside Act 1981 (as amended), wild birds are protected from being killed, injured or captured, while their nests and eggs are protected from being damaged, destroyed or taken.</p>	<p>Advice (protection & mitigation): It is advised that a glint and glare assessment should be undertaken to ensure potential impacts on nesting birds are addressed. For example, bird such as kestrels may be prevented from nesting at the towers and/or disturbed as a result of solar glare. Prior to any work commencing.</p> <p>Advice (mitigation): All people working at the proposed development site should be made aware of the likelihood of encountering nesting birds and should be made aware of the legal protection of nesting birds and their own responsibilities as regards implementation of precautionary measures. Prior to any work commencing.</p> <p>Advice (mitigation): It is advised that the most appropriate way to address the risk to nesting birds is:</p> <ul style="list-style-type: none"> • Avoid working on Building 4 and/or in close proximity to vegetation around Building 1, 2 and 3 during the nesting season Or • If works cannot take place outside the nesting season, the following measures should be adopted: • All people working at the site should attend a tool box talk by an ecologist

Species	Impacts, Issues & Rationale	Action
Nesting birds continued		<ul style="list-style-type: none"> All areas for removal/disturbance should be carefully checked by an ecologist, immediately prior to works commencing. If the risk of nesting birds remains, then monitoring for nesting bird activity should continue for the duration of works. <p>Prior to any work commencing (checks) and throughout works in nesting season (monitoring)</p> <p>Advice (mitigation): If nesting birds are found at the proposed development site, or close enough to cause unlawful activities as a result development works, it will be necessary to delay works or seek advice as to whether or not any development can proceed lawfully at that time. Under these circumstances, work must stop until advice has been sought from an appropriately experienced Ecologist.</p> <p>Prior to any work commencing (checks) and throughout works in nesting season (monitoring)</p>

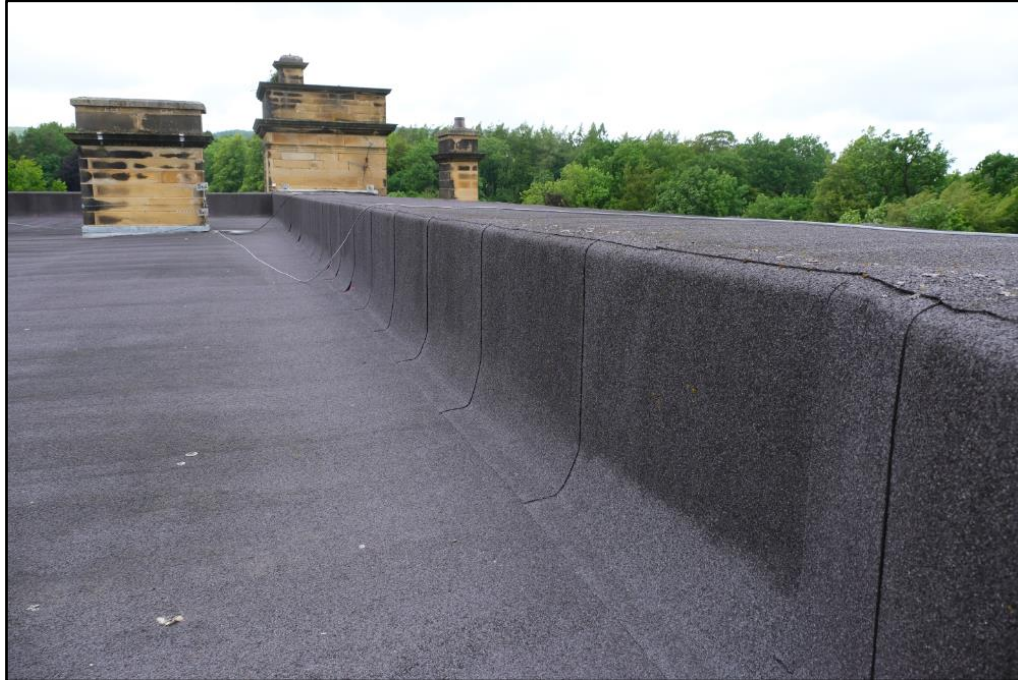
Building 4- South Fronts (including West Wing) comprises a flat roof covered with a bitumastic membrane roof liner and lead flashing trim along the base. There are stone chimneys, air conditioning units and heavy-duty cable trays present on the roof top. There are no roof voids, and apart from a lift chimney cap stone on one of the chimneys, all other features and structures are sealed tight with no suitable features for use by roosting bats. The gap associated with the lifted chimney cap stone was too large and open for use by bats but does provide potential shelter for use by nesting birds.

Image of roof top showing sealed liner and stone chimney stacks on Building 4

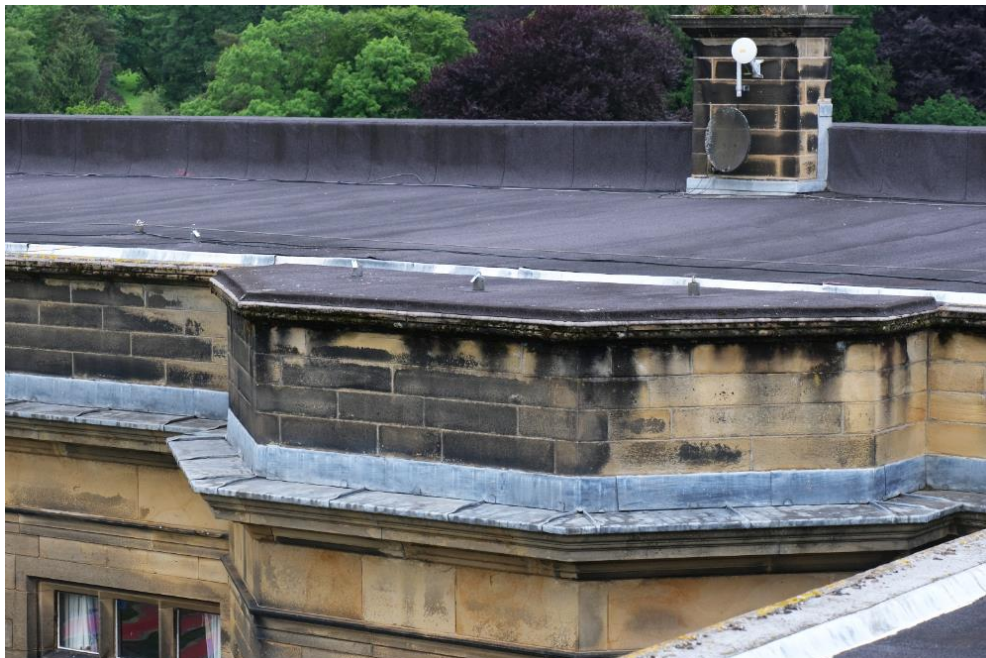
There is high potential for nesting birds to utilise building features such as the towers, ledges and cavities (e.g. lifted chimney cap stone) during the nesting season (February to September) on Building 4.

*Image showing example of ledge features below roof top (proposed work area).
These ledges have potential for use by birds during the bird nesting season
(February to September)*
