BAT SURVEY, AT -

22 CLITHEROE ROAD
WHALLEY

DATE AND TIME OF VISIT
9th Oct 2025 9.00am

REFERENCE NO 7240

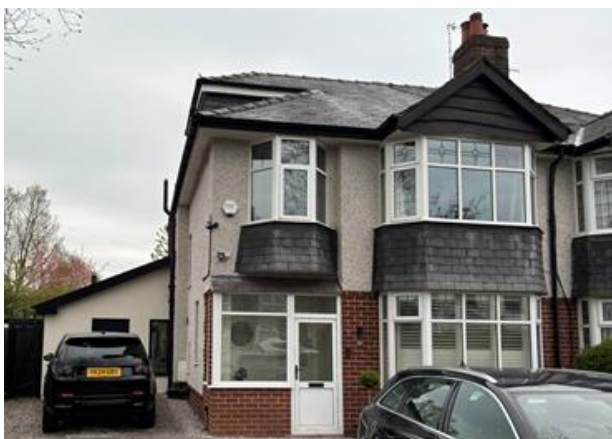
Front Elevation

The building is a semi-detached dwelling probably dating from the 1930's. A single storey side lean-to extension has been added, and the roof space has been converted to form bedroom accommodation with a dormer window.

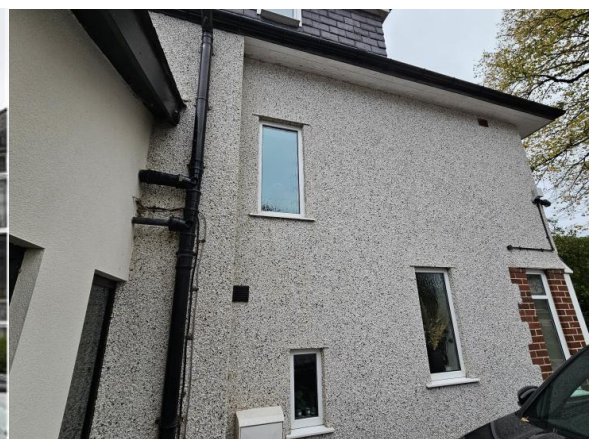
Side elevation.

The location of the proposed extension.

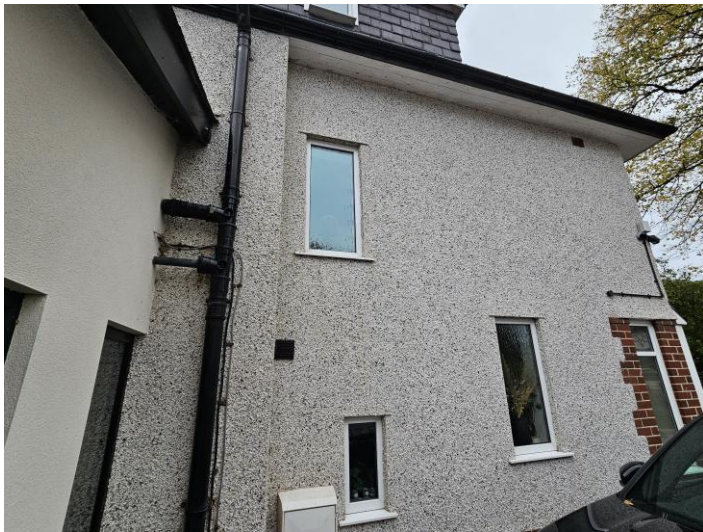
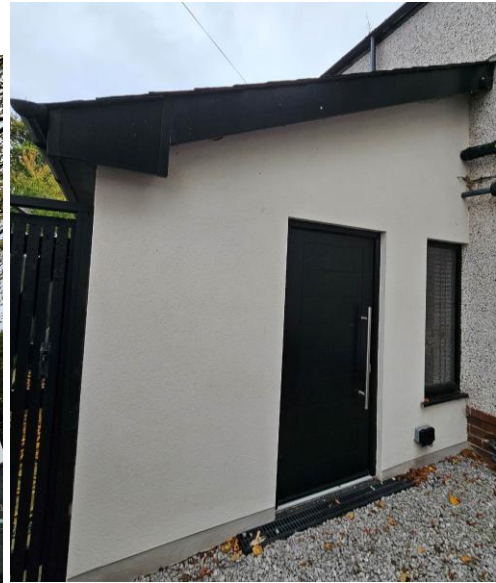
The side wall which will be affected by the proposed extension has a pebble dash render finish over brick. The front elevation of the lean-to has a K Rend finish over blockwork.

The side elevation being affected by the proposed extension The front elevation of the lean-to

The walls are in perfect condition with no cracks or crevices suitable for bat ingress.

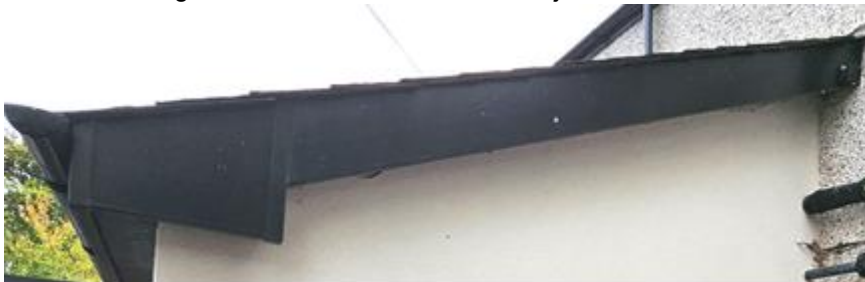
The new lean-to roof has a blue slate finish. With upvc barge boards, fascia's to the side and soffits to the overhang. The roof is flashed into the adjacent wall.

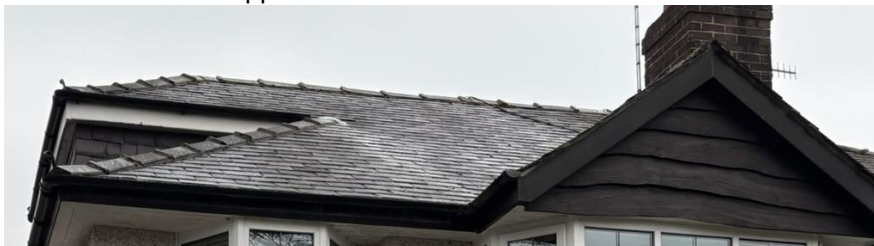
The main roof is a hipped blue slate structure. With a dormer formed in the hipped side of the roof.

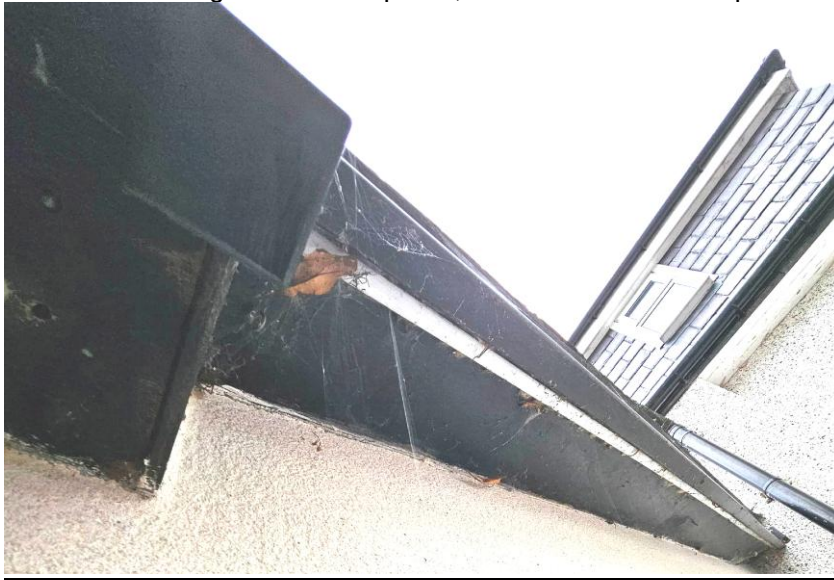
The lean-to roof is relatively new and in perfect condition all abutments are very tight fitting as are the slates and flashings. No access points, cracks or crevices are present in this roof.

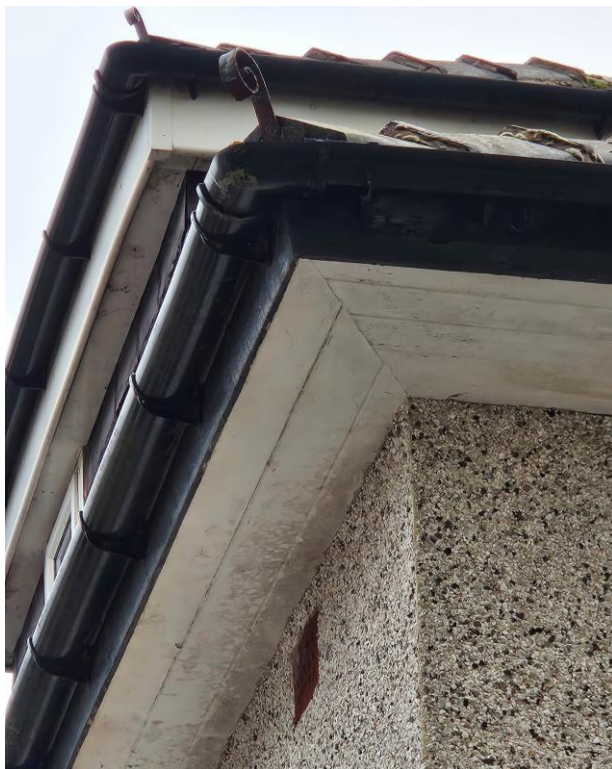
The main roof fascia's and soffits are in good condition. all very tight fitting. The slates are tight fitting and hip/ ridge tiles are in good condition as is the pointing. The roof did not provide any access points or crevices with the potential to provide roost potential for bats.

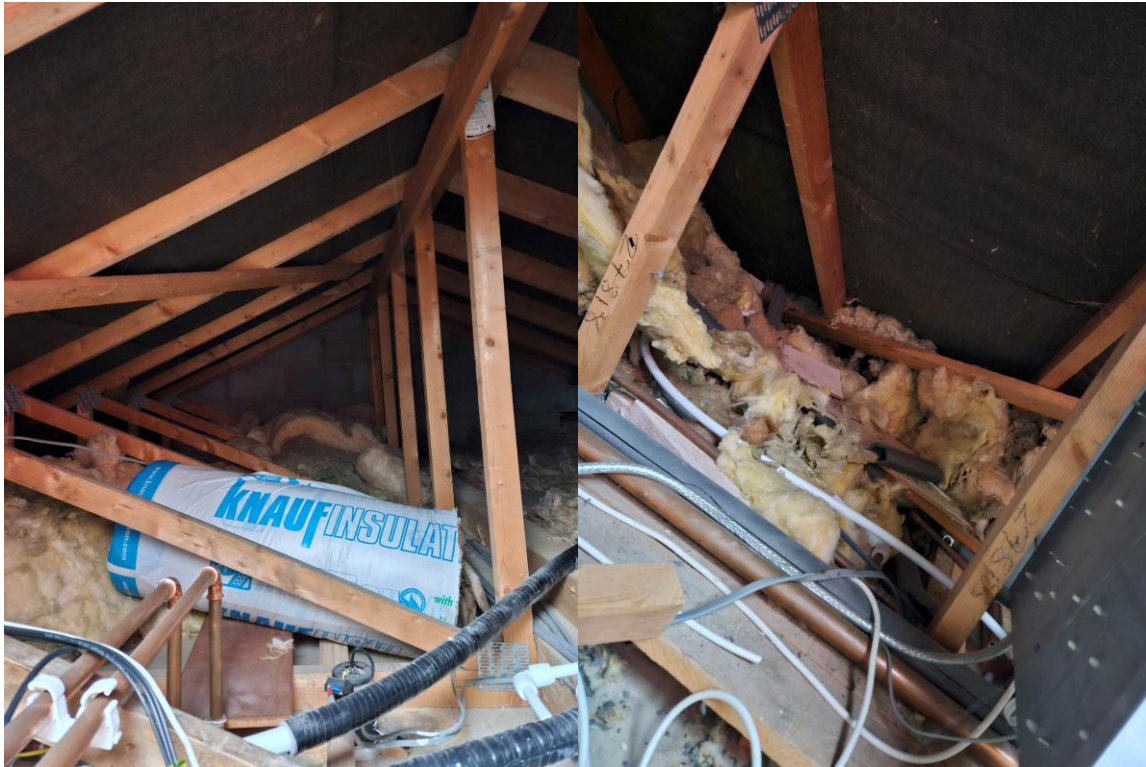
The roof space in the lean-to was examined from a ceiling hatch, the timber structure was in excellent condition as was the felt.

Insulation quilt was present; all surfaces were clean and free from dropping or feeding evidence. The space does not provide any high value roost habitat.

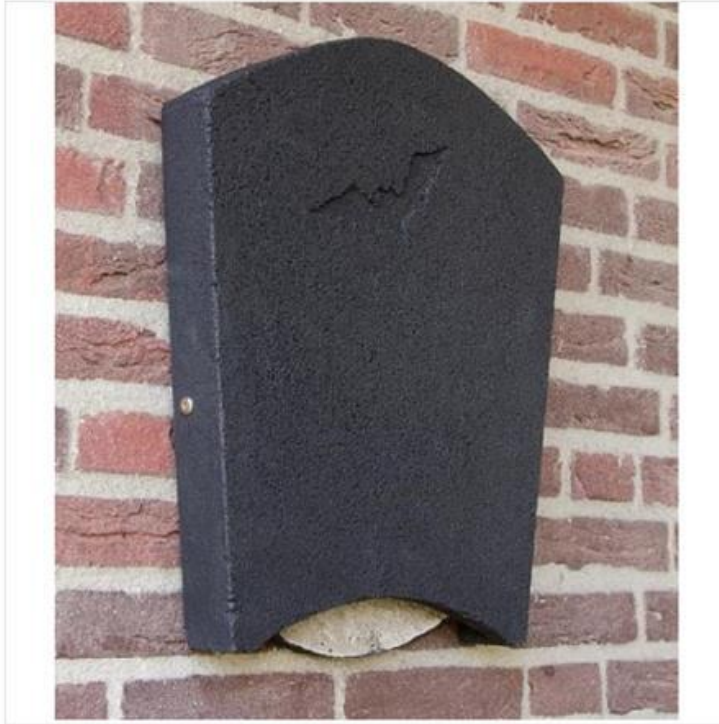
The basic requirement being that a **Sku Beaumaris (or similar)** bat box be fixed to the Southeast / southwest elevation, relatively sheltered from strong winds and ideally 3-4m above ground level., in accordance with manufacturer's instructions

See illustration below.
