Lower Beatrix Farmhouse, Dunsop Bridge, BB7 3BE

Bat Building Inspection

Simply Ecology Limited

Ref: SE/LSRQ012/01

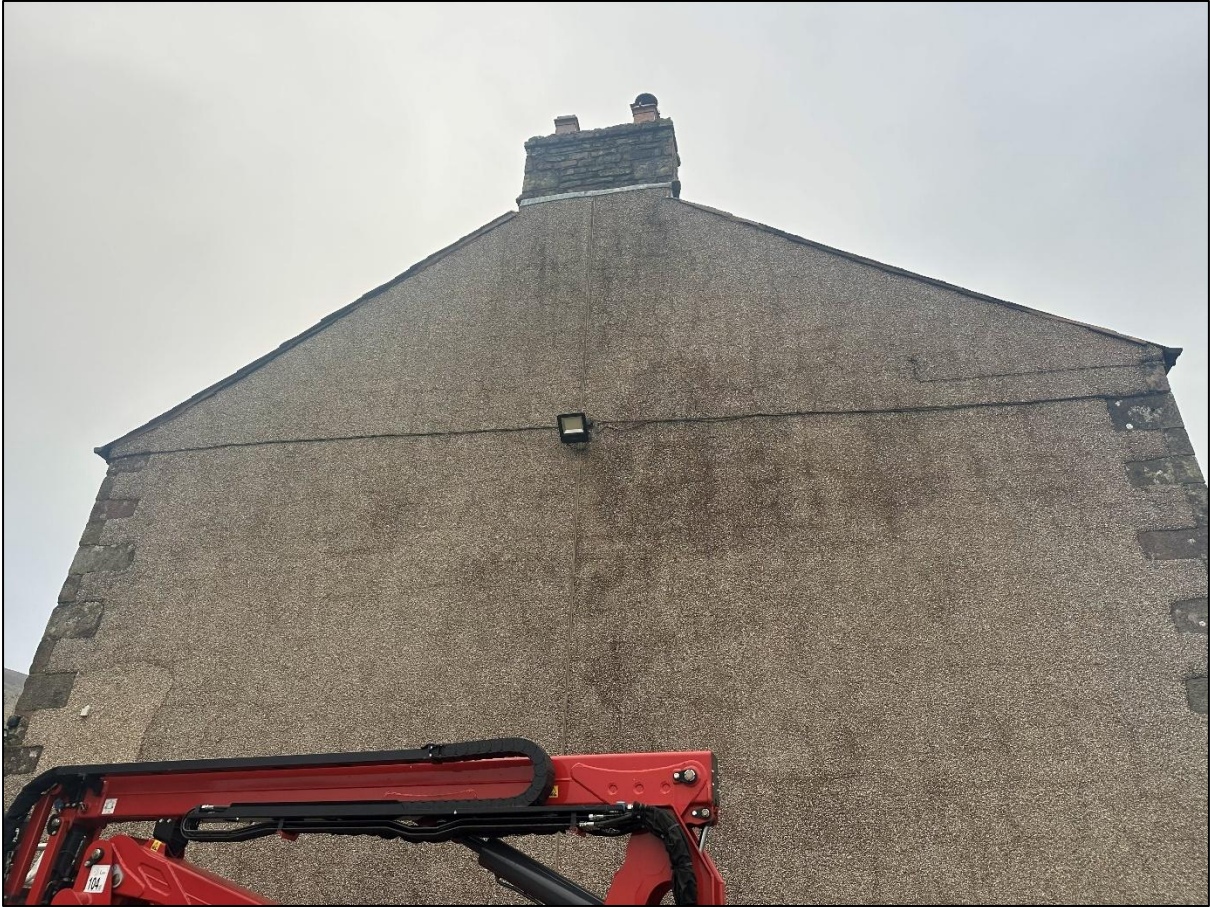
Plate 1: General view of the west-facing elevation of the property (with MEWP in foreground).

- 3.1.1 The target building was a detached two storey residential property (see Plate 1 and Plate 2). The building is constructed of local stone and the gable end where the works will be carried out had a pebbledash render coat. The pitched roofs had slate tiles. The building was occupied at the time of the Roost Assessment and was found to be in good condition.

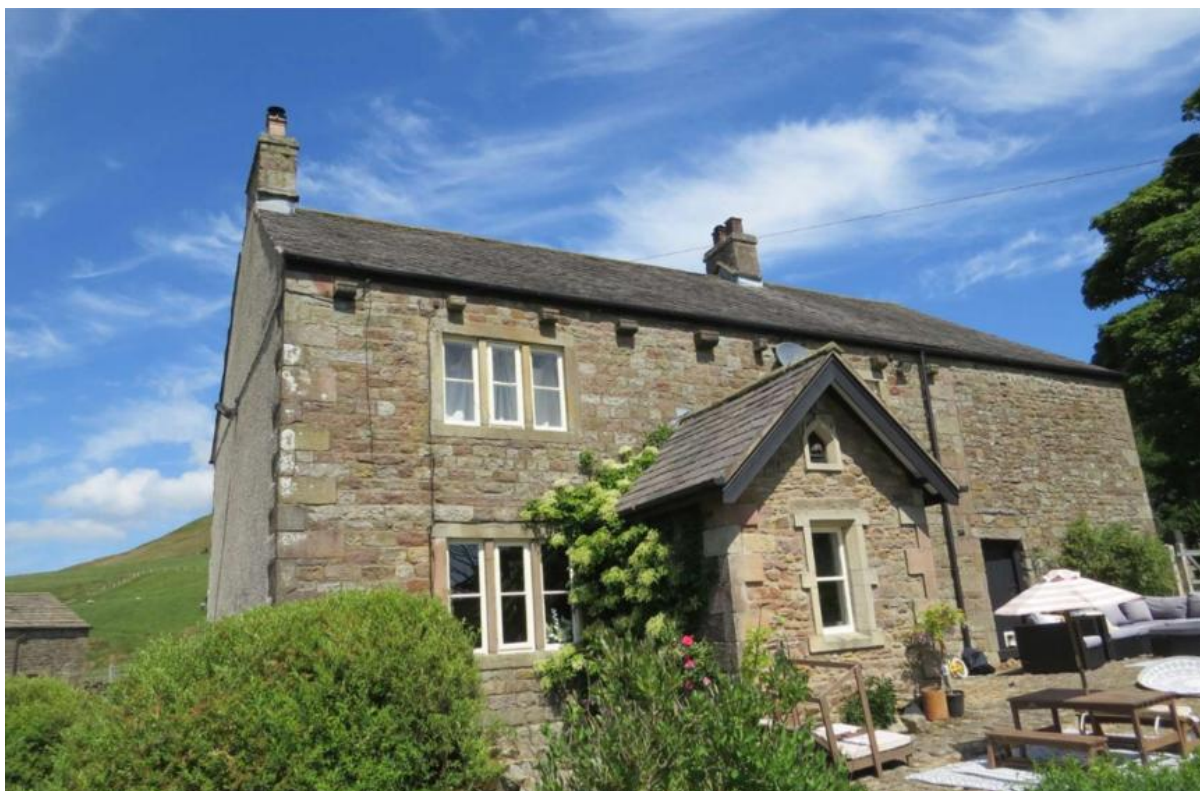
Plate 2: General view of the south facing aspect of the house (gable end subject to inspection on LHS).

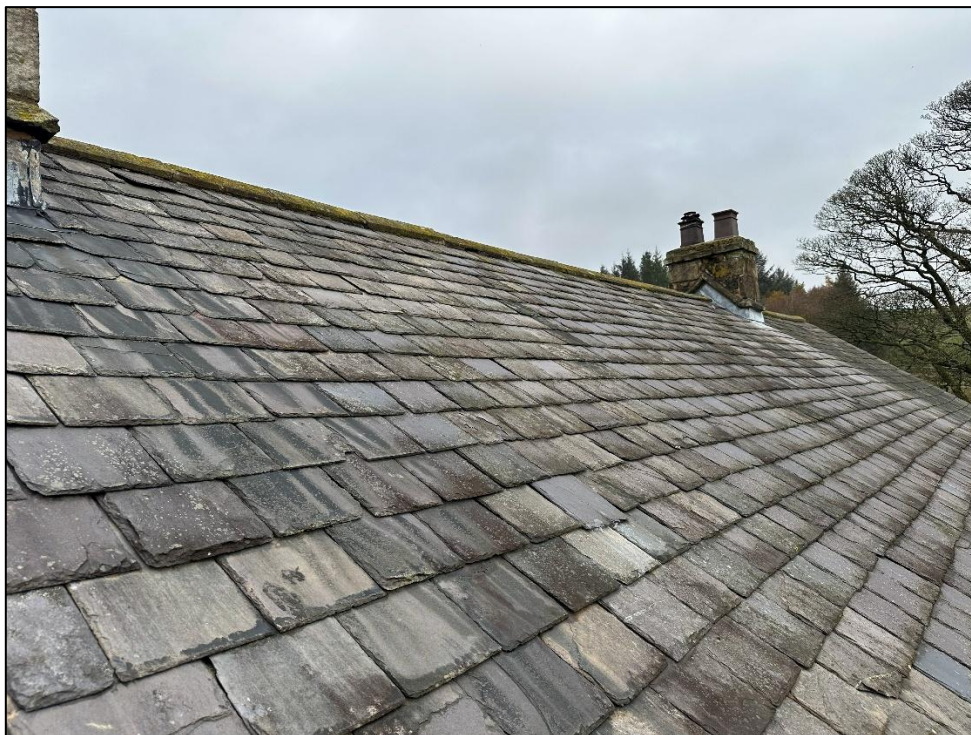
- 3.1.1 Overall, the pitched roof of the property was intact, there were some slates that were cracked or had been re-fixed into place, but it was generally in good condition (see Plate 3). No detailed assessment of the entire roof was needed as the working area is at the verge, so this is addressed below.
- 3.1.2 Similarly, no inspection of the ridge was undertaken as this was not necessary due to no connection to the verge and did not fall within the Zone of Influence of the proposed works.
- 3.1.3 The verge along the gable end was inspected at height using a Mobile Elevated Working Platform (MEWP) (see Plate 4).

Plate 3: The pitched main roof was in good condition.

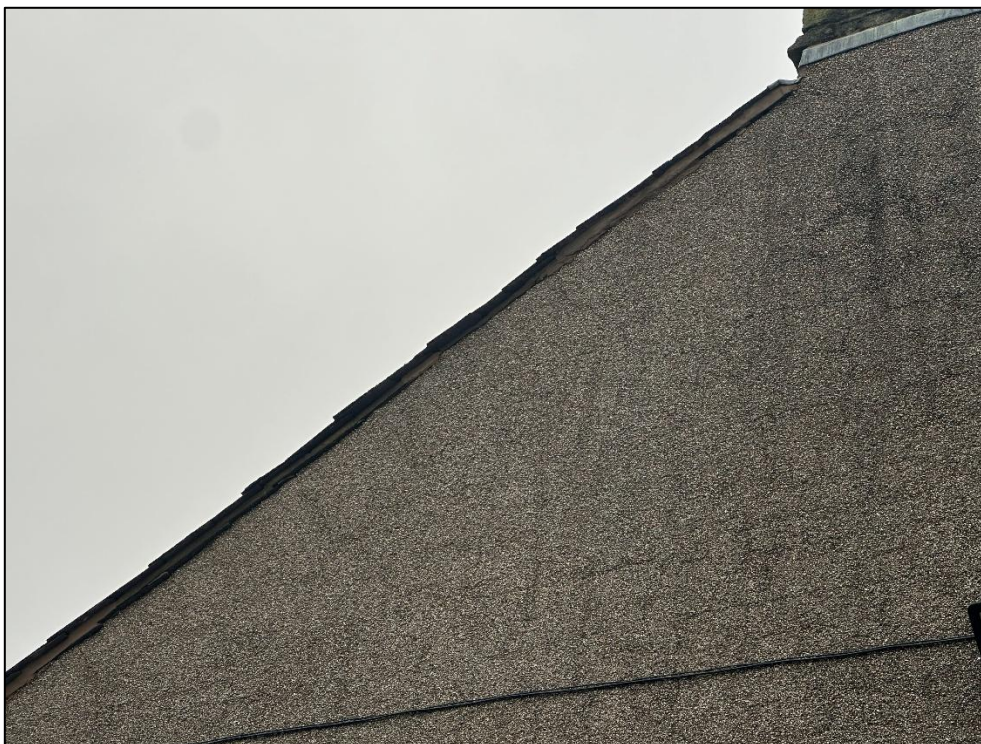
Plate 4: The water tabling will occur along the verge, so the roof edge and chimney and whether they offered any PRFs were the key area for inspection.

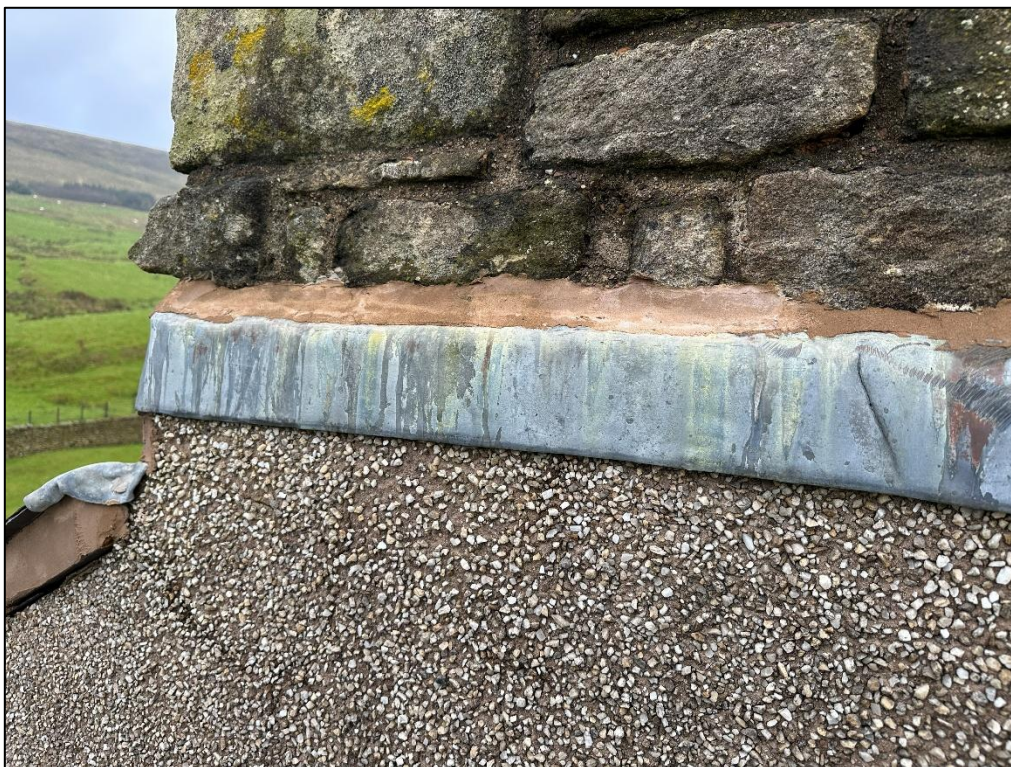
- 3.1.4 Lead flashings around the chimney were inspected and found to be intact and well fitted (see Plate 5). No lifting or gaps were present, and therefore **no potential roost features (PRFs) were identified** in this area.

Plate 5: The survey started by inspecting the chimney. Lead flashings around the chimney were intact and offered no roosting potential.

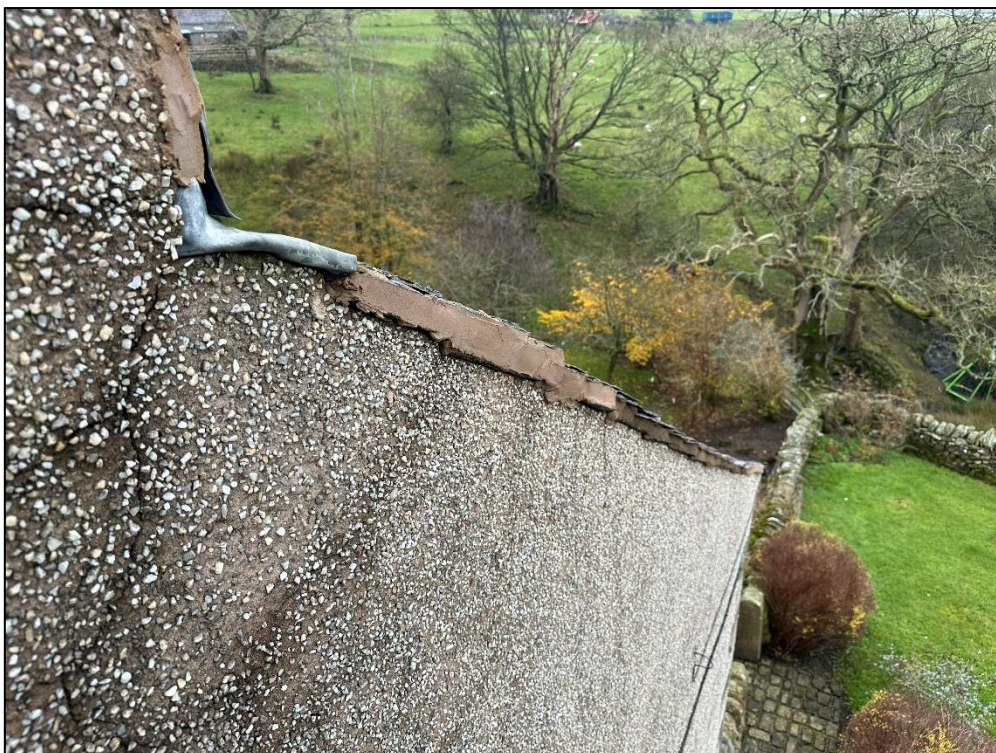
- 3.1.5 The MEWP access showed that the verge render was variable in quality and coverage (see Plate 6). In most areas, the mortar bedding between the pebbledash render and slate tiles was generally intact and well sealed, offering negligible roosting potential (see Plate 7 and Plate 8).

Plate 6: Once up at height in the MEWP, it was clear that the mortaring along the verges was patchy/inconsistent.

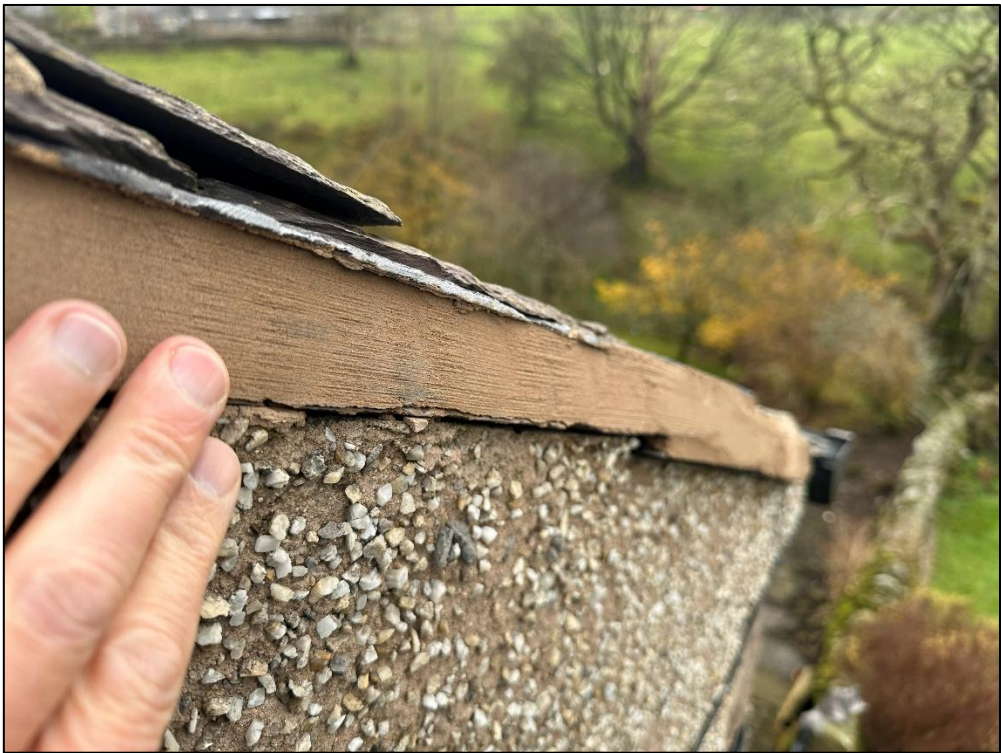
Plate 7: The close-up inspection found that the verges were generally well sealed, and large parts of the mortar offering nil roosting potential.

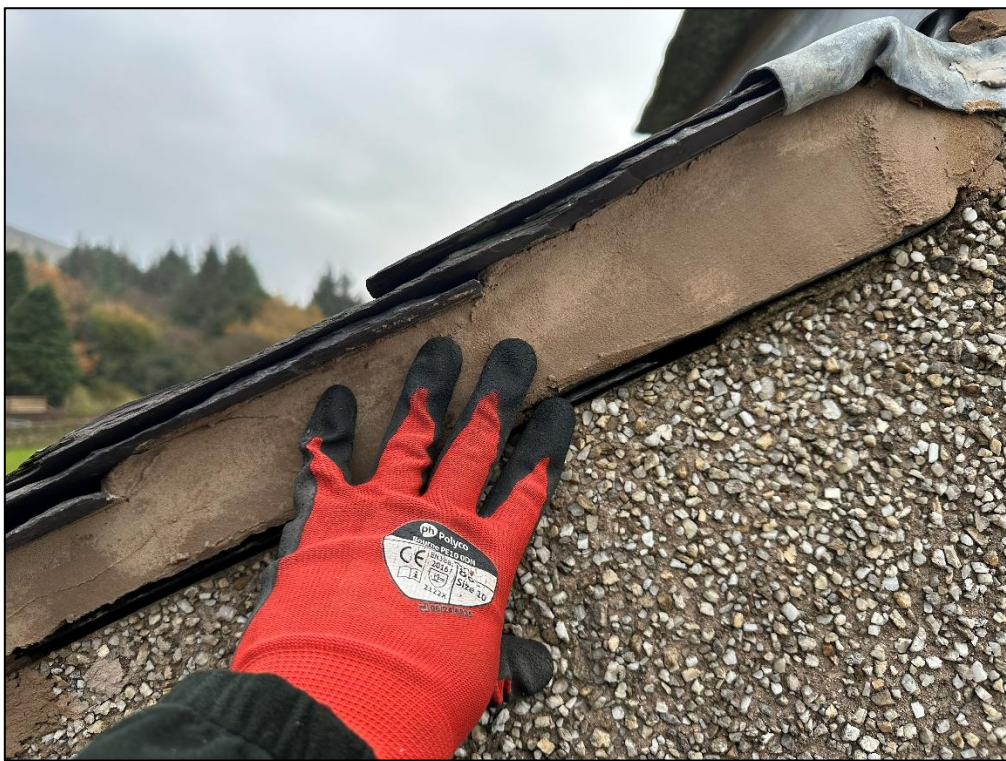
Plate 8: A thick bed of mortar was present between the pebbledash and the slates, and mostly had no roosting potential.

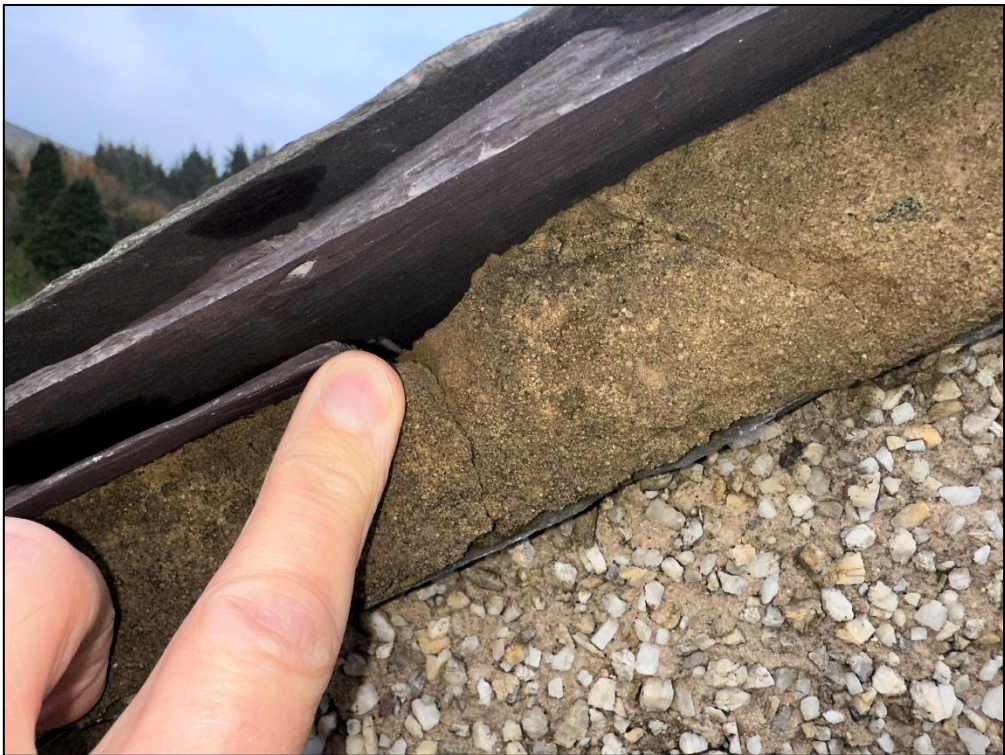
- 3.1.6 However, in some areas, the verge mortar was patchy and inconsistent (see Plate 9). Occasional gaps were noted, but many of these were too small and exposed to be suitable for bats.

- 3.1.7 The external render and stonework adjacent to the verge were in good condition (see Plate 9). No significant cracks or holes were identified that could provide roosting opportunities.

Plate 9: There were some gaps in the verge which, were too small and did not have roosting potential.

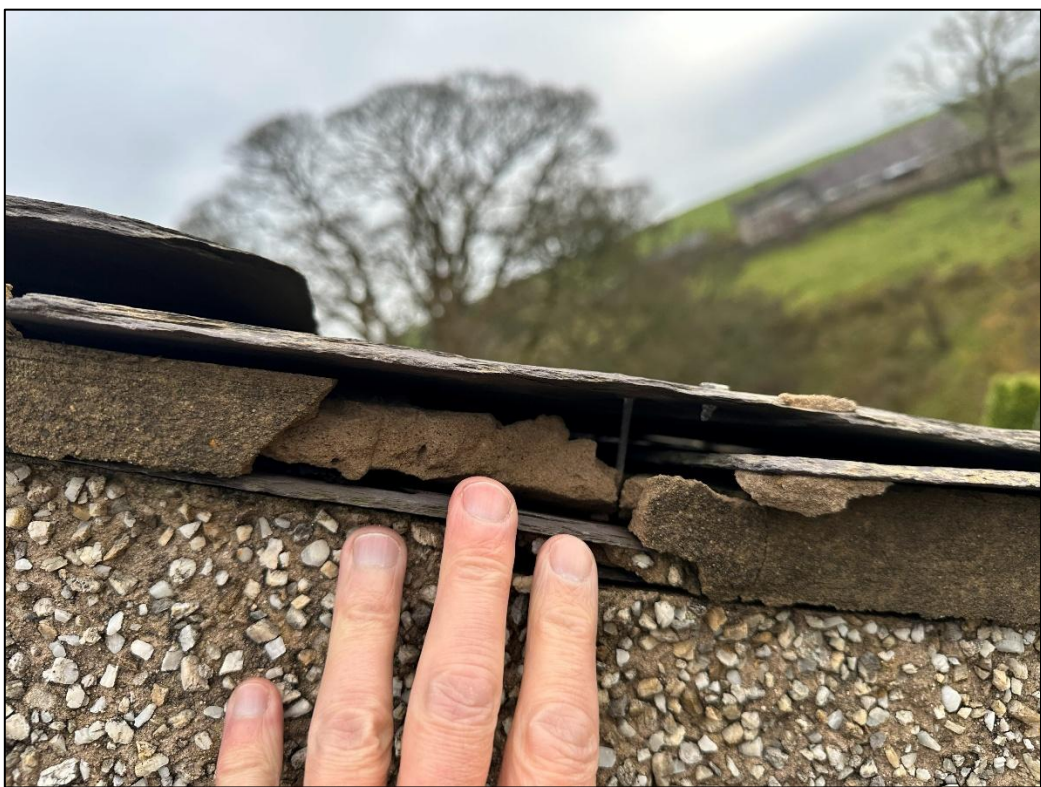
- 3.1.8 A handful of larger voids were present. These did not provide access to roof battens or enclosed cavities, reducing suitability for crevice-dwelling bats (see Plate 10). These gaps were considered to open and draughty to provide meaningful roosting opportunities

Plate 10: The larger gaps between the two layers of slate offered no access to the roof battens and the gap did not offer a suitable crevice for bat roosting.

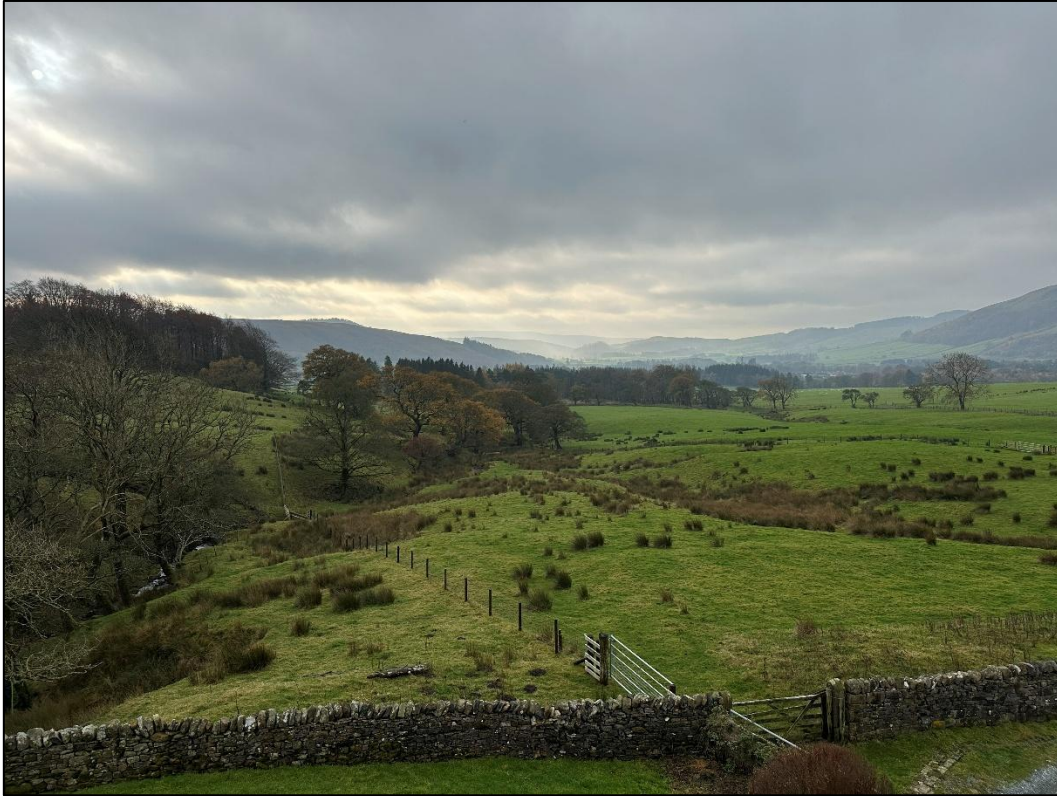
Plate 11: The landscape around the Farmhouse has a small amount of woodland nearby, but is in an exposed and open location, which reduces overall suitability for bats.

the site (see Plate 11) meant that overall bat roosting potential in the working area was considered to be Negligible.
