HERITAGE STATEMENT

ALTERATIONS TO LOWER BEATRIX FARMHOUSE

**DUNSOP BRIDGE
CLITHEROE
BB7 3BE**

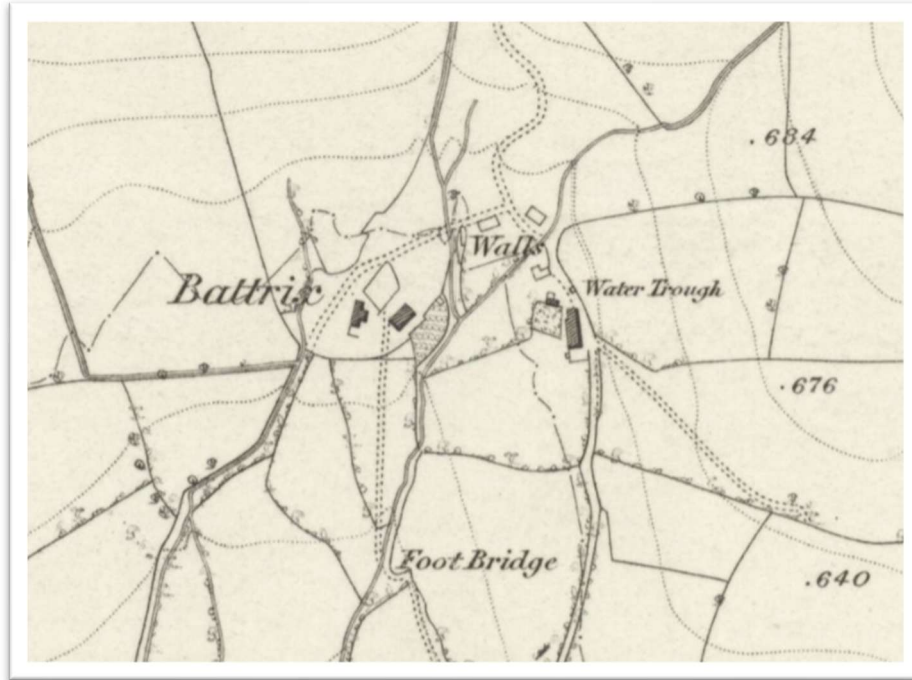
OS Map 1851

From the early OS Mapping available it is clear the barn extension to the farmhouse already existed in 1851. Additions and extensions to both the house and farm buildings are clear from the later mapping. The 1907 map still shows the current layout of the site.

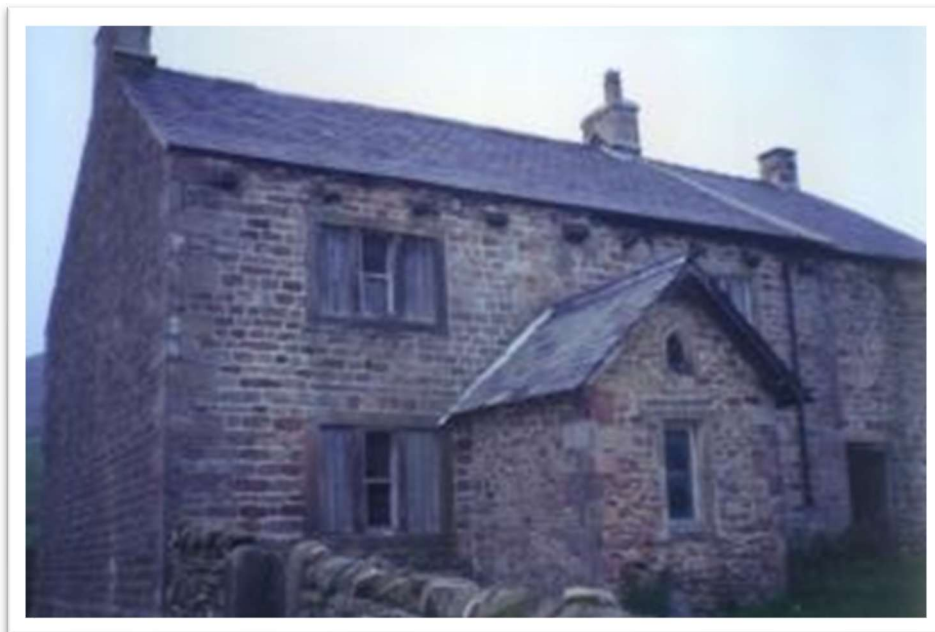
The above image shows the property in 1989 when the property was unoccupied. The junction between the barn and farmhouse clearly shows some form of stone junction detail which no longer exists. We assume this was removed during re-roofing in later years.

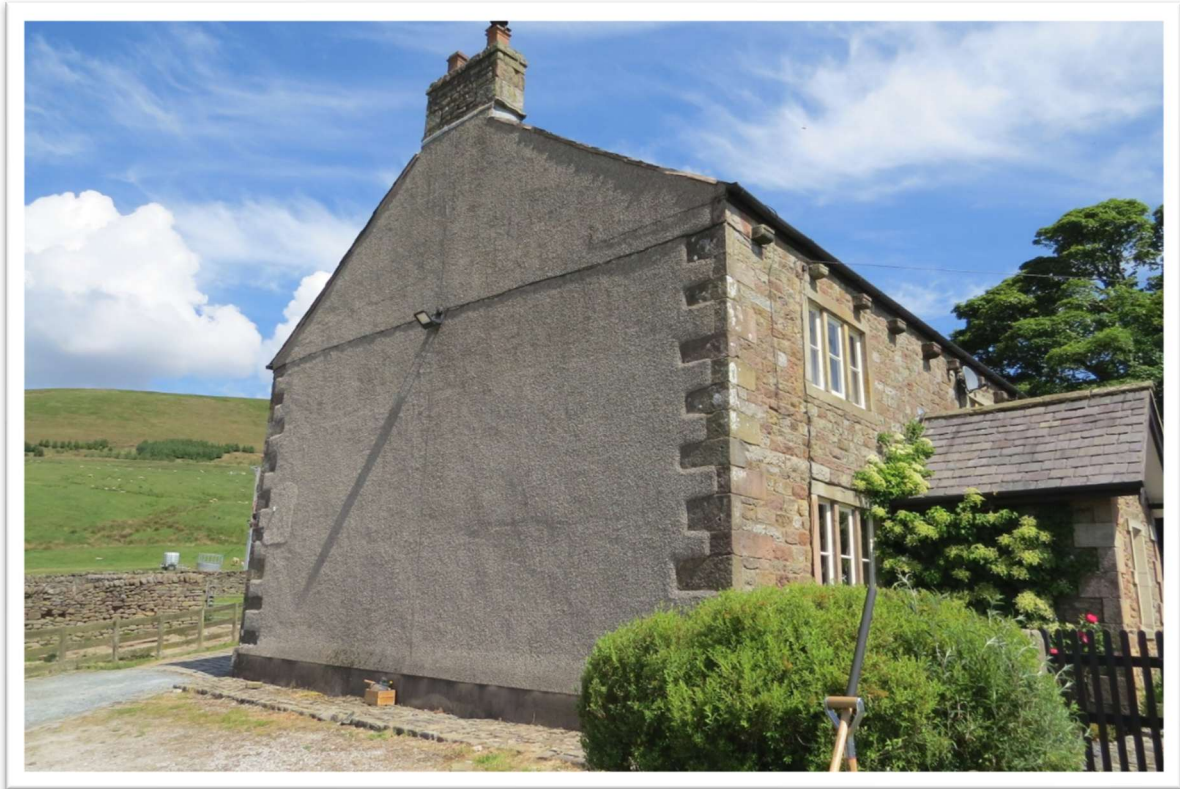
The works are proposed due to long suffering water ingress found to this gable elevation. The cement render is in poor condition with crazing and cracking visible allowing for water ingress and trapped moisture within the wall. The use of lime render will protect the stone wall from the driving inclement weather to this elevation whilst allowing the wall to breathe and moisture to evaporate at a slow rate.

1. Cement render to gable wall

- Removal of cement pebble dashed render to South-west gable elevation and renewal with lime rough cast render to provide breathable protection from weather.
- Installation of stone water tabling detail to South-west gable verge to protect the slate roof covering from driving rain ingress.

The lime-based render material will be applied with a rough harl finish to withstand water ingress from the driving rain suffered in this location in winter months.

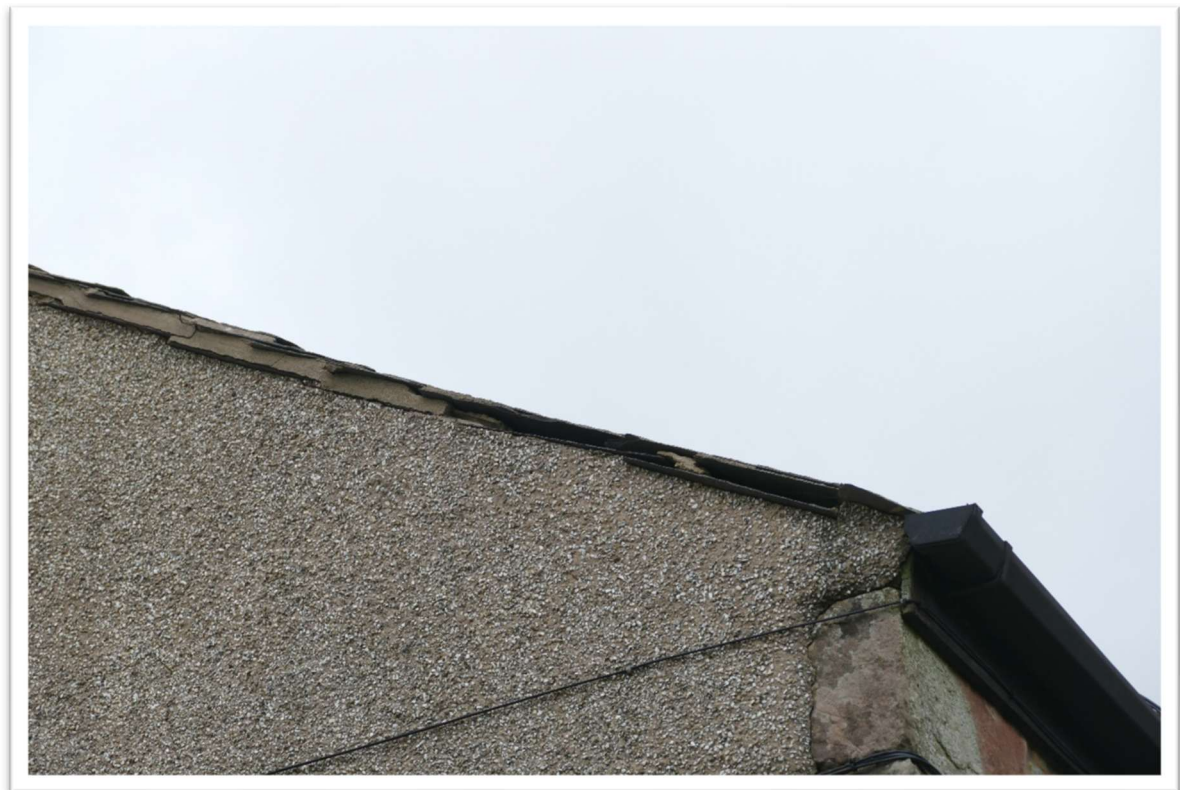
The verge detail between the slate and wall top is also exposed to driving rain and allowing water to enter the top floor room of this property. The introduction of the water tabling will protect this edge and prevent damage to occur which could ultimately lead to timber decay and loss of historic fabric.

2. Poor verge detail

The water tabling will be of buff sandstone material to match the existing materials used on the property and complete with lead flashings will provide a watertight detail on the junction between the roof covering and wall-head. The water tabling will be designed to match the barn opposite the house which is of a similar age and provides this roof/wall detail already.

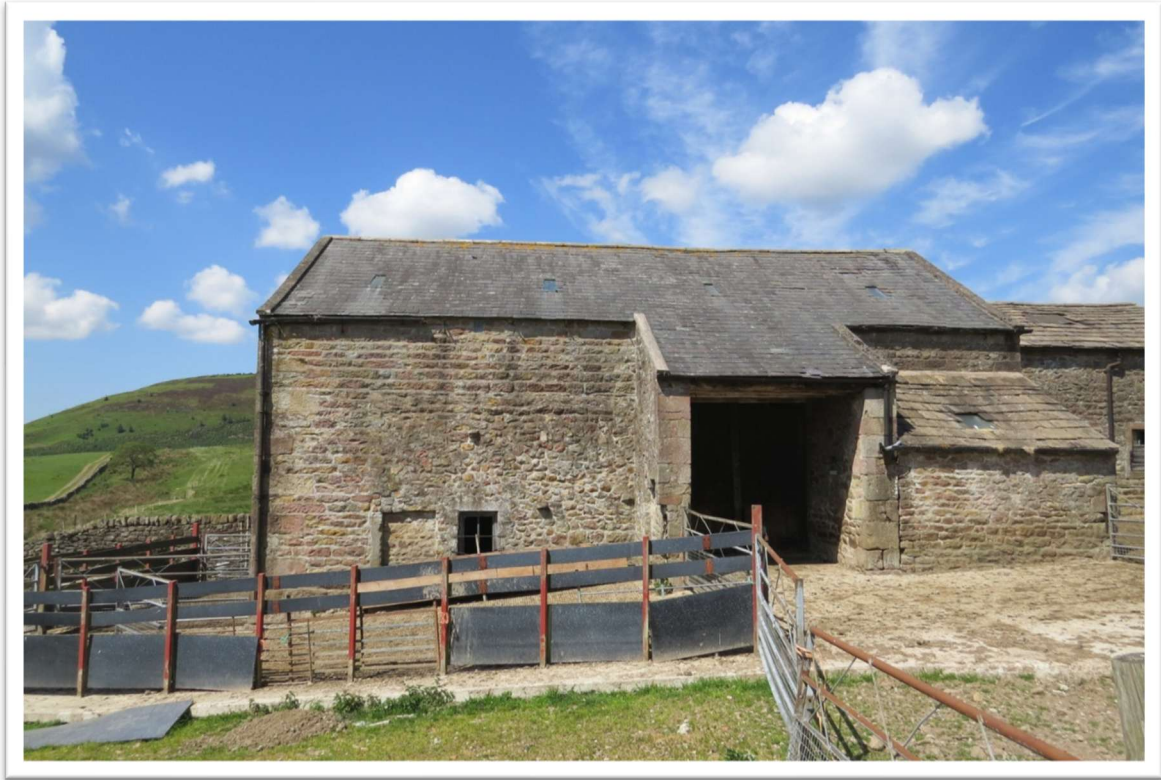
3. Historic barn opposite farmhouse with water tabling to verge
