**BAT SURVEY, AT -
28 LONGRIDGE ROAD
CHIPPING**

DATE AND TIME OF VISIT
10TH Sept 2025 10.00am

REFERENCE NO 6721

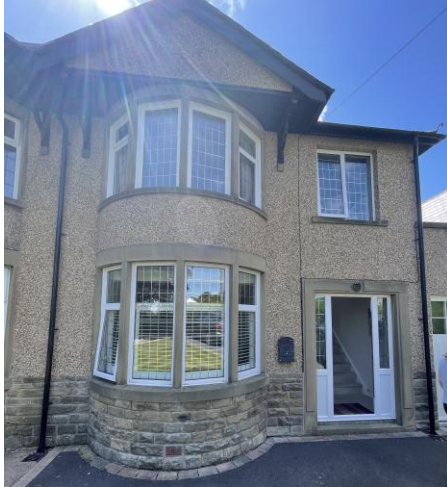
Front Elevation

The semi-detached property probably dates from the 1940's 50's. It is two storey with a hipped roof and a single storey garage/ kitchen to the side.

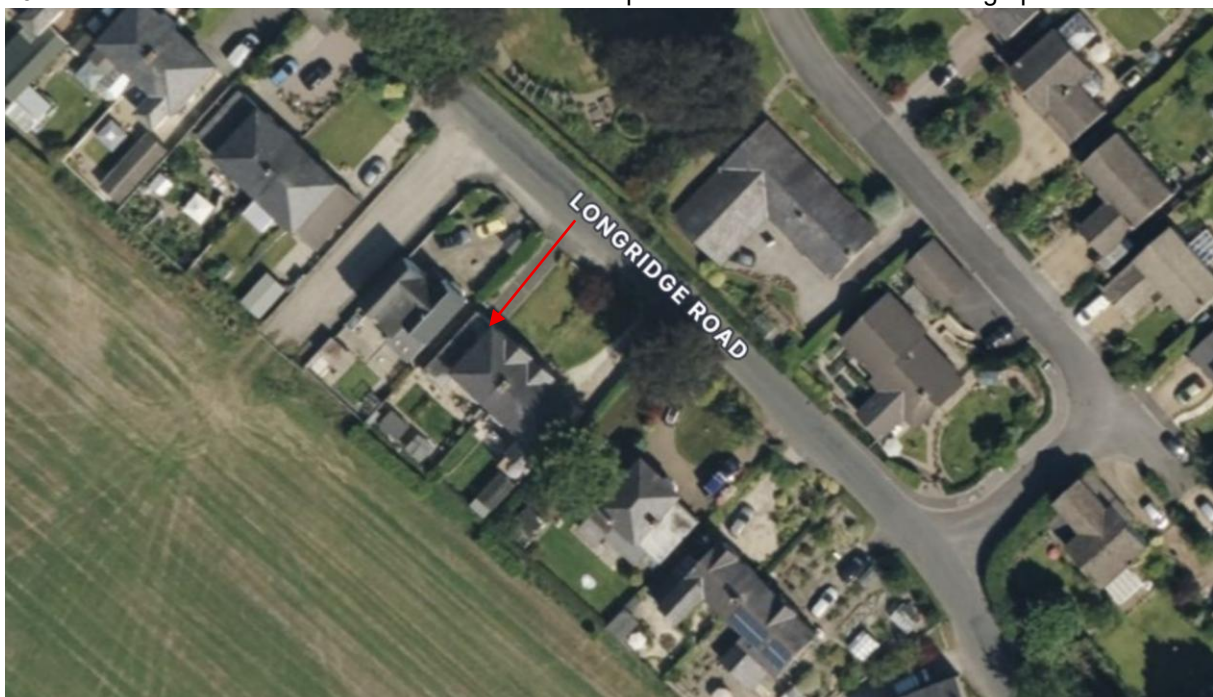
The house fronts Longridge Road a main thoroughfare out of Chipping Village. With a garden to the front and rear it is set between houses of a similar type and period. To the rear there is a hedge boundary to the large acreage pastureland which continues along the northeast boundary of the field. There are some mature trees located in a neighbouring garden to the southeast, the greater locality has some good tree line boundaries to the fields. The nearest water course is Chipping brook at 104m to the northeast. The location is considered to provide a medium level of forage potential.

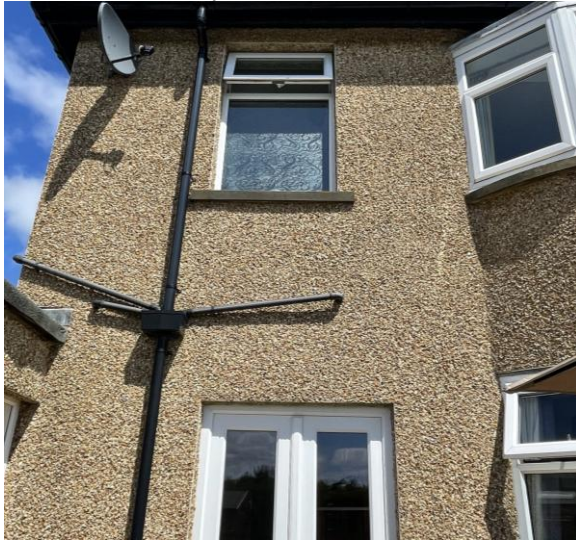
The walls have a pebble dash finish

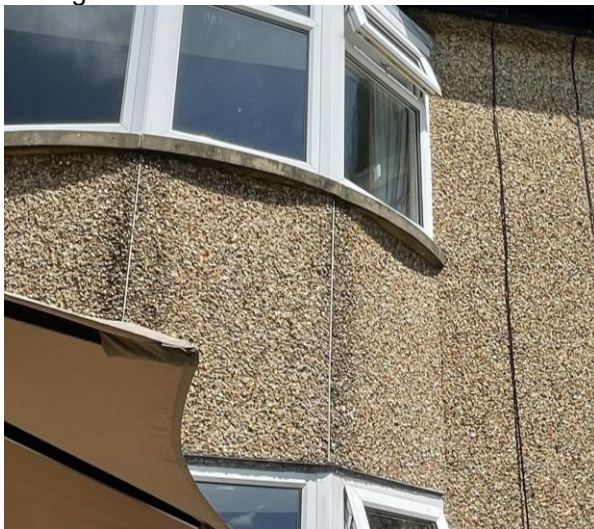
The pebble dash render is in excellent condition. No cracks or crevices present with the potential for Bat ingress.

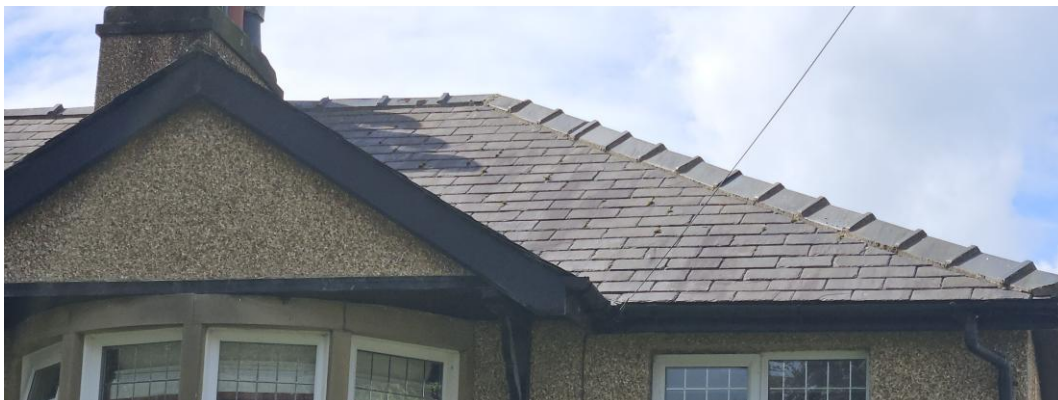
The blue slate roof is hipped with a small gable over the bay window to the front elevation, lead valleys are present at the abutment with the main roof. There is an overhang to the eaves with a boarded soffit and fascia boards.

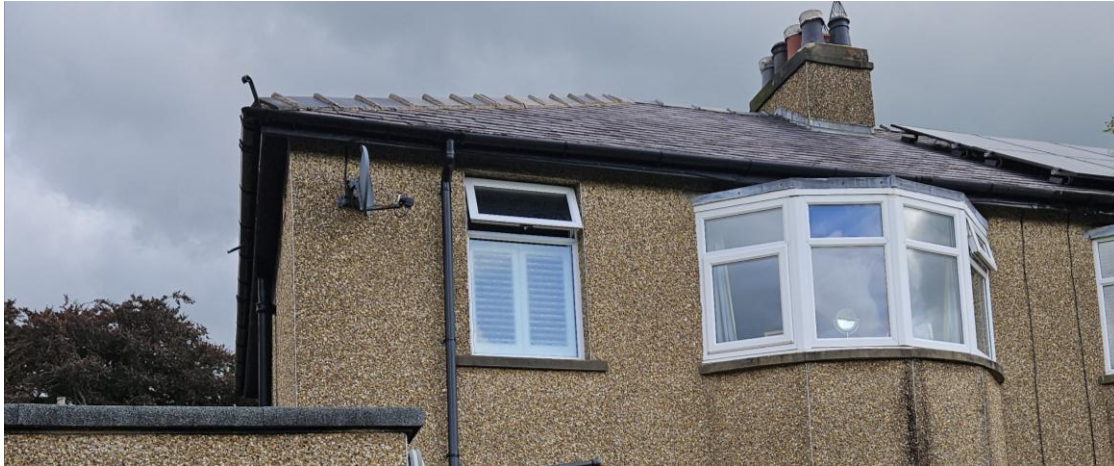
Rear elevation

The Flat roof on the garage is solid concrete with a felt finish externally laid directly over the concrete deck lapped over the edge; a parapet wall is present to the front elevation.

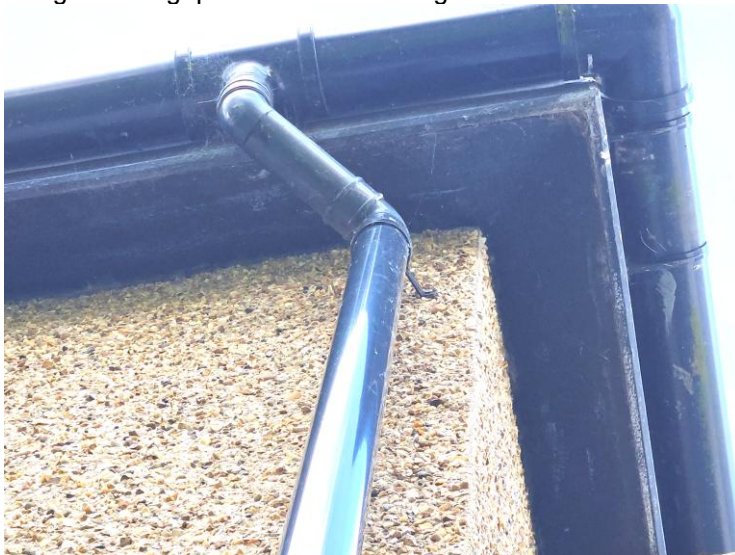
The slates in good condition and are tight fitting. The ridge / hip tiles and the pointing are in good condition with no gaps. The flashing at the abutment of the chimney and the front gable roof is tight fitting with no gaps suitable for bat ingress.

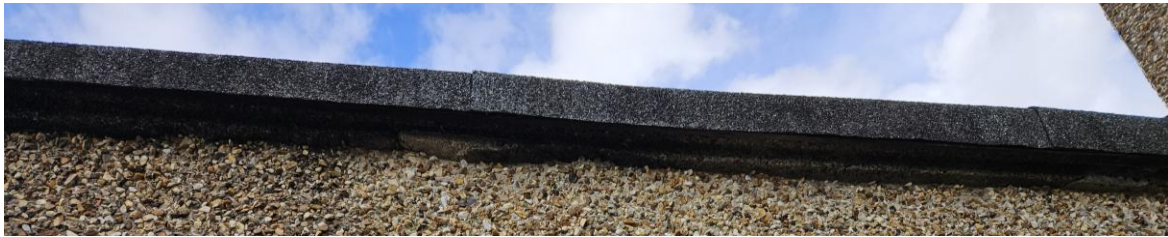
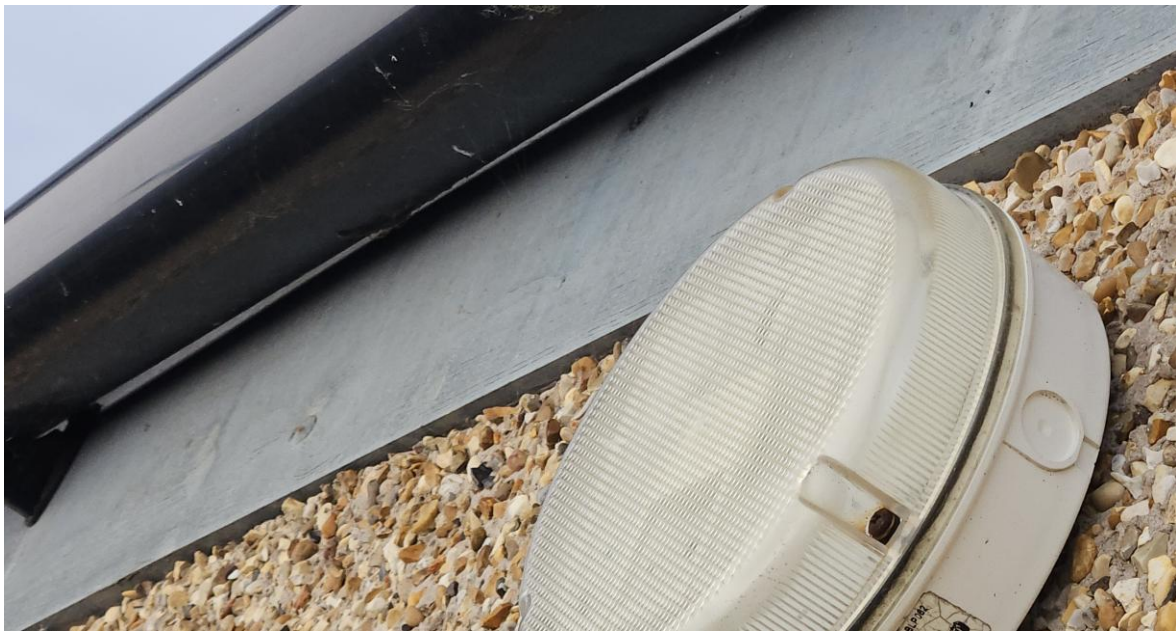
The flat roof covering was in good condition with tight laps in the felt. The flashing at the abutment with the house wall in tight fitting. The side elevation has a flush fixed fascia board.

The flat roof is not accessible to bats nor are there any crevices or cracks suitable for bat ingress.

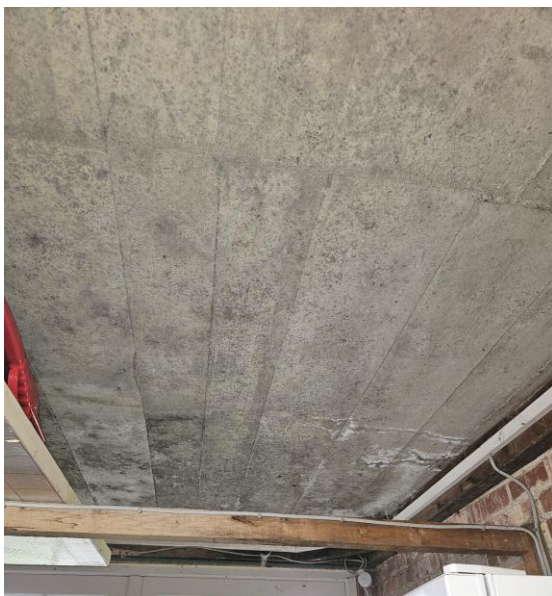
There is no enclosed roof void in the garage the concrete is fully visible. The space does not provide any roost potential for bats.

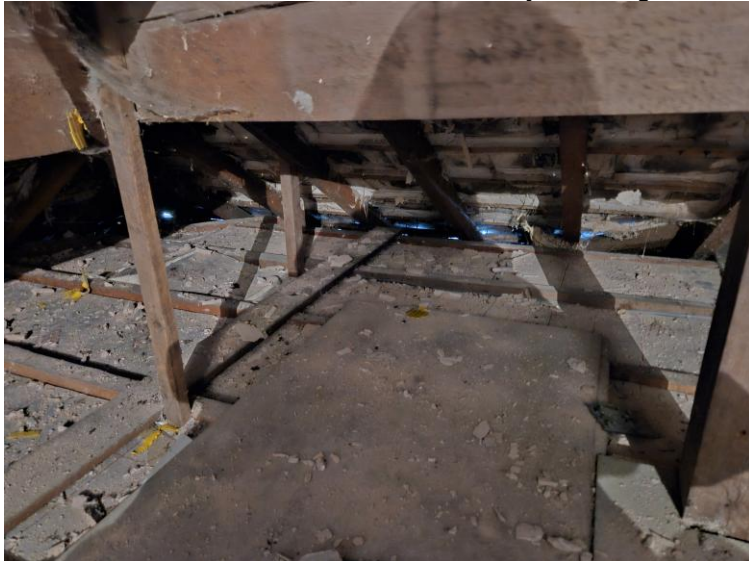
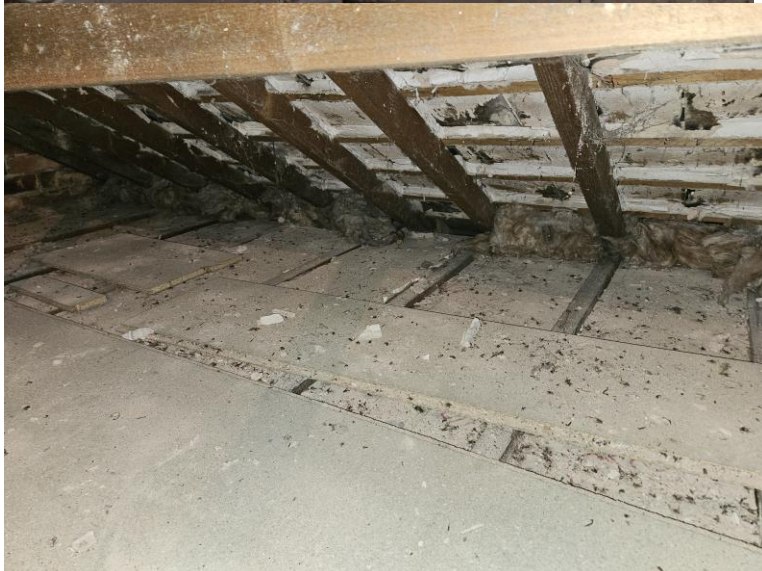
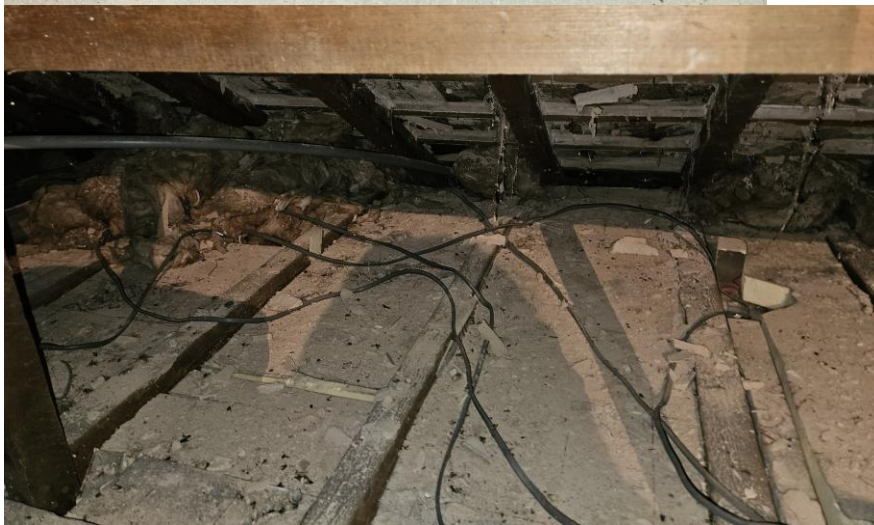
The main roof space was accessed via a ceiling hatch, the floor was boarded, no insulation quilt was present. The timber rafters and purlins are old but in good condition with no signs of decay, cracks or crevices. Underlay is not present, and the slates are back pointed on to the battens. The space is dry but the floor is covered with pointing debris and dust due to the degrading pointing. The roof structure could be examined entirely including the eaves areas.

The space did not provide any roost potential for bats. No signs of historic or current bat presence were evident.
