House at Hambledon View, Wiswell

BAT SURVEY REPORT

August 2025

Report Ref: 279_01

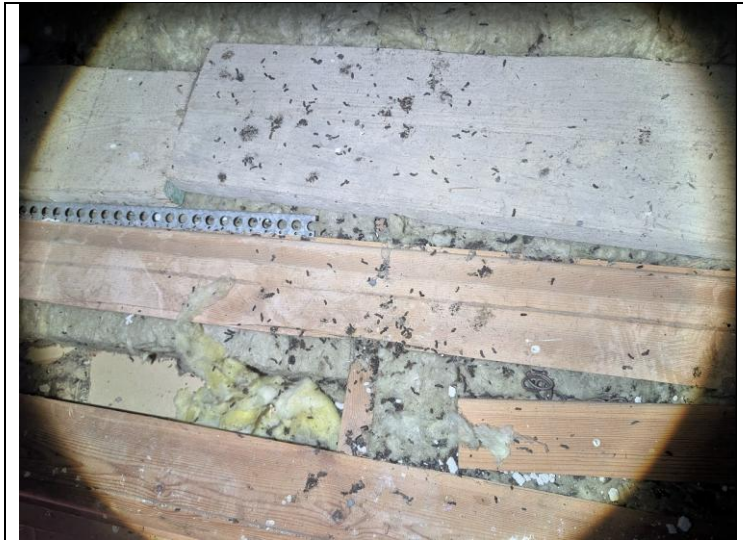
Plate 1. Bat droppings on loft floor under ridge

An accumulation of bat droppings were observed on the loft floor, under the ridge and directly adjacent to the access hatch (see Plate 1). Furthermore, several droppings were observed in a sagging section of roof underlining in the same location. No bats were seen. Whilst it could not be fully confirmed, the droppings were indicative of individual or small numbers of brown long-eared bats.

- The licensed ecologist will supervise the soft destruction of the bat roosts via the careful hand stripping of the roof slates. If the bat is present during the supervision, it will be captured by the ecologist who will assess the condition of the bat before transferring one of the bat boxes.

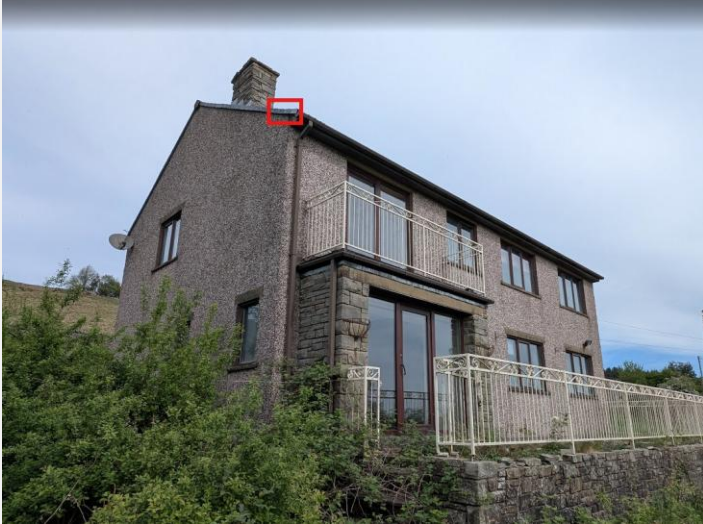
Date	Description	Location
19 March 2025	Emergence of single common pipistrelle from the roof verge at 21:42.

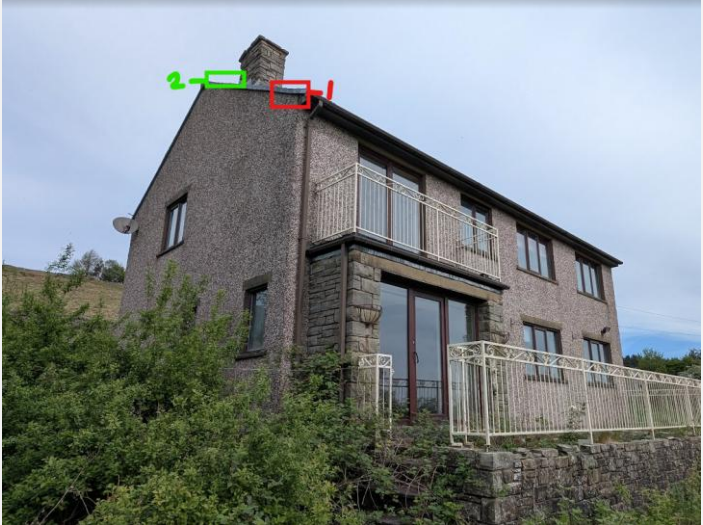
10 June 2025	<p>1) Emergence of single common pipistrelle from the roof verge at 21:58.</p> <p>2) Emergence of brown long-eared bat from ridge behind chimney at 22:40.</p>

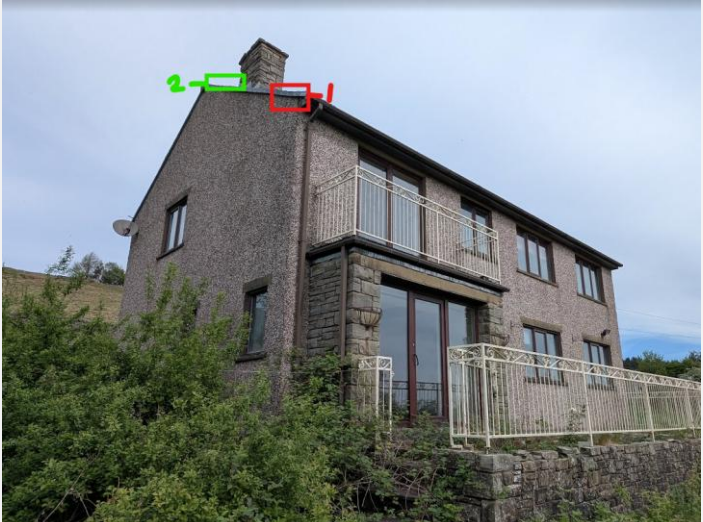
3 July 2025	<p>1) Emergence of single common pipistrelle from the roof verge at 22:05.</p> <p>2) Emergence of brown long-eared bat from ridge behind chimney at 22:16.</p>

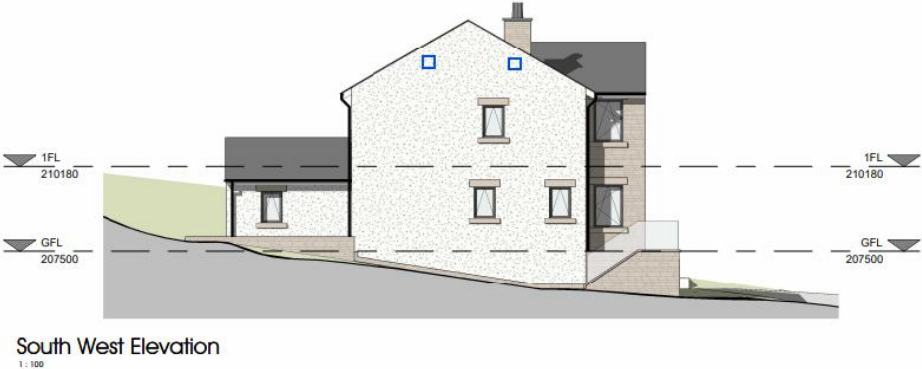
Figure 5.1. Bat box recommendations

BAT BOX							
Locations and positioning	<p>The boxes can either be fitted onto the walls of the property (south-west elevation) The boxes must be fitted to a height of at least 3m from the ground. Under the roof eaves is preferred as per the illustration below.</p>

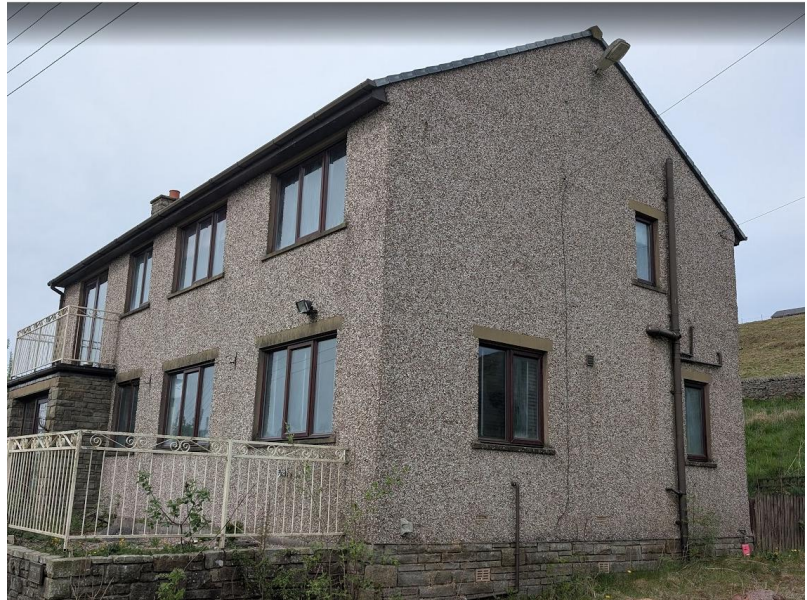
Photo 1.
Frontage and north-east gable.

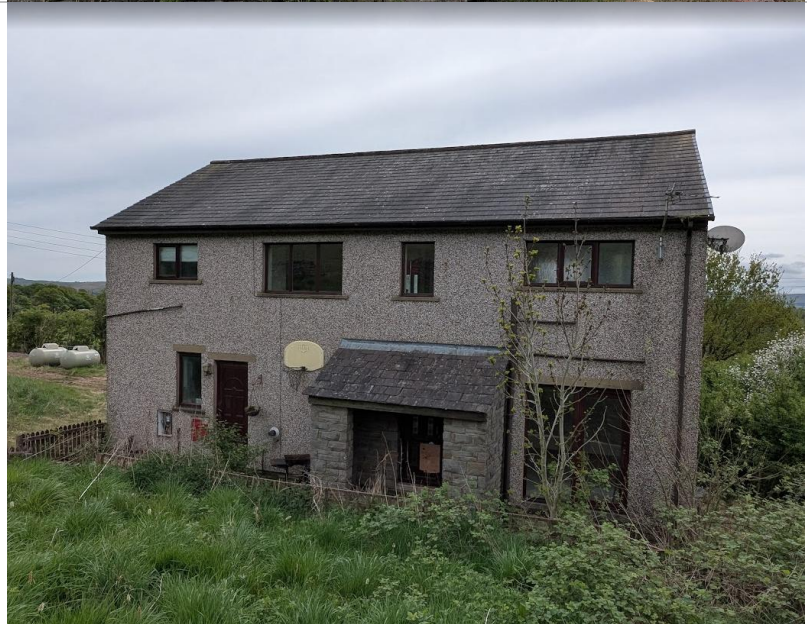
Photo 2.
Rear (north-west) aspect.

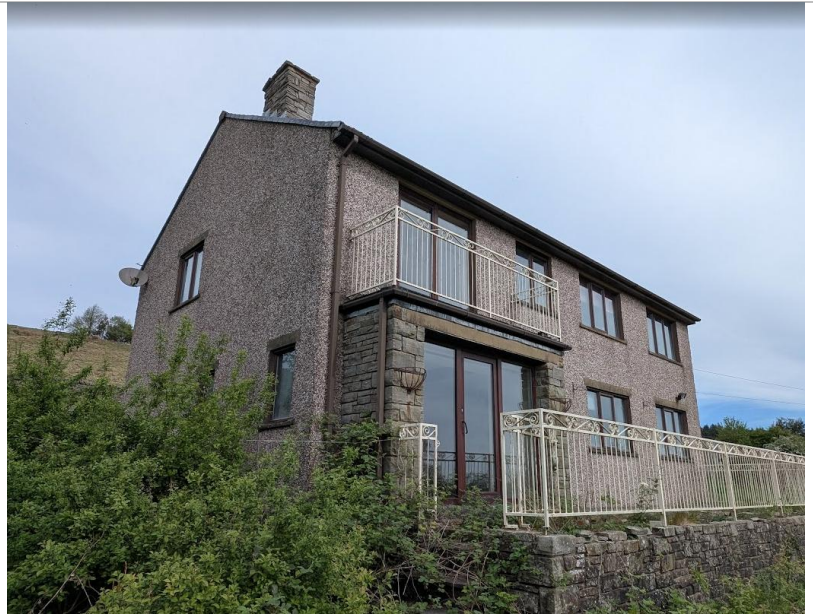
Photo 3.
South-west gable and
frontage.

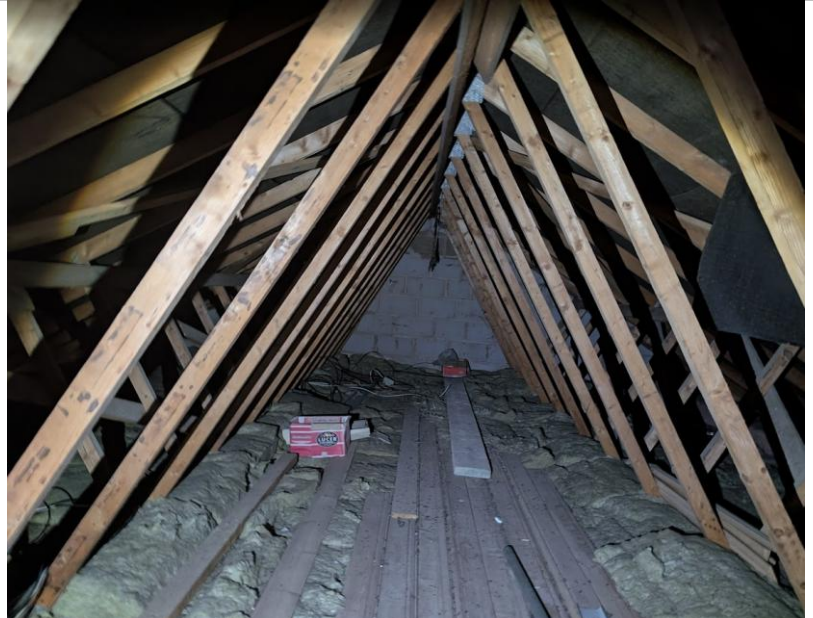
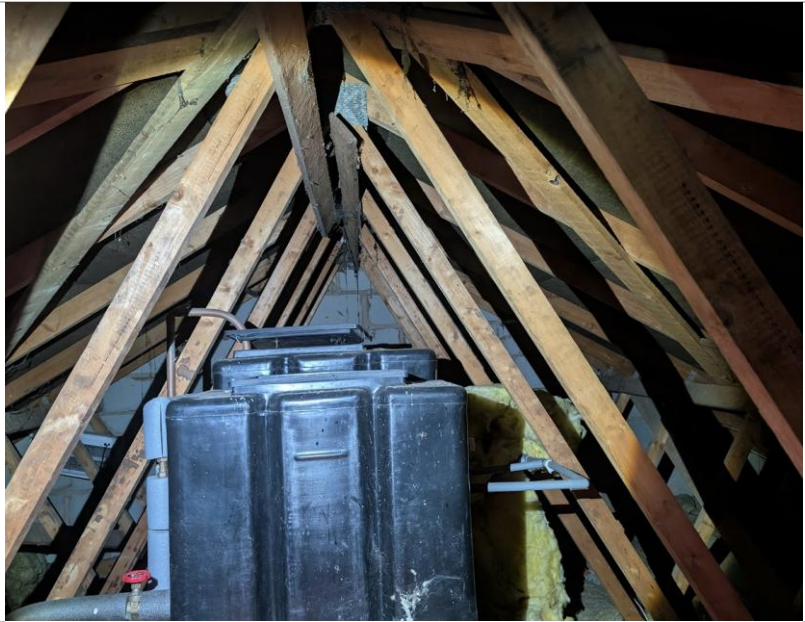
Internally, the loft space is constructed with standard roof trusses and includes a narrow central access route. Owing to the steep pitch, the internal height from floor to ceiling was approximately 2m. The roof is underlined with a traditional bitumen-based Type-1 membrane. There were several crevice 'pockets' within the overlapping of the lining.

Photos 4a & 4b.
Loft area.

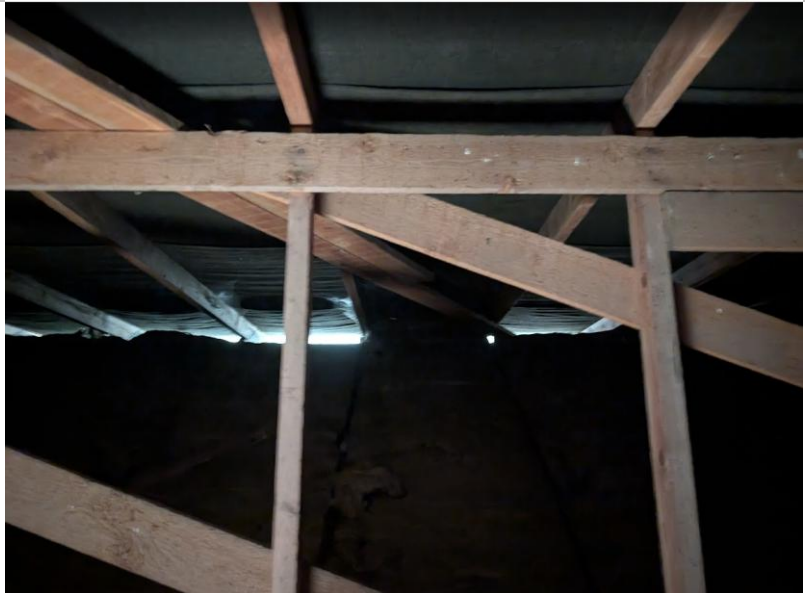
A notable level of light ingress was observed at the eaves on the front elevation, likely originating between the roof edge slates and the top of the soffit. A view of this area was obscured by guttering from the outside.

Photo 5.
Light gap in loft from roof
verge at frontage.

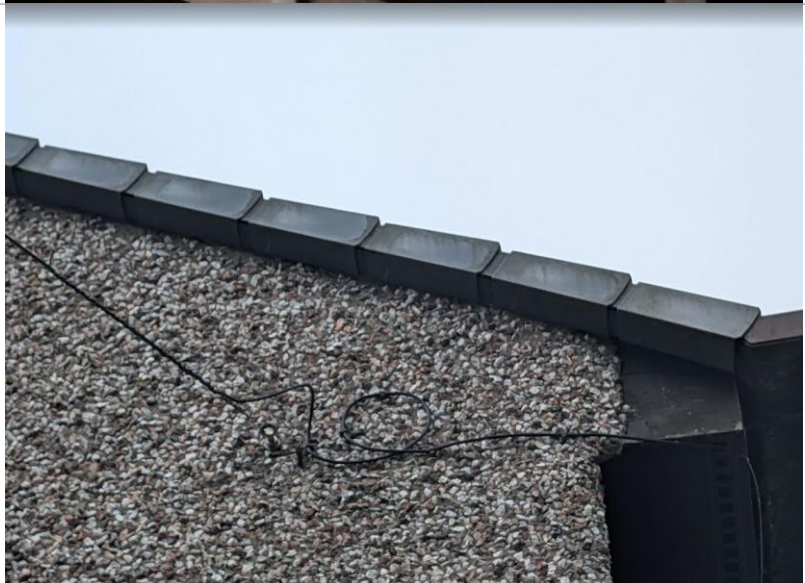
The property comprises a two-storey, pebble-dashed brick dwelling with a small front-facing upper floor balcony, ground floor veranda and a rear porch. The roof is a steeply pitched gable design, finished with slate tiles and fitted with a plastic dry verge and ridge system. A single chimney is present. The roof appeared to be in good condition, with no evidence of slipped, missing, or lifted slates. However, slight gaps were noted beneath the verge caps on both gables.

Photo 6.
Example of slight gap under
the roof verge on the gable.

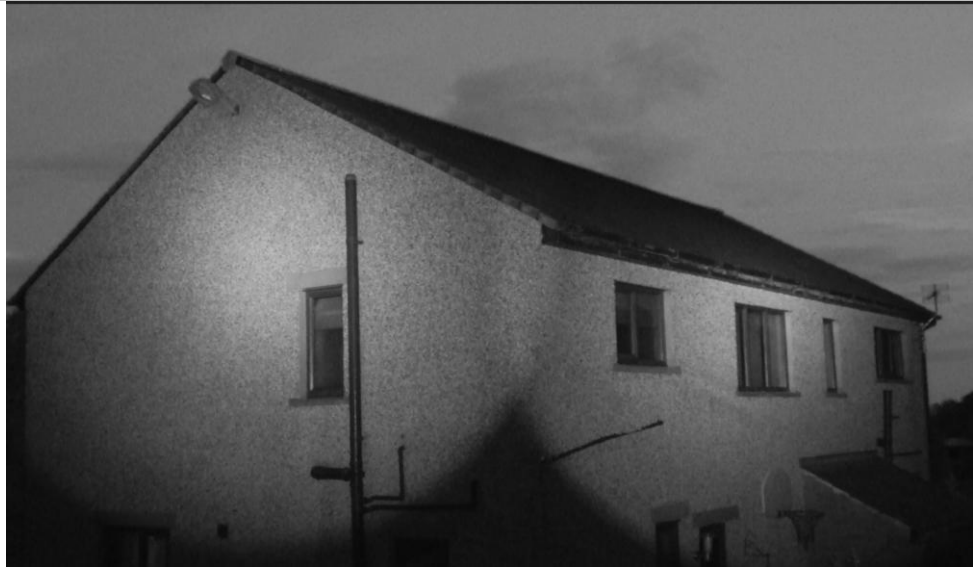
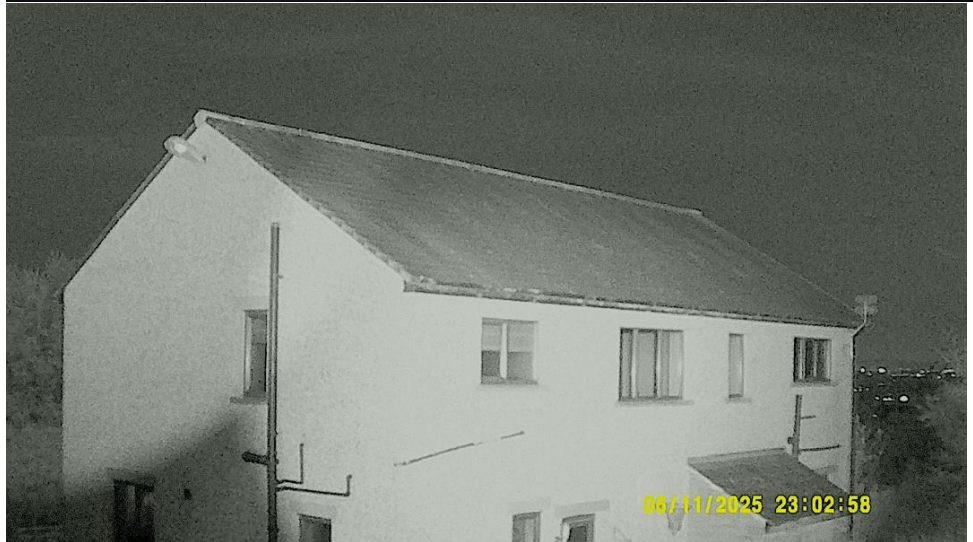
1a & 1b.

North-east /
north-west
elevations

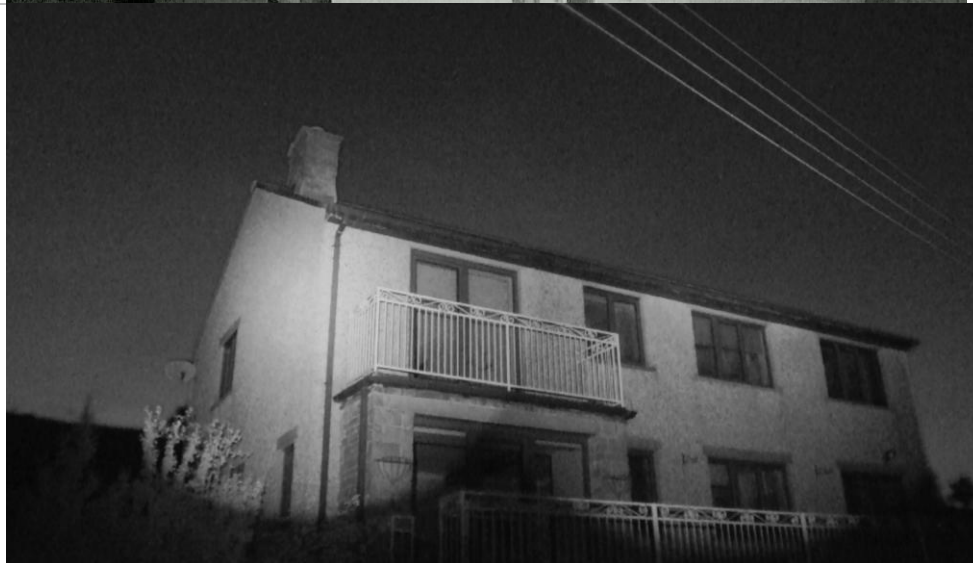
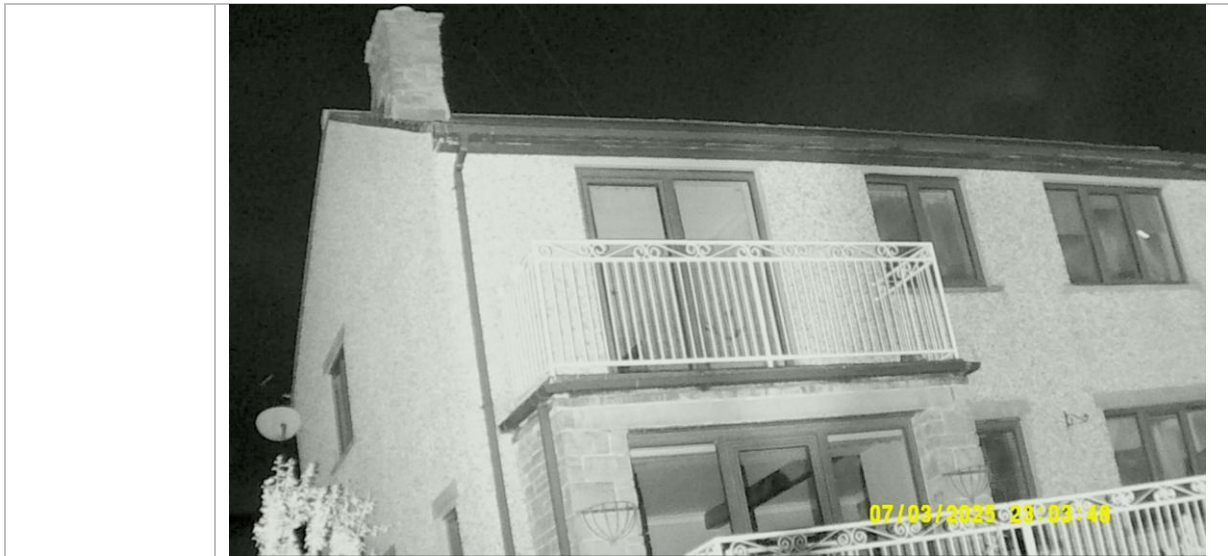
2a & 2b.

South-west /
south-east
elevations
