# Preliminary Bat Roost Assessment Report

60 Mitton Road  
Whalley  
BB7 9RY

27.09.2025

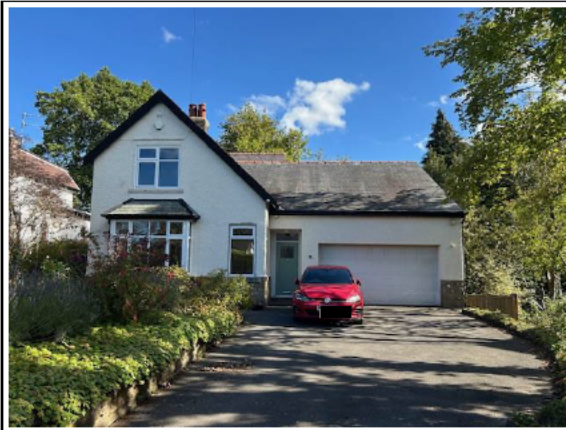
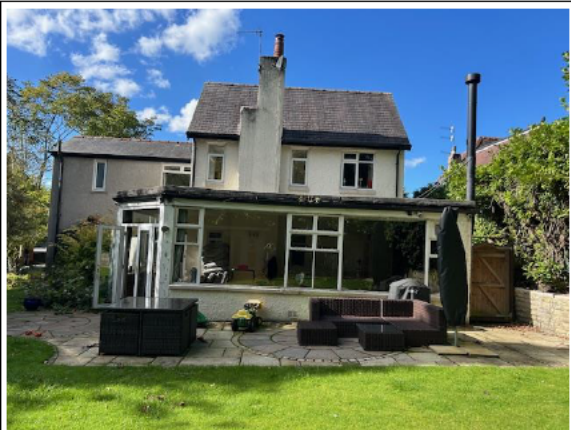
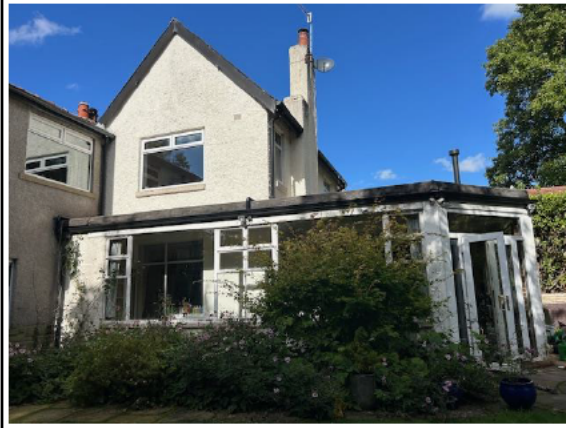
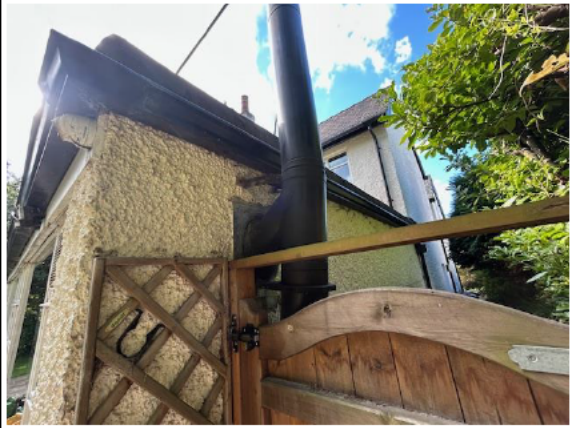
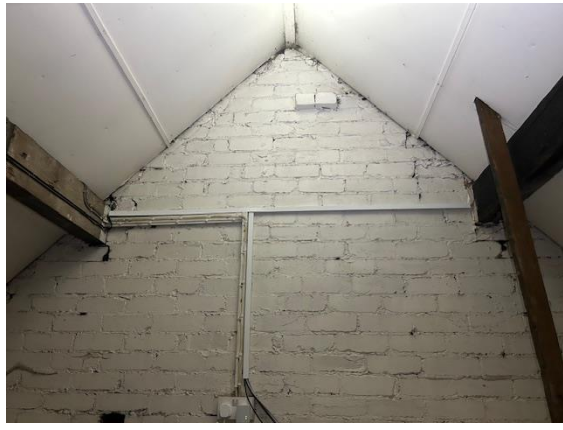
The property consists of a detached, two-storey house with a double pitched, slate roof.

External walls are rendered with no obvious cavities, cracks, gaps or crevices present. The narrow eaves are well sealed. All UPVC windows and doors are in excellent condition with no gaps.

At the rear of the property is a single-storey flat-roofed sun room extension. The roof is felted and in good condition with no visible gaps, lifted sections or crevices that could provide access opportunities for bats. External walls are rendered and the UPVC framed windows and doors are well-sealed and in good condition.

The chimney located at the rear of the property is in good condition with intact render and no visible gaps, cracks or crevices which could provide suitable access opportunities for bats. Lead flashing around the chimney is well fitted and securely sealed to the roof.

Roof tiles are close fitting with no obvious slipped, missing or lifted tiles present. Ridge tiles are pointed and sealed. Internally, the loft space around the chimney is fully boarded. All accessible loft spaces were inspected with no visual evidence of bats.

The building can be considered to offer negligible bat potential.
