Preliminary Roost Assessment

Lower Greystoneley Farm, Ash Barn, Leagram, Preston, Ribble Valley, Lancashire, PR3 2QS

This report is prepared to inform a planning application with the Ribble Valley Borough Council. The proposal is described as: Removal of existing front and rear porch, addition of chimney stack and roof light (alterations to roof), front extension [Unsubmitted].

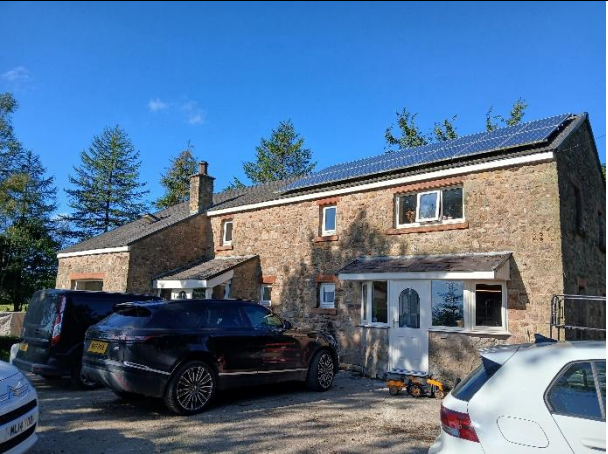
B1 Building description			Photographs
<p><i>Summary</i></p> <p>B1 is a two-storey residential property. The roof has slate tiles, and the walls are stone with solar panels along the southern elevation. The proposed development involves the removal of the front and rear porch, to facilitate an extension. None of the roof elevations have any lifted or missing tiles. The building has negligible habitat value for roosting bats.</p>

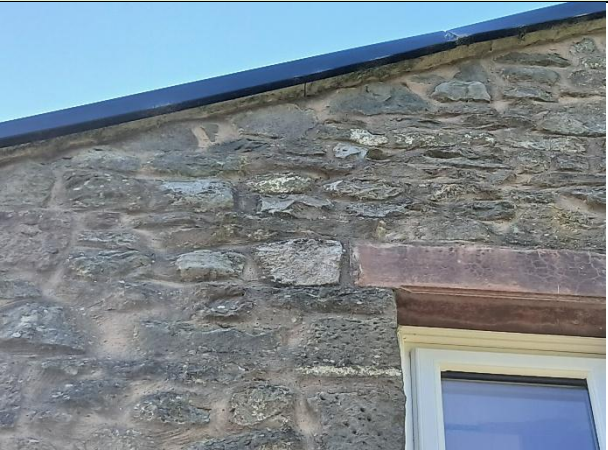
Feature	Materials	Condition/description/suitability	Photograph(s)
Walls	Stone	<p>Condition/description No areas of damage,missing stone or mortar.</p> <p>Suitability/access/evidence of bats Provides no suitable access into internal void for void dwelling bat species. No access to crevices on wall tops for crevice dwelling bat species. No evidence found but recent and current rain would wash this away externally.</p>

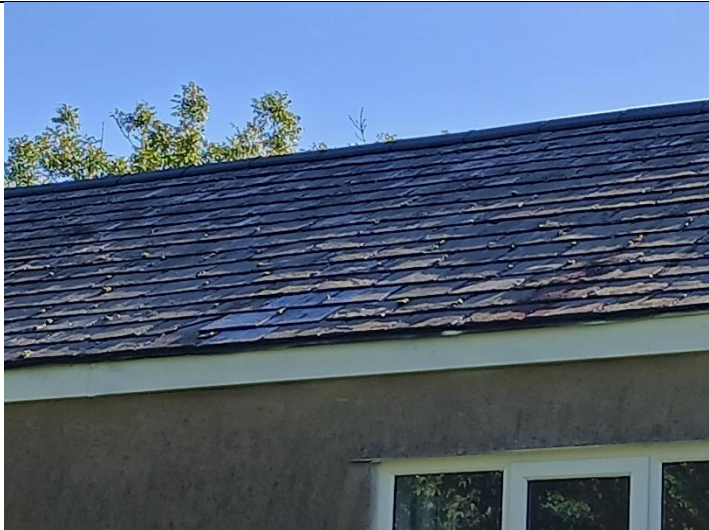
<p>Roof</p>	<p>Slate</p>	<p>Condition/description Gabled roof, cat slide on the southern and northern elevations. No lifted or missing tiles present, mortar is fully intact. There are a few tiles that do look to have been either recently replaced.</p> <p>Suitability/access/evidence of bats Provides no suitable access into internal void for void dwelling bat species. No access crevice dwelling bat species. No evidence found but recent and current rain would wash this away externally.</p>

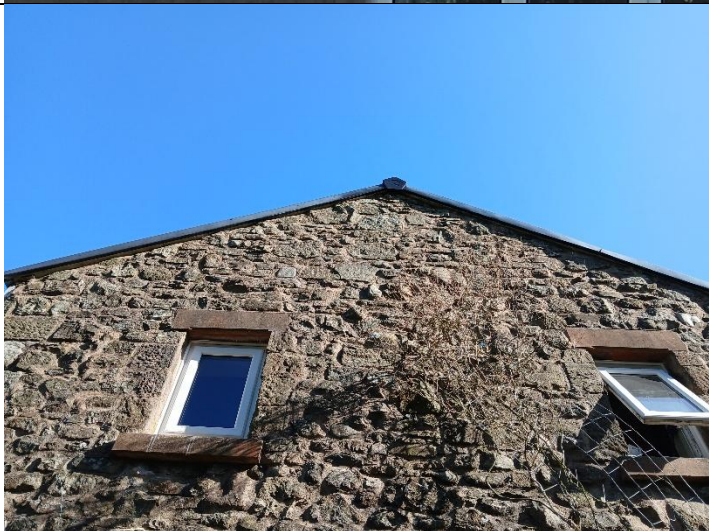
<p>Eaves</p>	<p>Flush to the building edge</p>	<p>Condition/description No gaps/crevices on wall tops.</p> <p>Suitability/access/evidence of bats Provides no suitable access into internal void for void dwelling bat species. No access to crevices on wall tops for crevice dwelling bat species. No evidence found but recent and current rain would wash this away externally.</p>

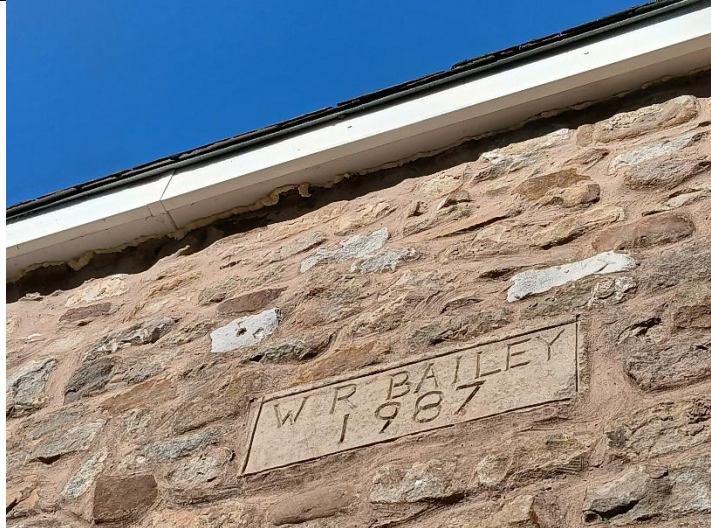
<p>Barge boards/fascia boards</p>	<p>Plastic barge board</p>	<p>Condition/description Intact and complete barge boards with no gaps or areas of damage.</p> <p>Suitability/access/evidence of bats No suitable bat access into internal void or crevices on wall tops. No evidence found but recent and current rain would wash this away externally.</p>

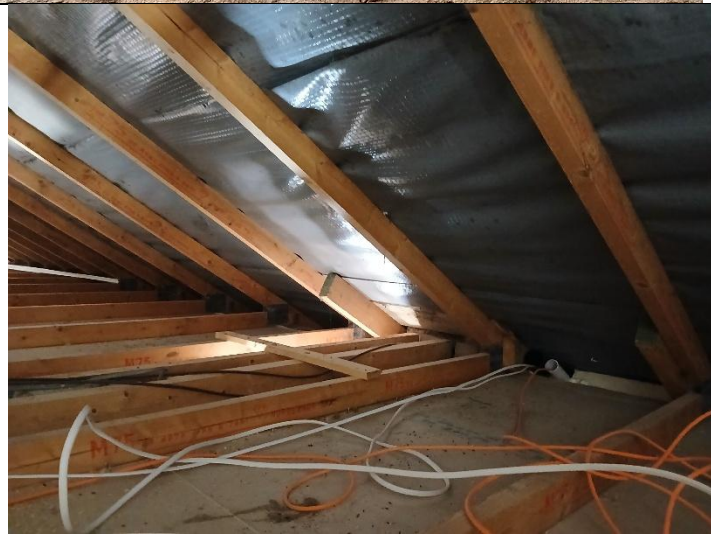
<p>Internal voids</p>	<p>Timber rafters and ridge beam. Open floor to ridge.</p>	<p>Condition/description Internal space measures approx. 16m long, 2.5m wide, floor to ridge height approx. 1m. Recent works to the loft space include the installation of air conditioning the cleaning of the loft insulation material. No daylight was visible from within the loft space, but lighting is installed within the loft, as the building is being internally renovated there is frequent disturbance.</p> <p>Suitability/access/evidence of bats No droppings were found inside the loft space, no staining or scratches on the beams. The low ridge height makes the space largely unsuitable for void dwelling bat species due to the lack of warm up space. The plastic lining appeared intact and flush.</p>

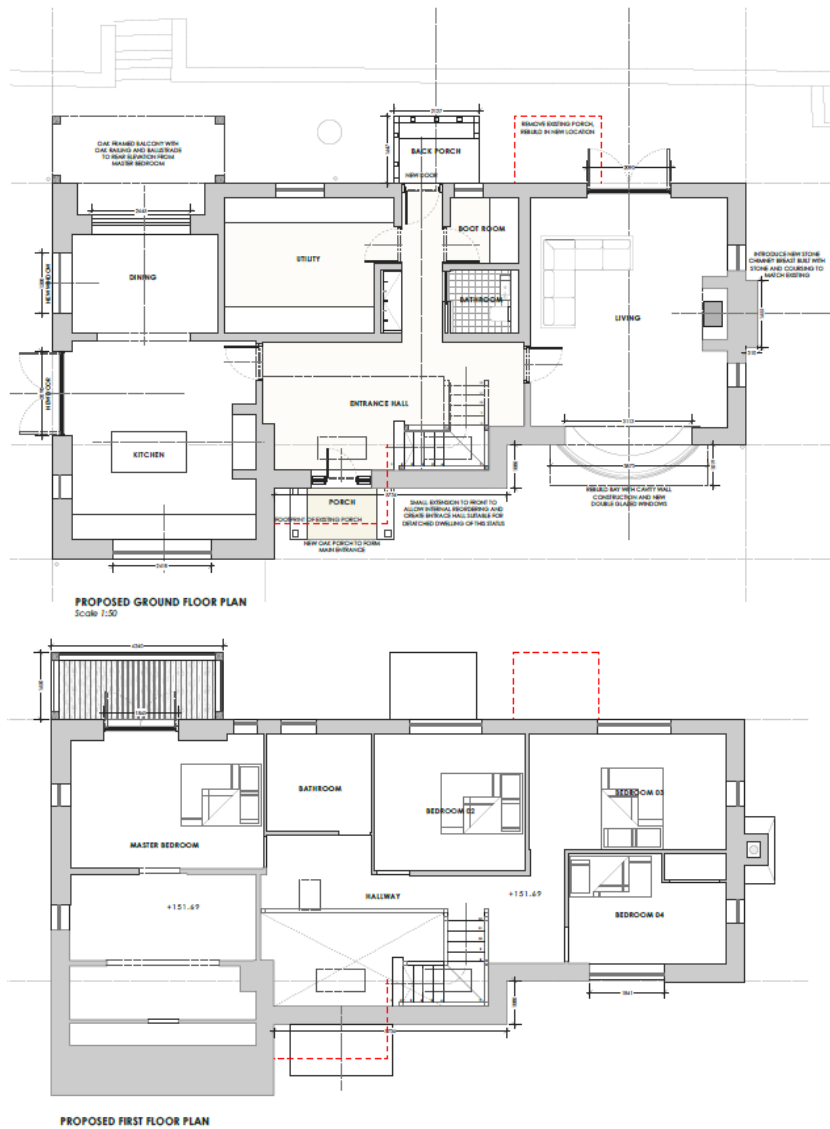
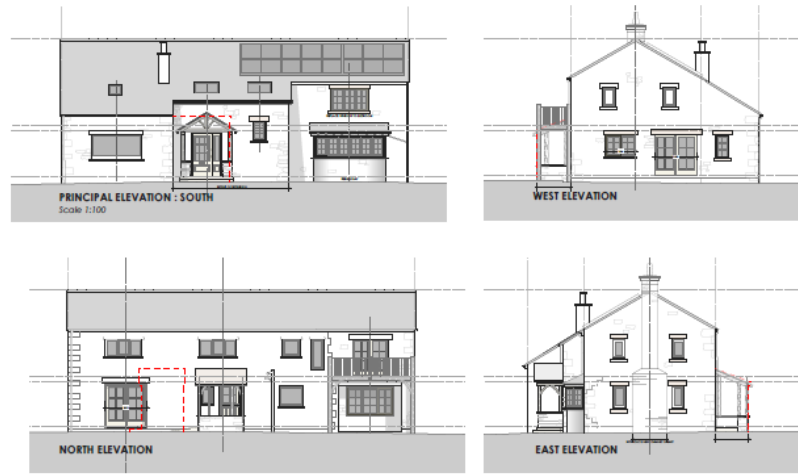
Appendix 3: Proposed plan

EXISTING MATERIALS
THE EXISTING DWELLING IS OF TYPICAL MODERN CONSTRUCTION, BEING CONSTRUCTED IN THE 1980'S IT IS OF CAVITY CONSTRUCTION FINISHED WITH RANDOM RUBBLE STONES WITH QUOINS TO THE CORNERS AND HAS A NATURAL GREY SLATE ROOF. PARTS OF THE REAR ELEVATION HAVE BEEN RENDERED TO THE QUOINS.
PREVIOUSLY THERE HAS BEEN A FRONT PORCH ADDED AND A CURVED BAY WINDOW, FROM INVESTIGATION ON THE COUNCIL'S PLANNING HISTORY IT COULD BE ASSUMED THAT THIS BAY WINDOW REPLACED A FORMER GARAGE. THE BAY HAS NOT BEEN BUILT WELL AND DOES NOT CONTAIN A DAMP PROOF COURSE OR CAVITY. THERE IS ALSO A REAR PORCH AND ALL EXTENSIONS HAVE GREY SLATE ROOFS. THERE ARE SOLAR PANELS ON THE MAIN ROOF. THE WINDOWS AND DOORS ARE A MIXTURE OF SIZES ALL FINISHED IN A PAINTED OFF-WHITE UPVC. THERE ARE IMITATION CONCRETE FORMED HEAD AND CELLS TO THE WINDOWS AS SHOWN ON THE DRAWINGS. THERE APPEAR TO HAVE BEEN FINISHED WITH A COLOURED CONCRETE.

ALL THE RAINWATER GOOD ARE UPVC
THERE IS AN EXISTING ROOFLIGHT AND SOME CHIMNEY. THERE IS A SHED ON THE DRIVE WHICH ALSO CONTAINS THE WATER FILTRATION SYSTEM FOR THE DWELLING

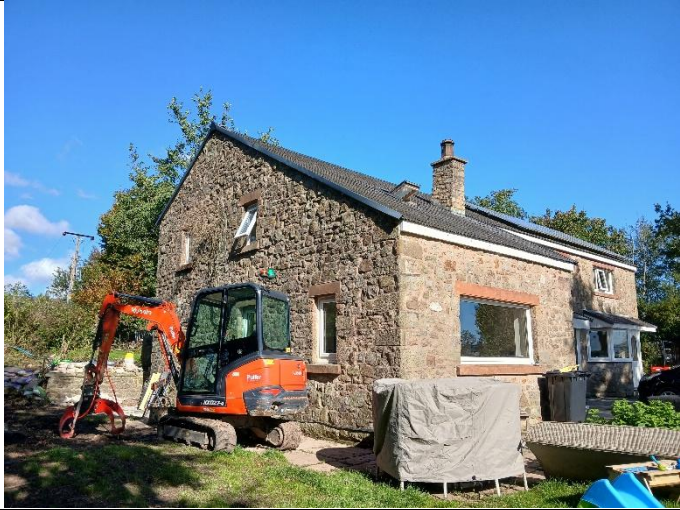
<p>Figure 3: View from the southern corner, showing the southern and western elevations</p>
Southeastern elevation	Description

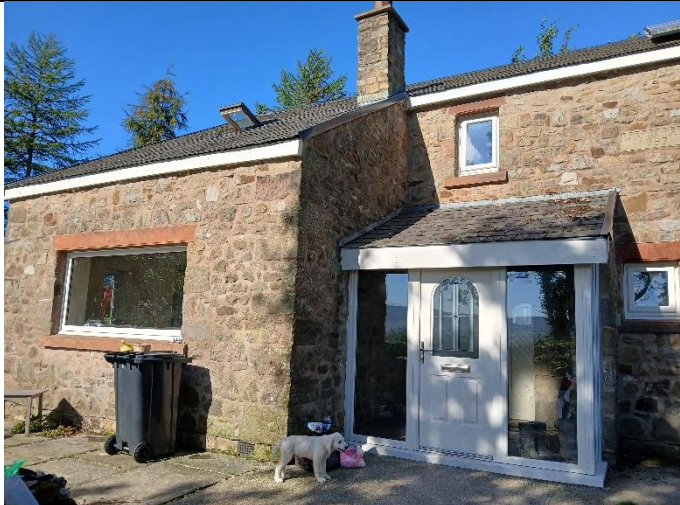
<p>Figure 4: A view of the front of the property showing the front porch</p>

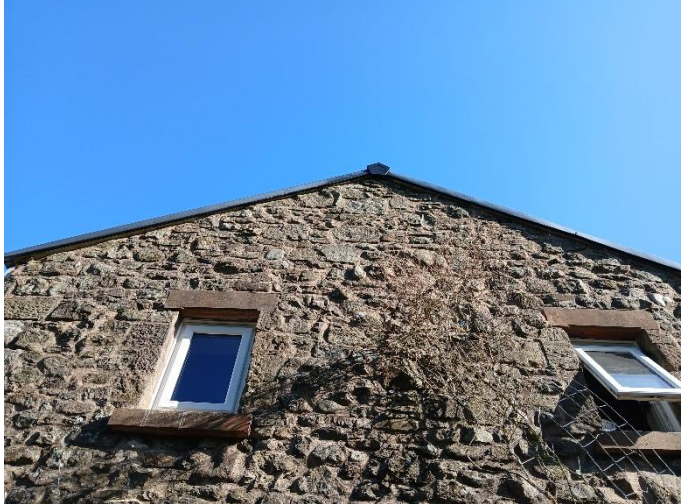
<p>Figure 5: Eaves present were flush with the wall tops</p>
Roof	
Photograph	Description

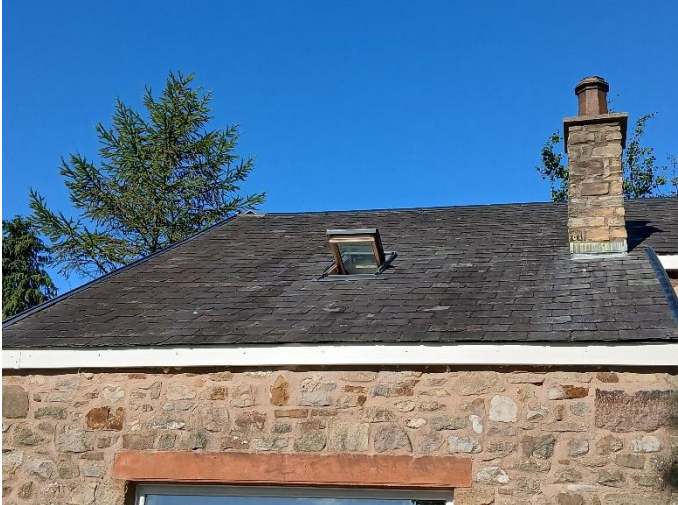
<p>Figure 6: Slate tiles present along the southern catslide</p>

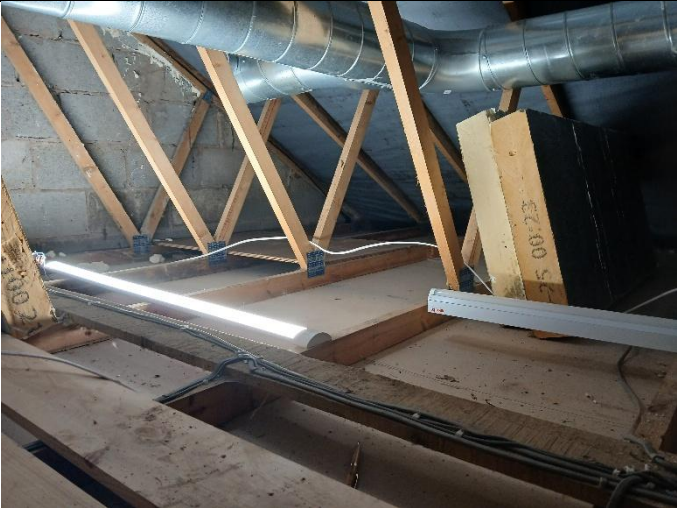
<p data-bbox="1384 453 1778 486">Figure 7: The internal loft space</p>
Southern porch	
Photograph	Description

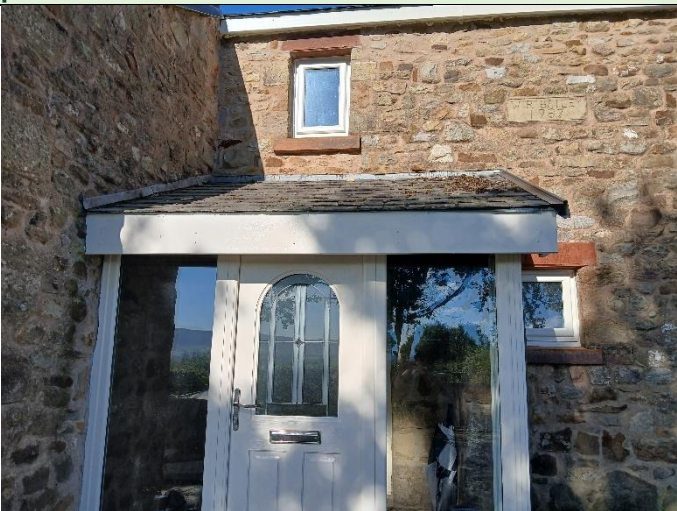
<p data-bbox="1348 1034 1816 1067">Figure 8: A view of the southern porch</p>

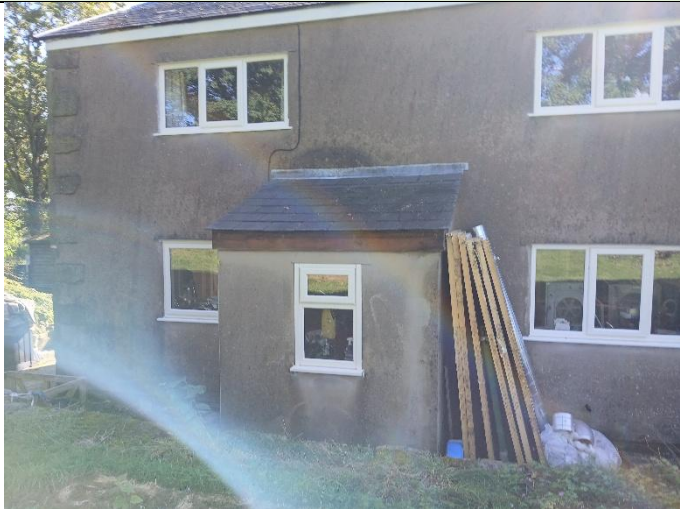
<p>Figure 9: A view of the northern porch</p>
