# PHASE I PRELIMINARY CONTAMINATION RISK ASSESSMENT

**SALESBURY VIEW ROAD, WILPSHIRE, LANCASHIRE, BB1 9PL**  
**PERSIMMON HOMES (LANCASHIRE) LIMITED**

| <b>Report Type</b> | <b>Phase I Preliminary Contamination Risk Assessment</b> | | |

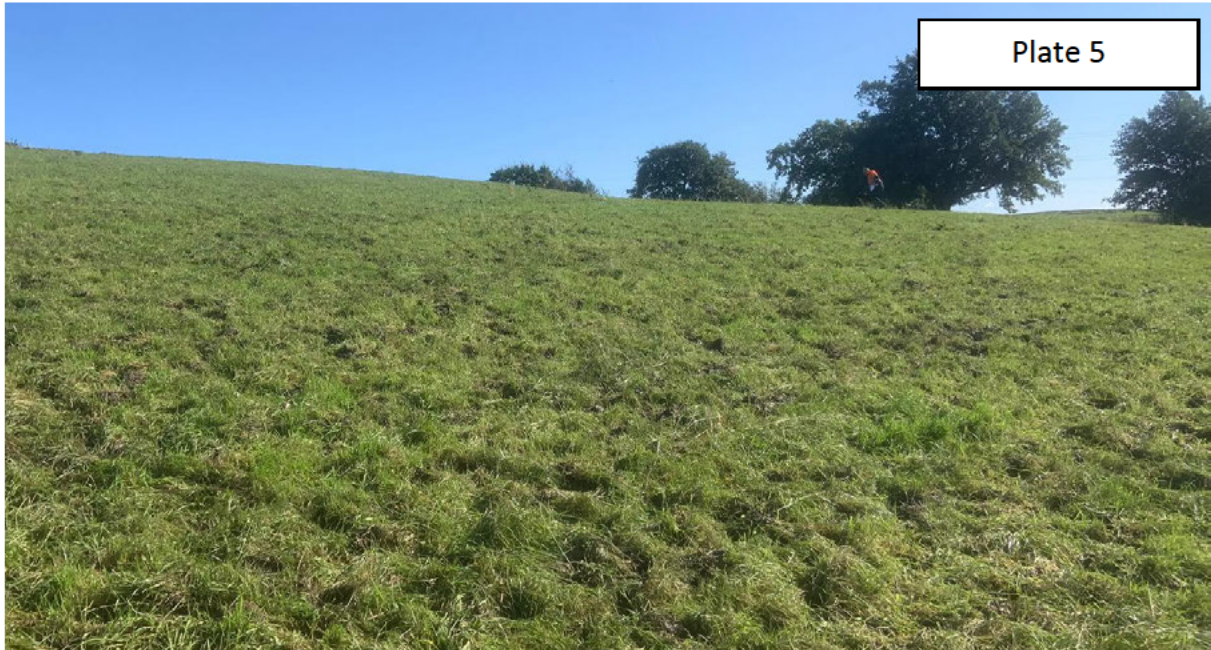
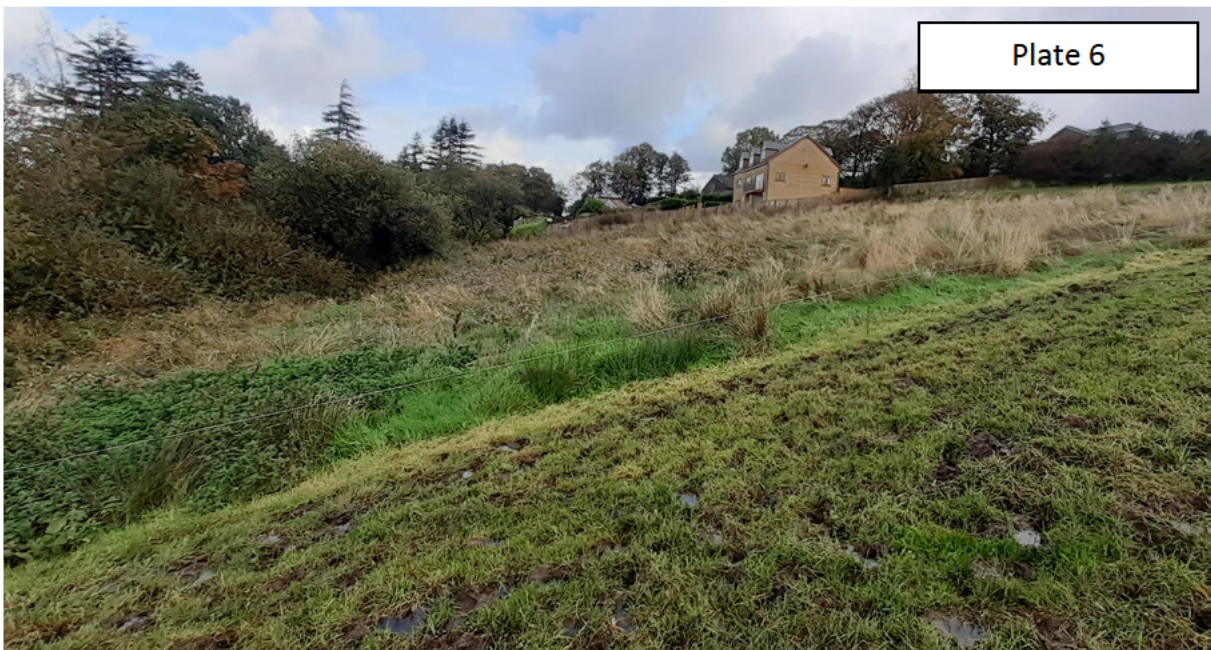
**SITE PHOTOGRAPHS**

| Detail | Description |
|---|---|
| Additional comments | The ground surface is noted to be heavily saturated / waterlogged. An electric fence surrounds the boundary of the two fields, with grazing cattle occupying the southern fields. An area of unmanaged / overgrown vegetation was noted on the north-western portion of the site, with occasional Himalayan Balsam noted. |

During the reconnaissance (walkover) survey it was noted that there is significant standing surface water / waterlogged ground conditions across the site, and surface water was noted to be flowing from the site onto Salesbury View Road. Appropriate surface water management will need to be adopted to deal with the future management of positively drained surface water, when considering the development of this site.
