# PHASE II GROUND INVESTIGATION REPORT

**SALESBURY VIEW ROAD, WILPSHIRE, LANCASHIRE, BB1 9PL  
PREPARED FOR PERSIMMON HOMES (LANCASHIRE) LIMITED**

| <b>Project No.</b> | <b>GEOL19-9938</b> | <b>Client</b> | <b>Persimmon Homes (Lancashire) Limited</b> |
| <b>Report Type</b> | <b>Phase II Ground Investigation Report</b> | | |

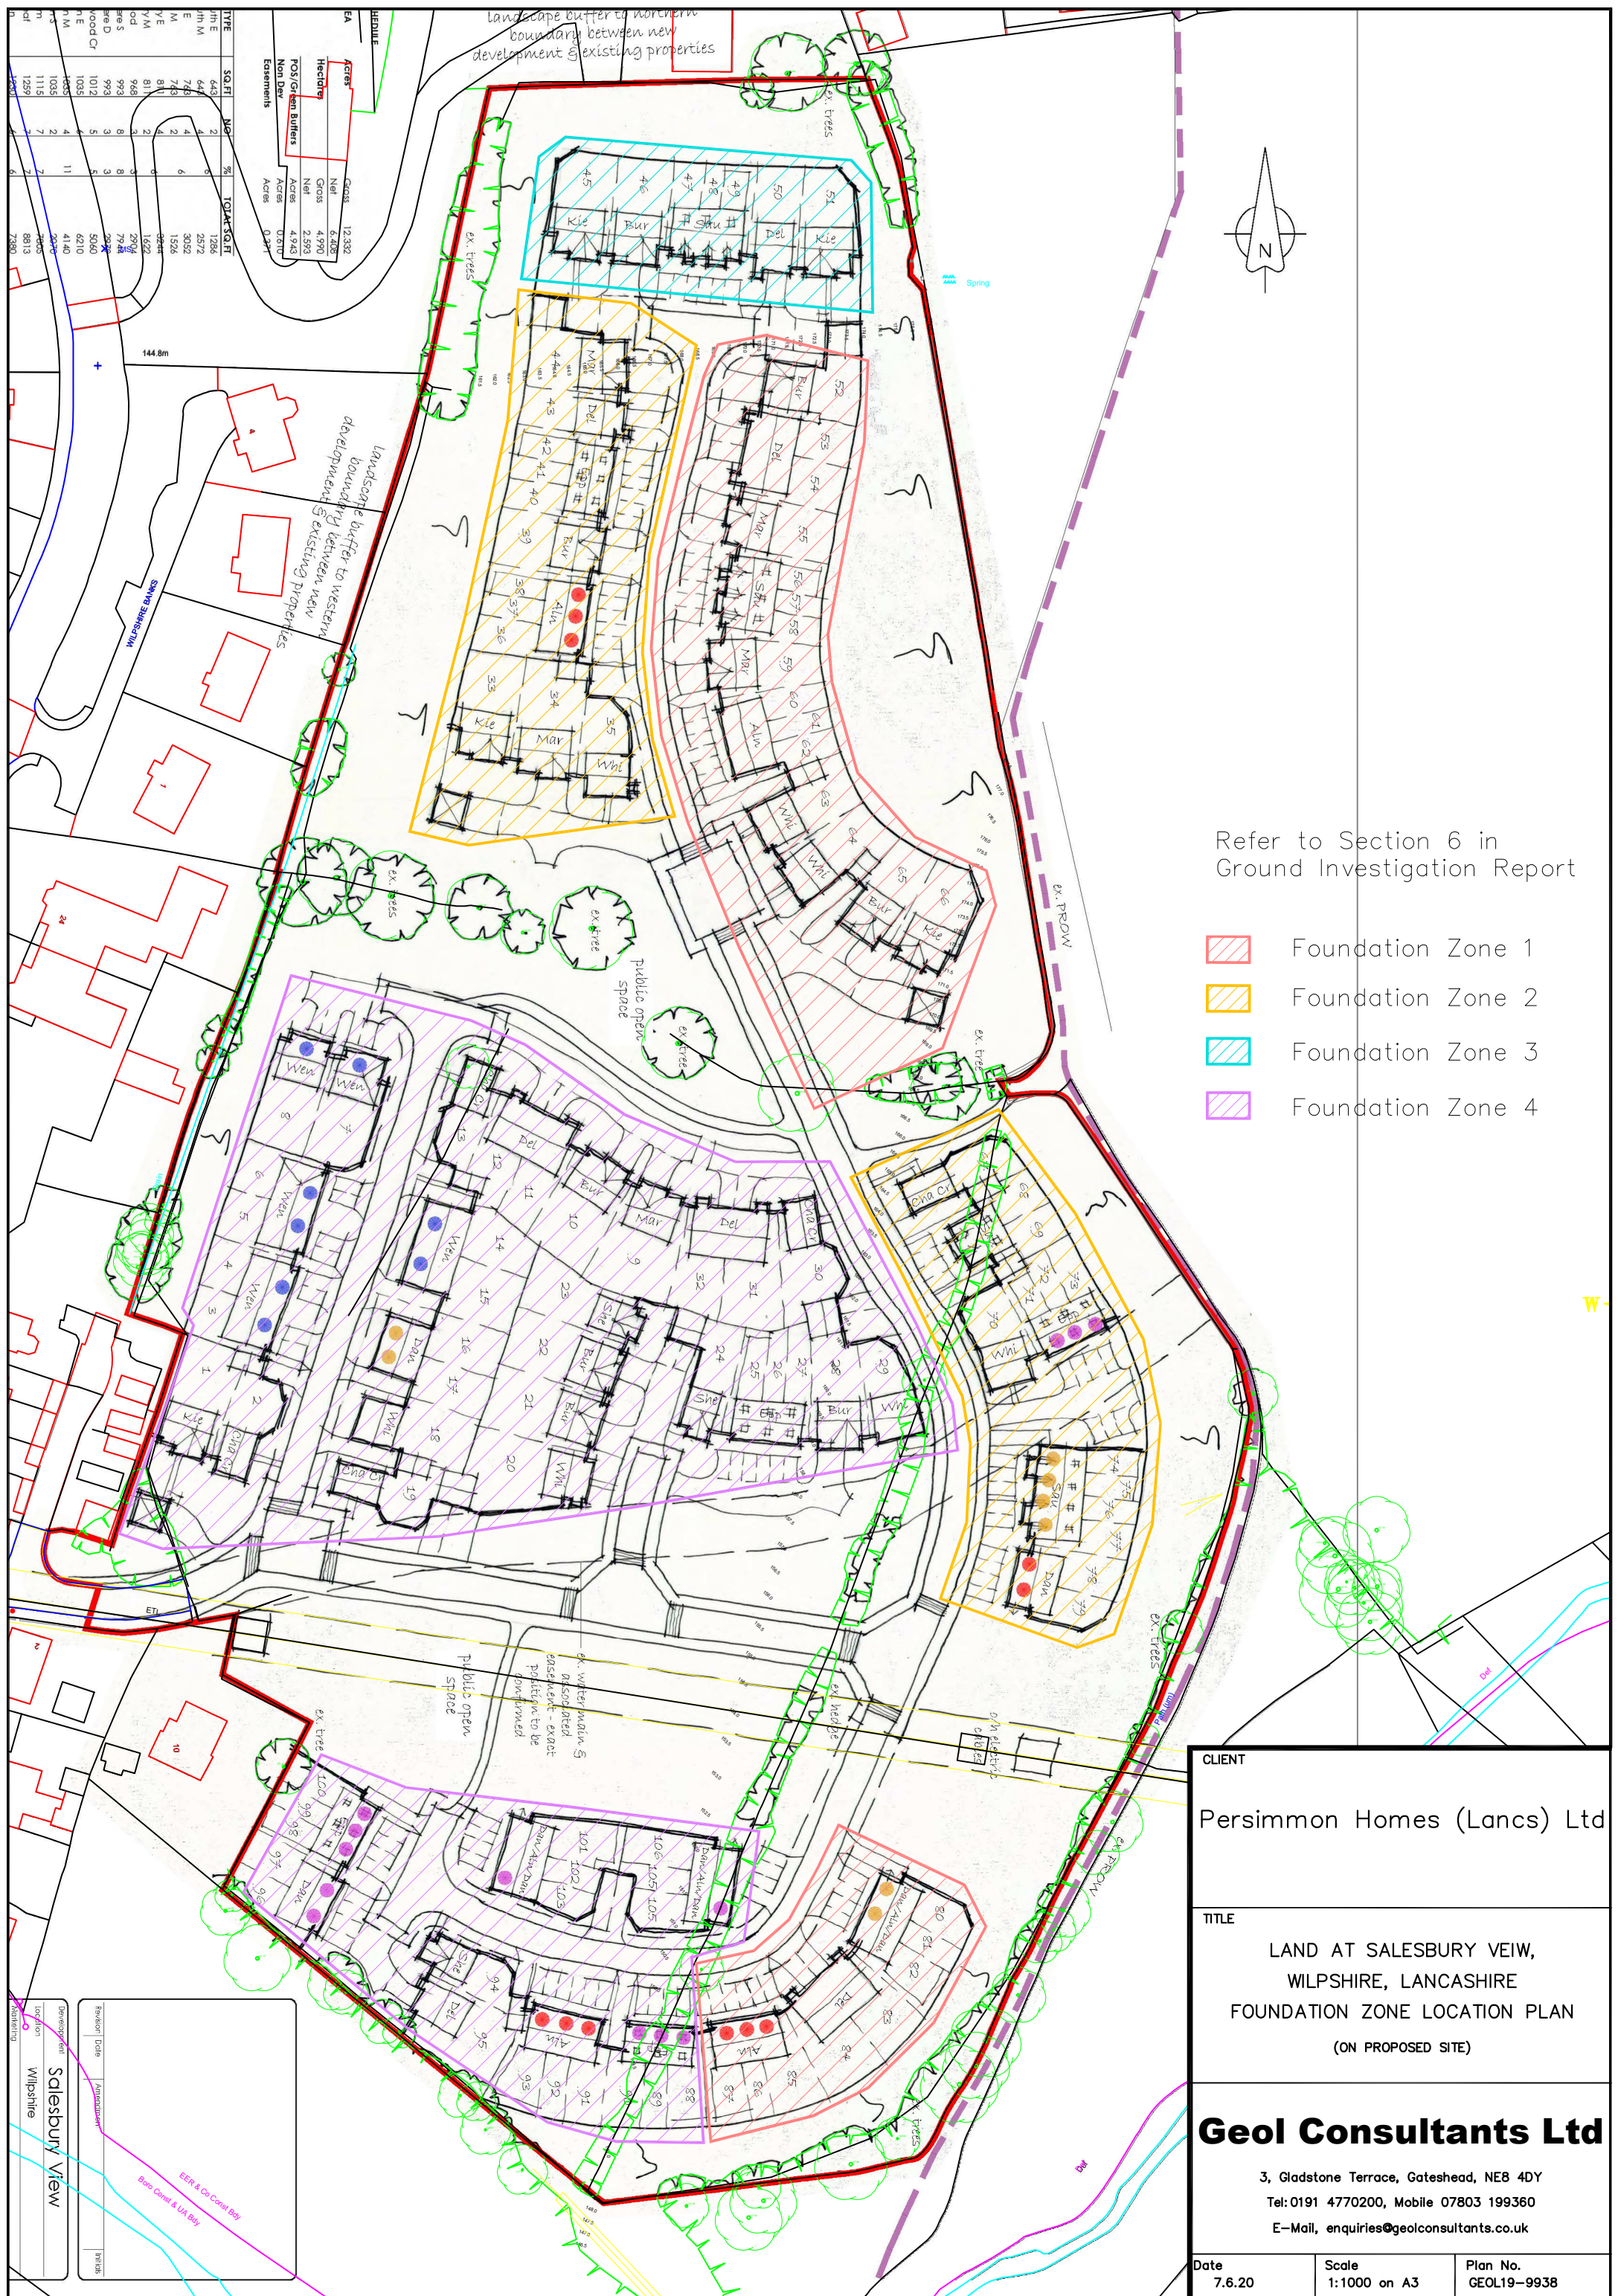
## **FOUNDATION ZONE LOCATION PLAN**

| Foundation zone | Plot range | Investigation positions | Min. foundation depth | Max. allowable bearing pressure | Comments |
| Zone 1 | 52 to 66 and 80 to 87 | TP's 01, 03, 06, 15, 16, BH's 04, 12, 14, 17, DP's 01, 03, 05 & 12 | 0.60m | 150kN/m <sup>2</sup> | Taking into account reductions in site levels, foundations will be wholly based within sand / coarse deposits |
| Zone 2 | 33 to 44 and 67 to 79 | TP's 02, 12 to 14, BH's 05, 11, 15 & 16, DP's 02, 04, 08 & 09 | 0.90m | 100kN/m <sup>2</sup> | Foundations could straddle between both sand and clay deposits below these proposed plots |
| Zone 3 | 45 to 51 | BH18 | 1.35m | 100kN/m <sup>2</sup> | Peat deposits in this location will require excavation and removal from below proposed building plots and foundations should be based wholly within sand deposits |
| Zone 4 | 1 to 32 and 88 to 106 | TP's 07 to 11, 17, 18, BH's 01, 02, 06 to 10, DP's 06, 07, 10 & 11 | 0.90m | 60kN/m <sup>2</sup> | Variable clay and sand deposits will be present below these plots and therefore widened reinforced strip footings will be required, or alternative foundation options could be considered, i.e. ground improvement or piling |

Conventional shallow strip foundations can be considered for the whole of the proposed development, however a plot specific foundation schedule has been devised based on the ground conditions encountered, and these foundation zones can be seen on the foundation zone location plan in Appendix V. Where necessary consideration has been given to the overall allowable bearing capacity and settlement characteristics of the ground where foundations are placed either directly within natural clay or sand strata. In addition, differential settlement has been taken into account where foundations could straddle between both sand and clay deposits. Foundations should be suitably reinforced which will provide added support given the variability of some of the recorded ground conditions encountered.
