**Re: Bat survey at Wilpshire Lane Cottage, Vicarage Lane, Wilpshire, BS9 1HN**

We understand that this survey has been requested to inform a planning application for a double storey extension to the west elevation of an existing dwelling house.

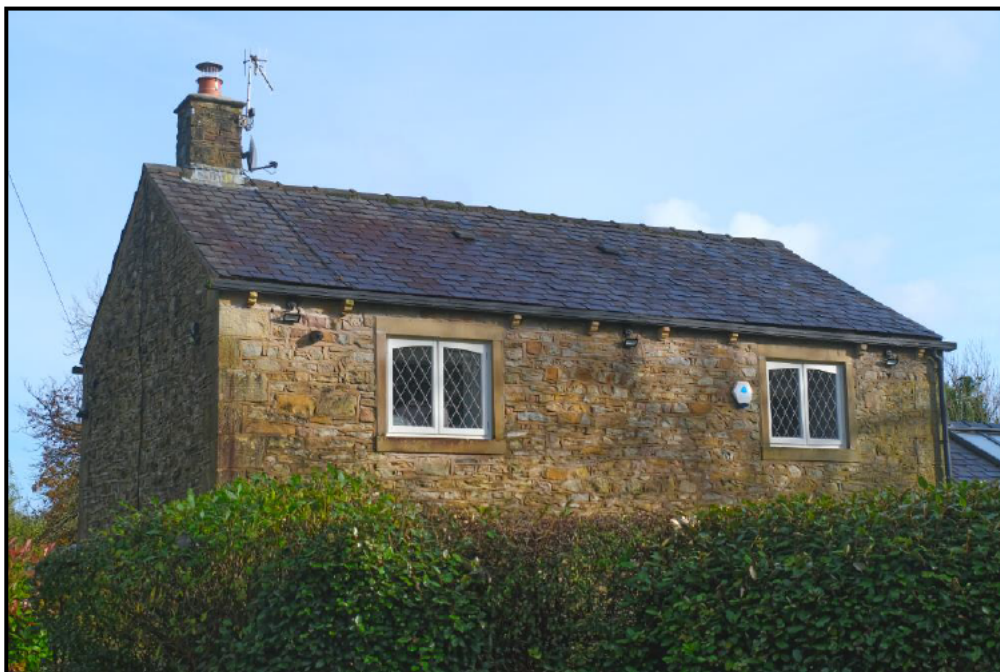
*Image of Wilpshire Lane Cottage, south (front) elevation of two storey detached, main house*

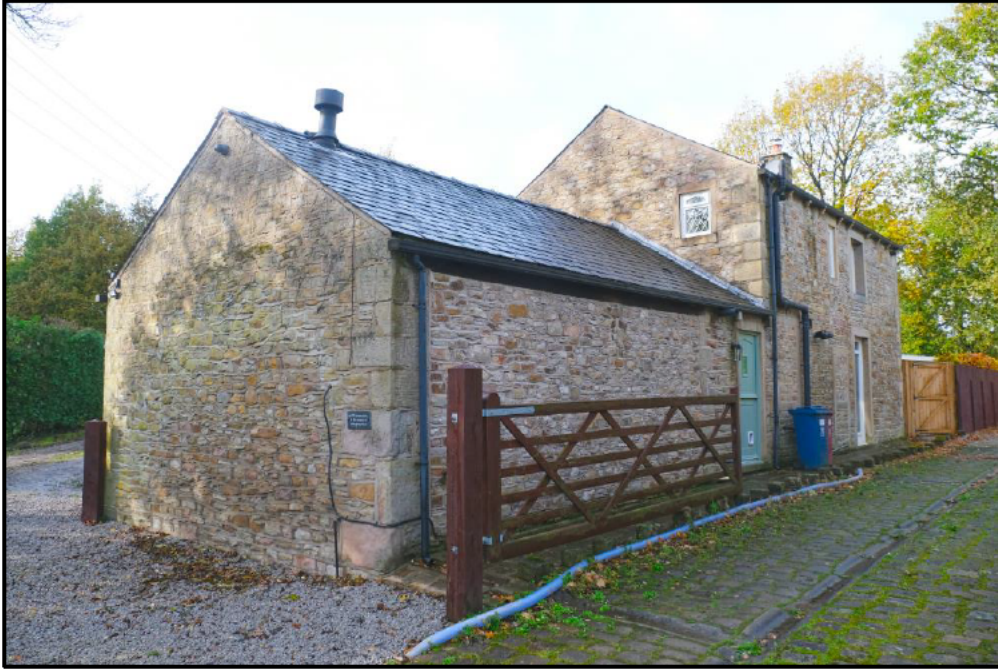
*Image of Wilpshire Lane Cottage, east (side) and north (front) elevations of two storey main house and single storey extension*

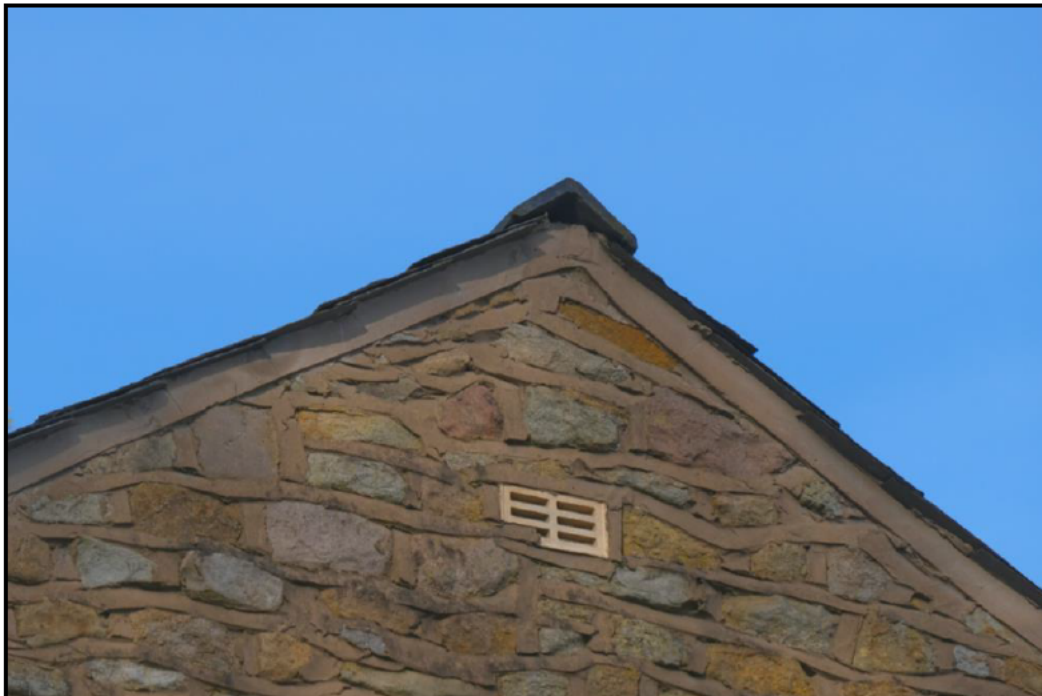
*Image of east gable, verge is mortared and sealed but single gap present at the apex*

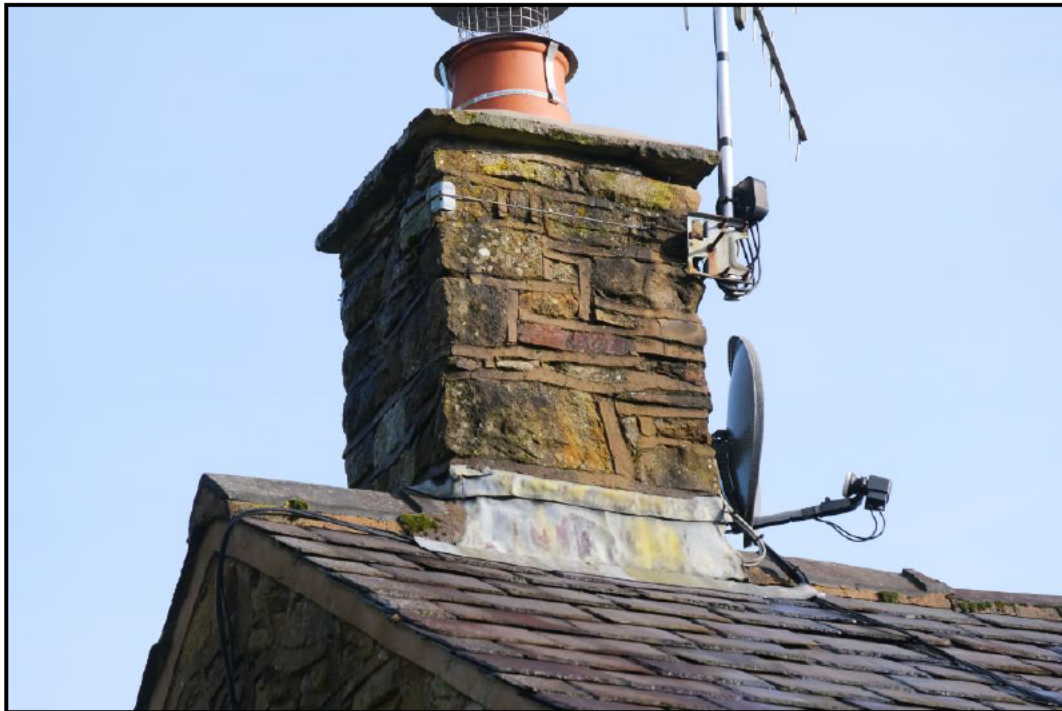
Low potential – roof coverings and wall tops.

*Image of west gable showing chimney, ridge and roof coverings. Roof verge and apex sealed but suitable gaps are present in roof coverings and along adjacent ridge*

The assessment above reflects the condition of the features and their environment. It is the professional judgement of Ecology Services UK Ltd that if all impacts to the existing roof coverings, as well as north and south elevation wall tops can be avoided then no further surveys are warranted at this time.

Impacts include scaffold placement and use, covering of existing roof slates, as well as removal, lifting and replacements of existing roof slates.

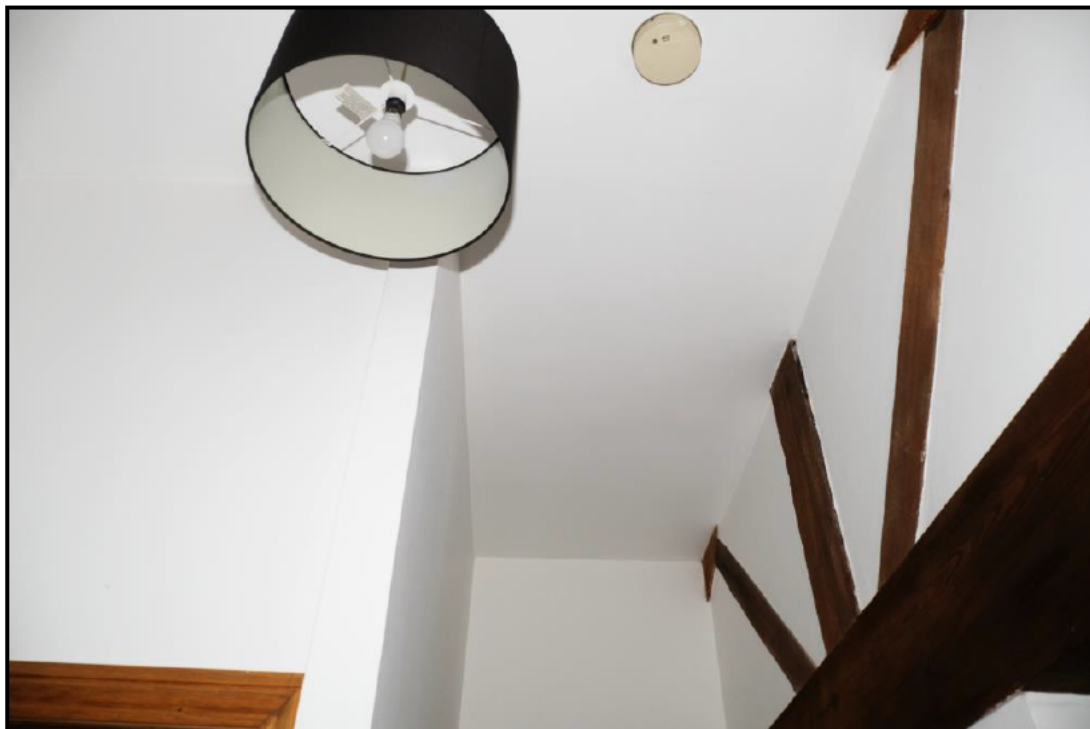
Internally, the first-floor rooms are vaulted and there is no accessible roof void. The single storey extension is fully vaulted with Velux windows and no roof void present. A small, shallow roof void remains enclosed along the length of the ridge on the main house. Small sections of bitumastic hessian roof liner are visible roof edge gaps, confirming that at least part of the roof is underlined with bitumastic hessian roof liner. This type of feature (enclosed dark space with slate roof and bitumastic liner), in this landscape setting has potential for use by roosting bats.

*Image showing vaulted ceiling in first floor stairwell.*

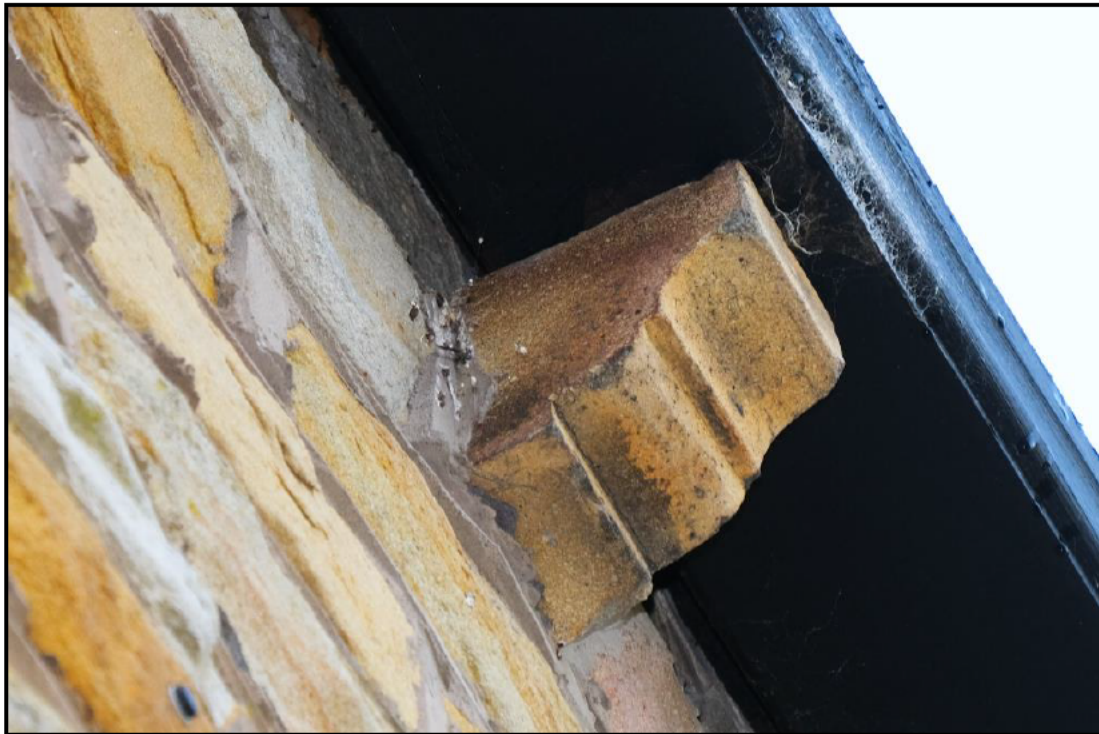
Bird droppings were found at the wall top on the north elevation.

There is high potential for nesting birds to utilise the building, during the nesting season (February to September).

*Image showing bird droppings below wall top gap north elevation. Wall top gaps have potential for use by bats.*

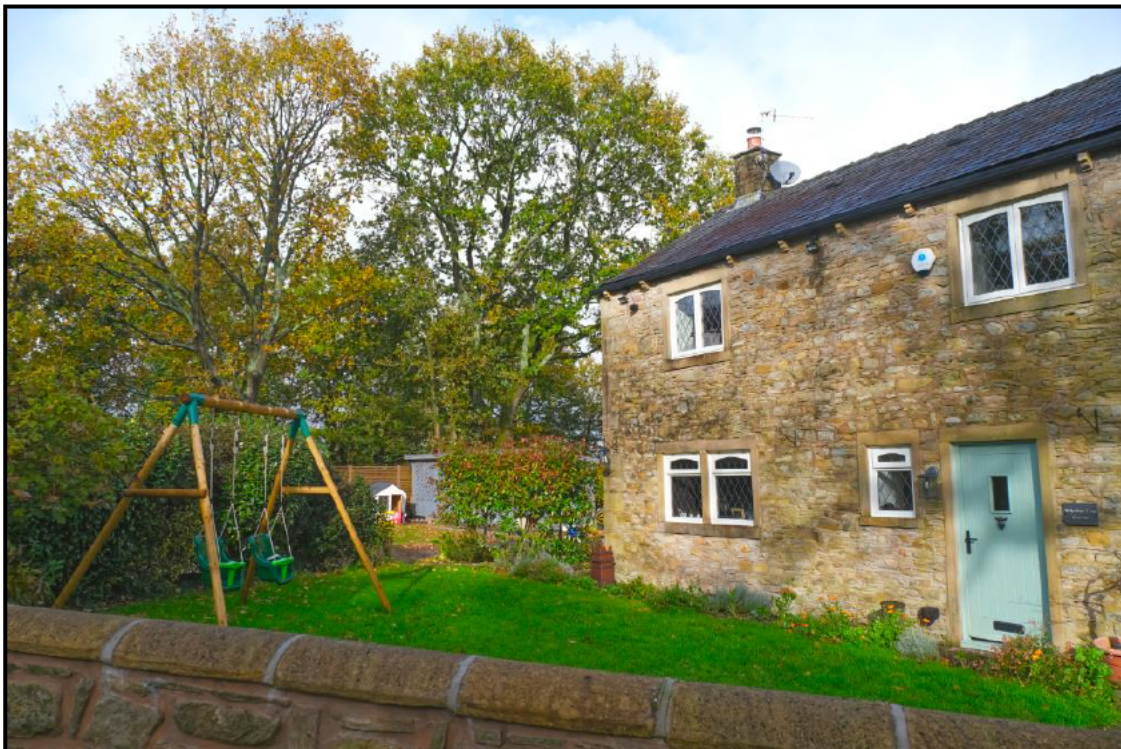
There is high potential for nesting birds to utilise garden vegetation as well as the mature trees in close proximity to the western boundary and proposed work area during the nesting season (February to September).

*Image of Wilshire Lane Cottage and garden setting, showing close proximity of mature trees and established garden vegetation with potential to support nesting birds.*
